## Memorandum For Record

**Date: July 1, 2022**  
**NTSB Accident Number: ERA21LA170**

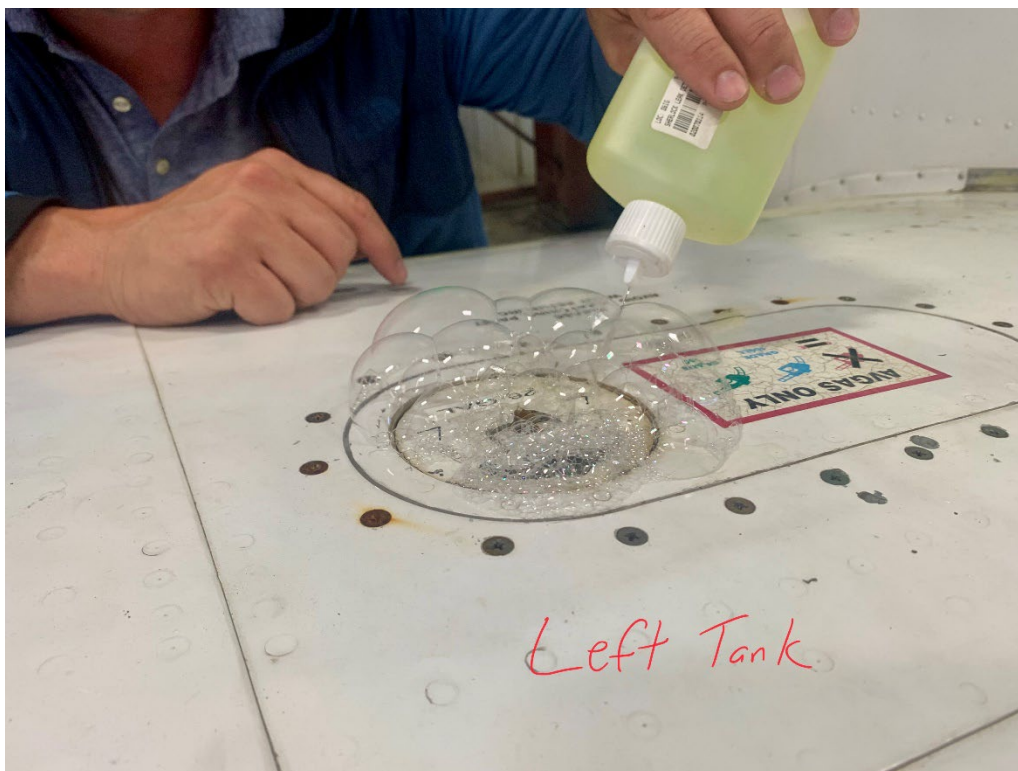
As part of the on-wing pressure testing of the fuel caps, “Sherlock Gas and Air Leak Detector Type I” (Sherlock) test fluid was used to detect leaks in the area of the fuel caps<sup>1</sup>. The test conditions were no more than .5 psi applied to the respective fuel vent line, the fuel selector off, and a solution to detect leaks. The fuel caps which were previously labeled by the Federal Aviation Administration inspector were verified to be installed on their proper side. The air pressure was set to .5 psi and the Sherlock was applied to the outer perimeter of the left fuel cap. Immediately large air bubbles were noted (Figure 1). The solution was dried and then added to the axle area of the cap and no bubbles were noted. The fuel tank access panel that housed the fuel cap was then tested on the perimeter and no fuel leaks were noted.

Figure 1: Digital Photograph From David Stanton. Left Fuel Cap Pressure Test Results.

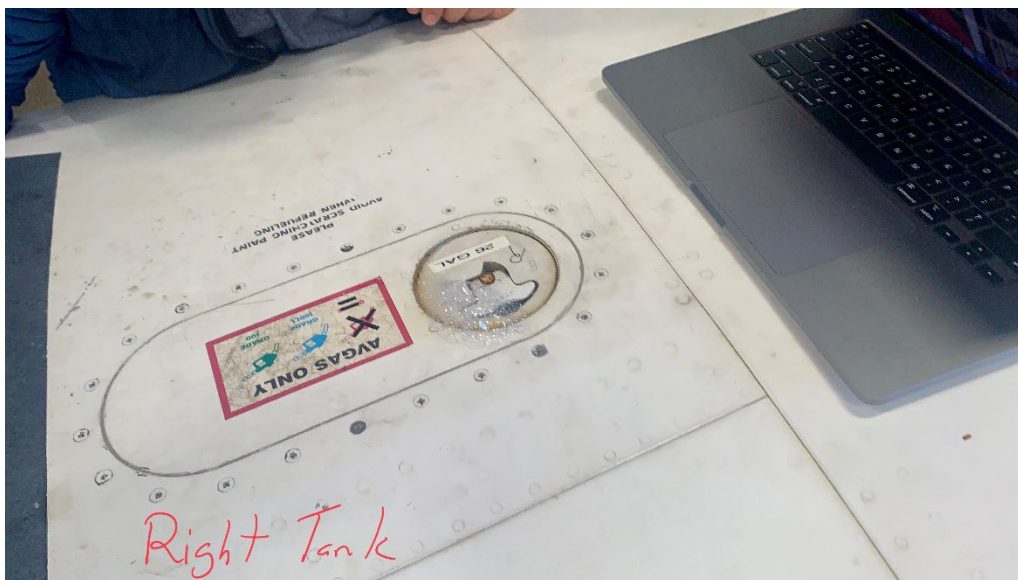
The right side fuel cap was then inspected for the original marking and was placed back into its receptacle on the wing. The fuel tank was pressure tested to .5 psi through the fuel tank vent line and small bubbles were noted on the aft side of the cap near the lever (Figure 2), or about the 7 o’clock position when viewed from the pilot’s seat looking forward. The solution was dried and then added to the axle area of the cap and no bubbles were noted. The fuel tank access panel that housed the fuel cap was then tested on the perimeter and no fuel leaks were noted. Following the testing both fuel caps were sent to the fuel cap manufacturer’s facility in Florida for testing.

Figure 2: Digital Photograph From David Stanton. Right Fuel Cap Pressure Test Results. Note the Small bubbles.

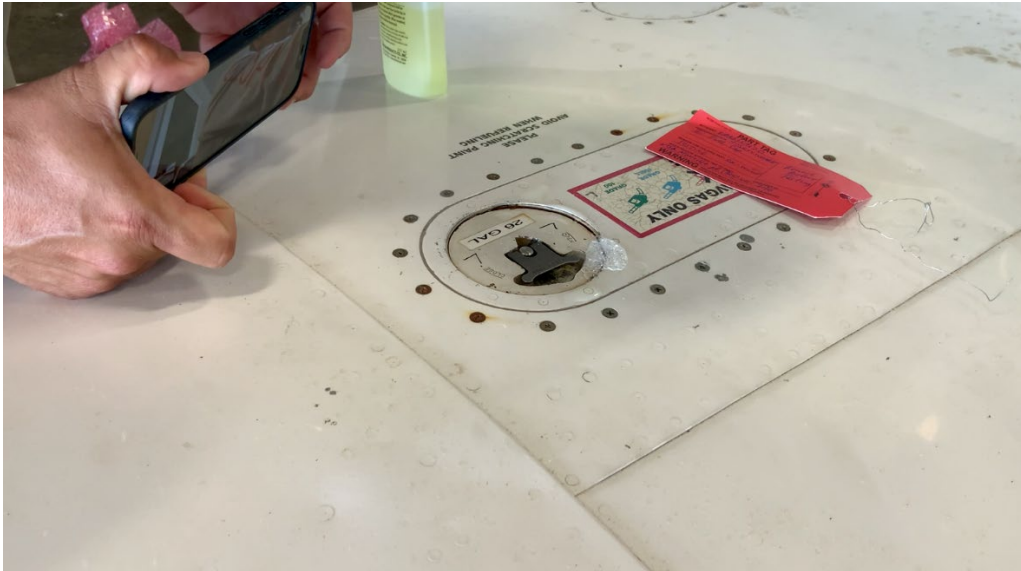
The fuel caps were returned to the salvage facility to repeat the on-wing testing, using the same Sherlock test fluid. During testing of both fuel caps done at .5 psi applied to the fuel vent. During testing of the left fuel cap bubbles were immediately noted at the 5 o'clock position<sup>2</sup> (Figure 3), but there was no leak noted around the axle. During testing of the right fuel cap, small bubbles were noted at the 7 o'clock and 11 o'clock positions<sup>3</sup> (Figure 4). There was no leak noted around the axle.

Figure 3: Digital Photograph From David Stanton. Left Fuel Cap Pressure Test Results After Fuel Cap repair. Note the Small Bubbles and the decreased Amount Compared to the Original Test in Figure 1.

During examination of the fuel caps at the manufacturer’s facility, both had loose handles and exhibited very little resistance and no audible snap when the handle was closed and locked. Testing of the left fuel cap could not be completed because of the extensive leakage, while the right fuel cap failed the pressure testing. Both fuel caps were completely disassembled revealing the outer and inner o-rings of both were dimensionally correct. Both contained unapproved, modified, and/or missing parts. Both fuel caps were re-assembled with new hardware as required and passed the acceptance testing which included pressure testing to 25 psig.

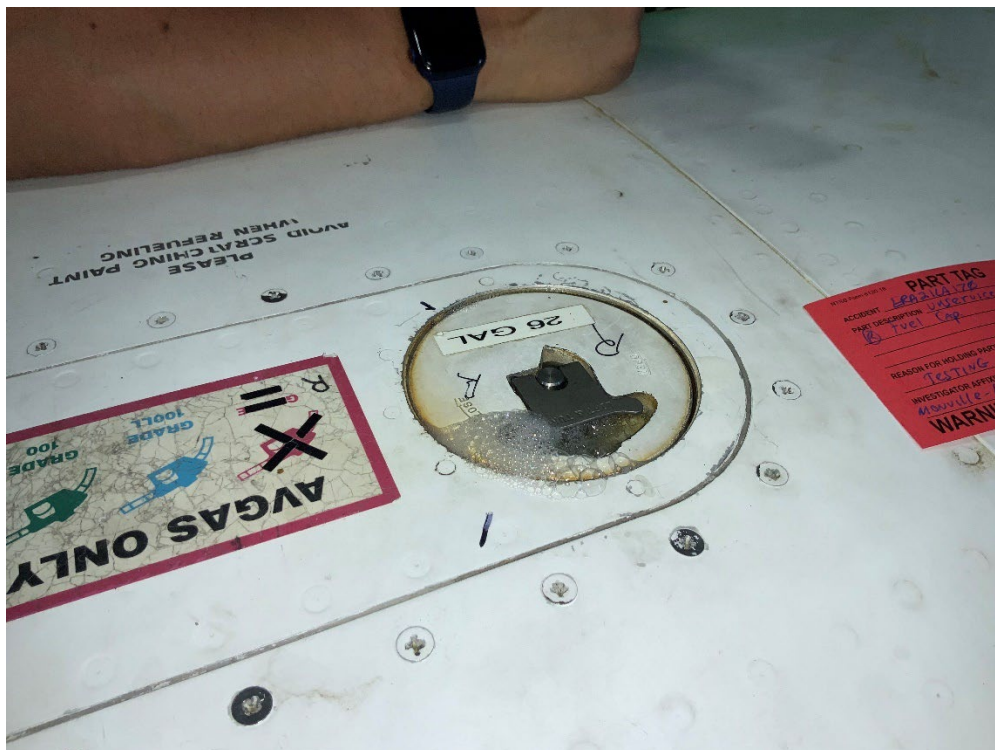
Figure 4: Digital Photograph From David Stanton. Right Fuel Cap Pressure Test Results After Fuel Cap repair. Note the Small Bubbles and the Slight decreased Amount Compared to the Original Test In Figure 2.
