## **ERA21LA173**

### **Hartzell Propeller Air Safety Investigator Examination** **Summary Rev. A 1/26/2022 (see change bars)**

Aircraft: Piper PA-23-250 Aztec

Aircraft Registration: N5018Y

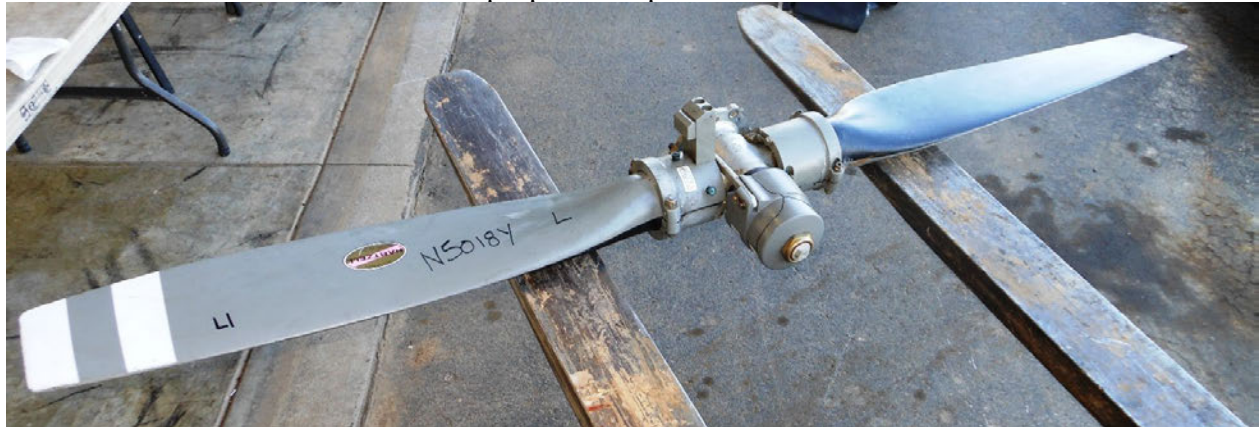
The aircraft components were recovered from the crash scene by AMF and stored at their facility on the Springfield Robertson County Airport, Springfield, TN. Only the left propeller was disassembled during this examination due to questions about state of operation of the left powerplant prior to impact. The right propeller was examined only visually/externally. The left propeller was presented for examination as shown in Photo #1. Both blades and the pitch change mechanisms were in a feathered position and the piston was fractured.

Photo #1 – Left propeller as-presented for examination

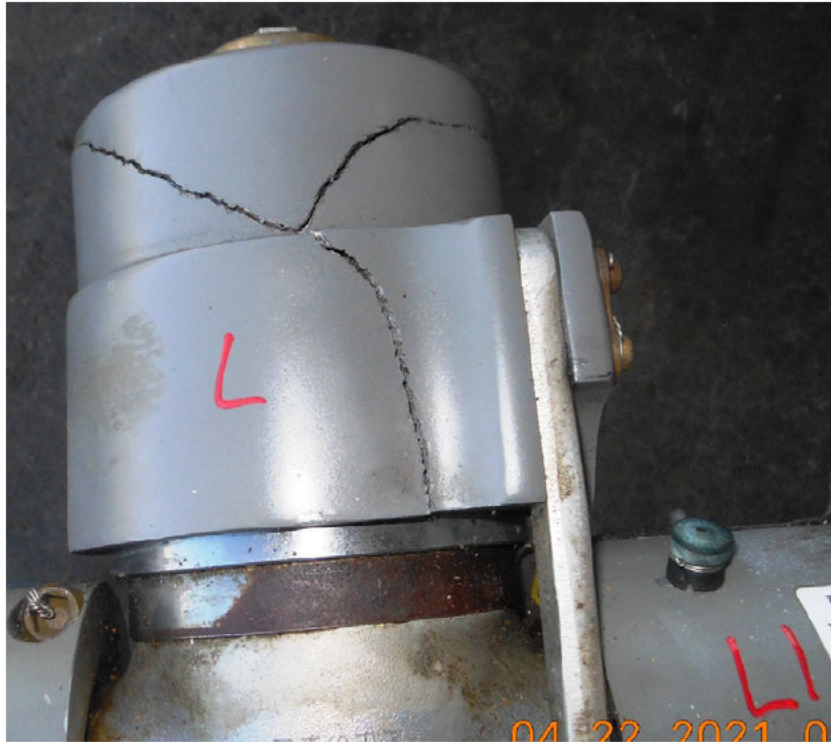
The left propeller remained attached to the engine crankshaft flange during the impact sequence and was removed by investigators prior to this examination. The spinner dome, spinner bulkhead and start lock brackets were also removed from the propeller prior to this examination. The piston was fractured around the forward/top corner and adjacent to blade L1 link arm attach point (Photo #2). Neither blade L1 or L2 had any remarkable indications of rotational damage; no remarkable chordwise/rotational scoring, no impact-related leading edge nicks or gouges and no remarkable bend or twist.

Photo #2 – Piston fractures

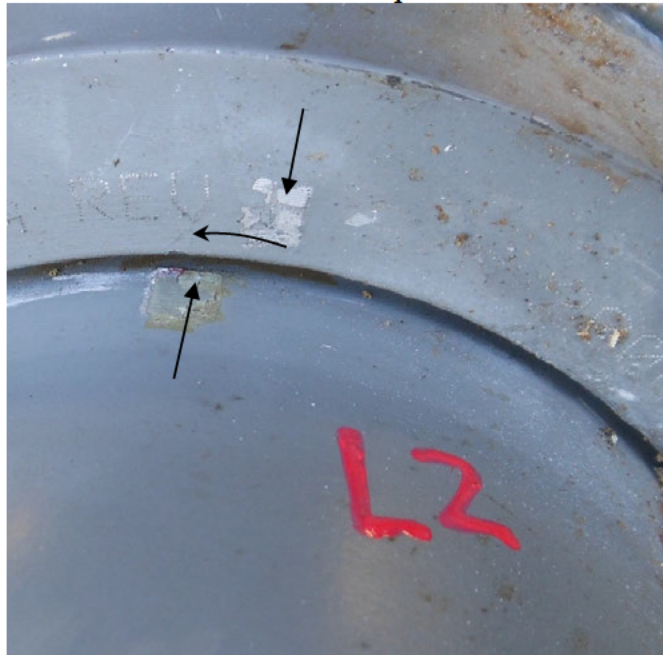
Both blade clamps were secure but remnant marks from slip indicator tape on blade L2 indicated a slight rotation/slippage toward high pitch (Photo #3). One of two start lock plate fasteners on clamp L2 was fractured.

Photo #3 – Blade slip indicators

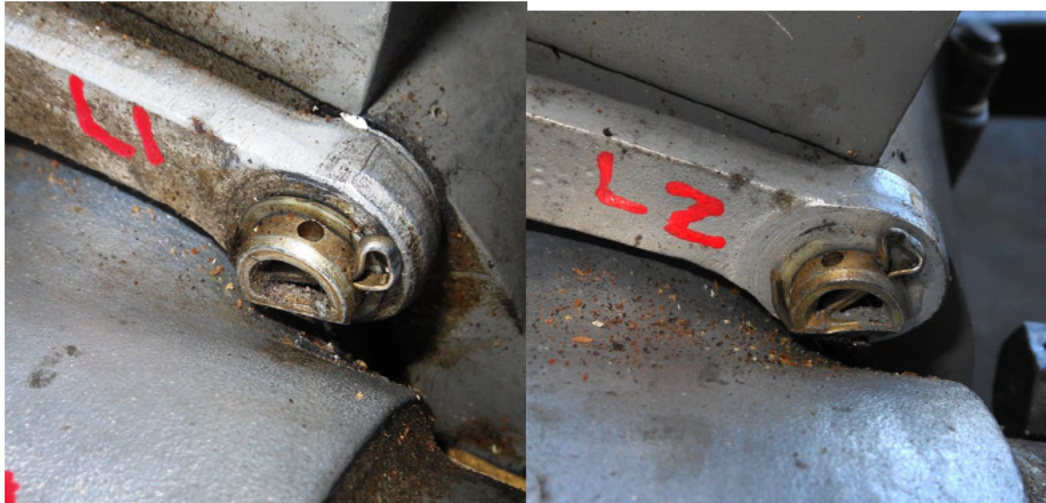
Both blade L1 and L2 link screws were crushed on the side adjacent to the hub arm. There was a corresponding impact mark on the hub arm indicating forceful rotation towards high pitch/feather at impact (Photo #4).

Photo #4 – Smashed link screws

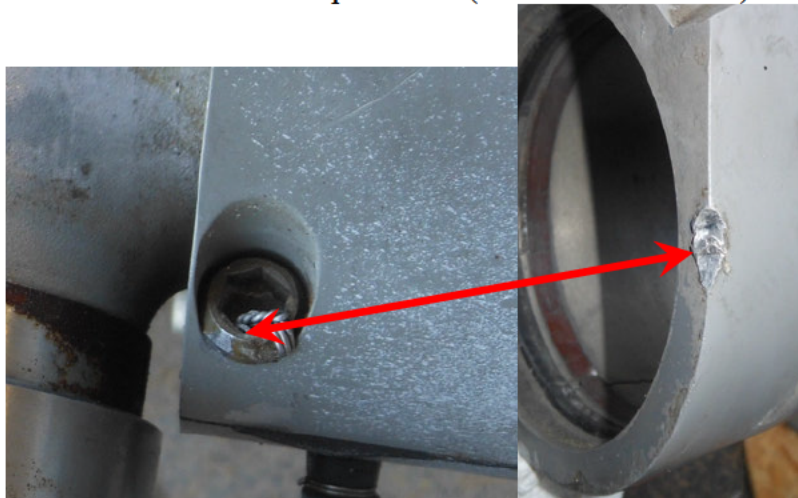
The piston bottom edge had impact marks adjacent to an inboard clamp screw on both blade clamps. There were corresponding impact marks on the screw heads (Photo #5). These marks are consistent with the piston being pulled down by forceful rotation of the blades beyond the feather position. The blade bearings had some minor corrosion (Photo #6) but were adequately lubricated and the blades rotated freely in the bearings once the link arms were disconnected.

Photo #5 – Piston impact mark (similar on other side)

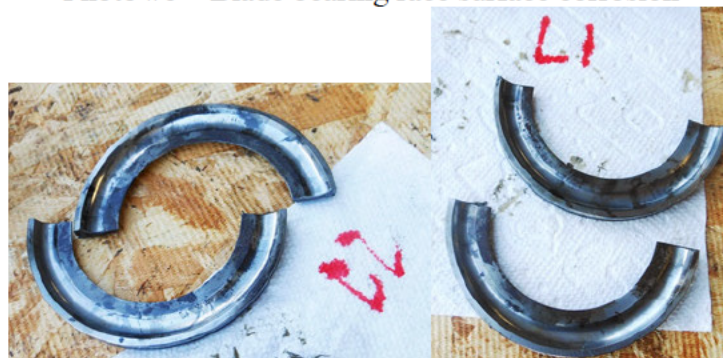
Photo #6 – Blade bearing race surface corrosion

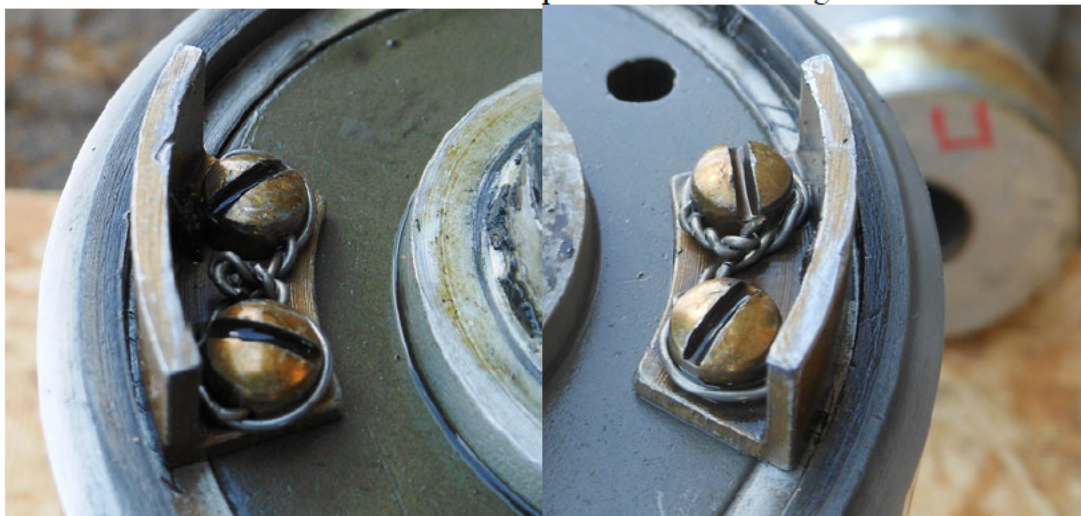
The feather stops had impact marks from contact with the top of the piston (Photo #7). There were corresponding marks on the top of the piston (Photo #8).

Photo #7 – Feather stops with contact damage

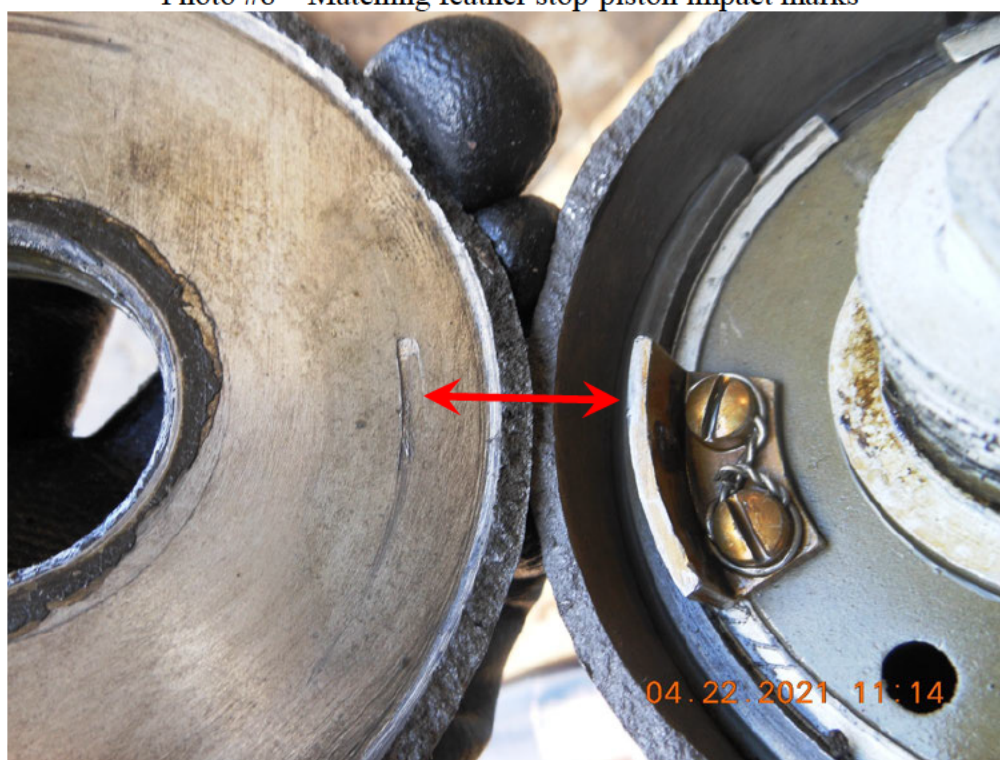
Photo #8 – Matching feather stop-piston impact marks

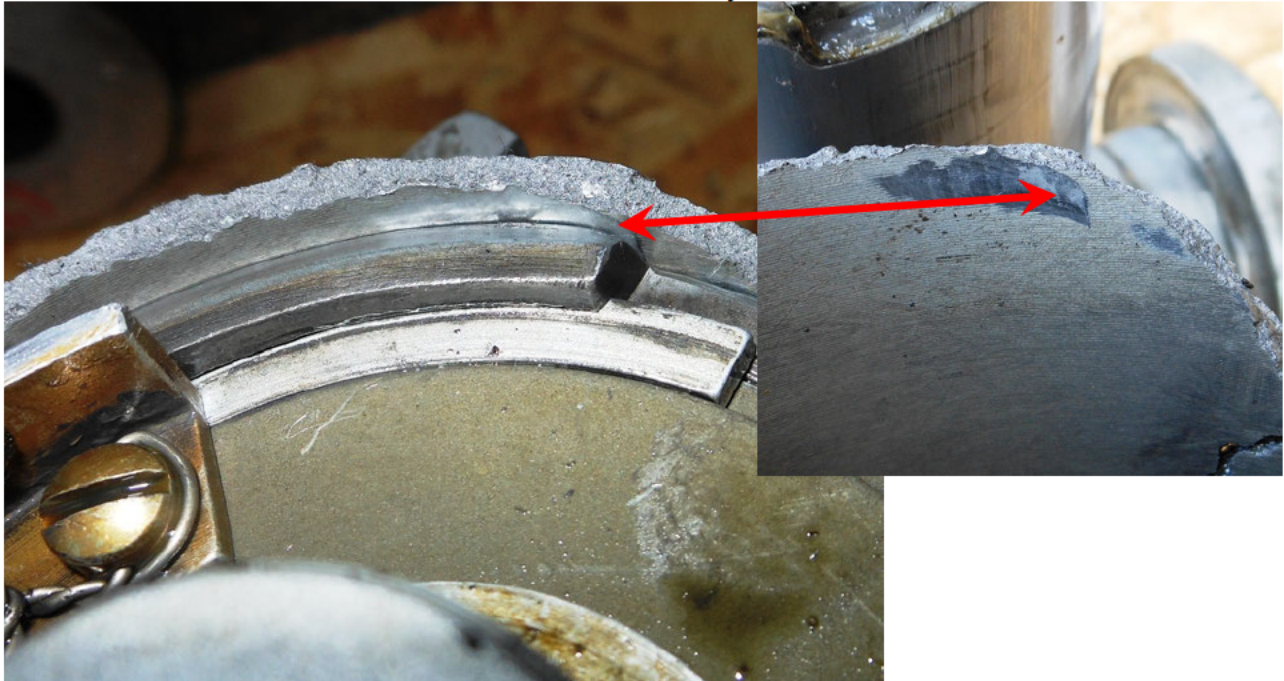
There was a contact mark on the interior surface of the piston where it contacted the top corner of the cylinder (Photo #9). This contact mark is consistent with the piston in the feathered position. Photo #10 shows the piston's position relative to the feather stops, also consistent with forceful contact between the pistons forward/top and the feather stops that contributed to the piston fractures.

Photo #9 – Piston contact mark with cylinder forward corner

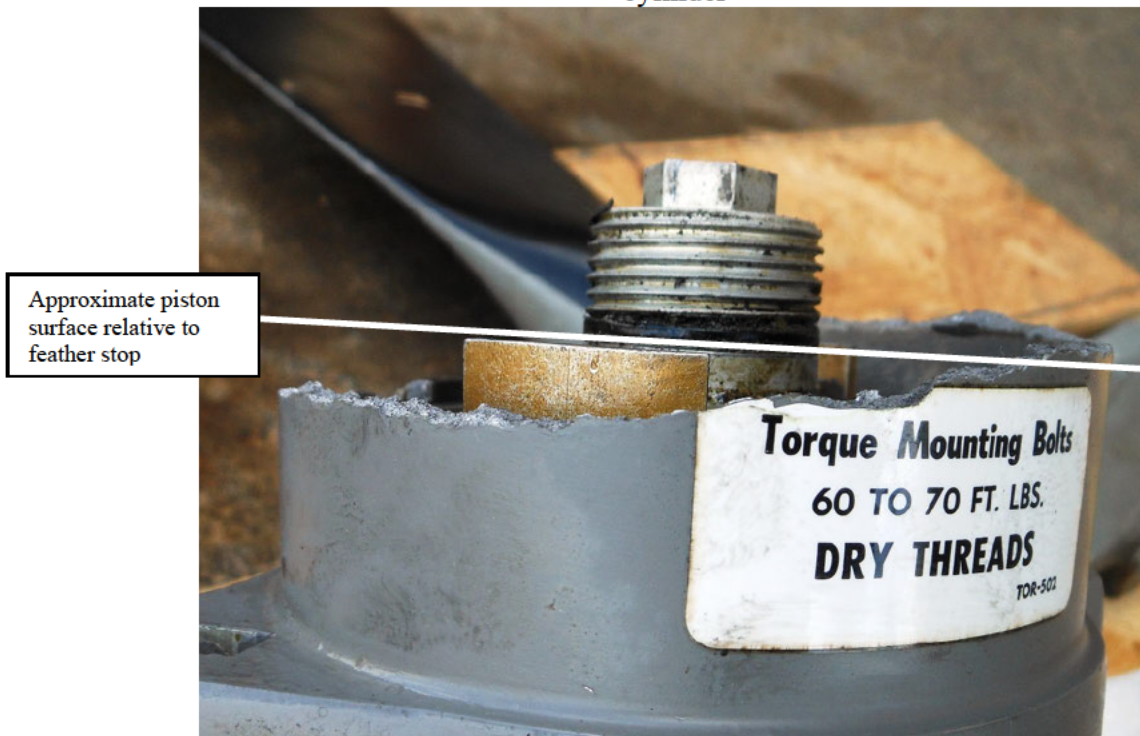
Photo #10 – Piston position relative to the feather stops with ID wall contact mark aligned w/ cylinder

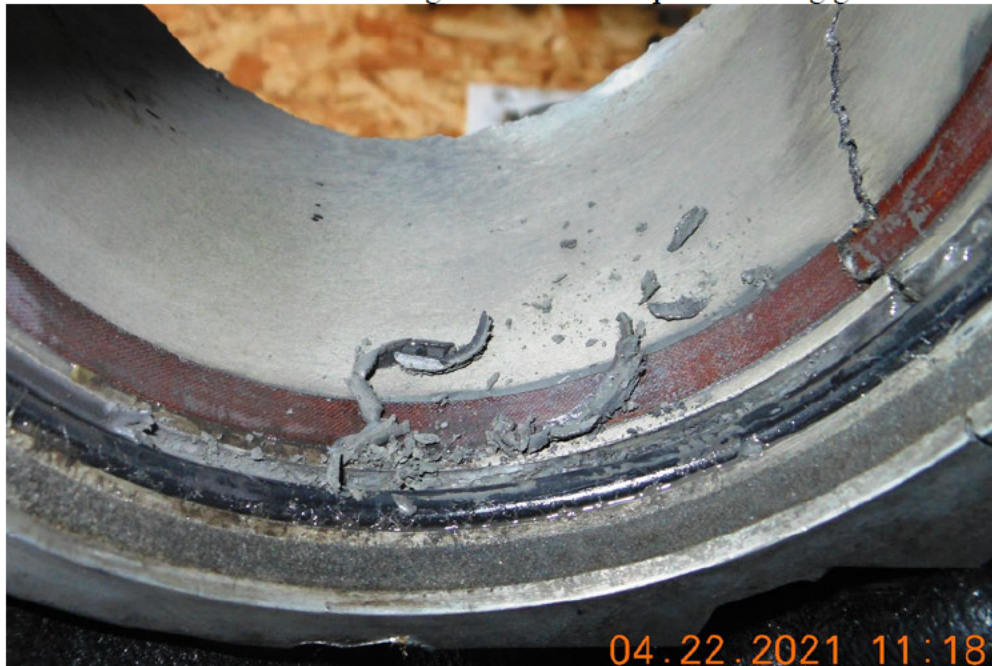
The interior surface of the piston was coated with a relatively heavy amount of hardened, engine oil sludge. This sludge was cleaned from the surface before Photo #11 was taken, but a noticeable amount remained packed in the piston O-ring groove. Photo #11 shows some of sludge that was scrapped out of the O-ring groove.

Photo # 11- Hardened sludge removed from piston O-ring groove

All visible damage on both propellers was consistent with high impact forces. There were no visible discrepancies on the propeller components examined that would prevent normal operation. Sludge in the left propeller hydraulic section (piston, cylinder and mounting bore) may have caused slow response but did not appear to inhibit the propeller from feathering. All the damage on the left propeller was consistent with the left propeller at or near the feathered position, with no power and little or no rotation at impact. Damage to the left propeller pitch change mechanisms is consistent with impact forces rotating the blades towards higher pitch, beyond the feather stop. The left propeller governor appeared intact and undamaged. It was bench tested and met all factory specifications except for the low RPM setting which did not prevent normal operation. The right propeller damage was consistent with rotation under power at impact.

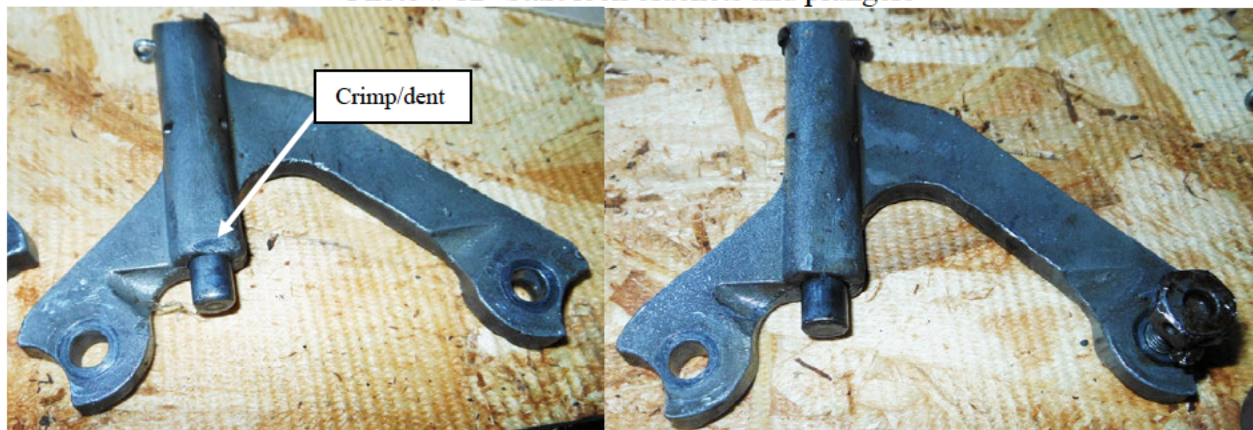
The start lock brackets were intact with relatively little damage (Photo #12). There were no remarkable bends or fractures on either bracket. One start lock plunger moved freely with finger force. The other start lock plunger moved freely in a limited range of travel but if depressed into the housing it would bind and not extend. There was a small crimp on the end of the plunger housing that appeared to be made by forceful contact with the start lock plate. The plunger could easily be extended with a small center punch through the top or a small tap against a table top surface. There was no evidence the start lock plate was in contact with the start lock plunger at impact. Videos of the start lock plunger action were taken at the examination.

Photo # 12- Start lock brackets and plungers

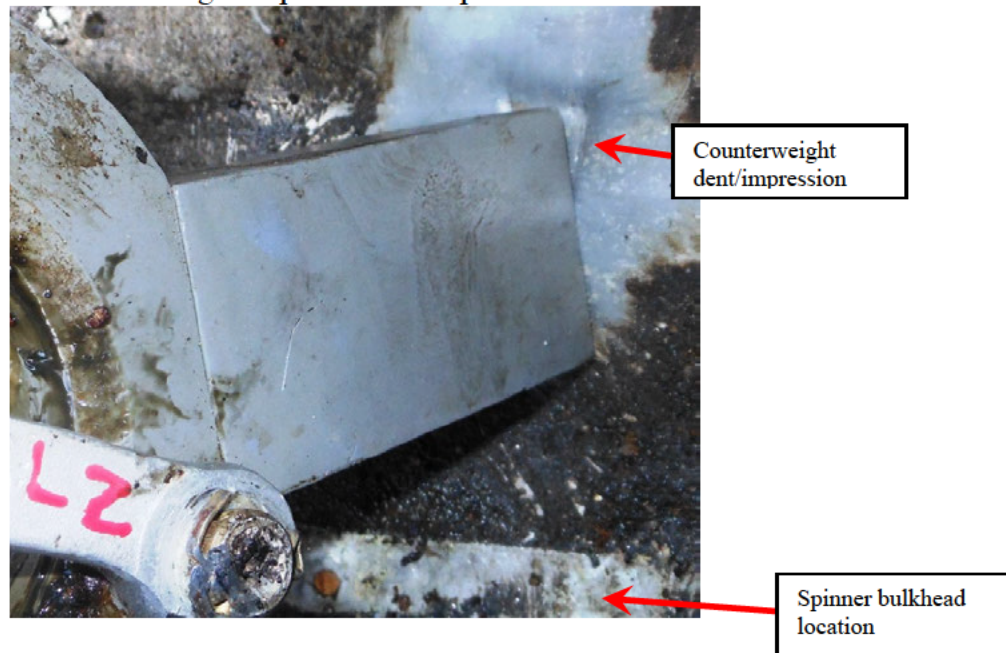
The spinner dome had a counterweight impact impression in a location consistent with the counterweight in the feathered position (Photo #13).

Photo # 13 - Counterweight impact mark in spinner dome internal surface

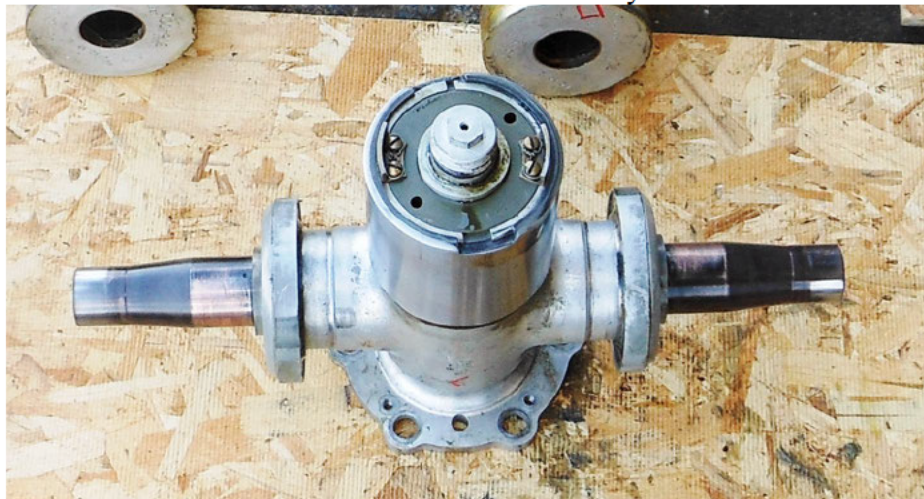
The hub assembly was intact with both pilot tubes intact (Photo #14). The cylinder remained secure on the hub and there was some surface corrosion on the cylinder near the feather end of piston travel (this portion would be exposed to the environment when on the start locks after shutdown). The feathering spring was not removed or observed but the spring keepers were present and there was spring tension on the pitch change rod when removing the piston top. The mounting flange appeared intact and undamaged with some sludge in the pilot bore (Photo #15).

Photo #14 – Hub assembly

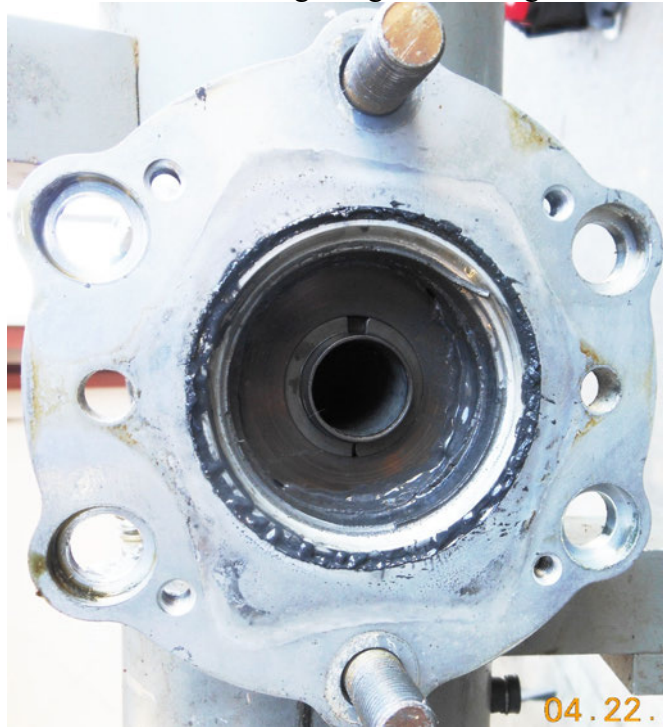
Photo #15 – Mounting flange with sludge in bore

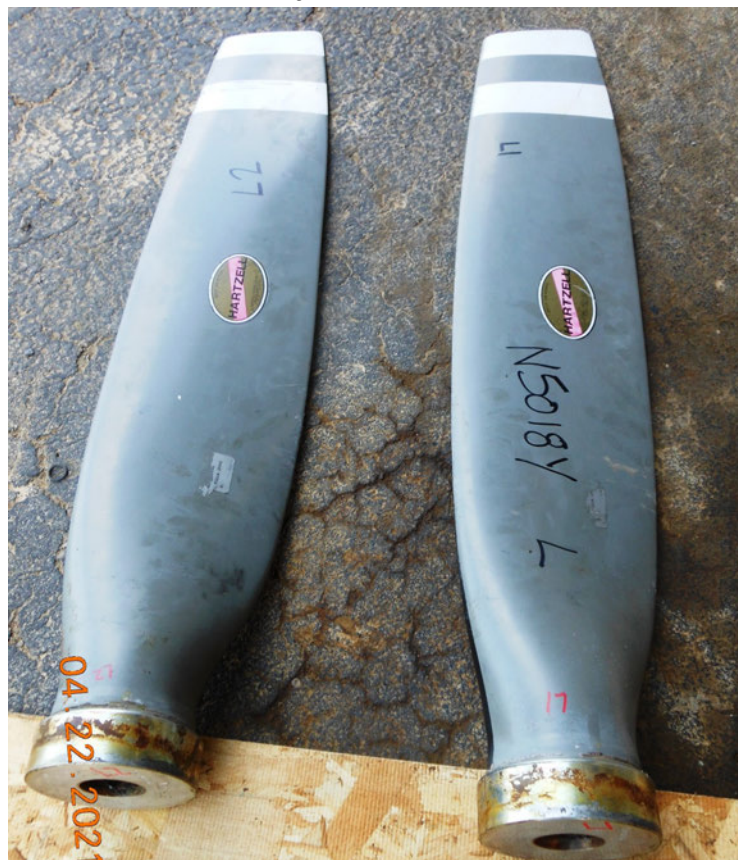
Photo #16 and #17 show the unremarkable and relatively undamaged conditions of the blade camber and face sides.

Photo # 16 – Blades camber side

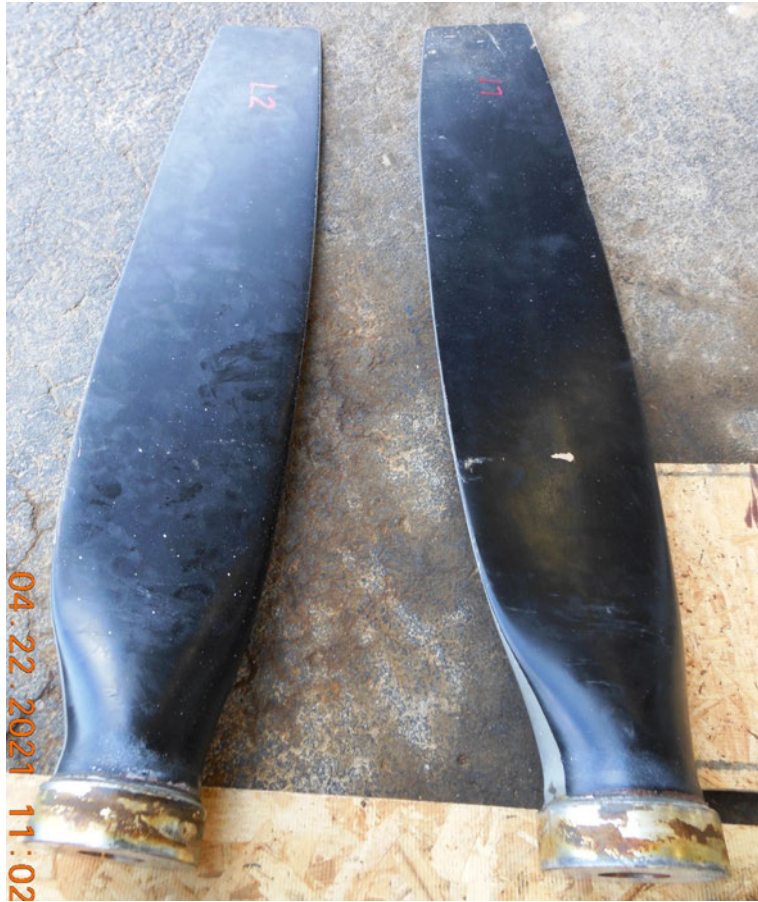
Photo # 17 – Blades face side

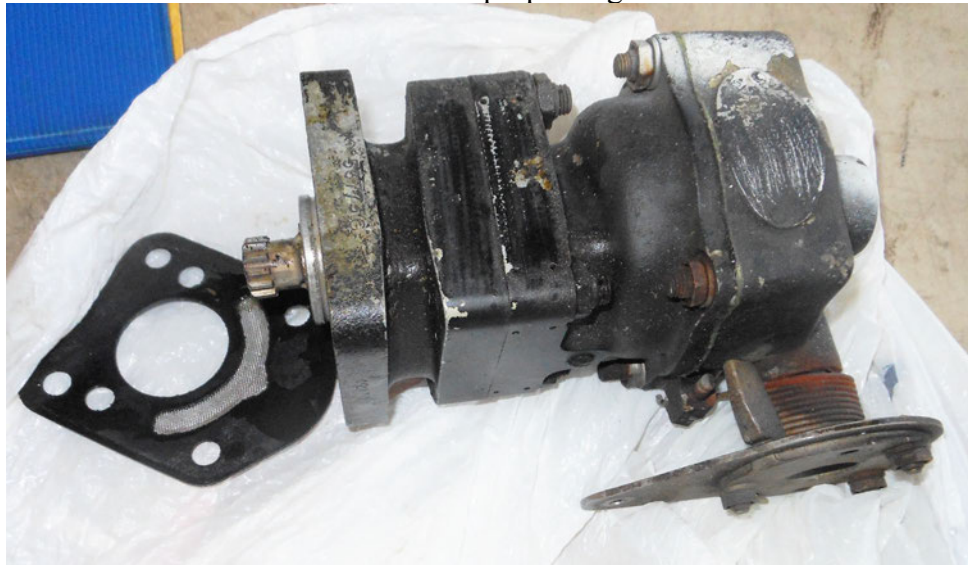
The left propeller governor was visually/externally examined (Photo #18). The governor P/N is B-4, S/N 4365F. The governor gasket screen was free of debris. The governor drive shaft rotated freely by finger force and the pump “gurgled” indicating pumping action. The control arm and shaft also rotated freely by hand force from the high RPM stop to the feathered position. The governor was retained for future bench testing.

Photo # 18 –Left propeller governor

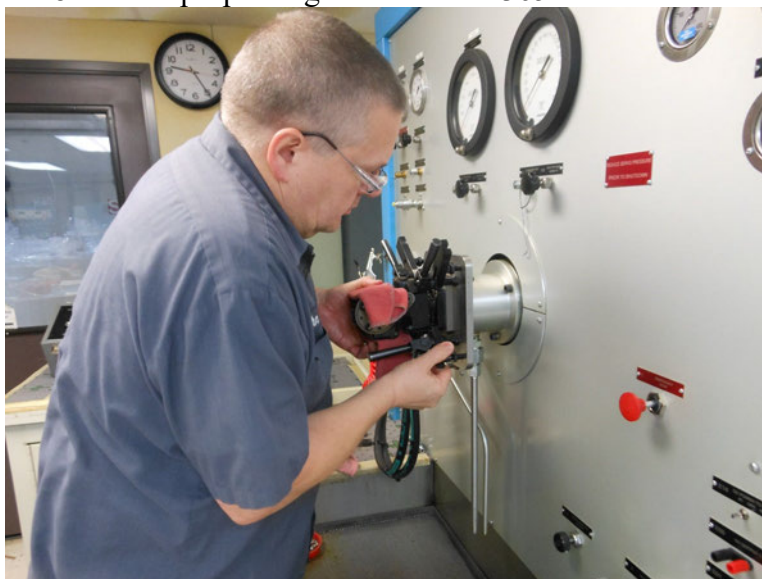
The left propeller governor S/N 4365F was bench-tested at Hartzell Propeller on 1/26/2022 using the Bauer Propeller Governor Test Stand. Angela Kachinski – FAA Aviation Safety Inspector, Nashville FSDO provided Federal oversight via GoToMeeting. Photo #18-1 shows the governor mounted to the test stand.

Photo # 18-1 –Left propeller governor S/N 4365F mounted to test stand

The governor was subjected to the Acceptance Test Procedure to record performance relative to specification. The governor functioned normally with no external oil leaks noted. The recorded performance relative to specification is provided in Table 1.

Despite having a slightly different low RPM setting of 1730 vs. 1700 $\pm$  25, the governor had no discrepancies that prevented normal operation. The low RPM setting is the minimum RPM the governor is capable of controlling. With a governor gear ratio of 0.895:1, 1730 governor RPM is equivalent to approximately 1932 propeller RPM. The Piper Aztec operation manual does not provide information regarding continuous engine operation below 2100 RPM in climb or cruise flight, therefore the 5 RPM discrepancy in the low RPM setting does not influence normal aircraft operation.

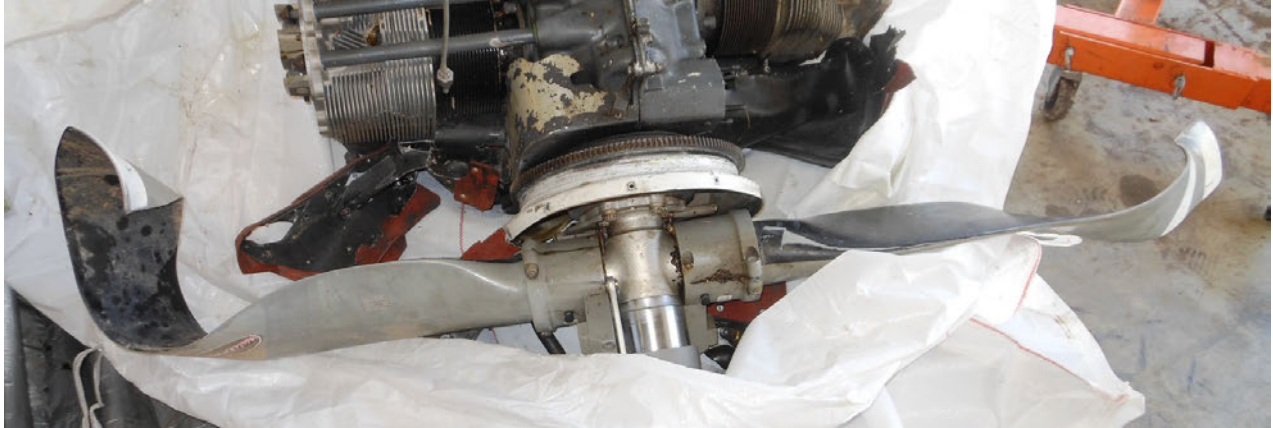
The right propeller was visually/externally examined (Photo #19). Both blades were in a low pitch position. The pitch change mechanism (piston, link arms and link screws) were all in a low pitch position. The start lock plungers were extended but the blade/clamp positions were at a lower blade angle than the start lock angle (i.e. start lock plate not in contact with start lock plunger). Both blades were bent opposite rotation, bent aft and twisted towards low pitch (Photo #20). Both blades also exhibited a leading edge wave bend consistent with a tree/limb strike (Photo #21).

Photo #19 – Right propeller

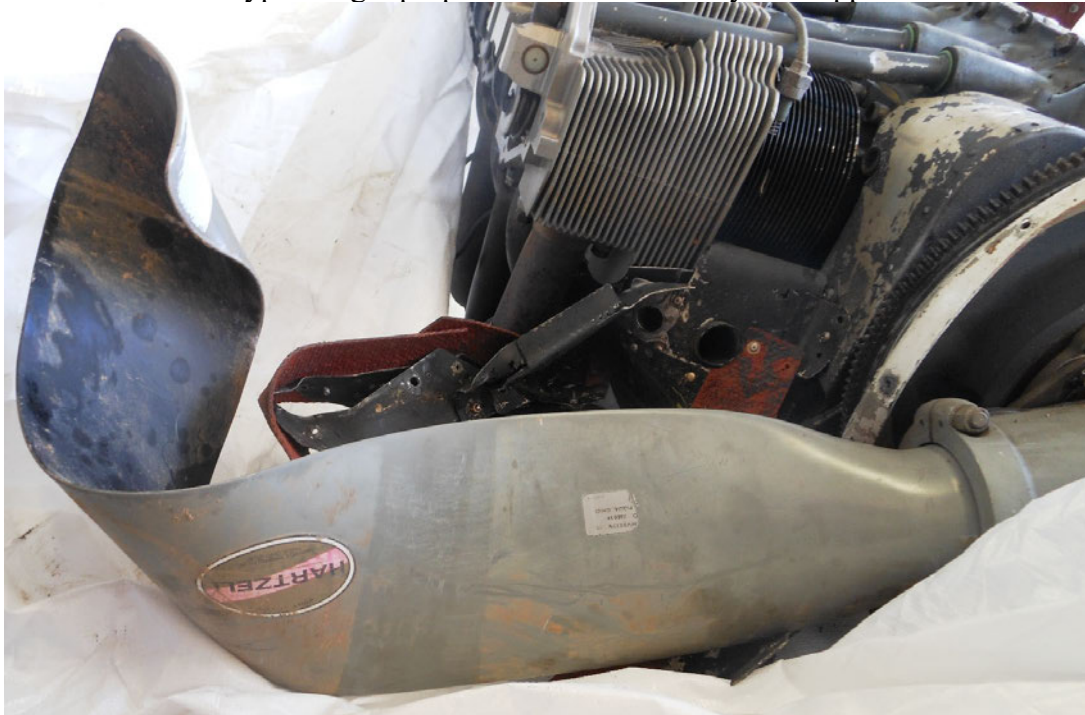
Photo #20 – Typical right propeller blade remarkably bent opposite rotation

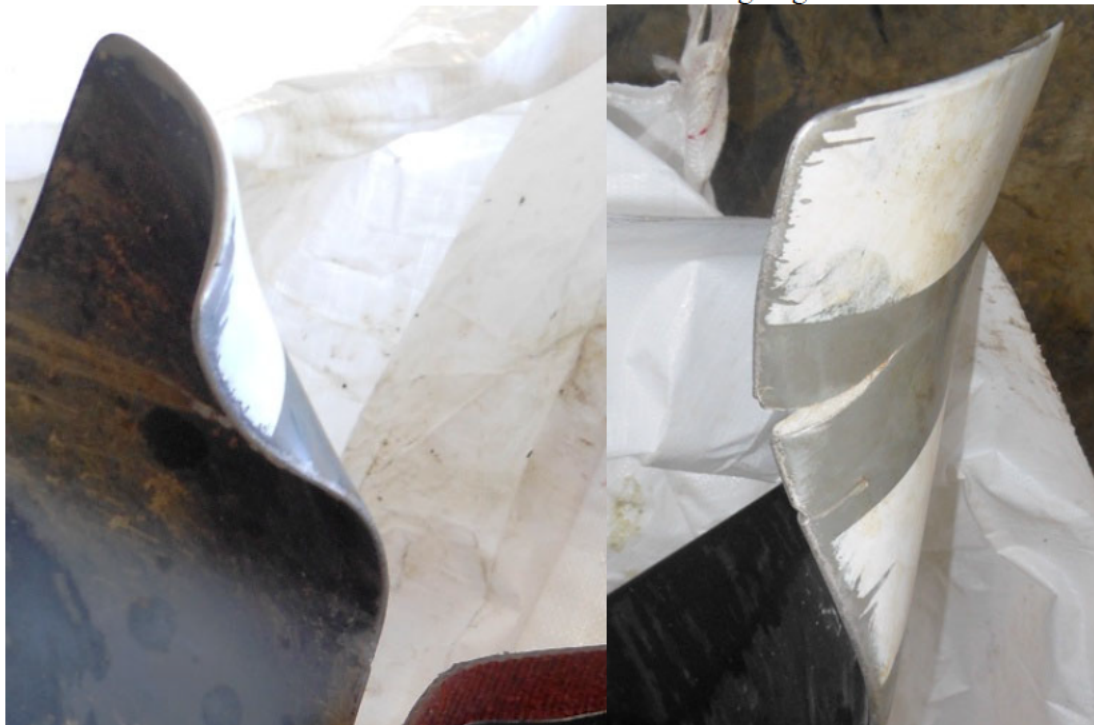
Photo # 21 – Wave bends in leading edge
