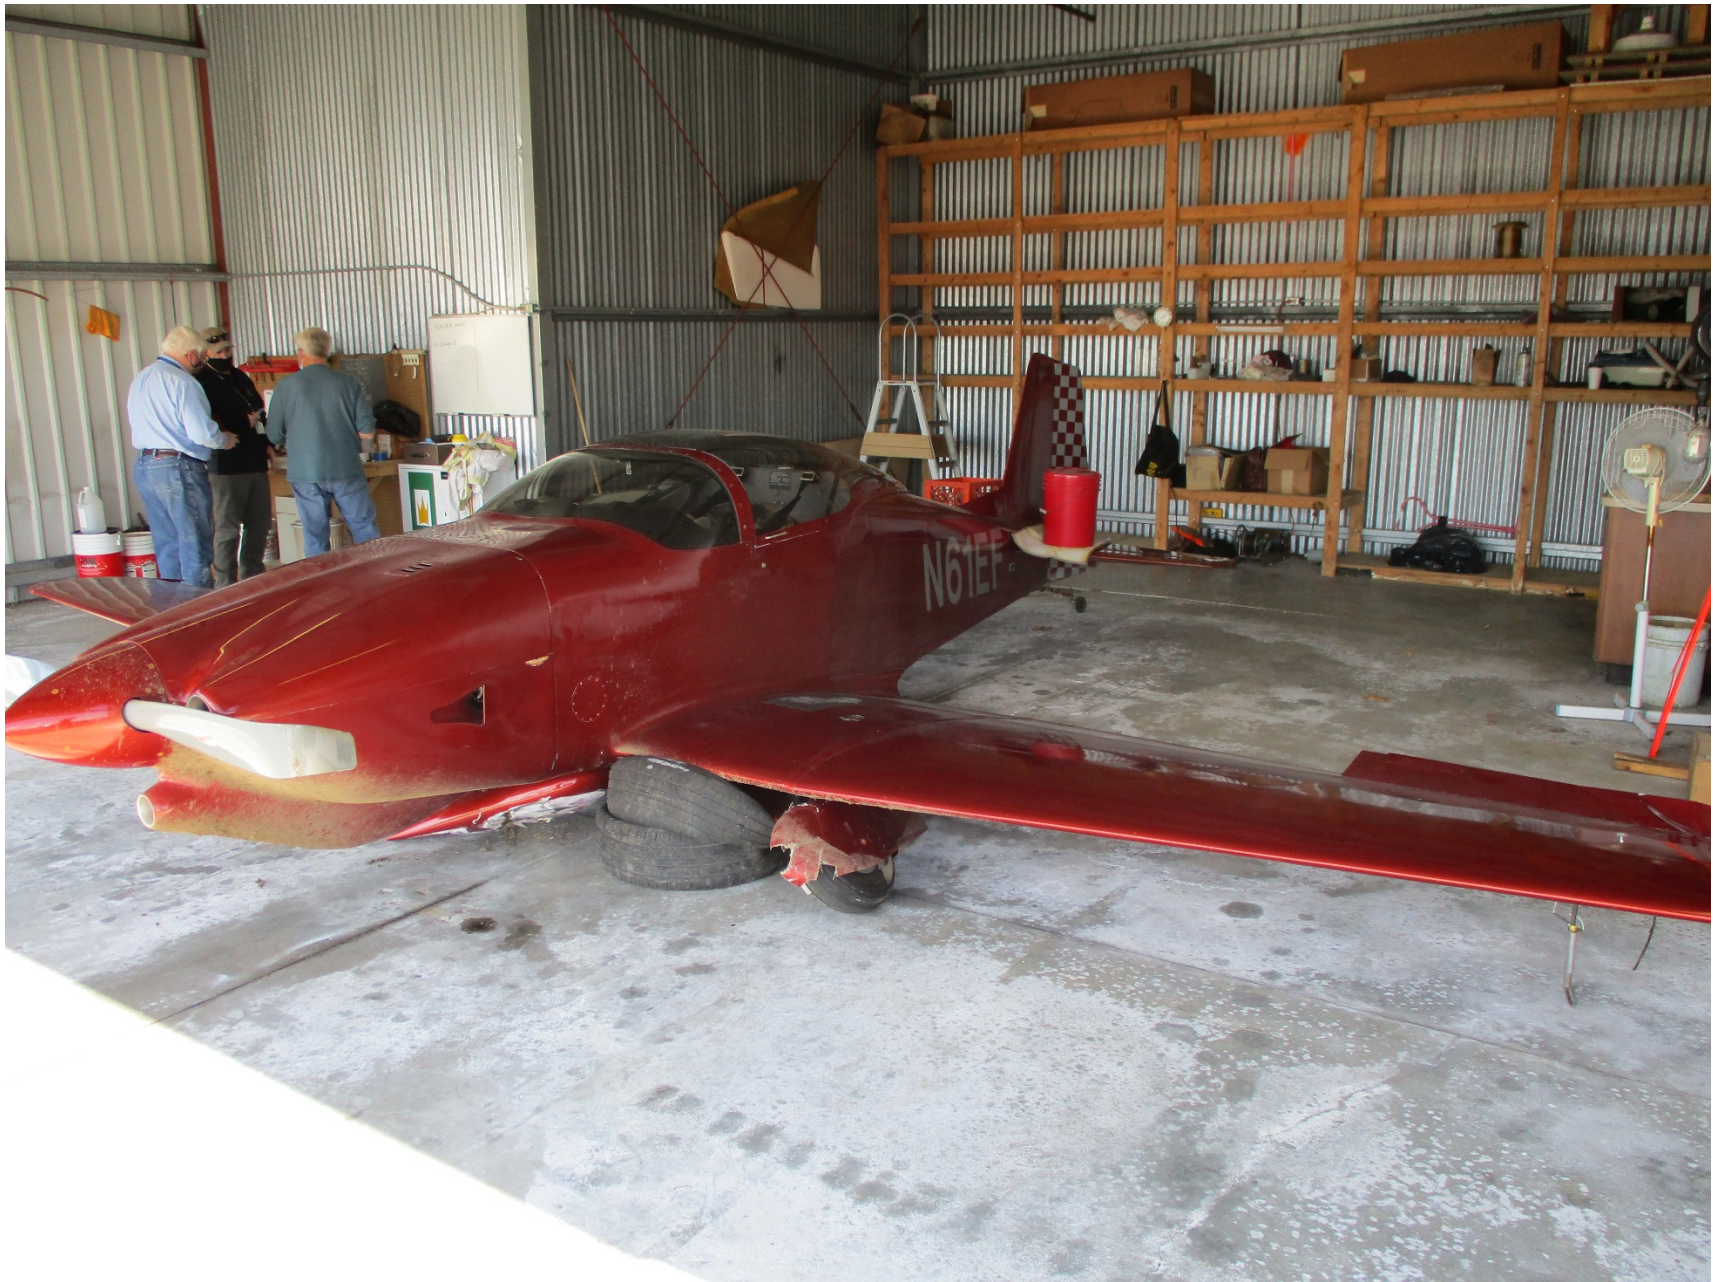
**Photo 1 – Main wreckage (FAA)**

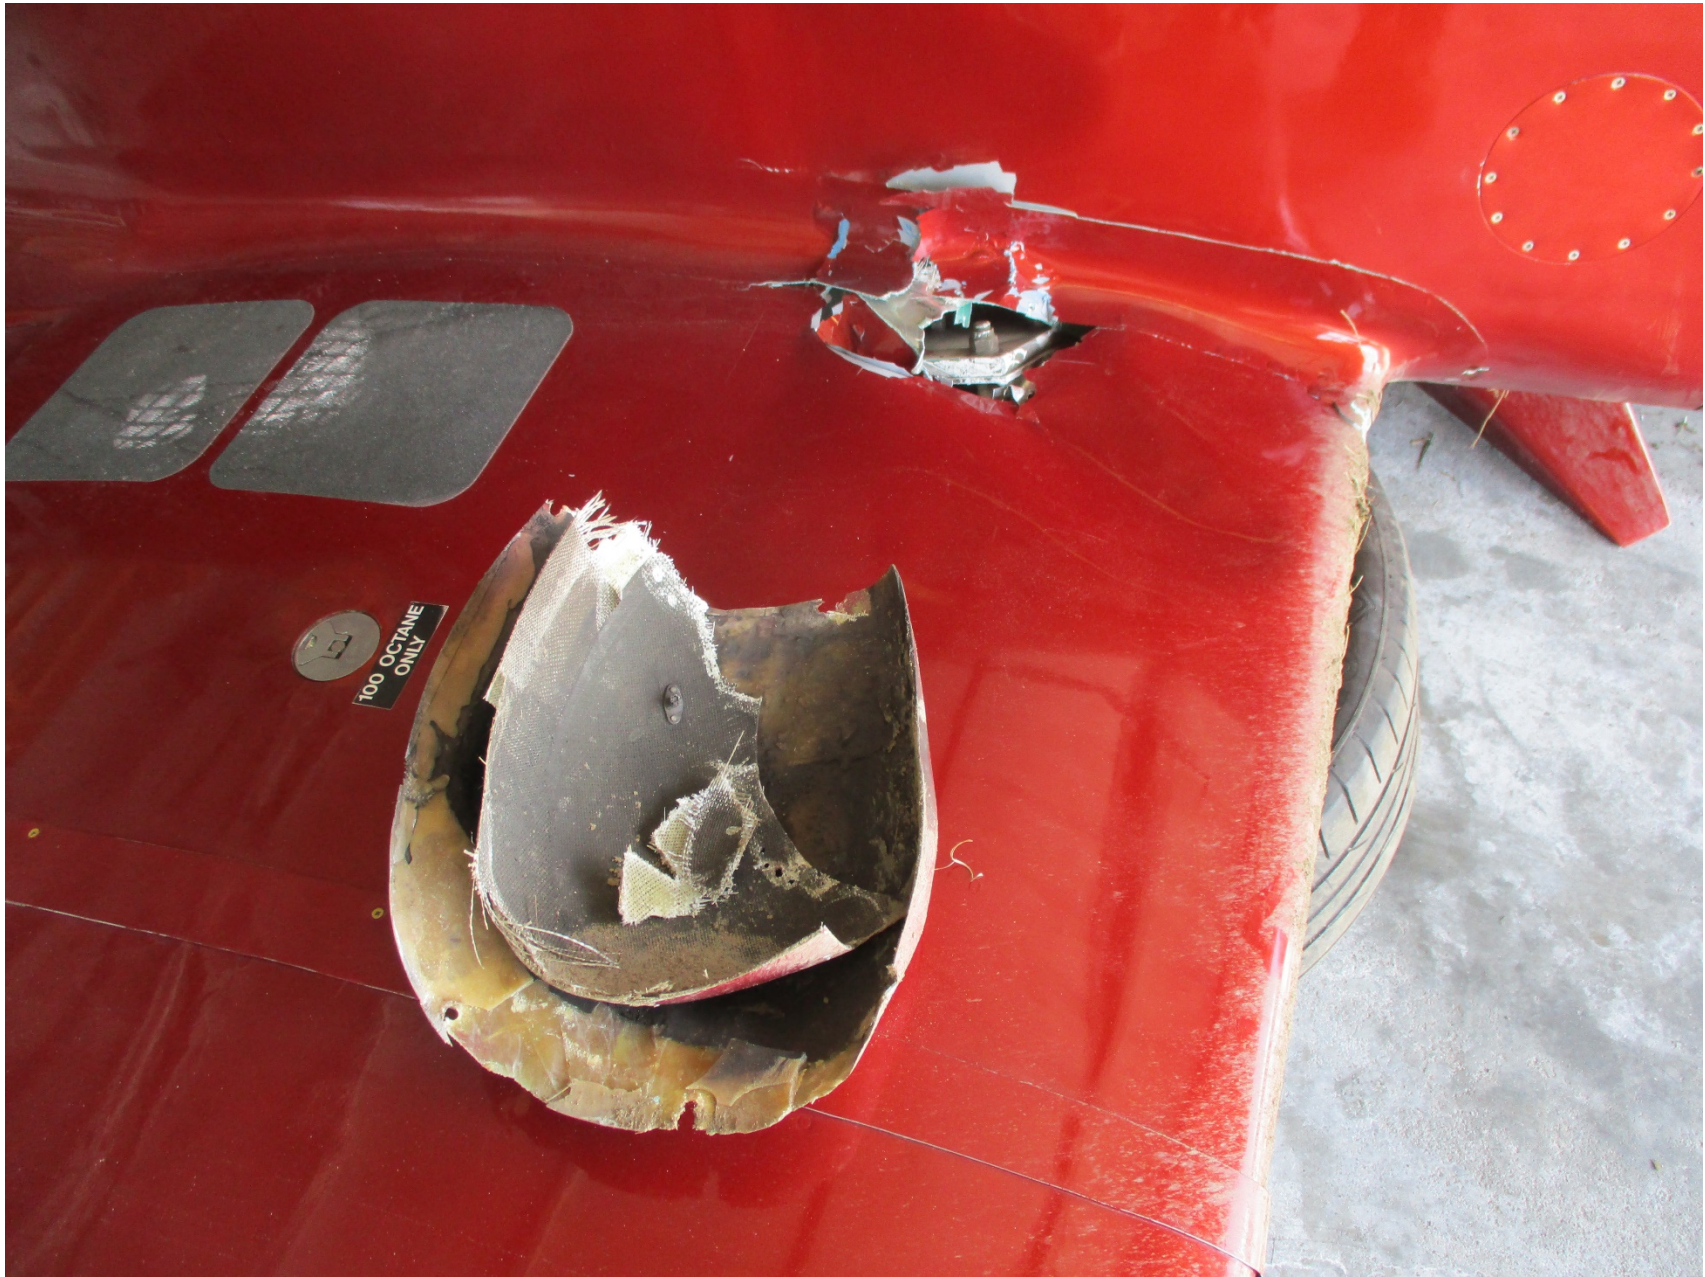
**Photo 2 – right wing with gear protruding through (FAA)**

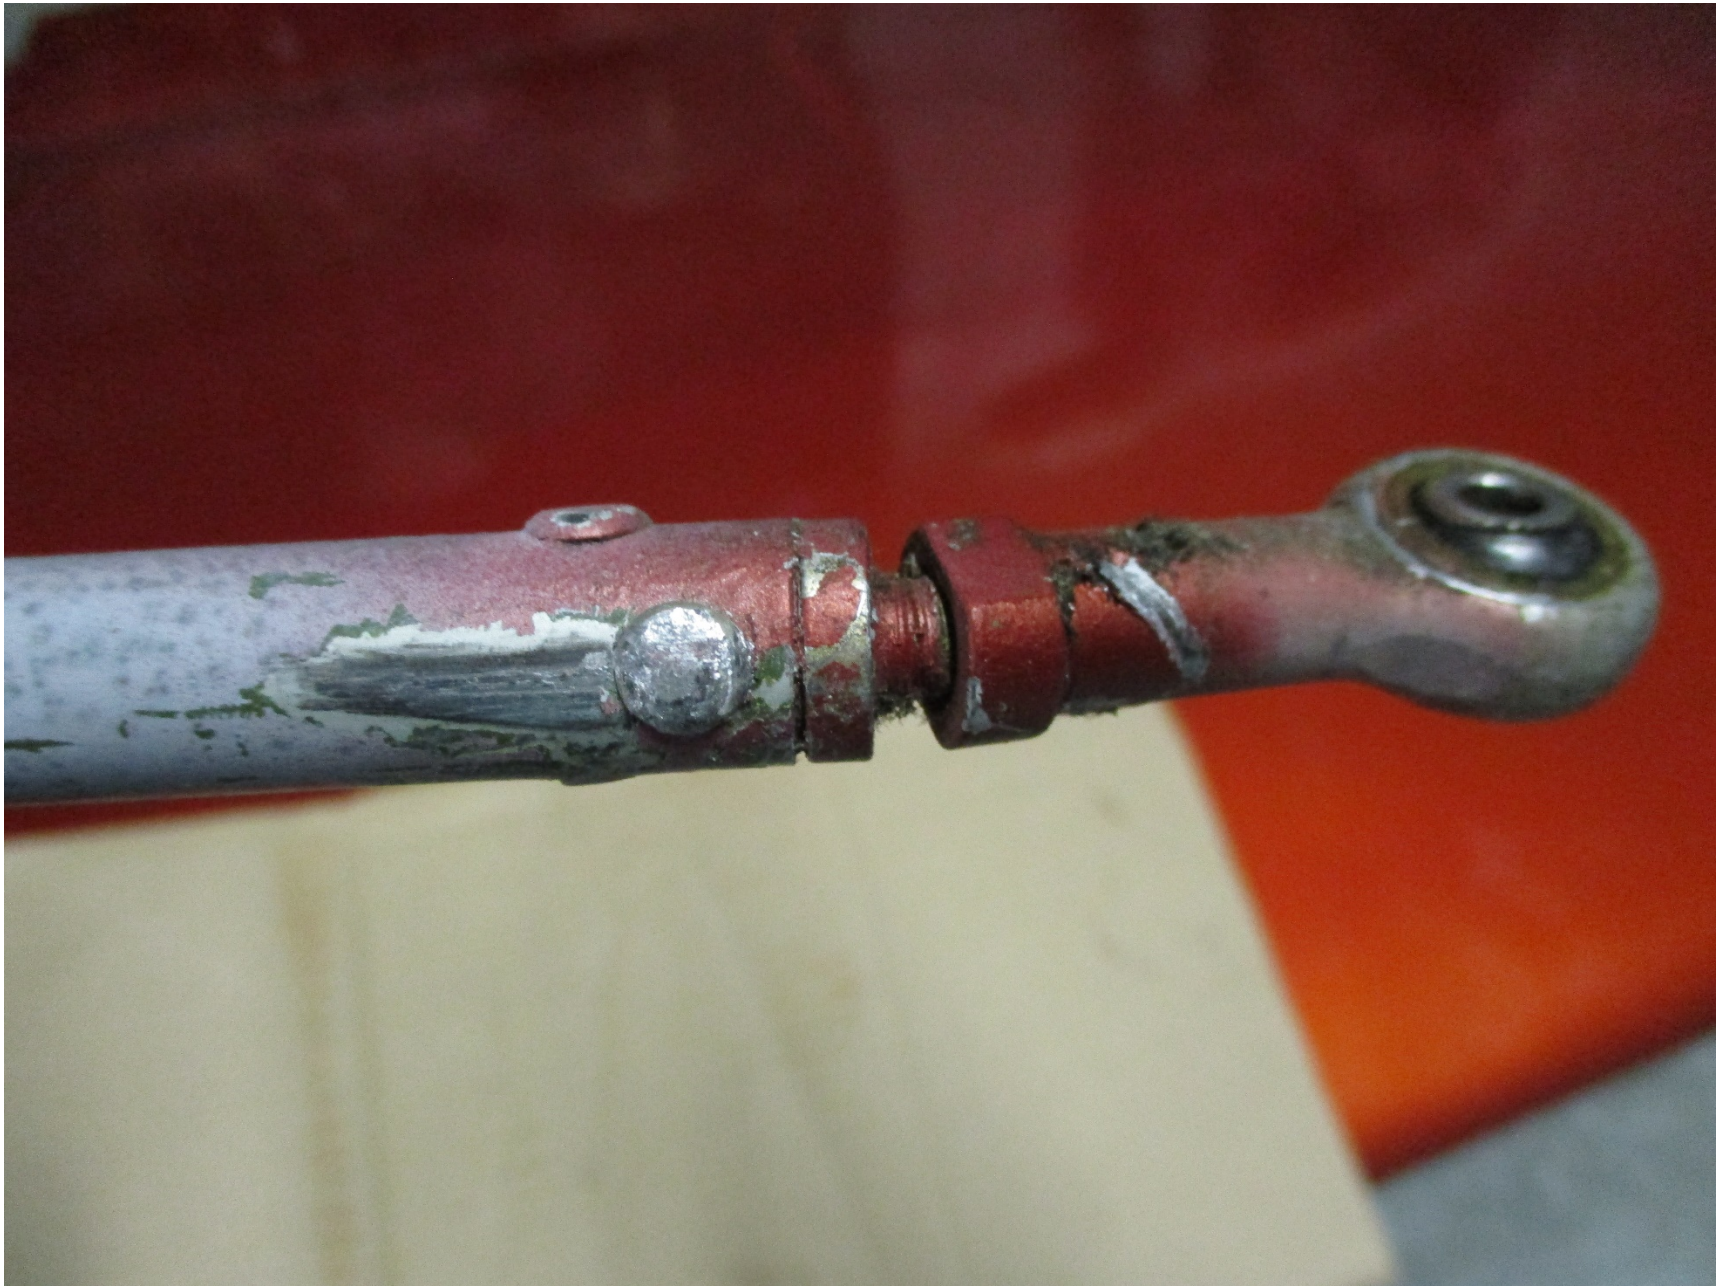
**Photo 3 – Left Push/pull rod with rivet that was binding (FAA)**

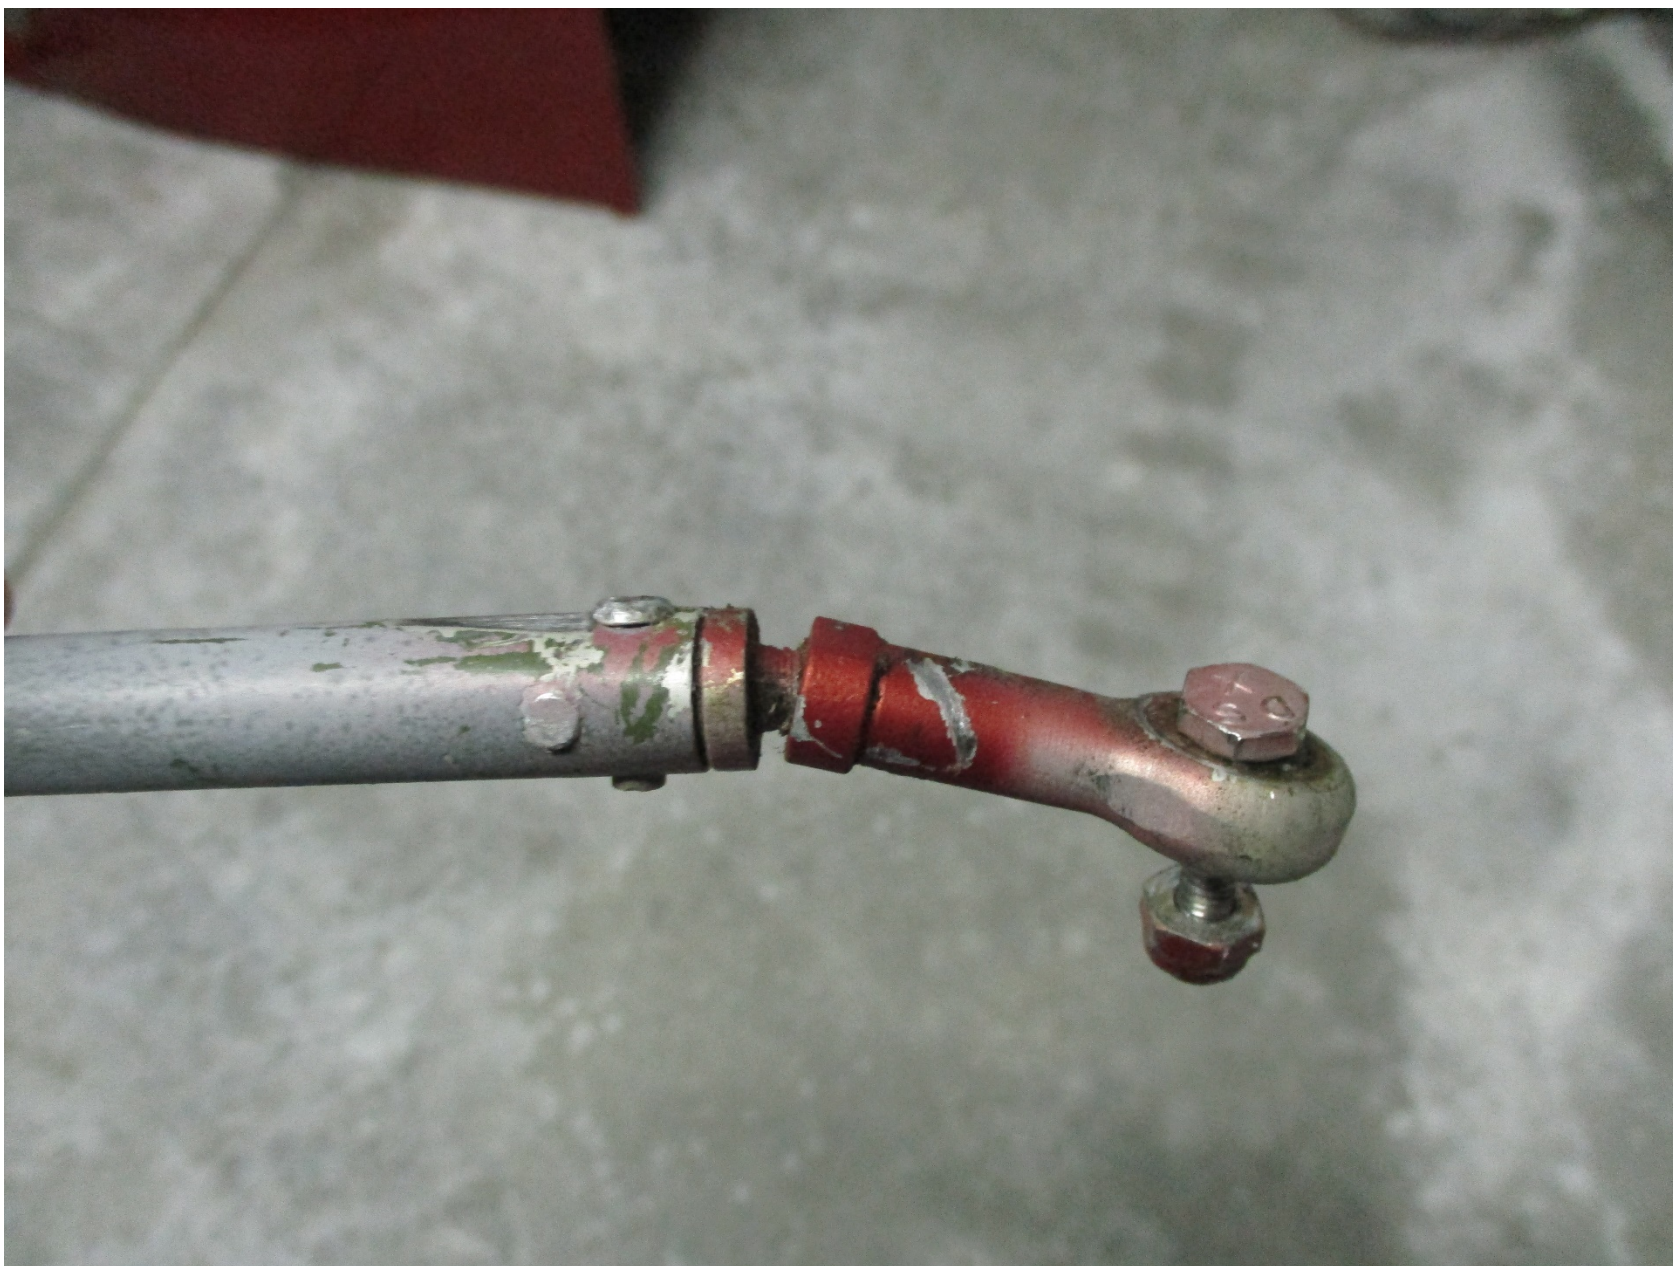
**Photo 4 – left push /pull rod bent (FAA)**

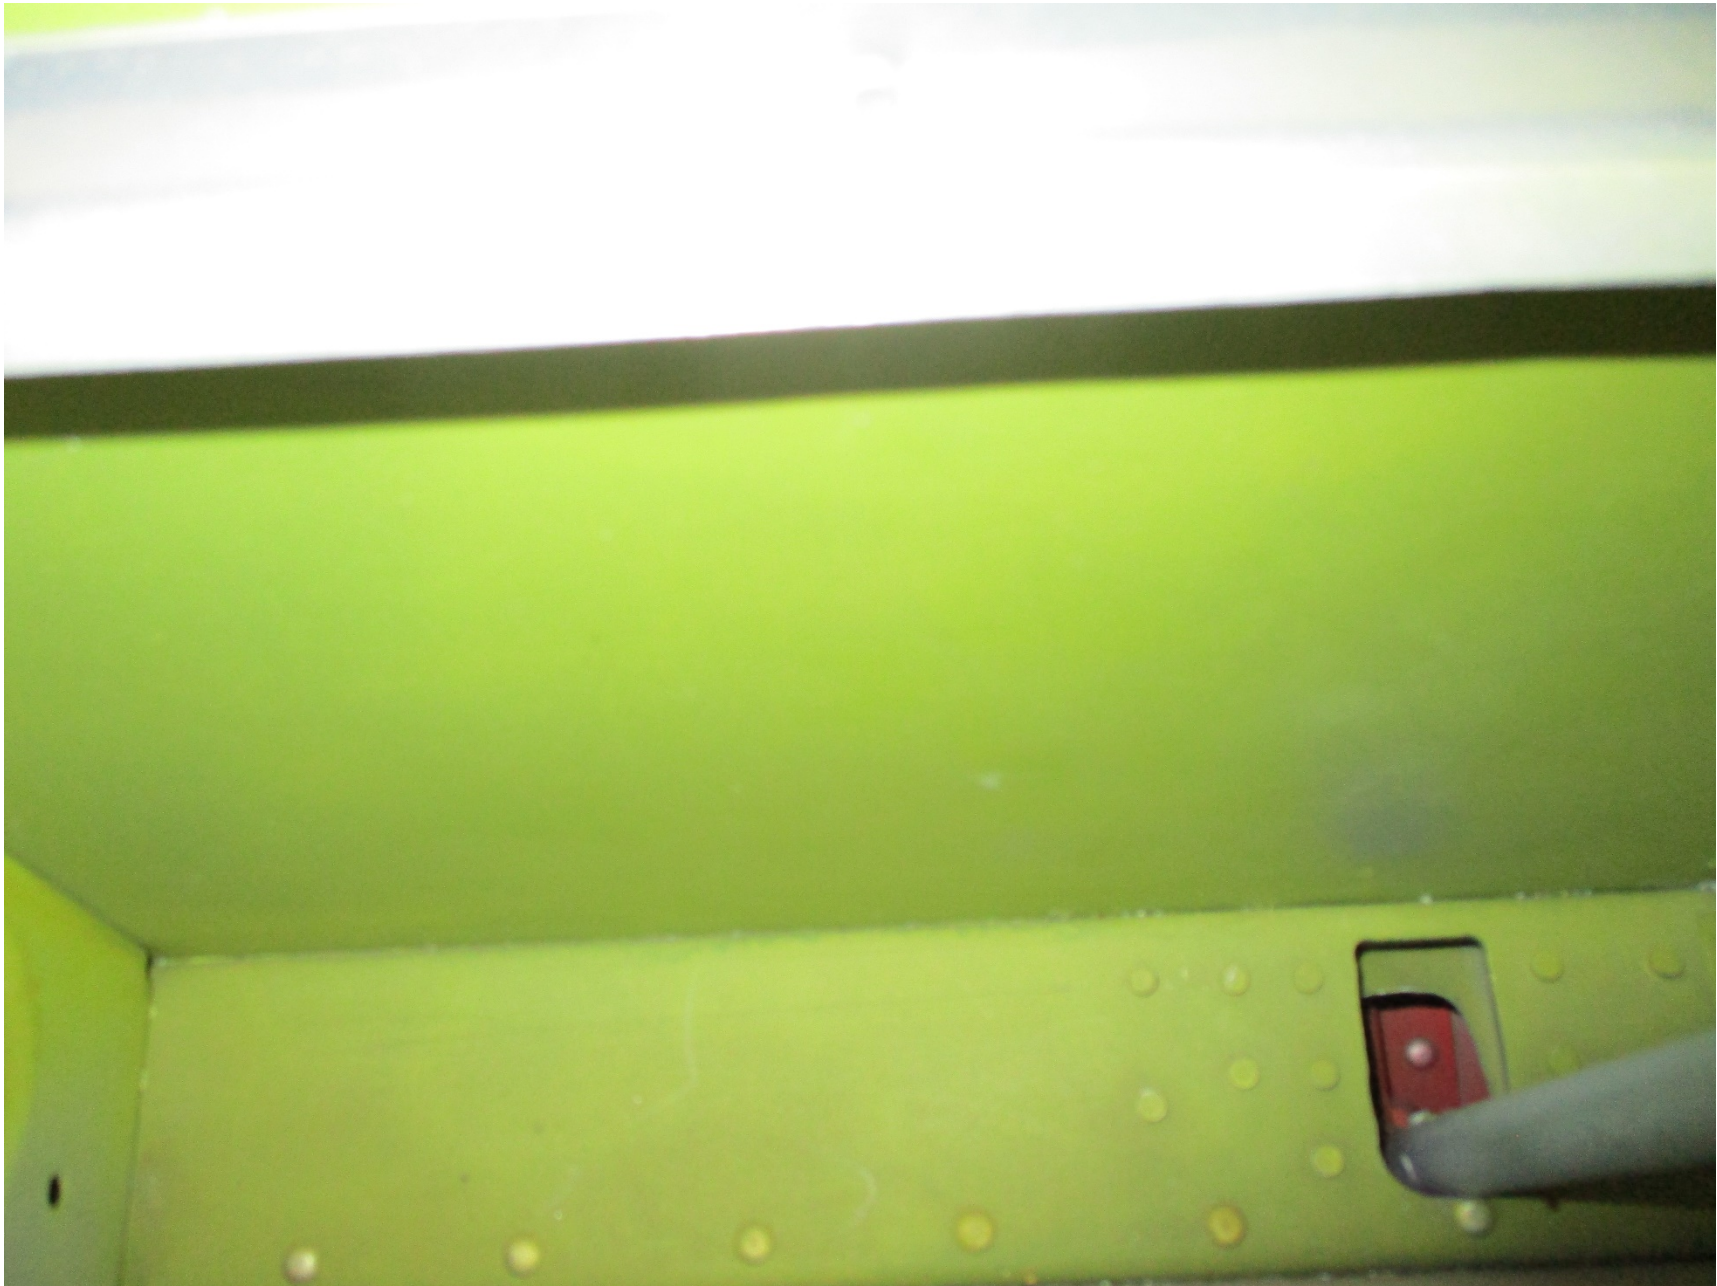
**Photo 5 – left push / pull rod binding on aft spar (FAA)**
