# SERVICE LETTER

No. 671

Piper Aircraft Corporation

Rudder Bar Assembly Inspection and Modification

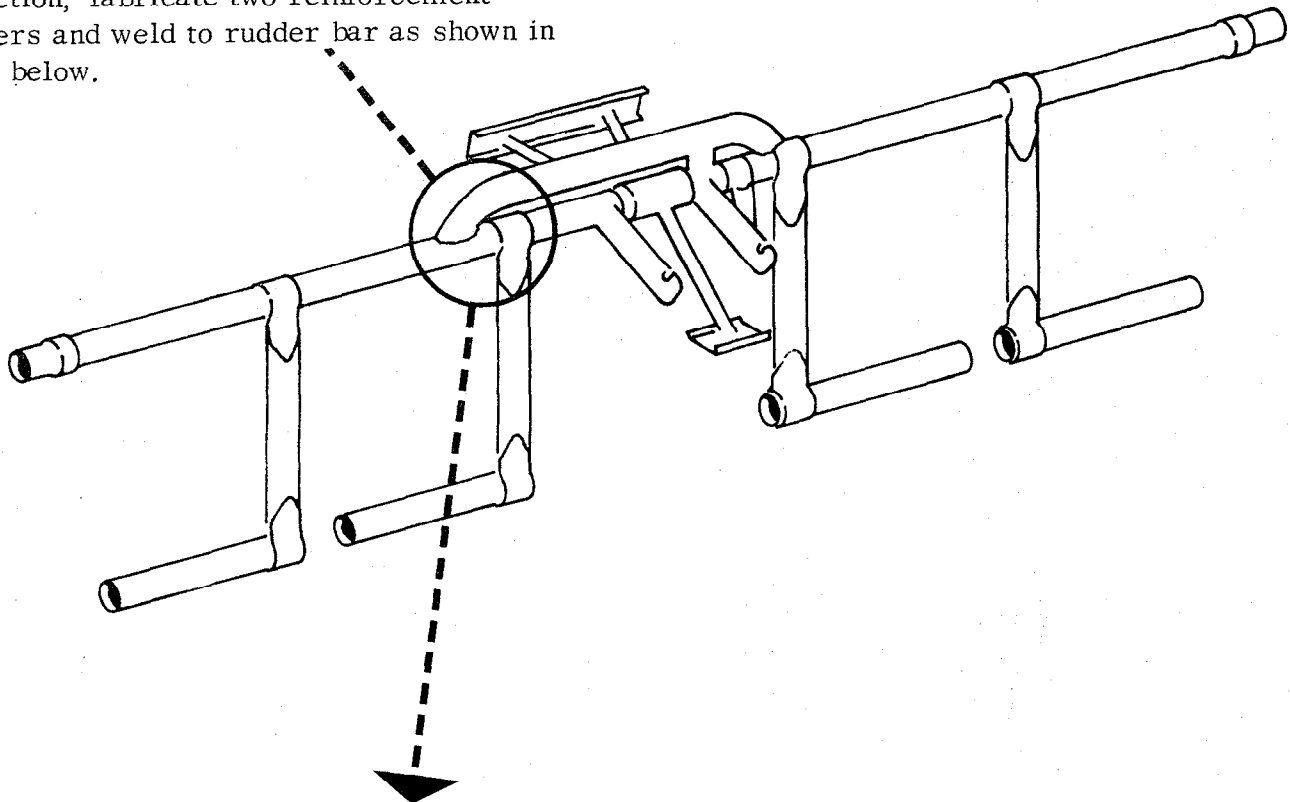
Inspect welded area for evidence of cracks.  
If cracks are found, or to alleviate repetitive inspection, fabricate two reinforcement doublers and weld to rudder bar as shown in detail below.

2. If cracks are detected, remove rudder bar assembly from the aircraft and proceed with Step No. 4, below.
3. To alleviate the repetitive inspection required in Compliance Time, above, even though no evidence of cracks is detected, proceed with Step No. 4, below.
4. Fabricate two each reinforcement doublers as described on the attached sketch/instruction sheet and install accordingly.
5. Reinstall rudder bar assembly.
6. Make proper log book entry.
