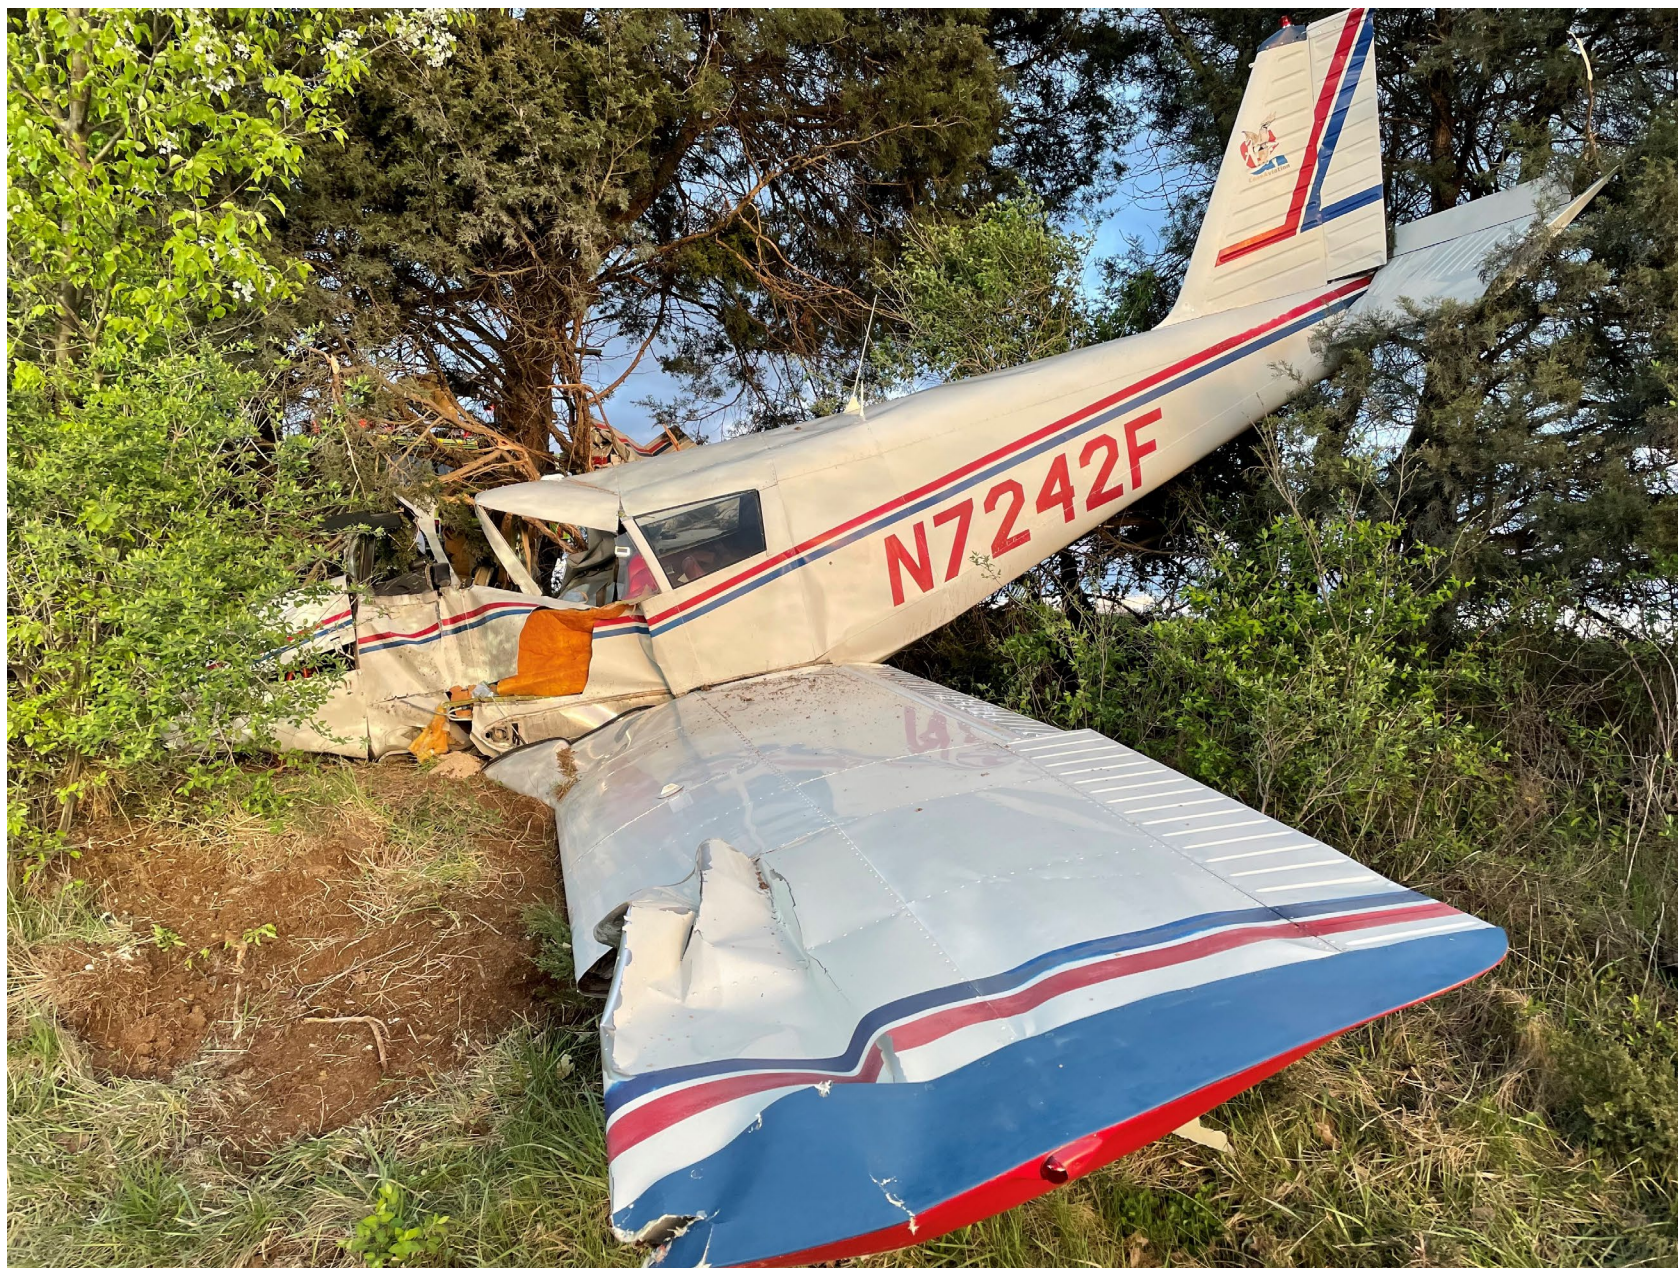
**Photo 1 – Left Side of Main Wreckage – Courtesy of KSHD Airport**

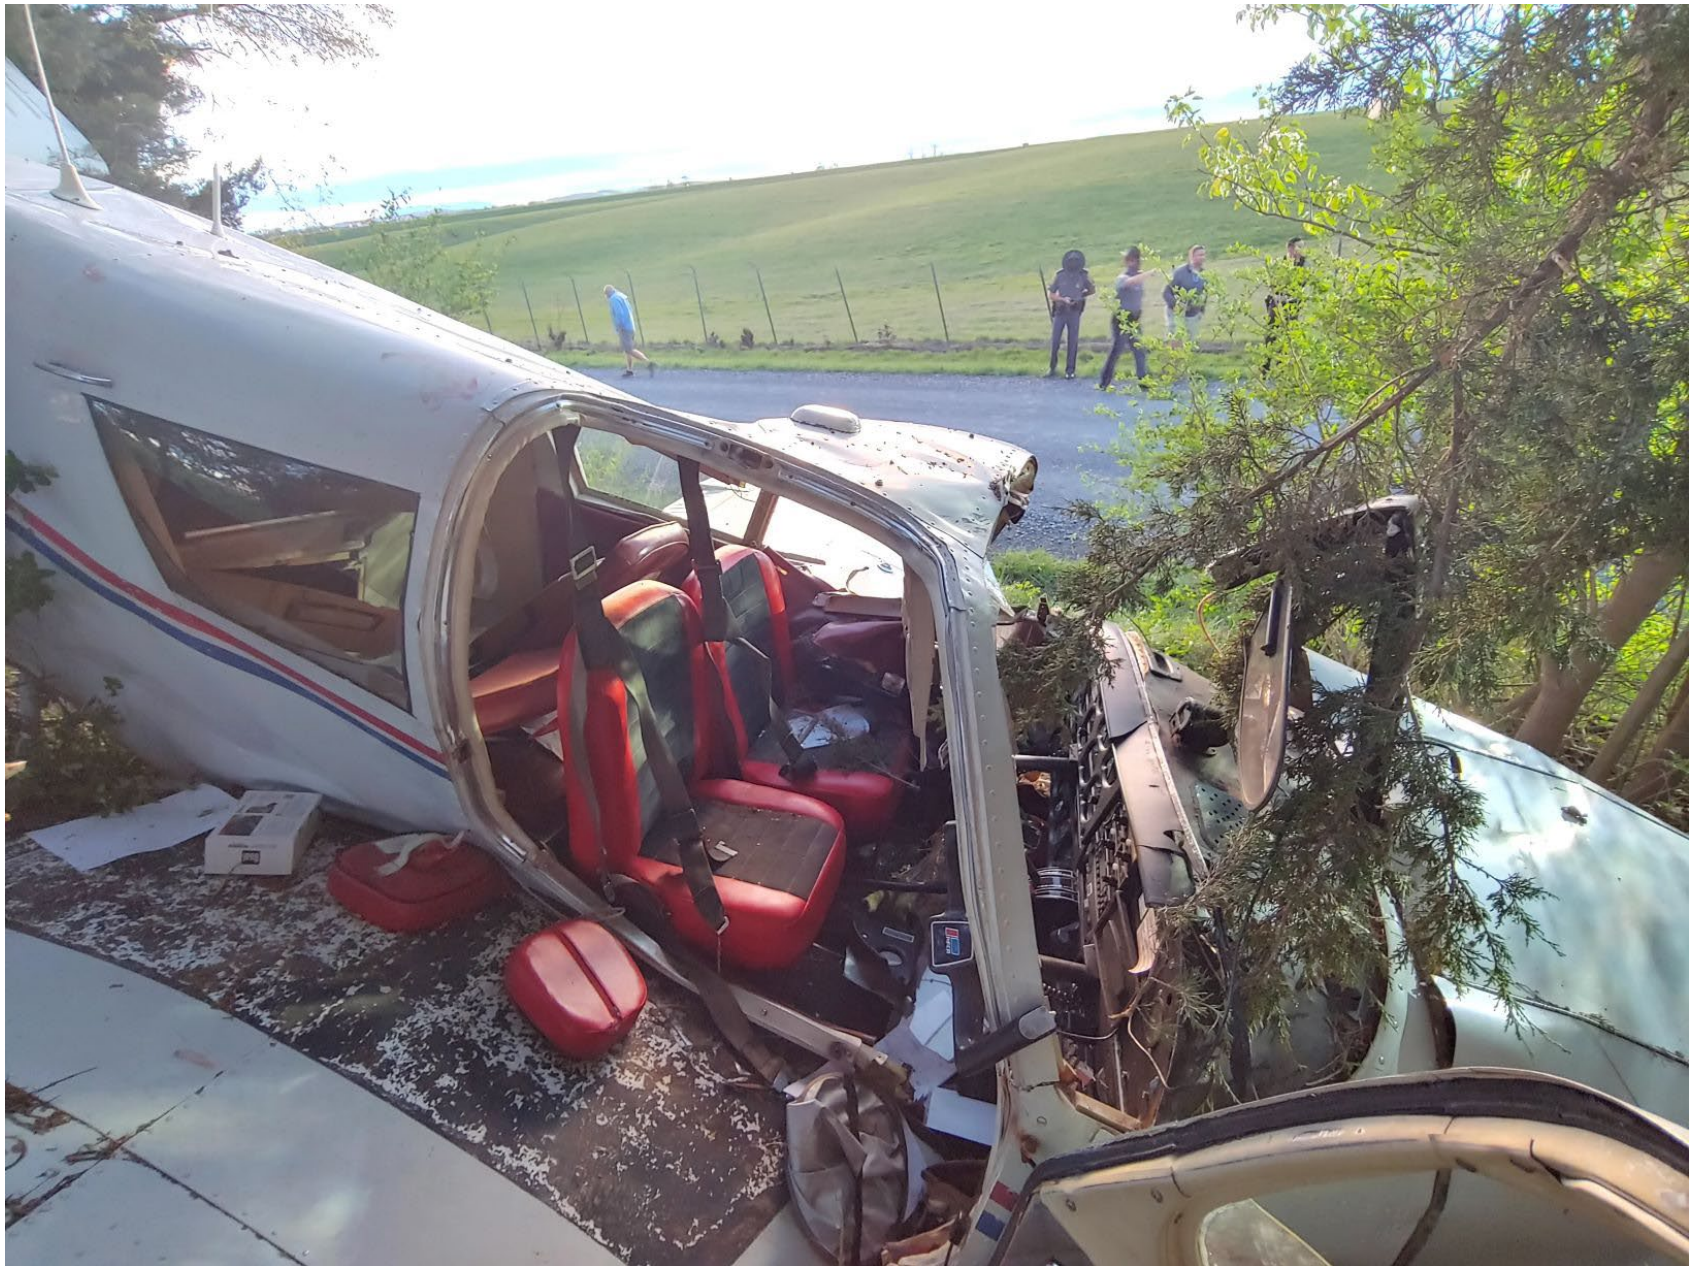
**Photo 2 – Right Side of Main Wreckage – Courtesy of KSHD Airport**

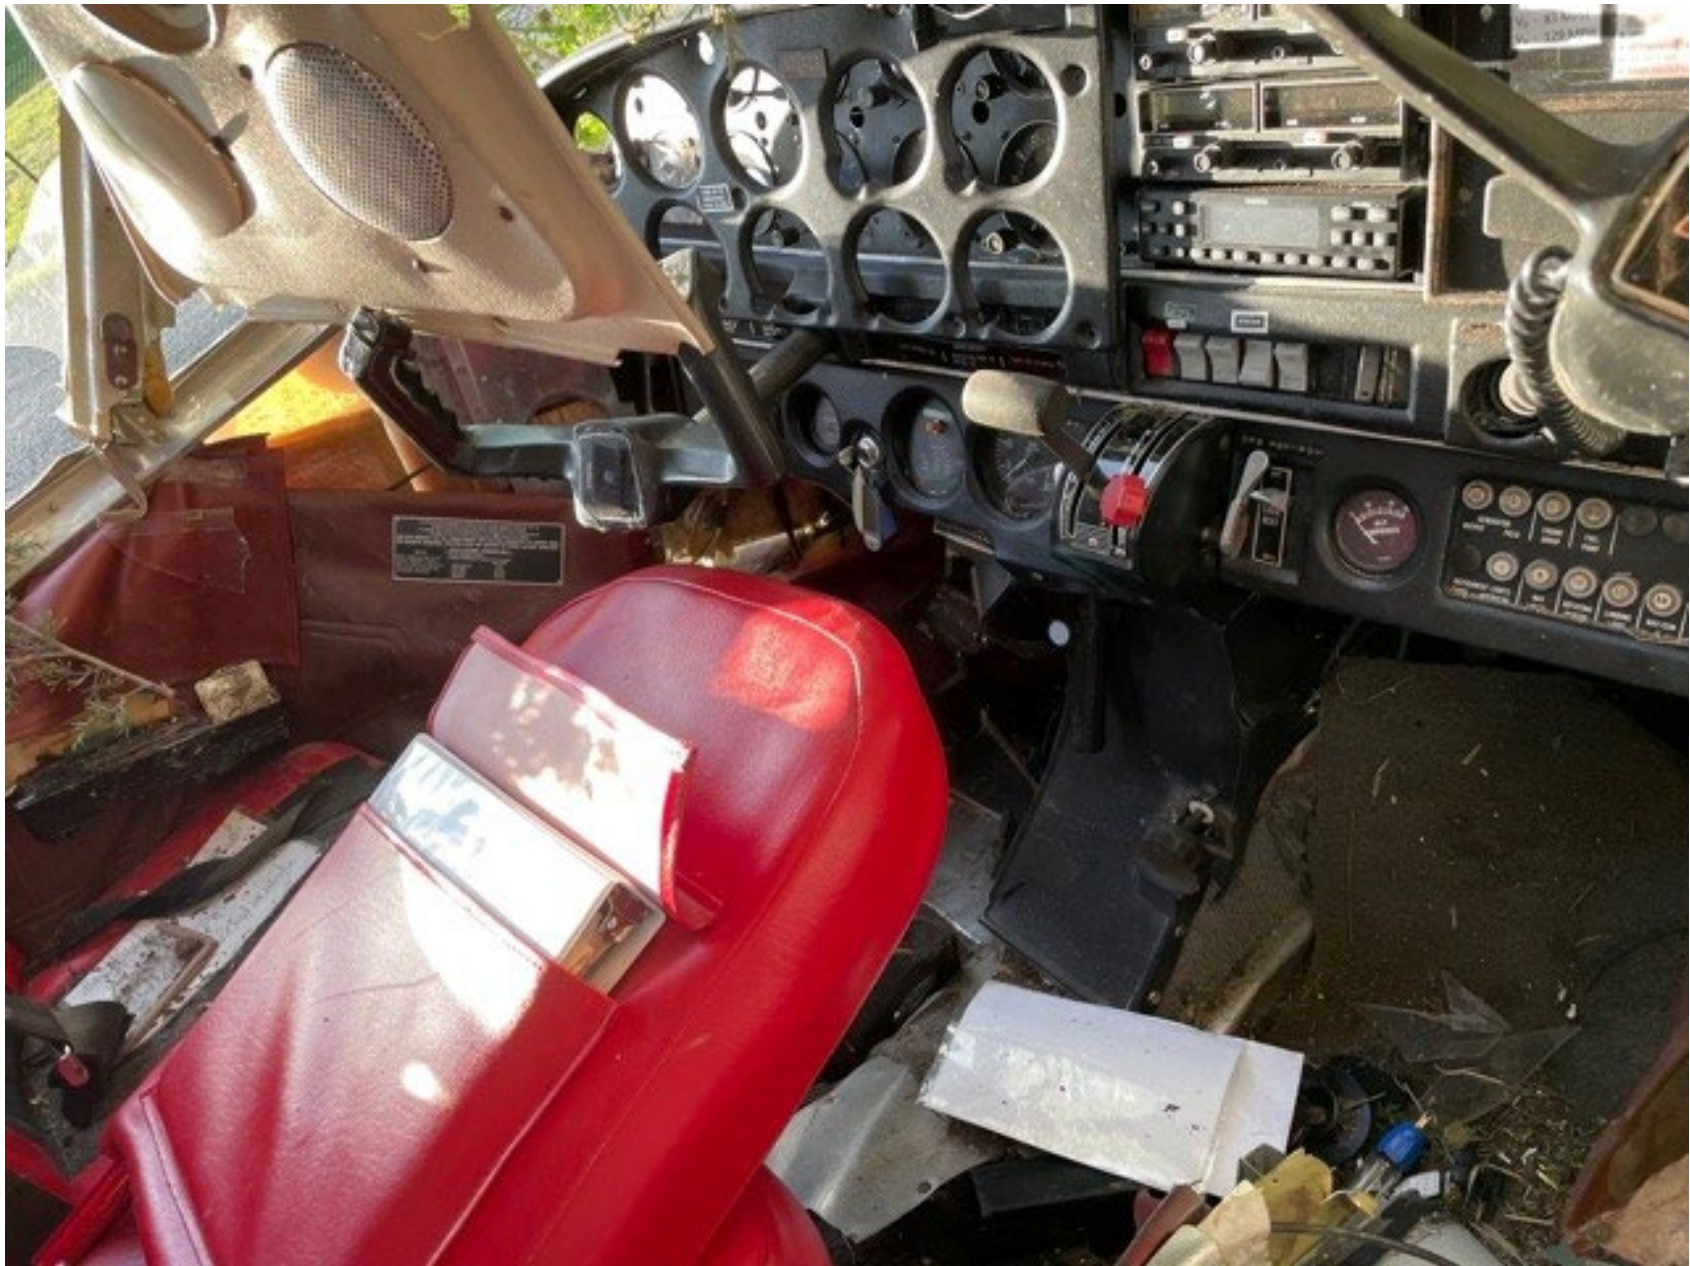
**Photo 3 – Cockpit – Courtesy of KSHD Airport**

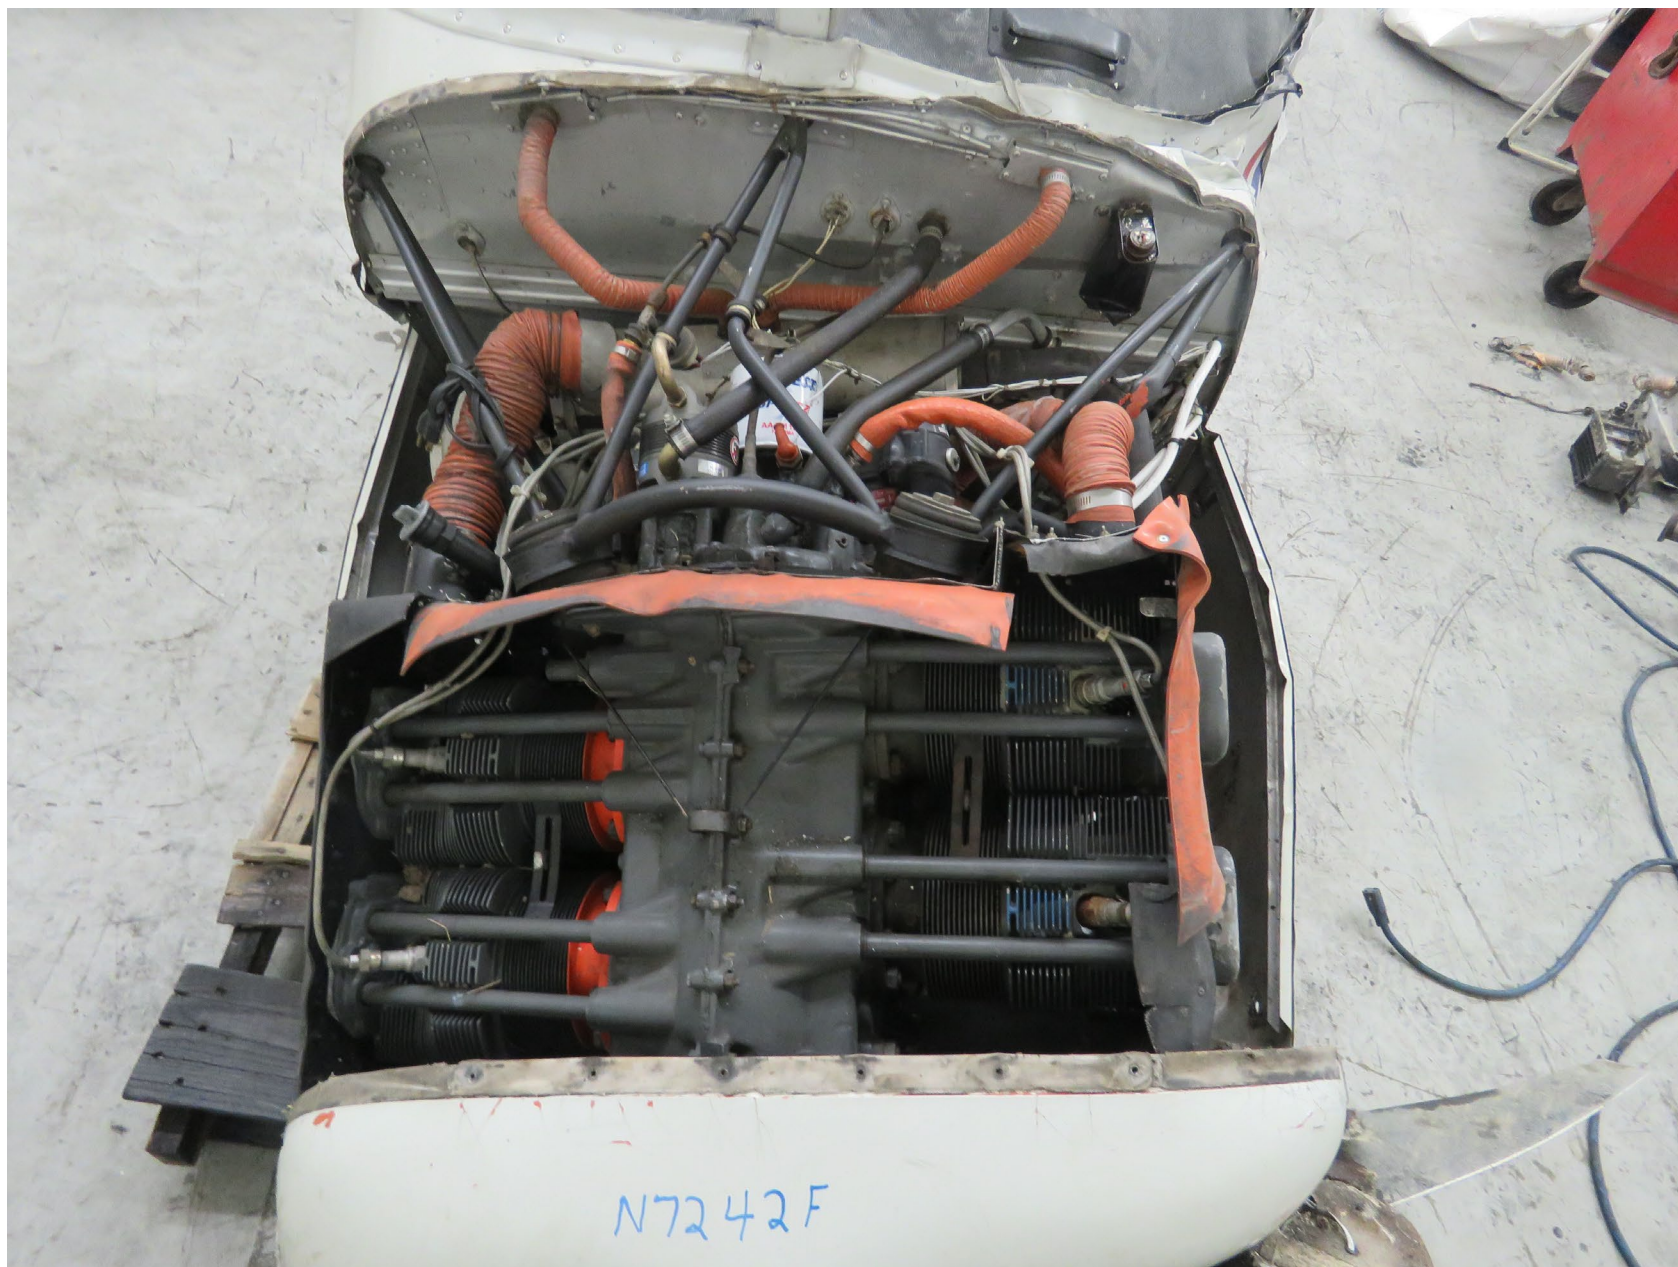
**Photo 4 – Engine – Courtesy of Lycoming Engines**

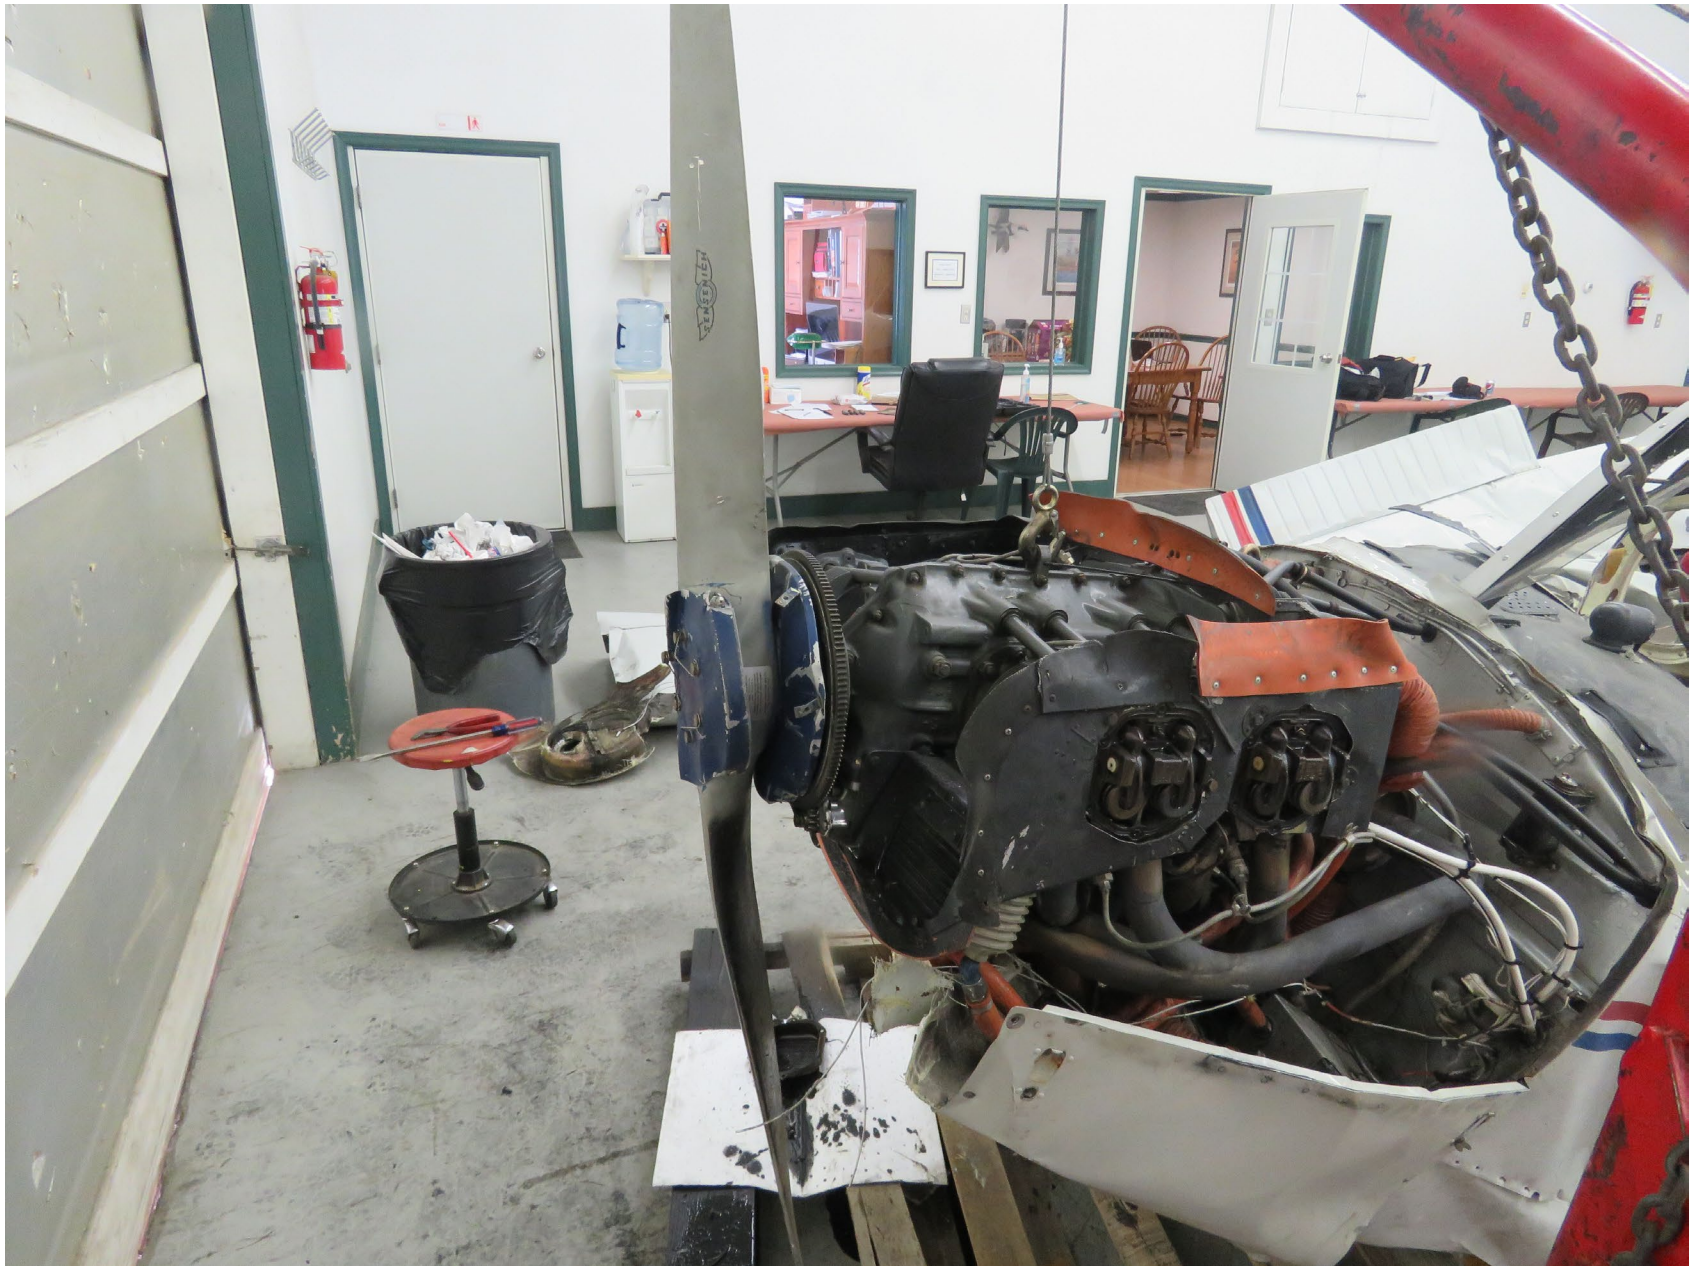
**Photo 5 – Propeller – Courtesy of Lycoming Engines**

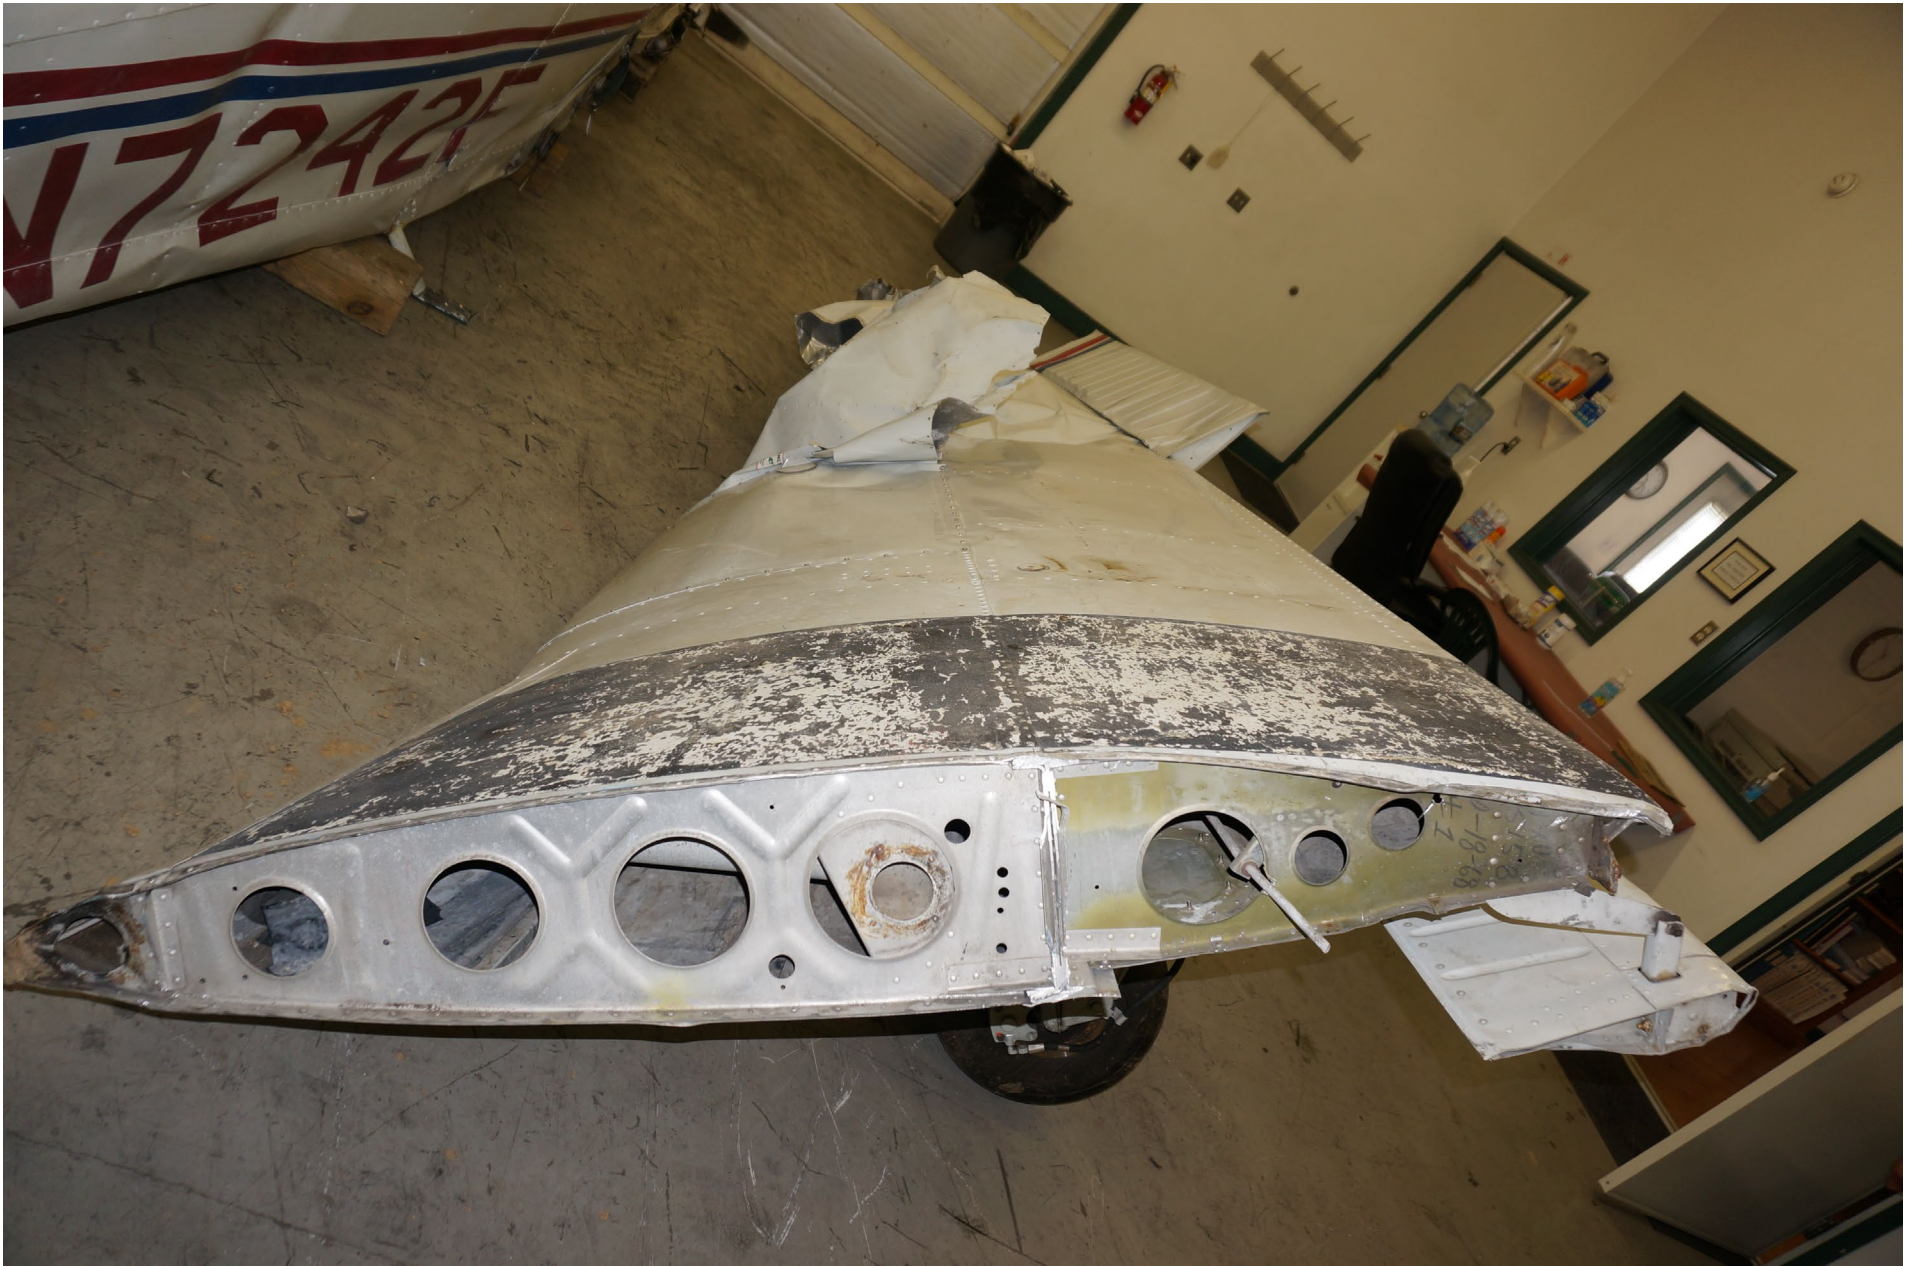
**Photo 6 – Right Wing**

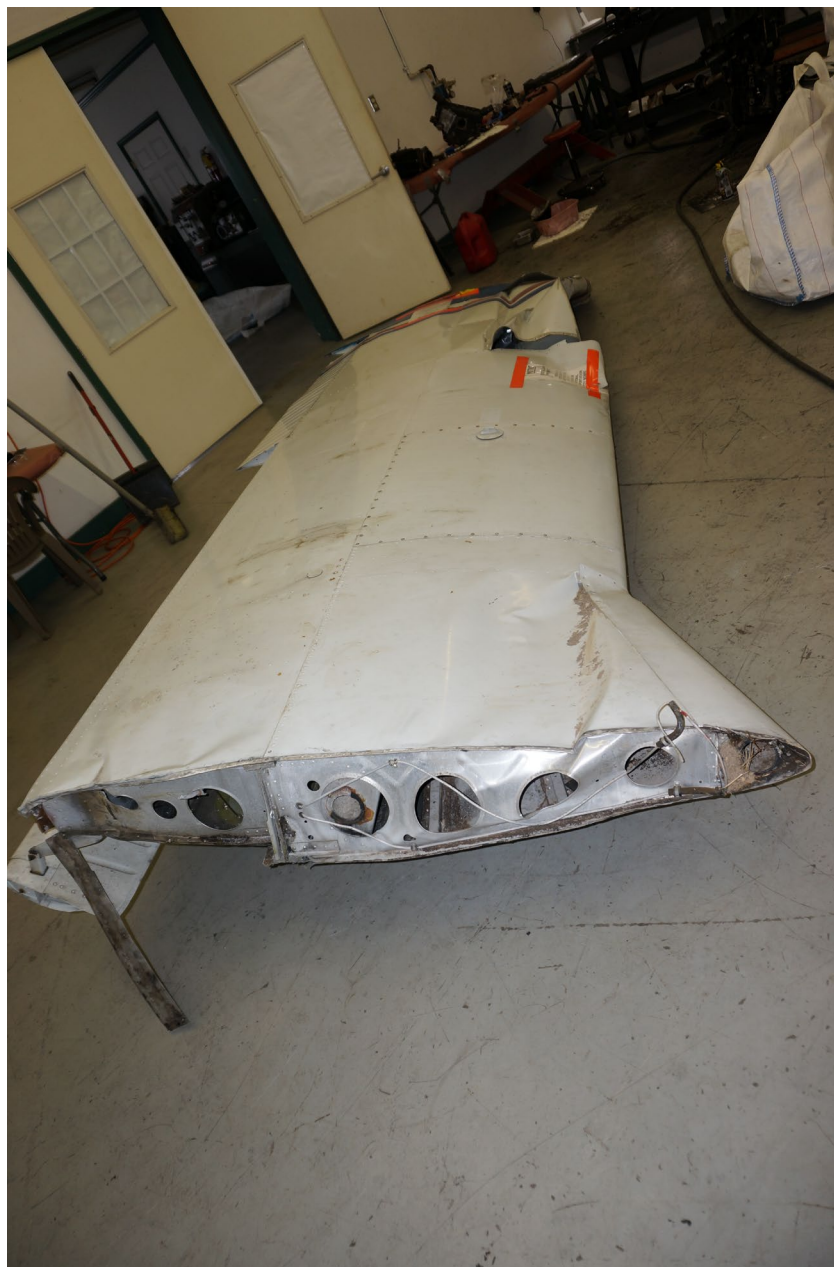
**Photo 7 - Left Wing**

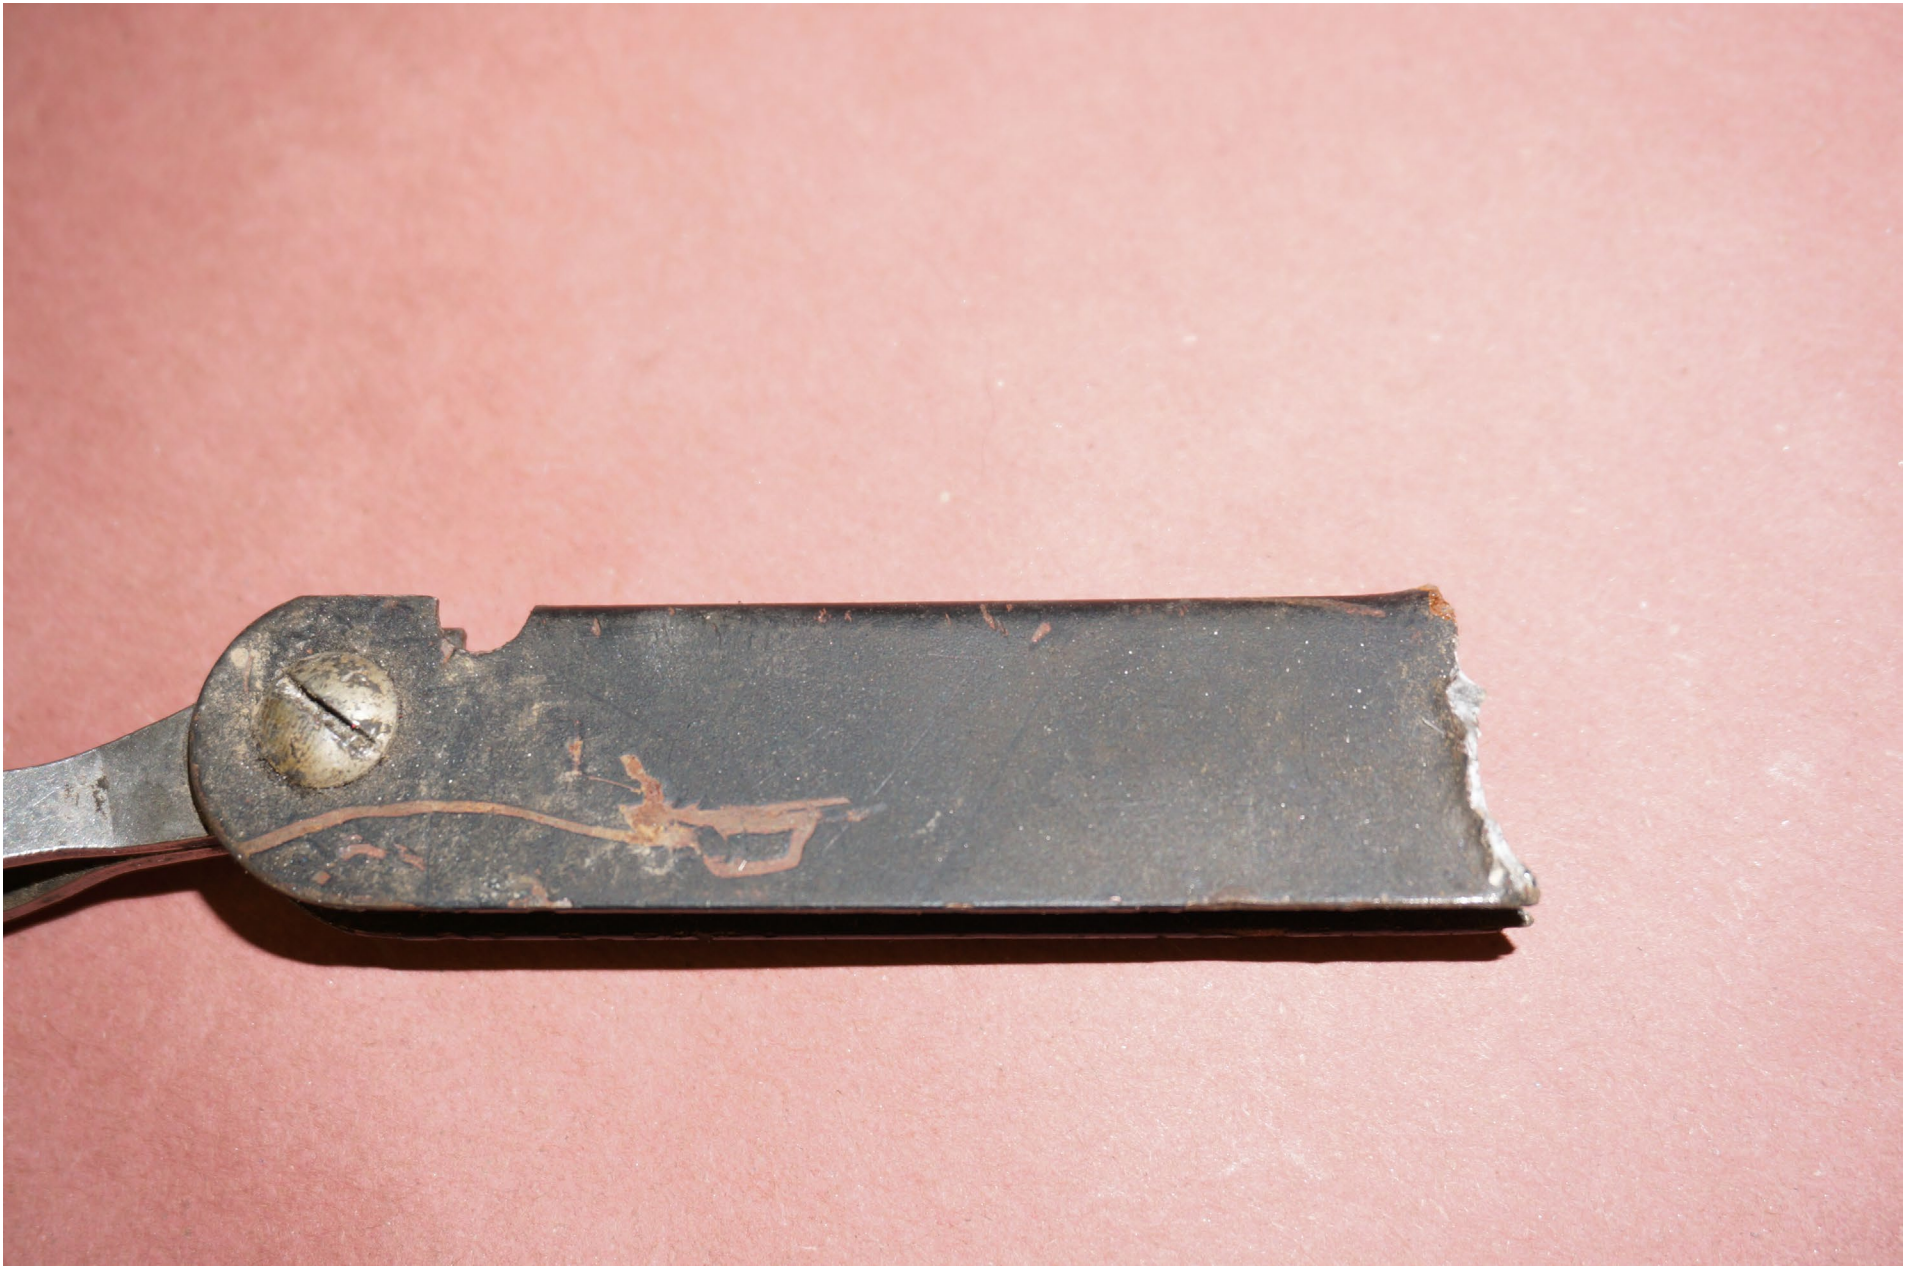
**Photo 8 – Rudder Control Arm**

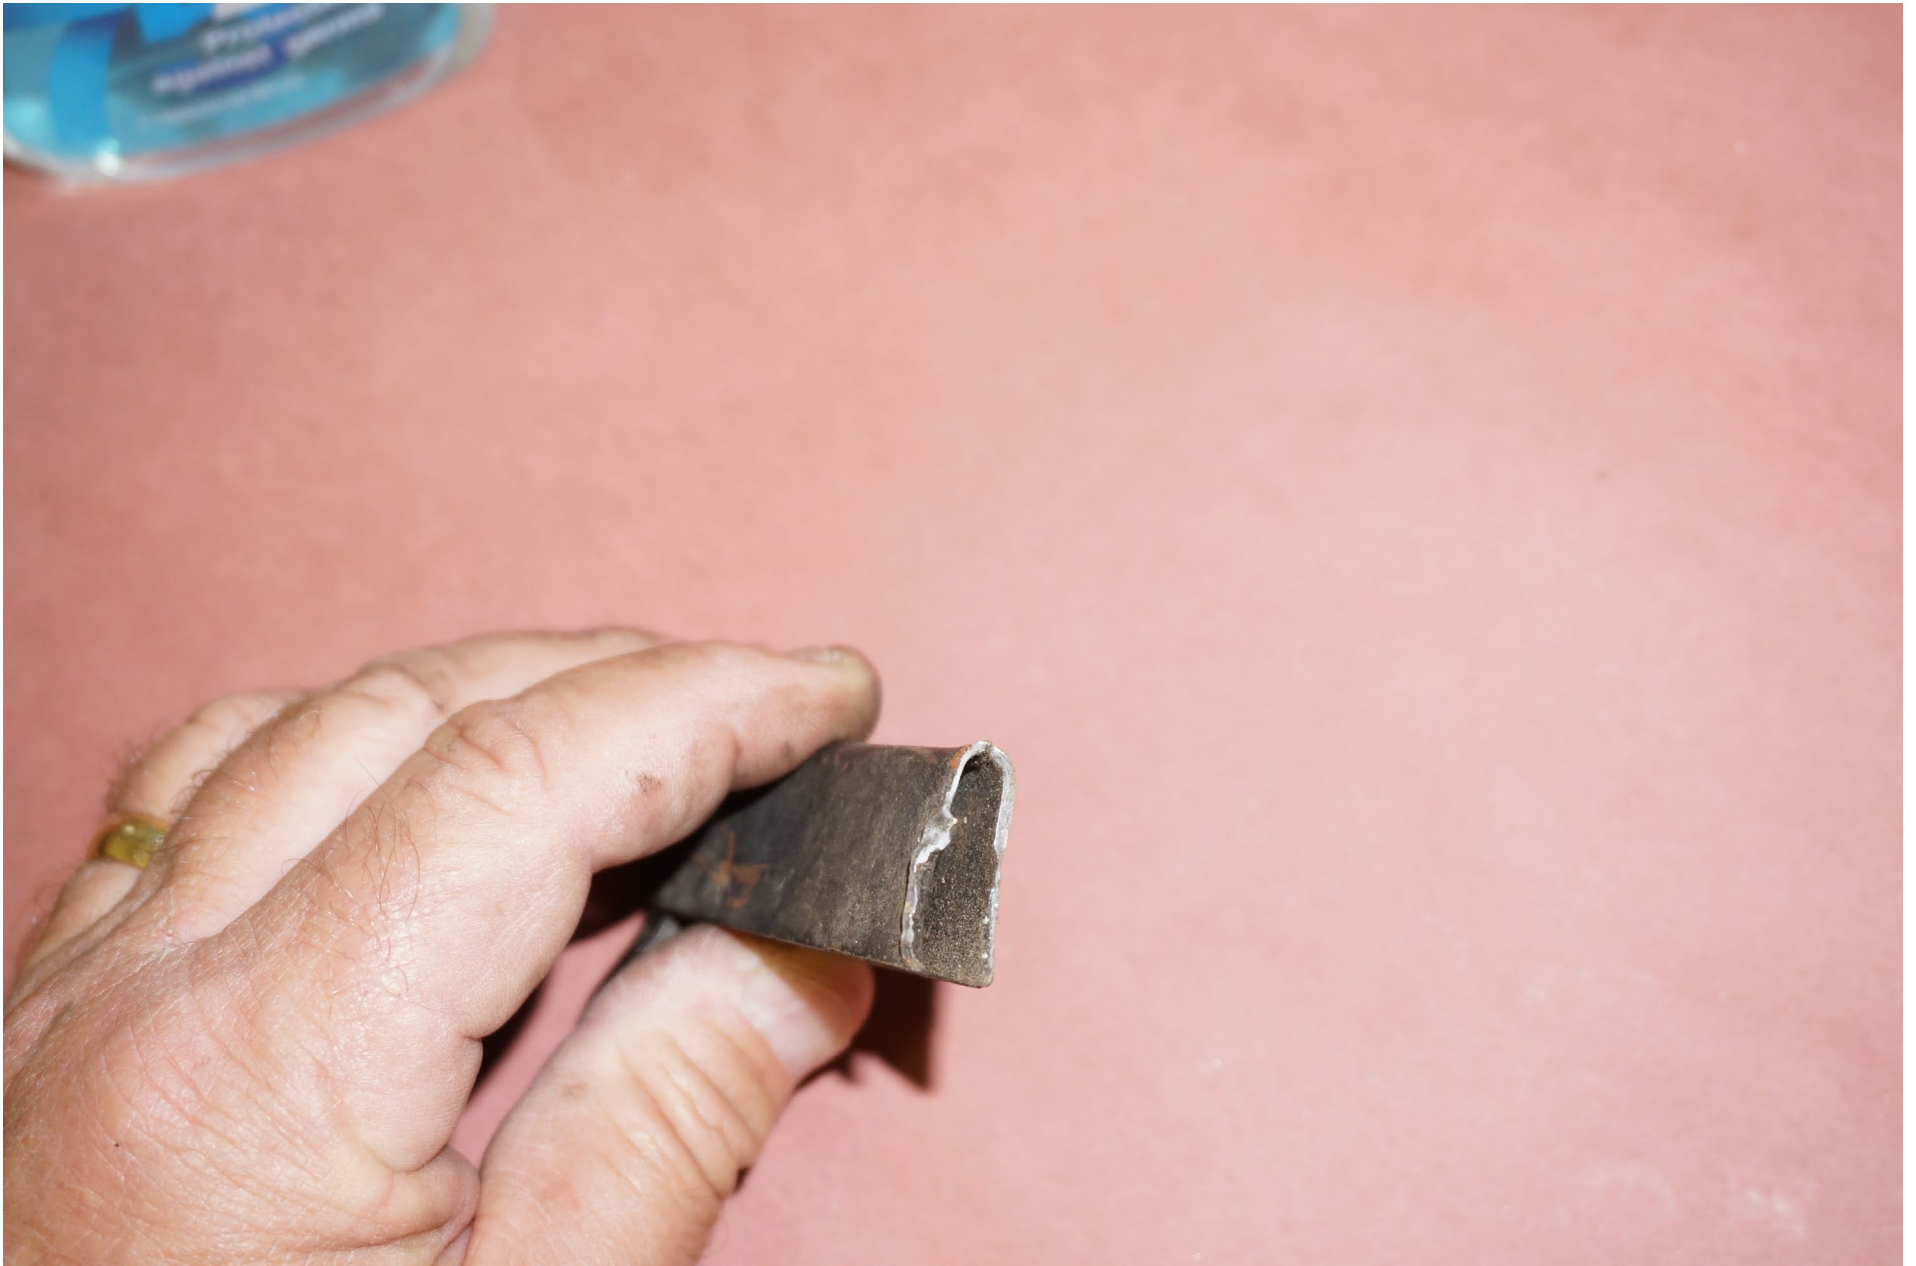
**Photo 9 – Upper Side View of Rudder Control Arm**

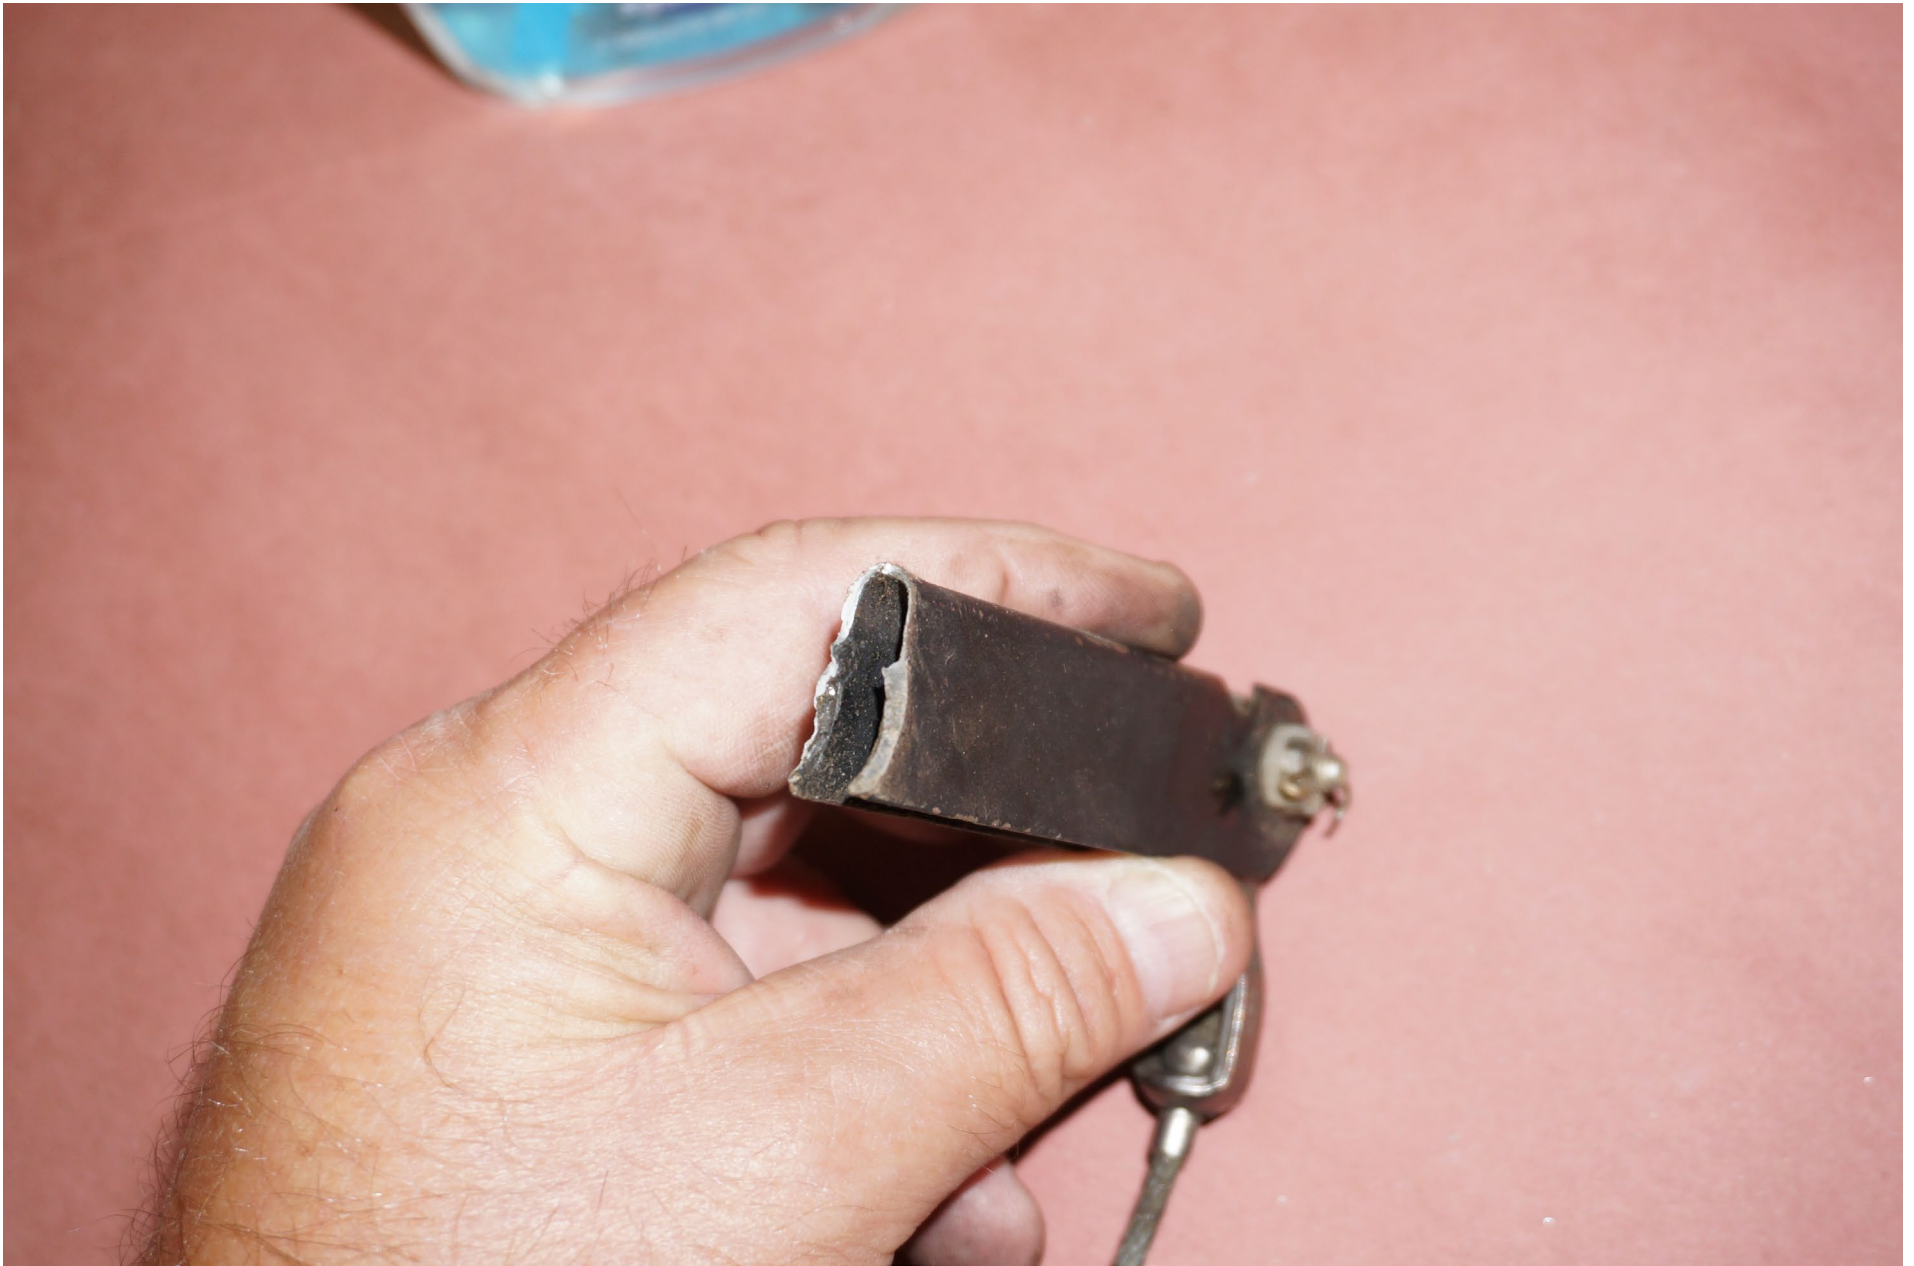
**Photo 10 – Opposite Upper Side View of Rudder Control Arm**
