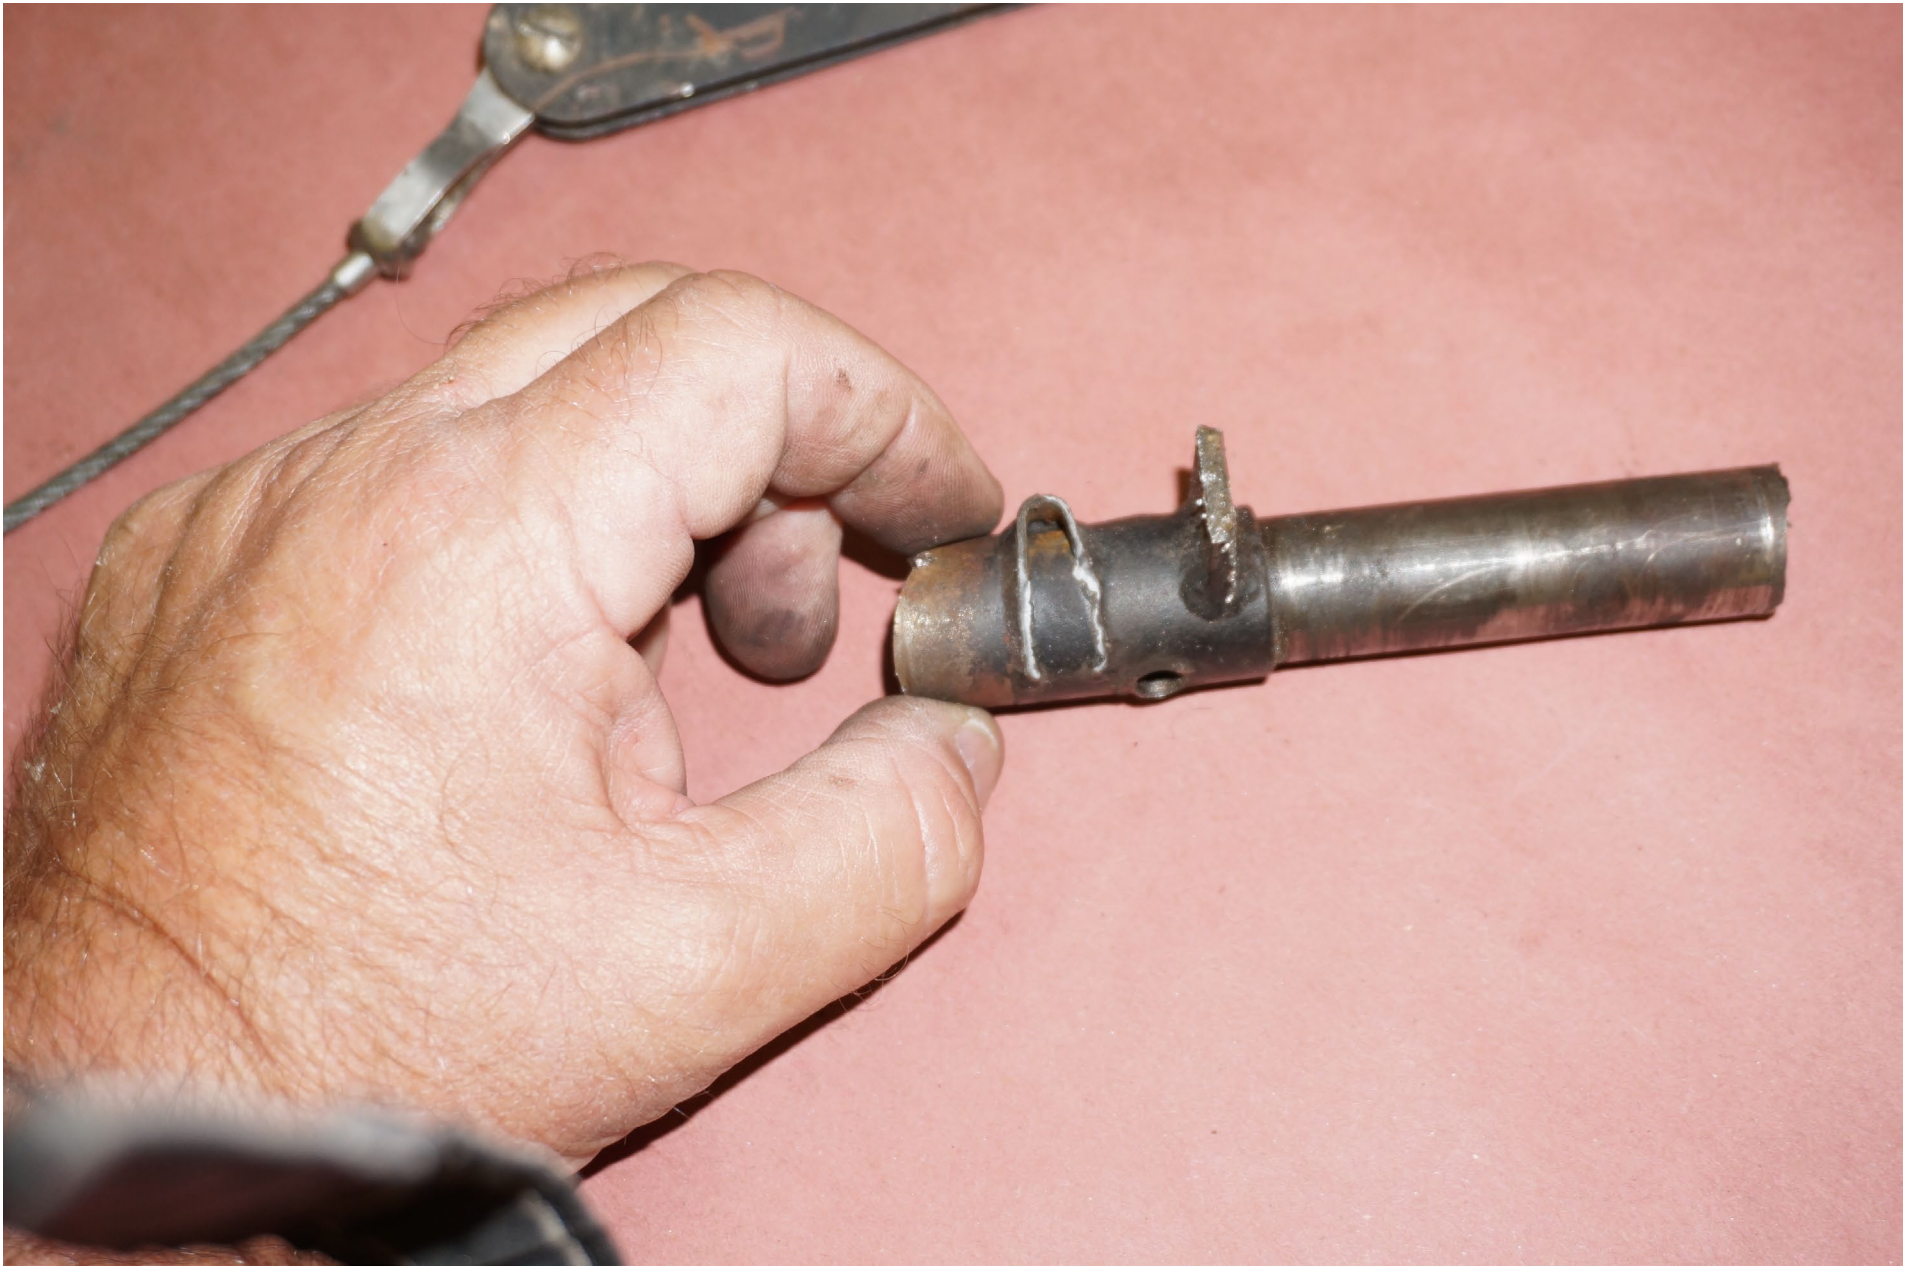
**Photo 11 – Rudder Control Assembly Tube**

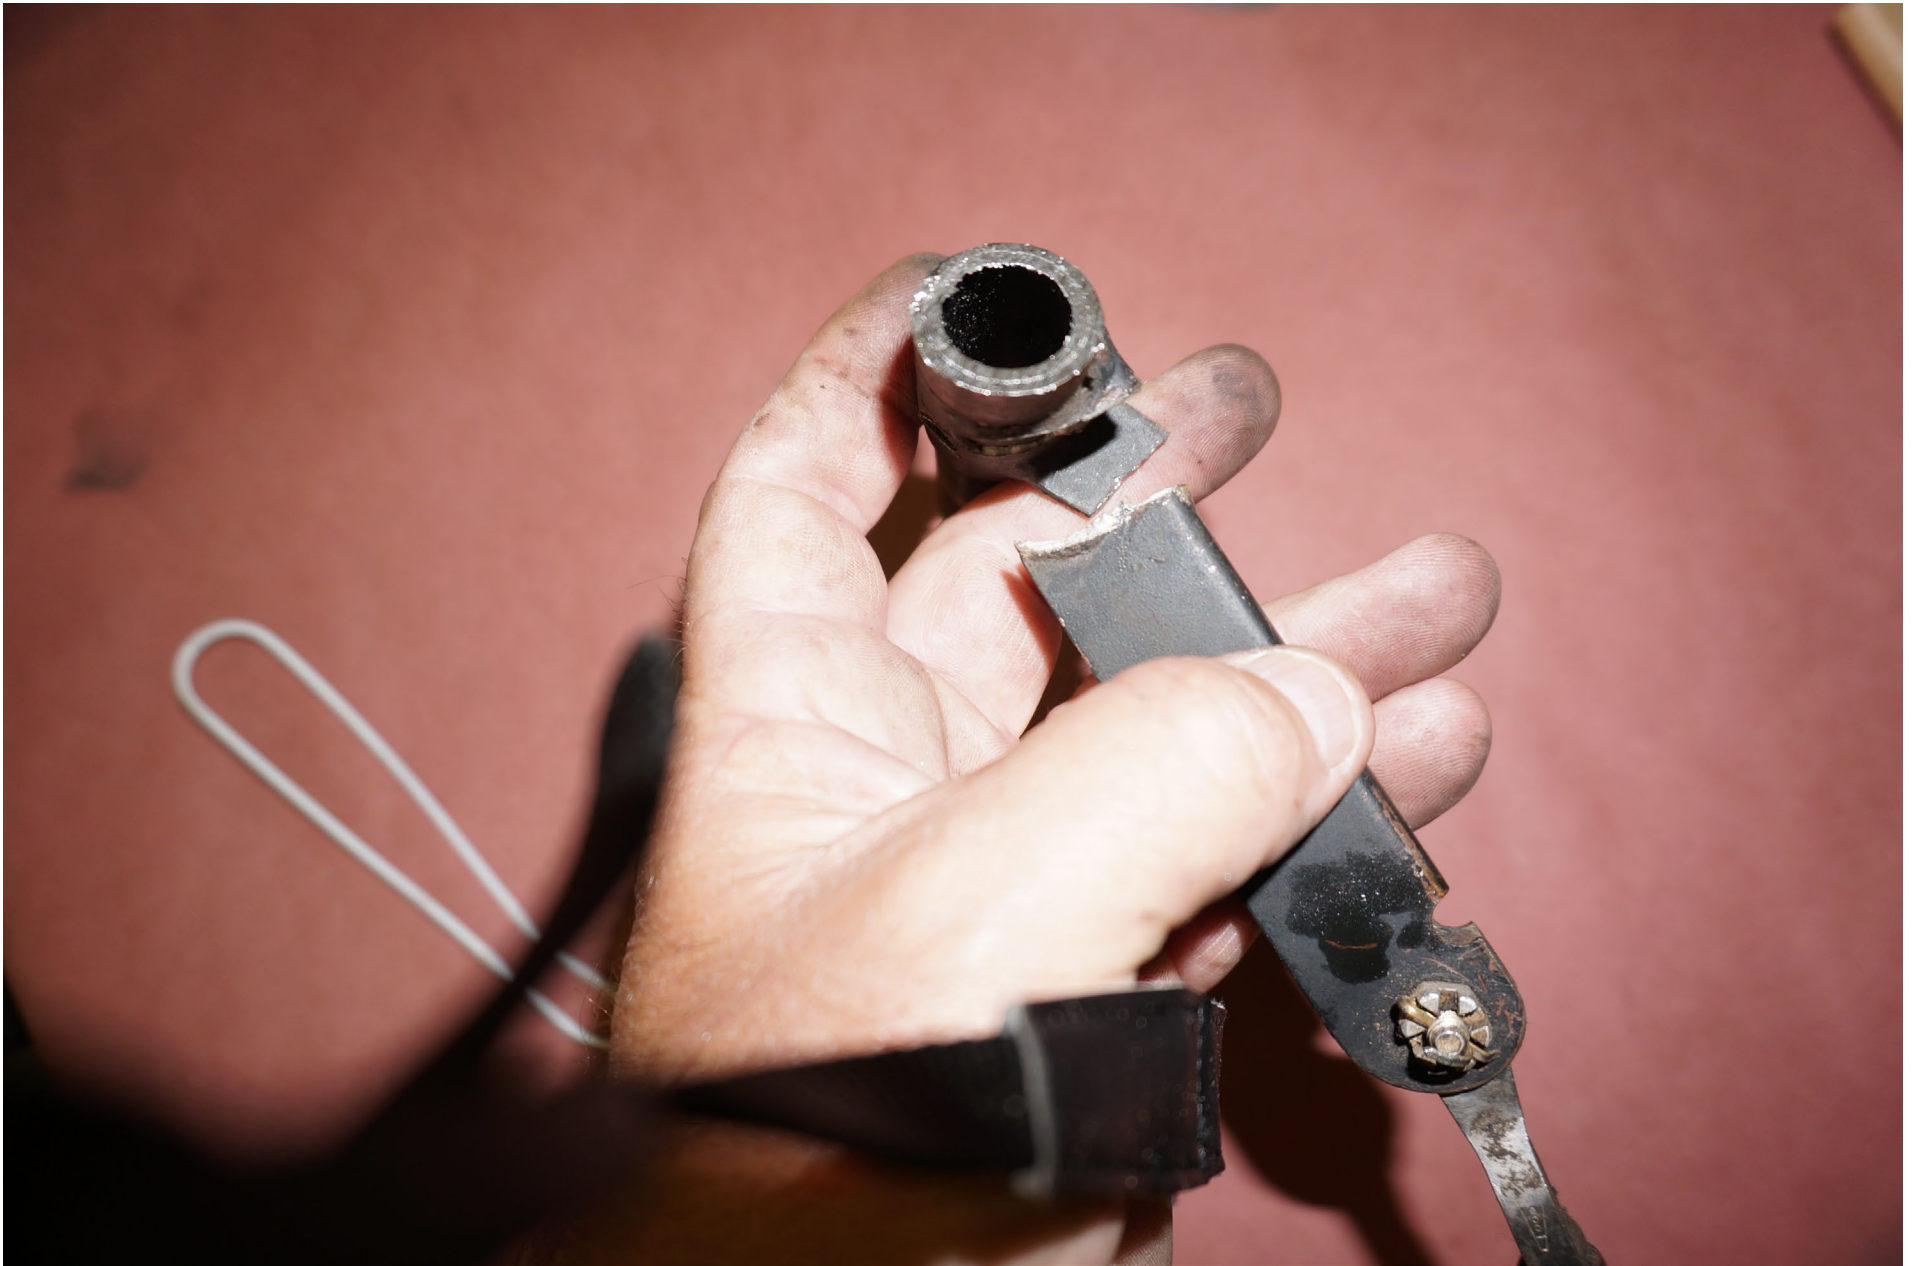
**Photo 12 –Rudder Control Assembly Tube and Rudder Control Arm**

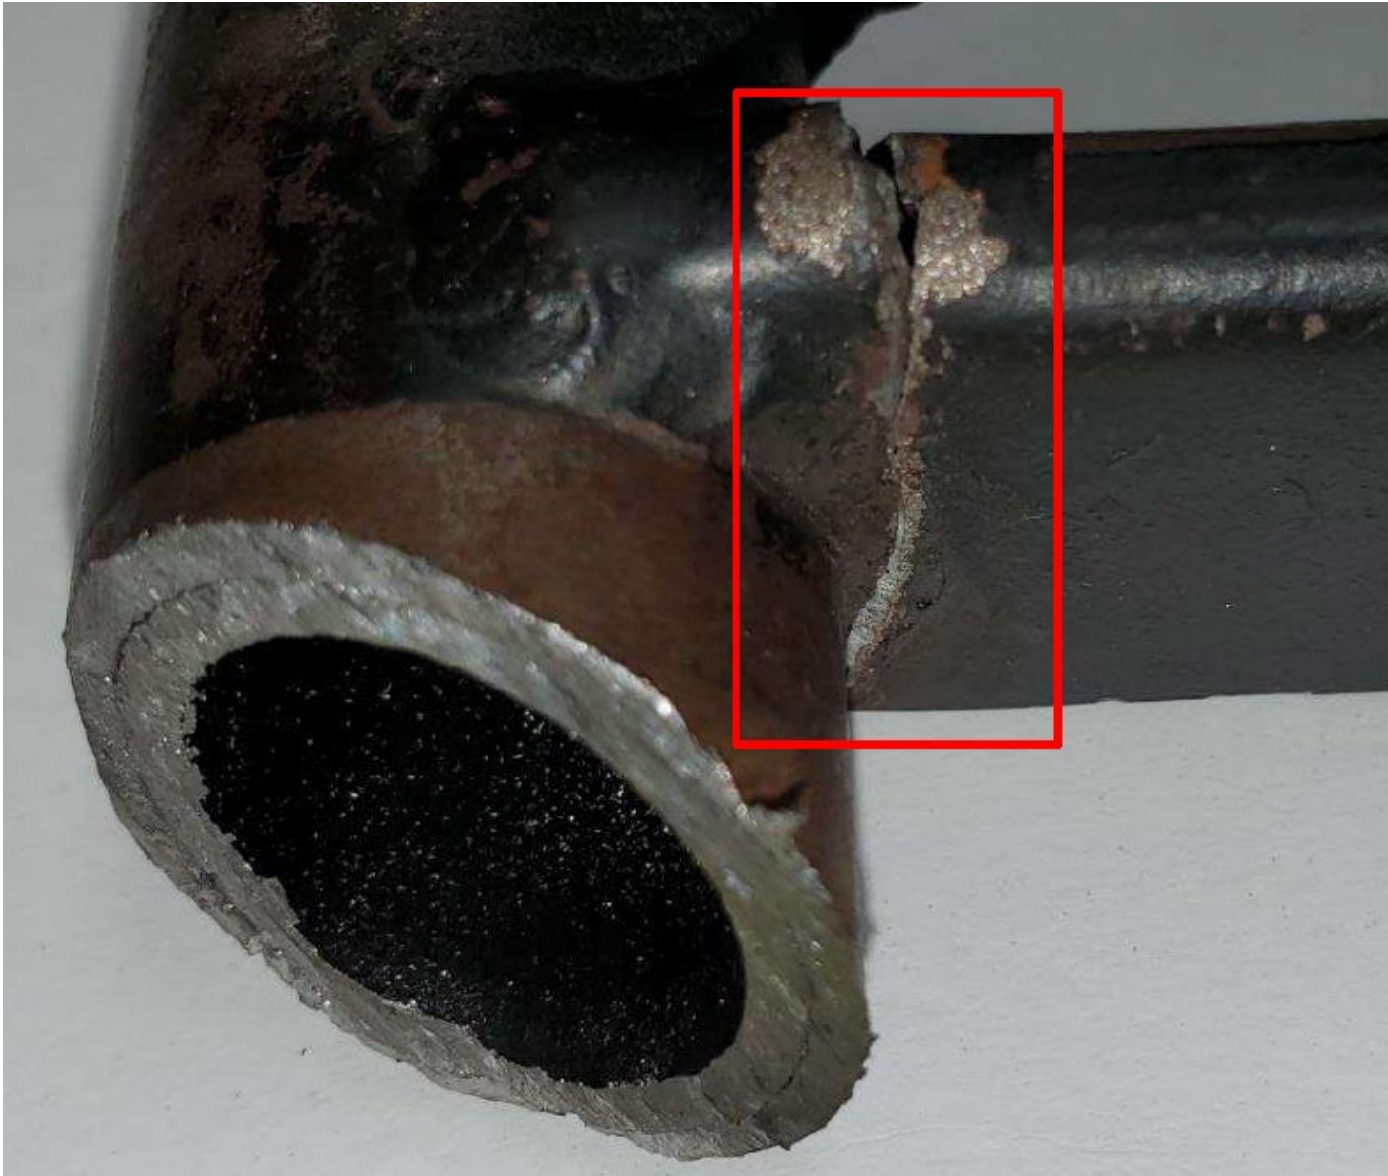
**Photo 13 – Macro View of Rudder Control Assembly Normal Position – Courtesy of Piper Aircraft**

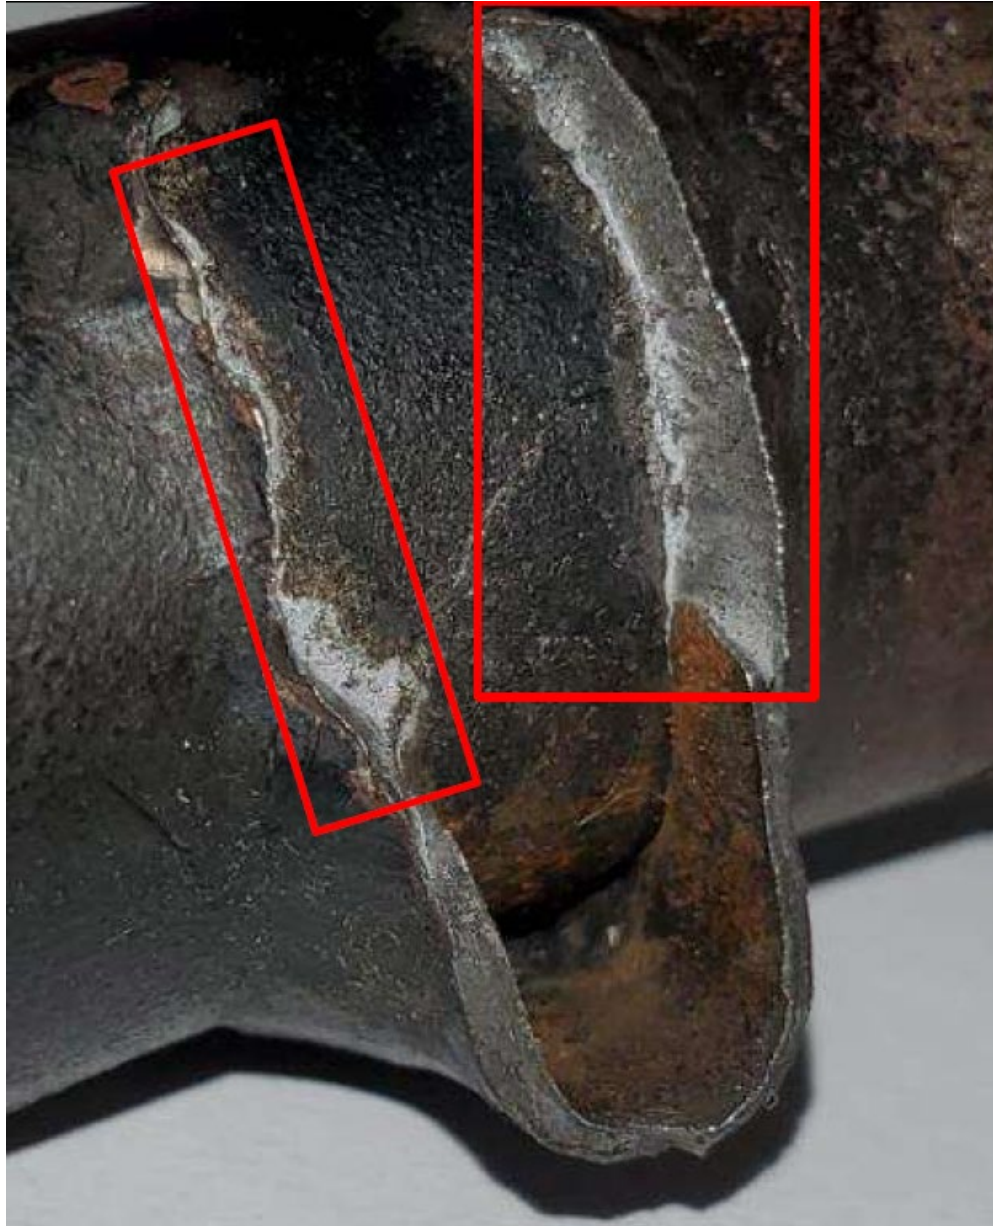
**Photo 14 – Fracture Surface Near Weld – Courtesy of Piper Aircraft**

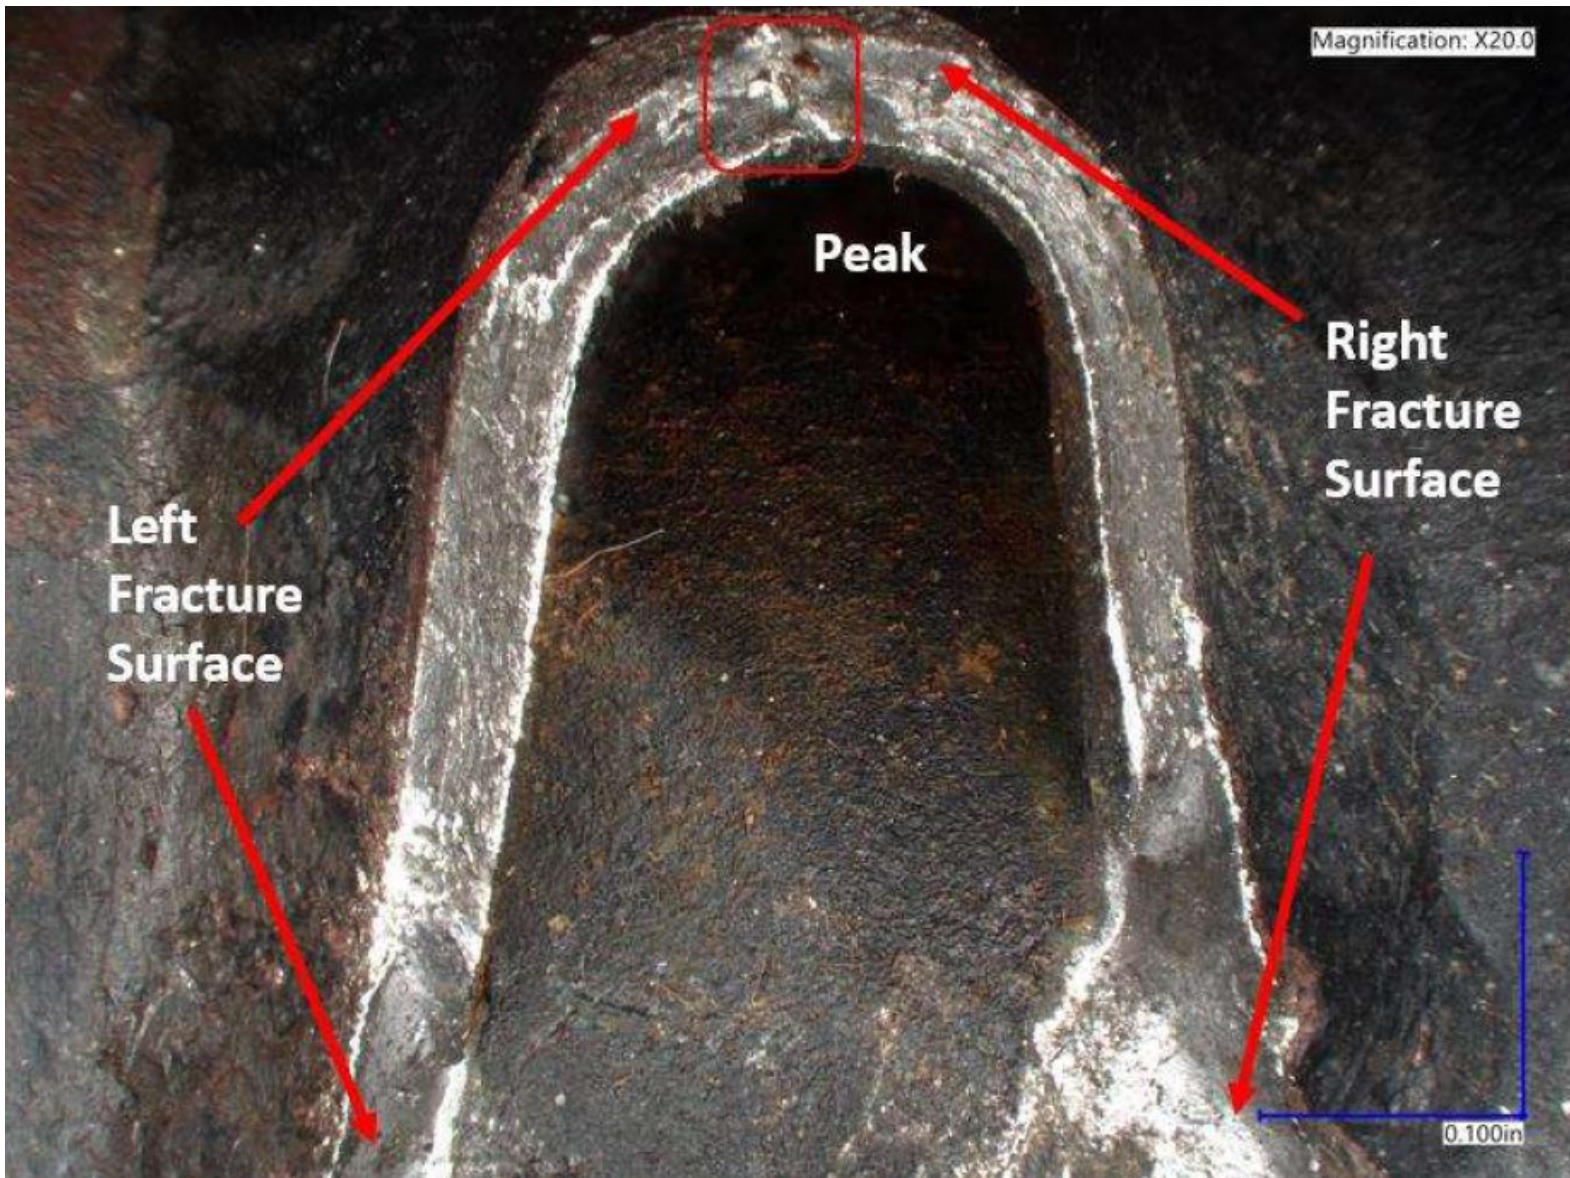
**Photo 15 –Fracture Surface Magnified to 20x - Courtesy of Piper Aircraft**

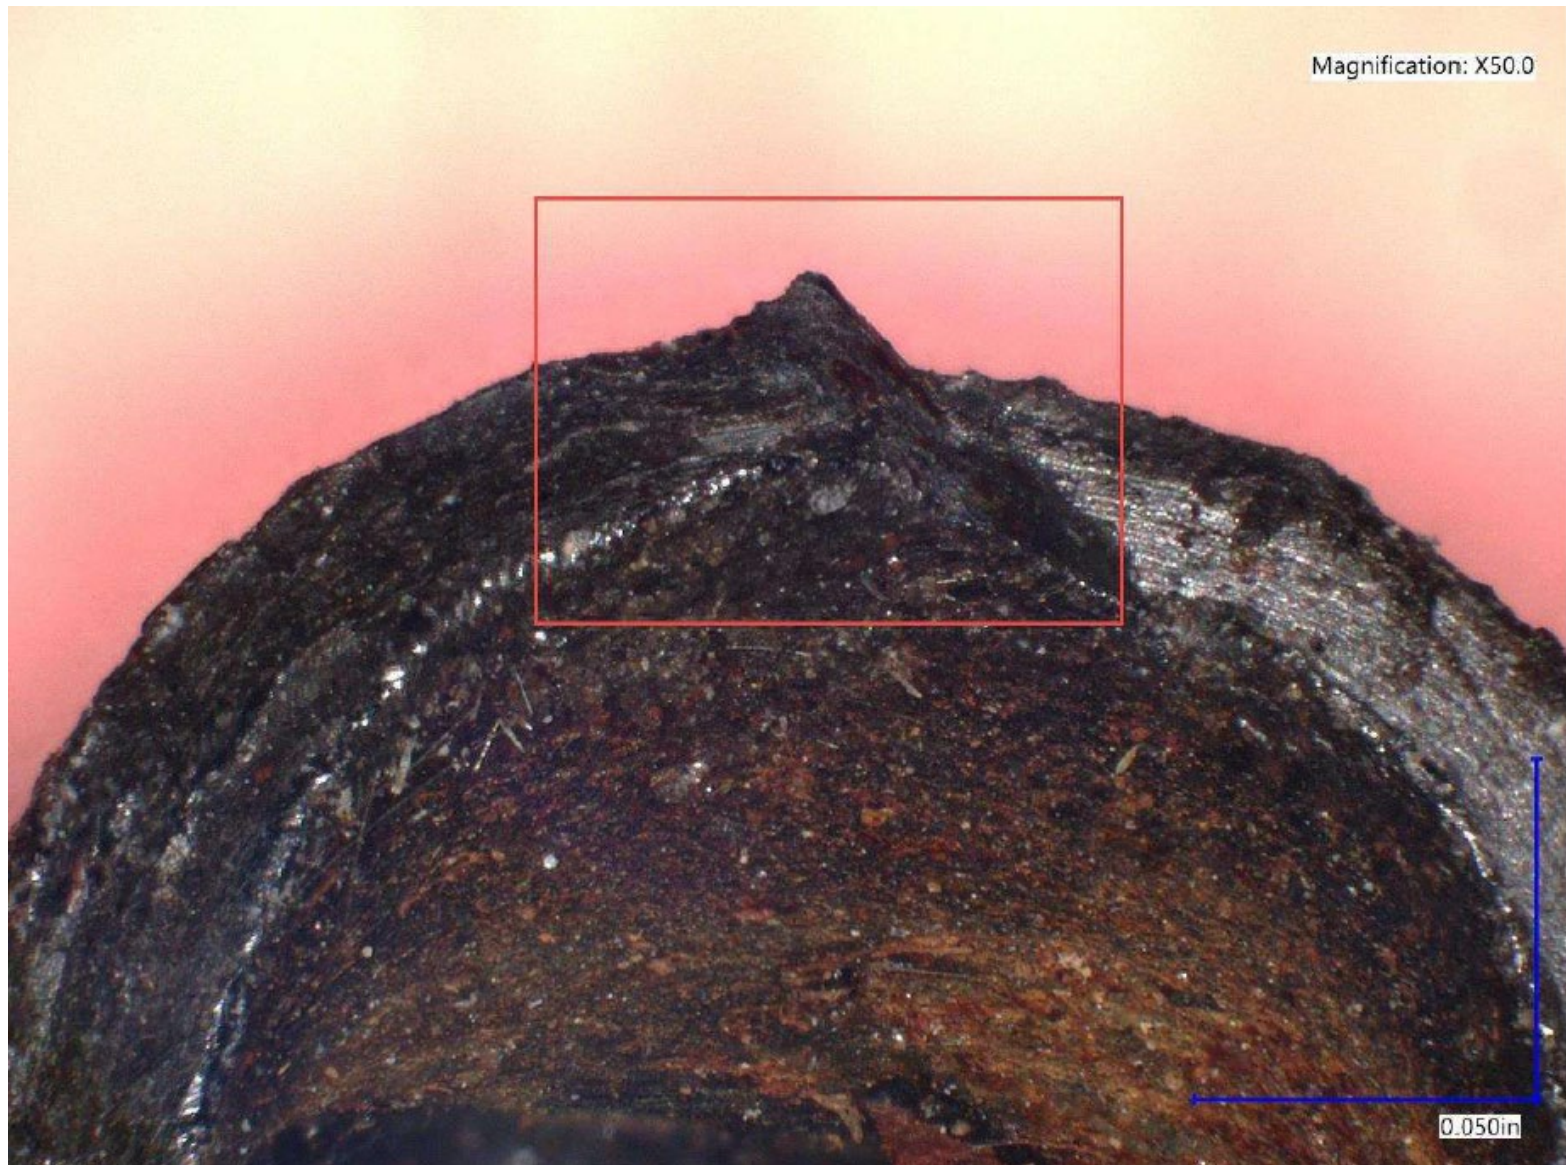
**Photo 16 – Peaked Surface Magnified to 50x – Courtesy of Piper Aircraft**

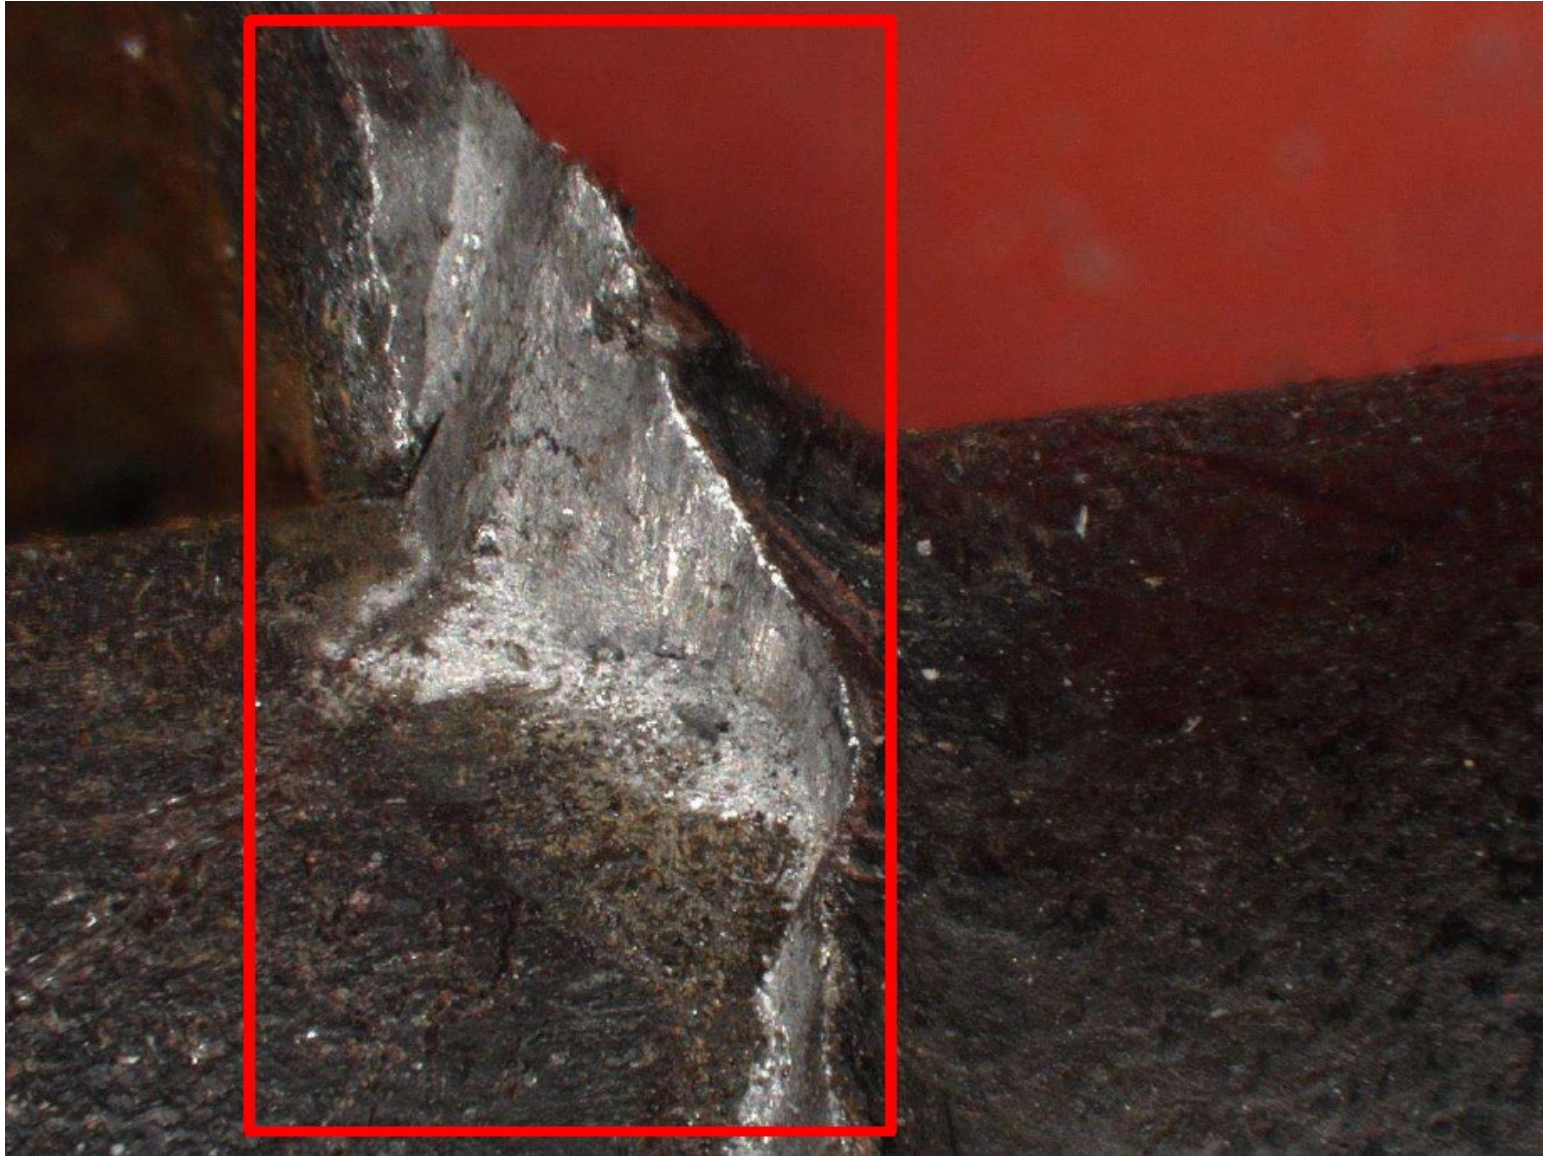
**Photo 17 – Right Hand Fracture Surface with Porosity – Courtesy of Piper Aircraft**

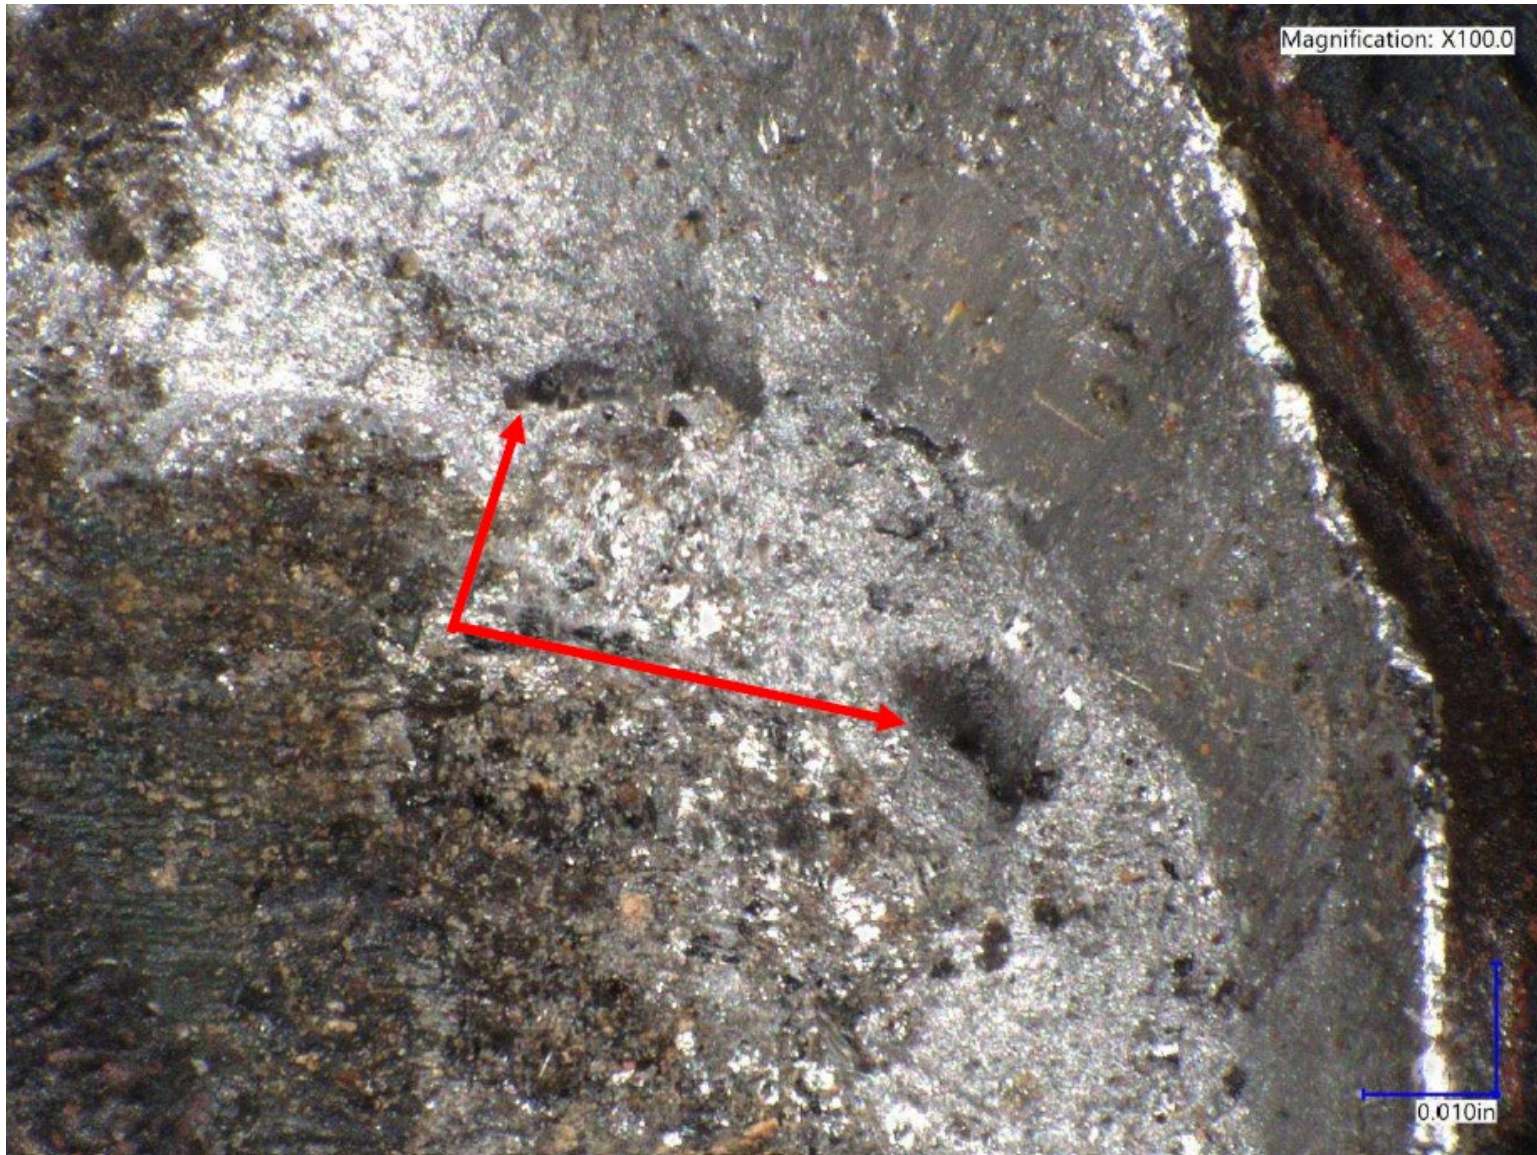
**Photo 18 – Right Hand Fracture Magnified to 110x with Porosity, Cup and Cone Signatures, and Voids in the Weld  
Courtesy of Piper Aircraft**

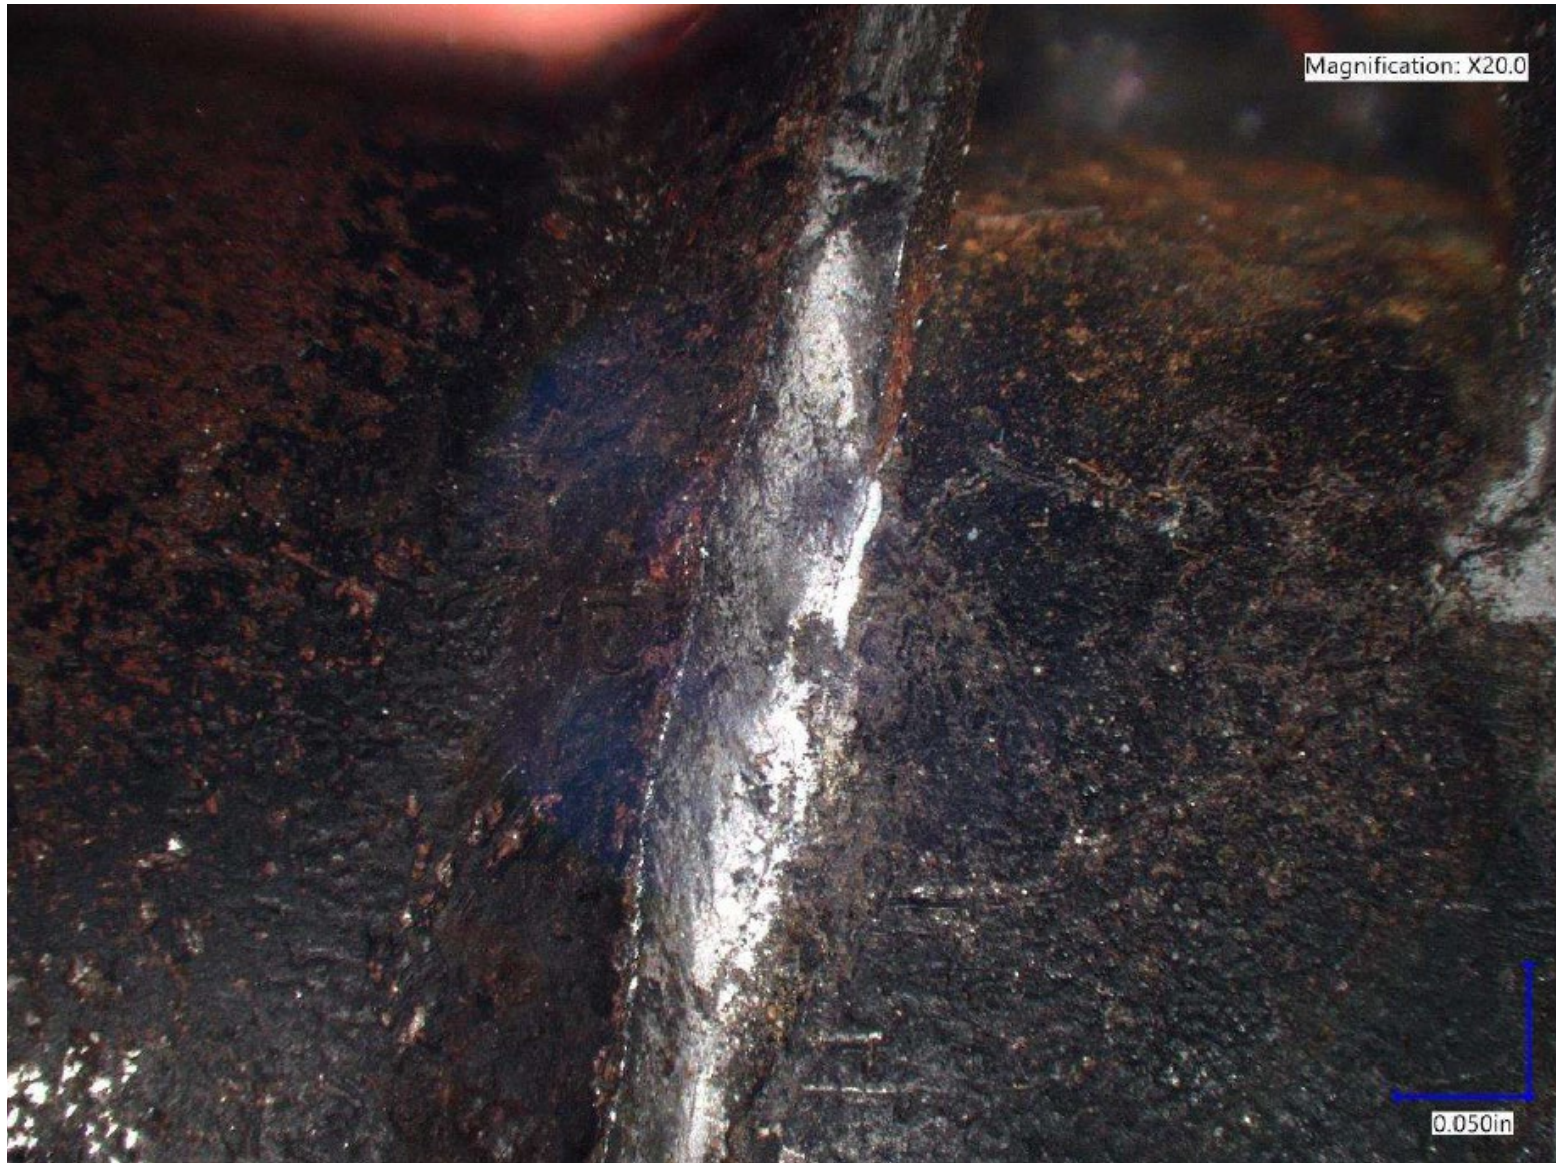
**Photo 19 – Left Hand Side of Fracture Surface Magnified to 20x Showing Fresh Substrate – Courtesy of Piper Aircraft**
