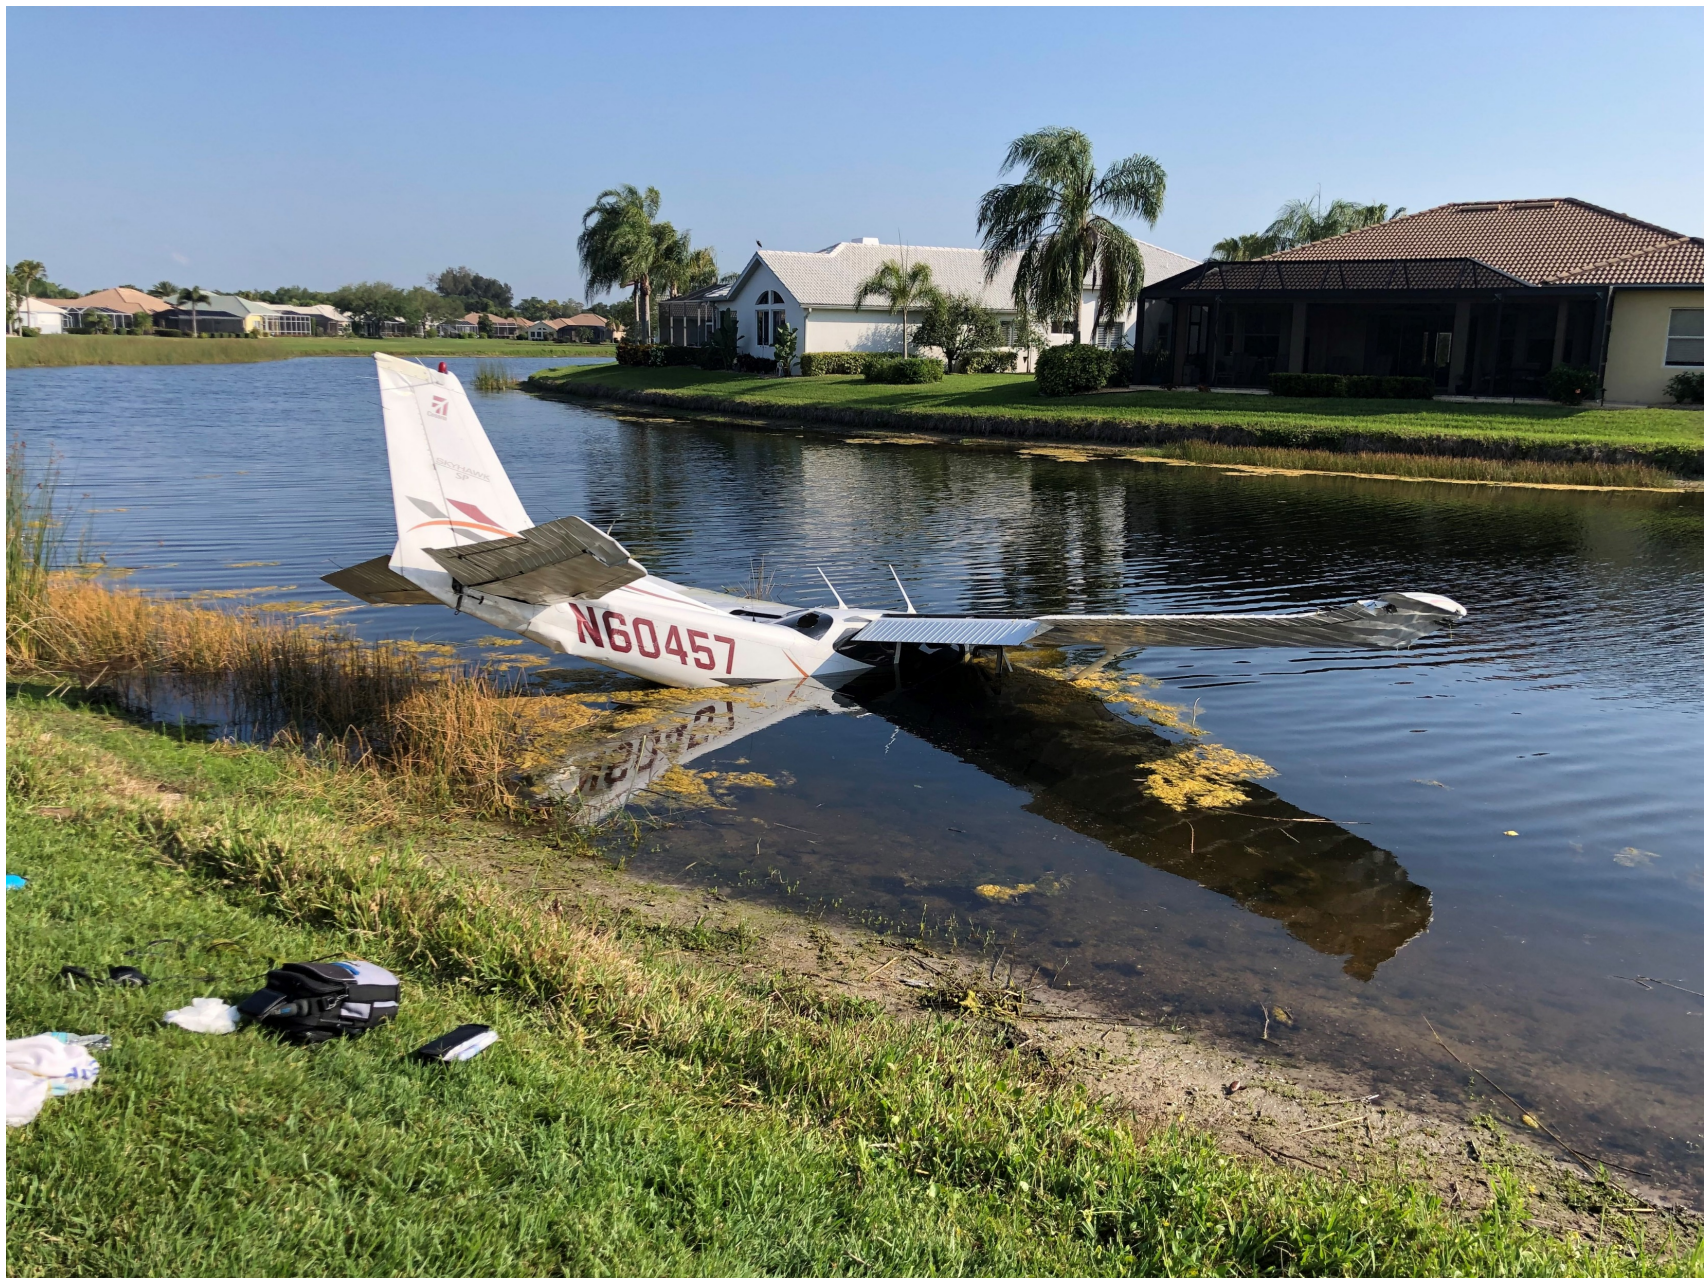
Photo 1 – View of the airplane submerged in water at the accident site (Photo Courtesy of FAA)

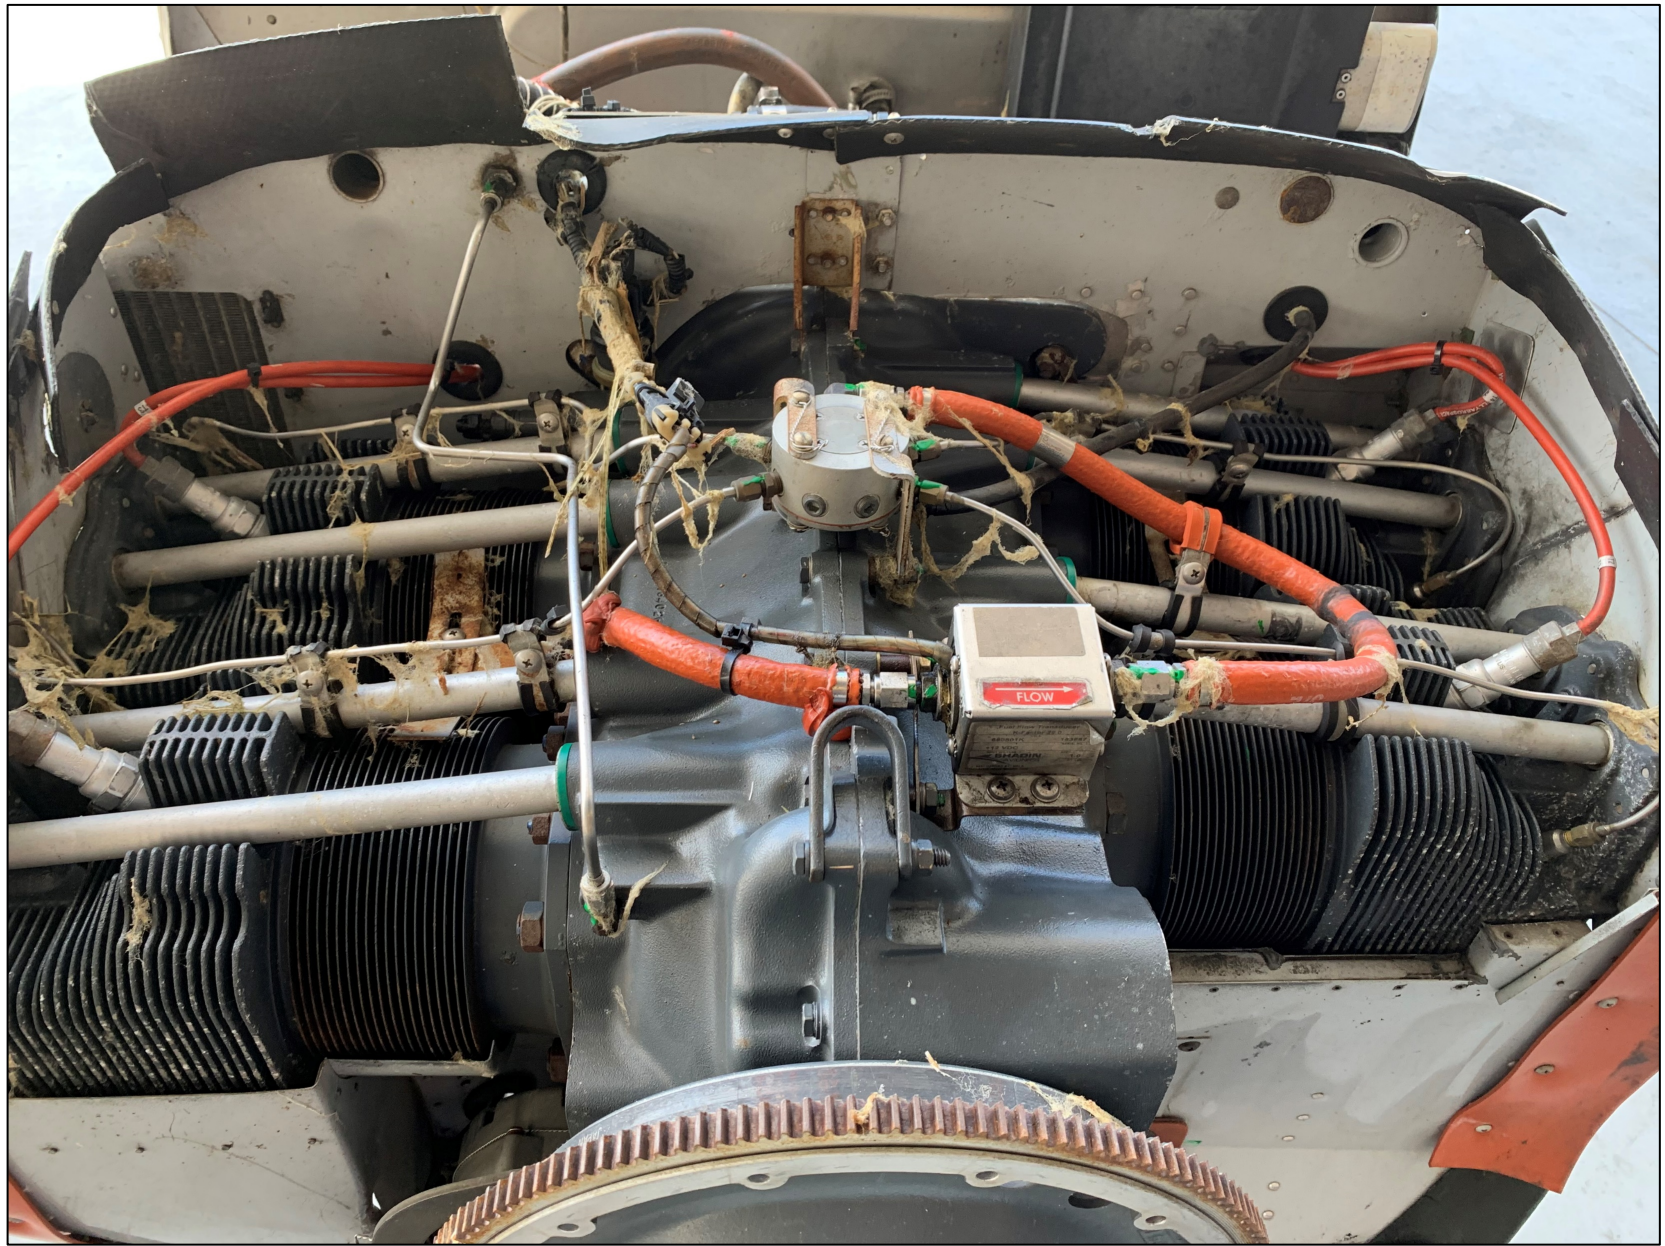
Photo 3 – Overview of the engine

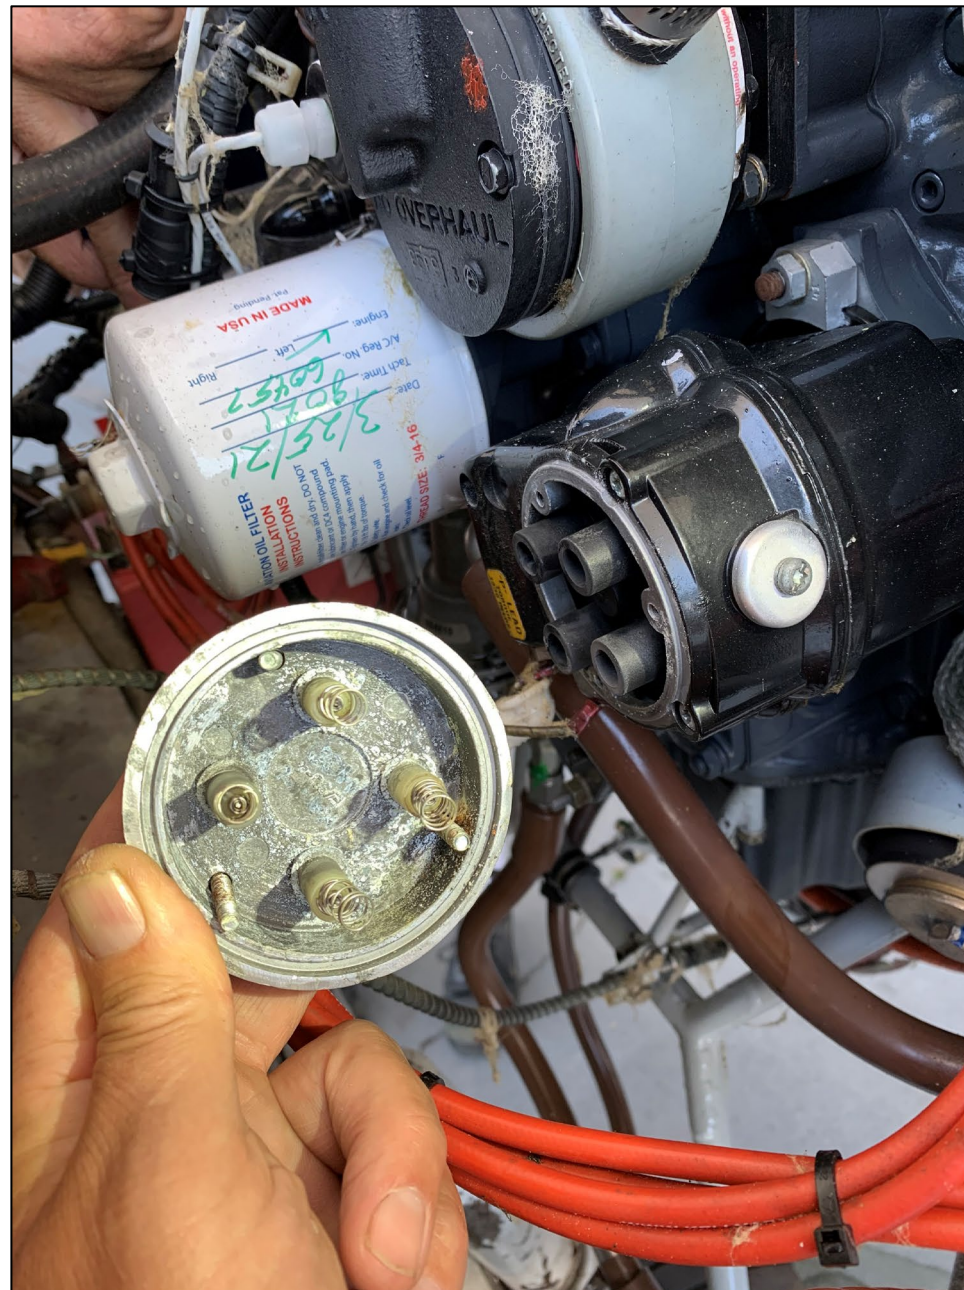
Photo 4 – Internal view of the right magneto
