## **NATIONAL TRANSPORTATION SAFETY BOARD**

# **EXAMINATION SUMMARY**

**ERA21LA188**

Location: Dover, North Carolina  
Date: April 15, 2021  
Time: 1605 EDT  
Airplane: Cessna A188, N731TB

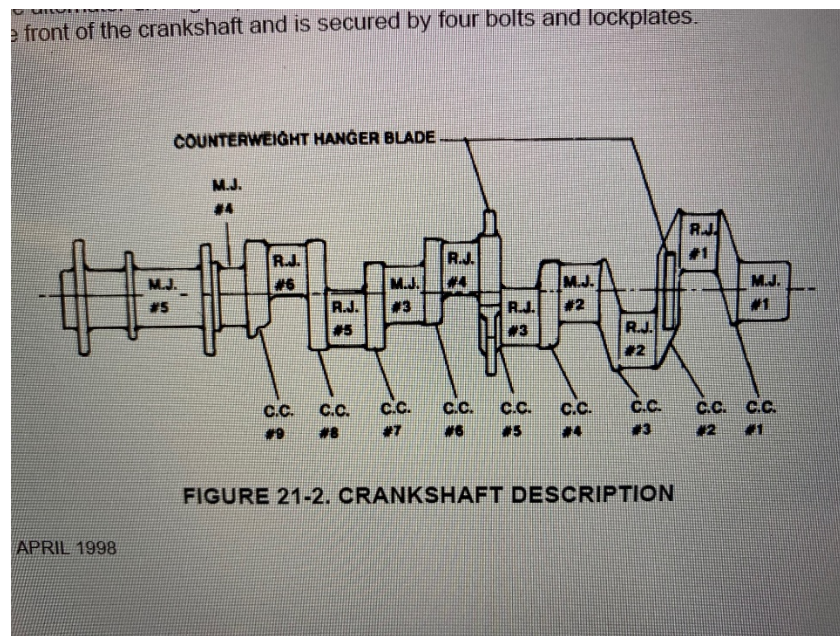
Figure 1 – Crankshaft Numbering (Example)

The crankshaft was fractured between main journal #2 and rod journal #2 (see Figure 1, below). There were visible signatures of heat distress near the fracture surfaces. All connecting rods remained attached to their journals on the crankshaft and they rotated freely.

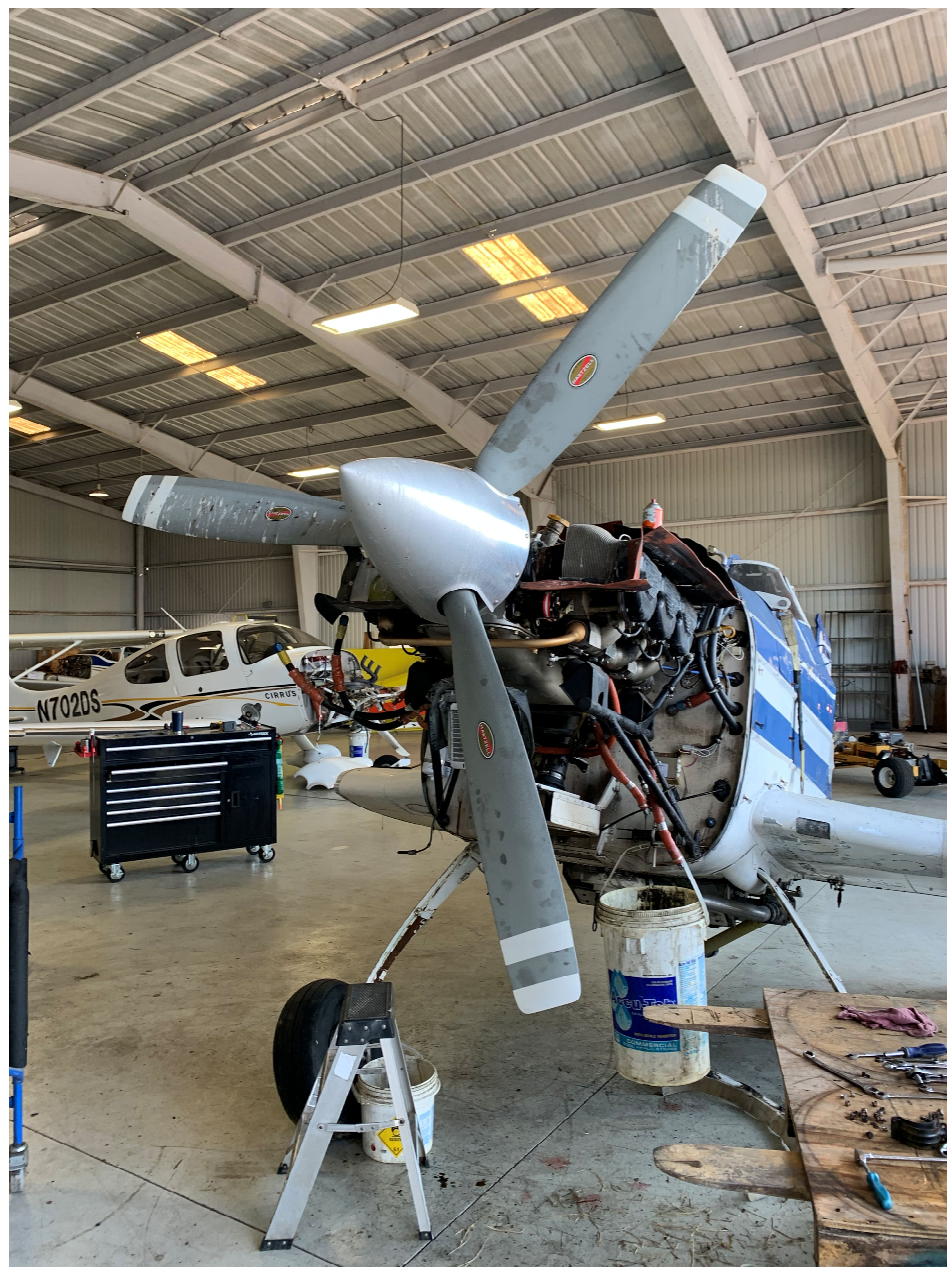
**Photo 3 – Propeller and Engine, Cowling Removed**

The three-bladed, constant-speed Hartzell propeller remained securely attached to the engine. The propeller blades exhibited no damage with no bending or chordwise scratching noted.

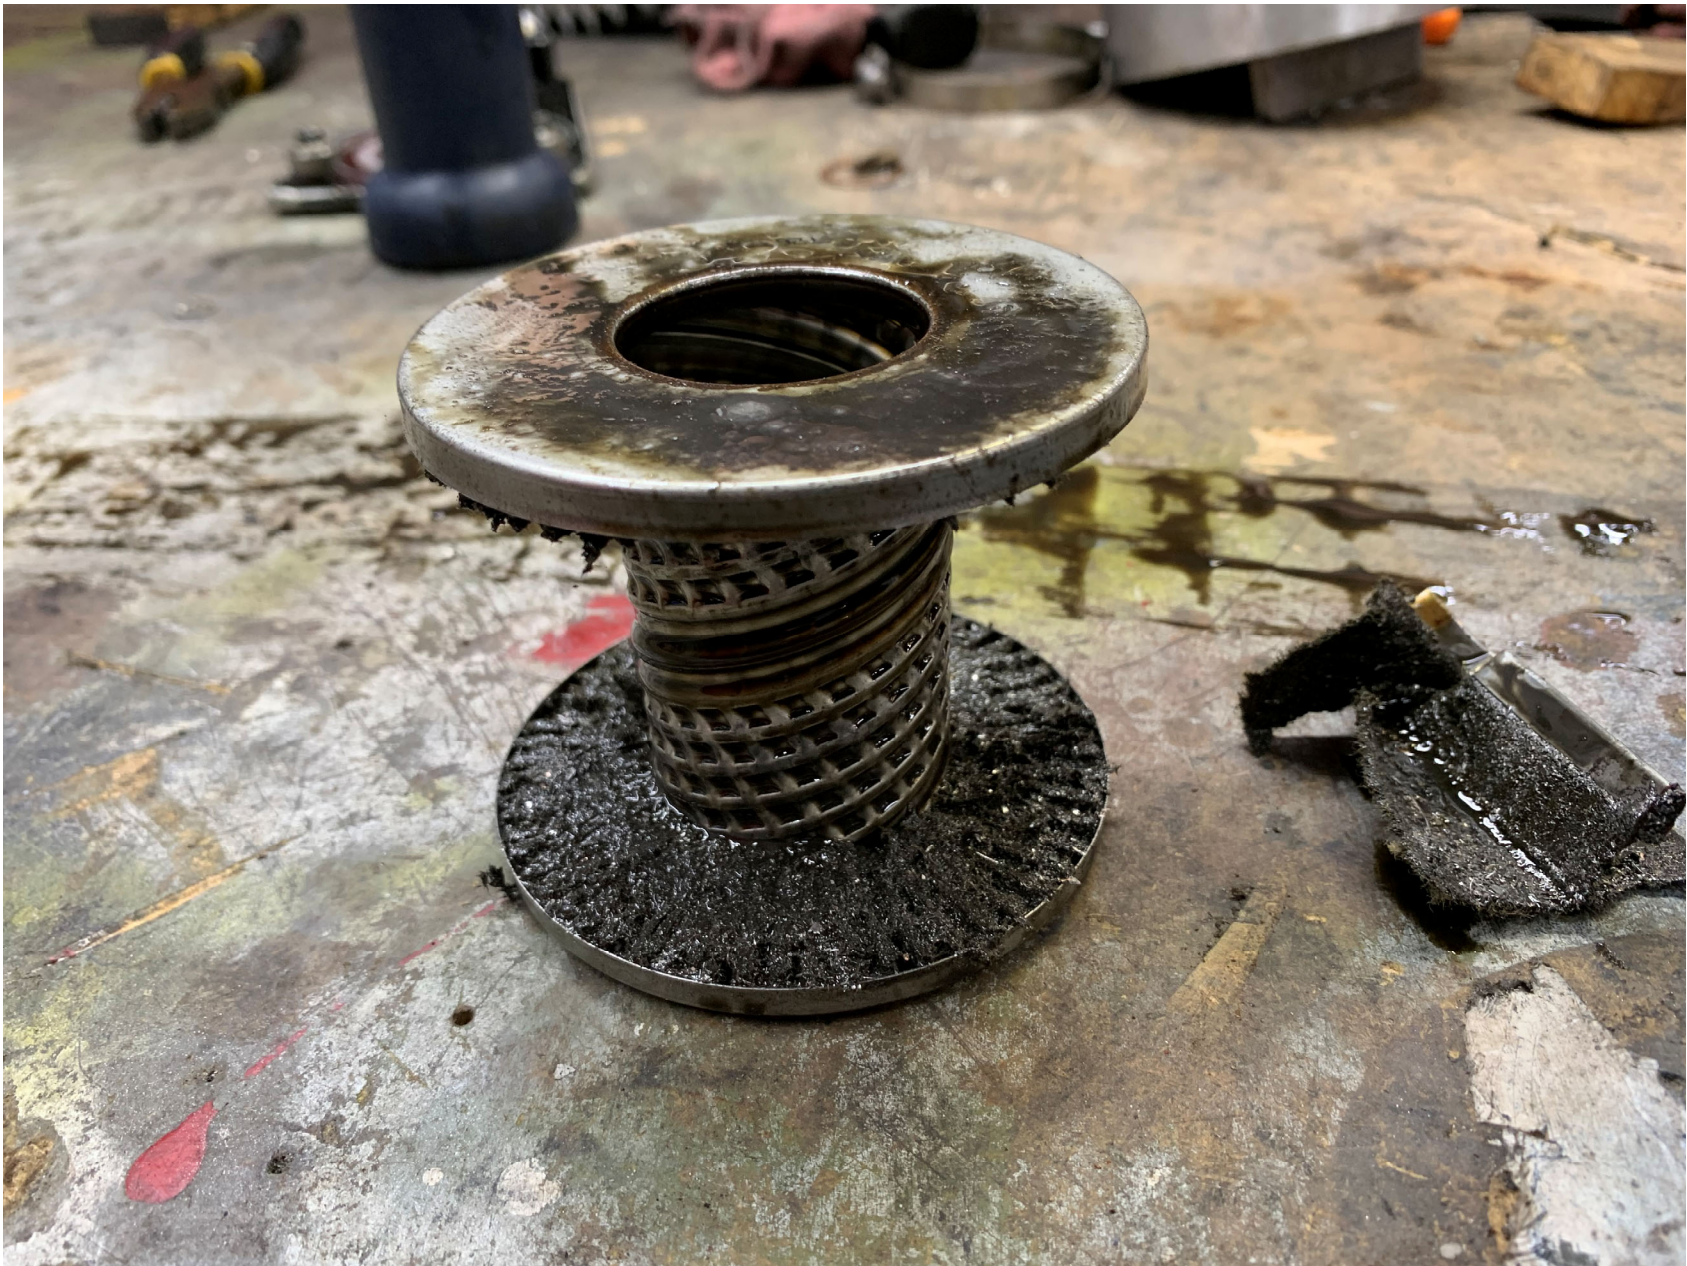
**Photo 4 – Engine Oil Filter, Opened for Examination**

The oil filter was cut open for examination. Silver-colored metallic particulates, consistent with bearing material, were found throughout the filter's paper element.

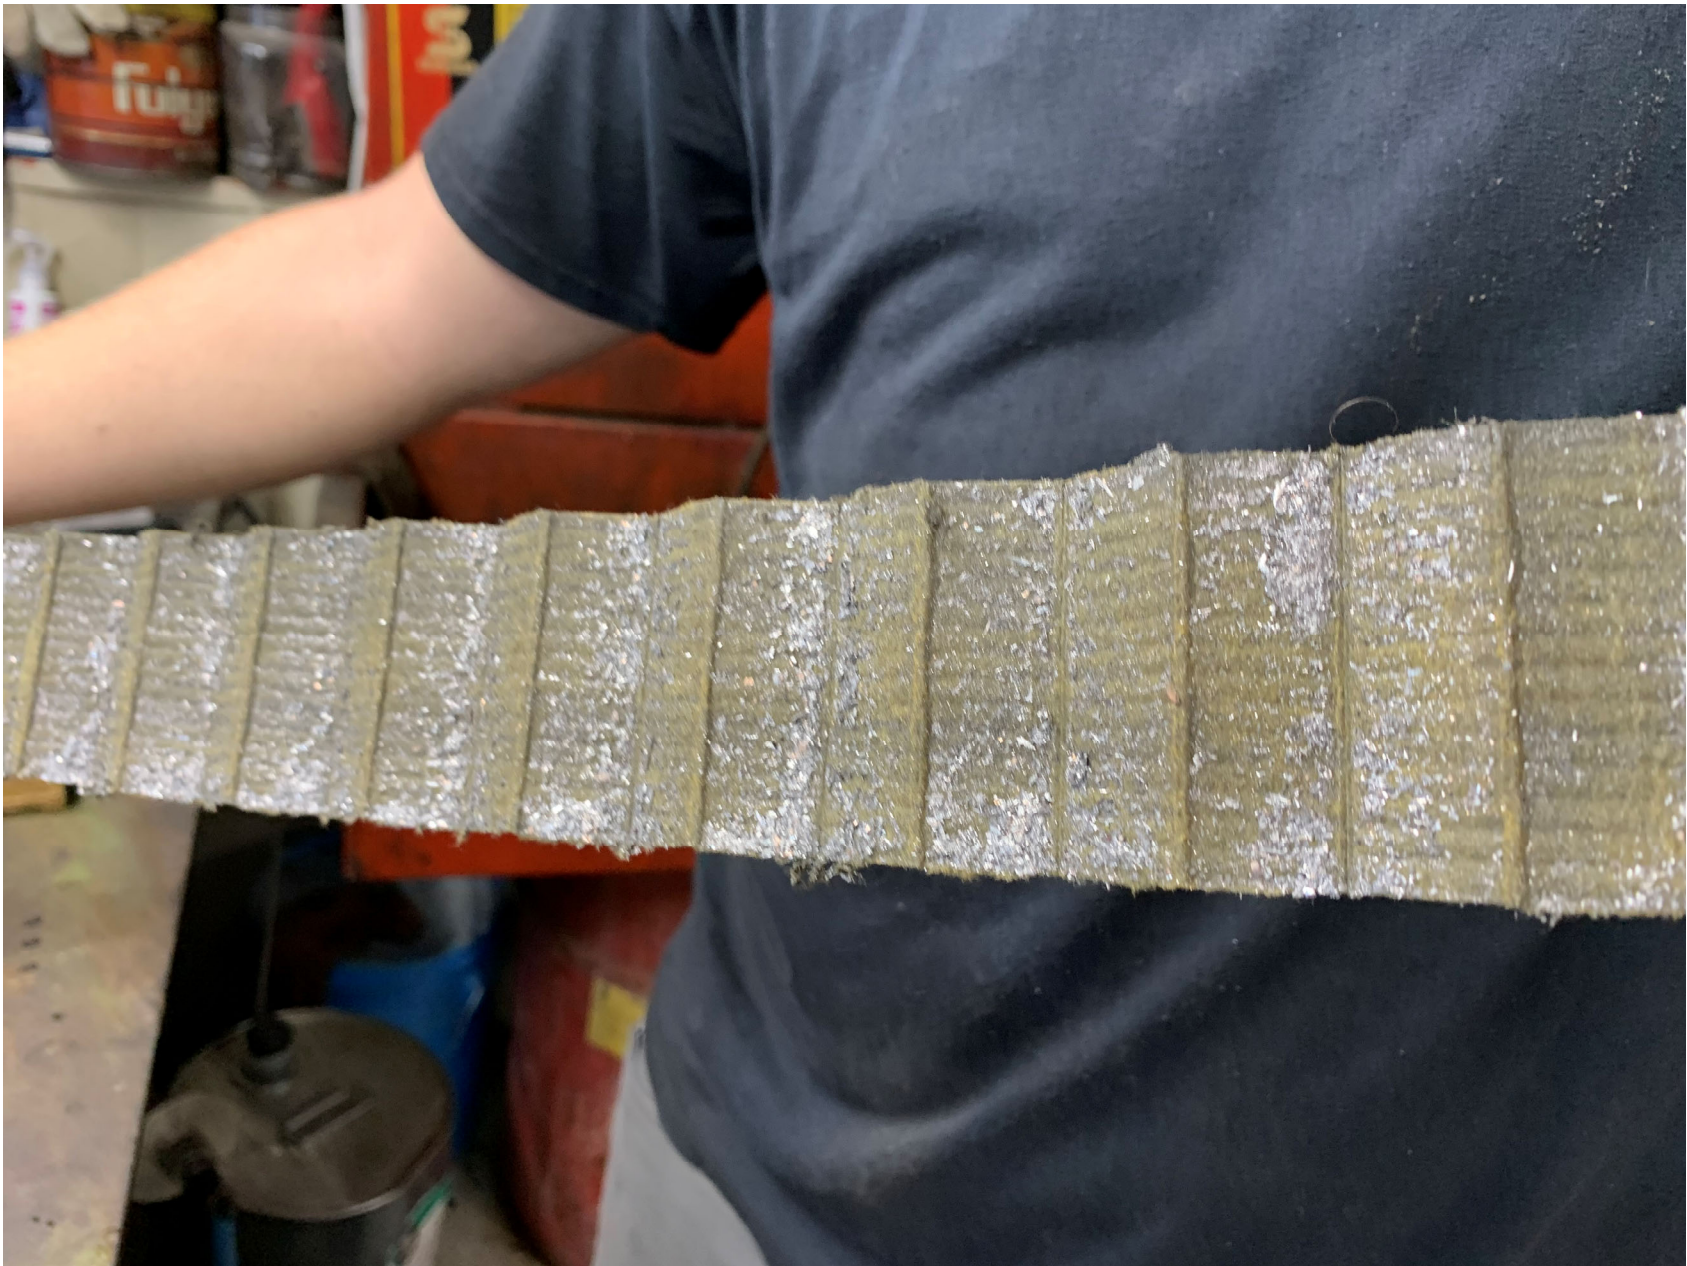
**Photo 5 – Silver-colored Metallic Particulates in Oil Filter Element**

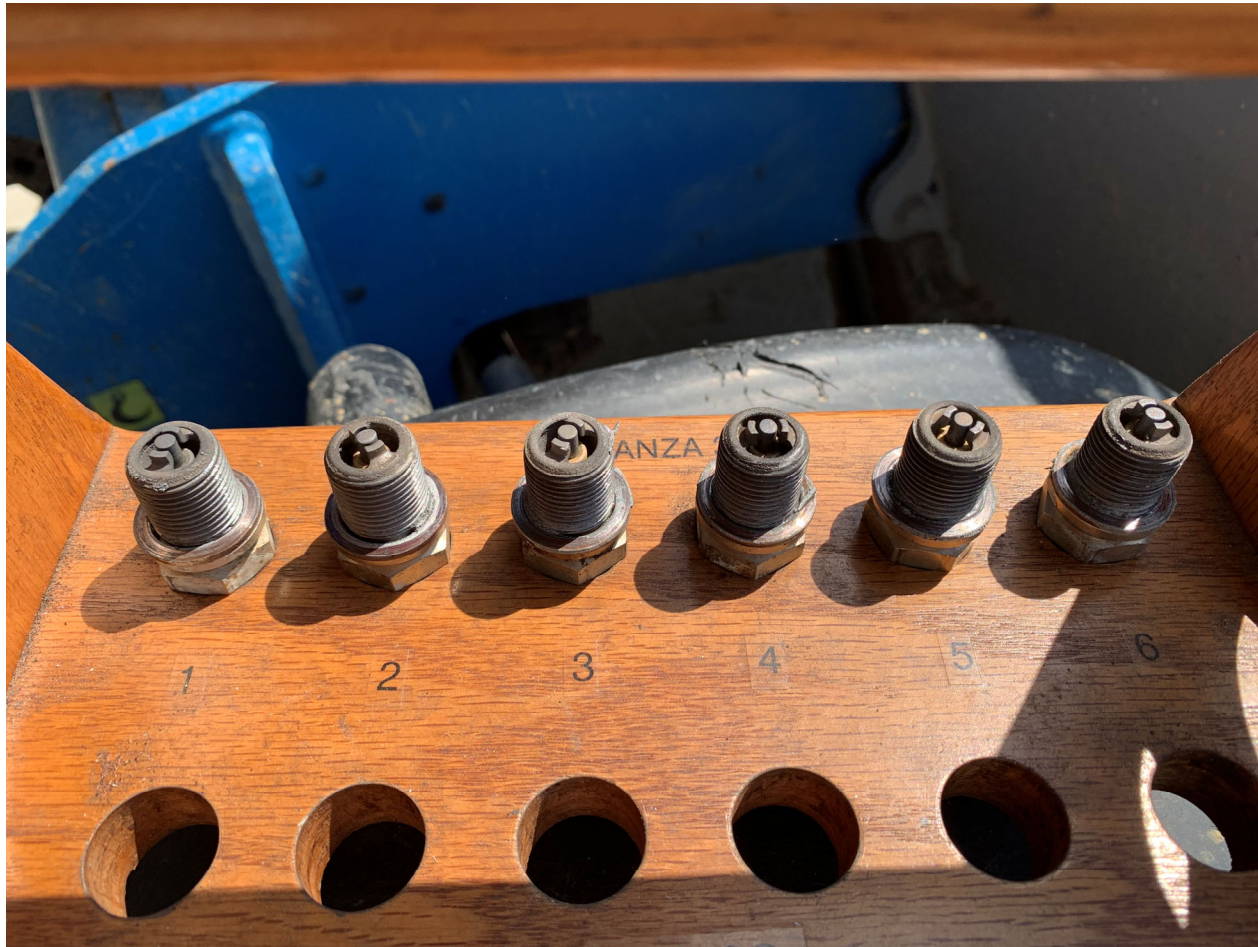
**Photo 8 – Top Spark Plugs, Removed for Examination**

The top spark plugs were removed for examination. The electrodes were normal in color and exhibited light wear when compared to a Champion Check-A-Plug chart.

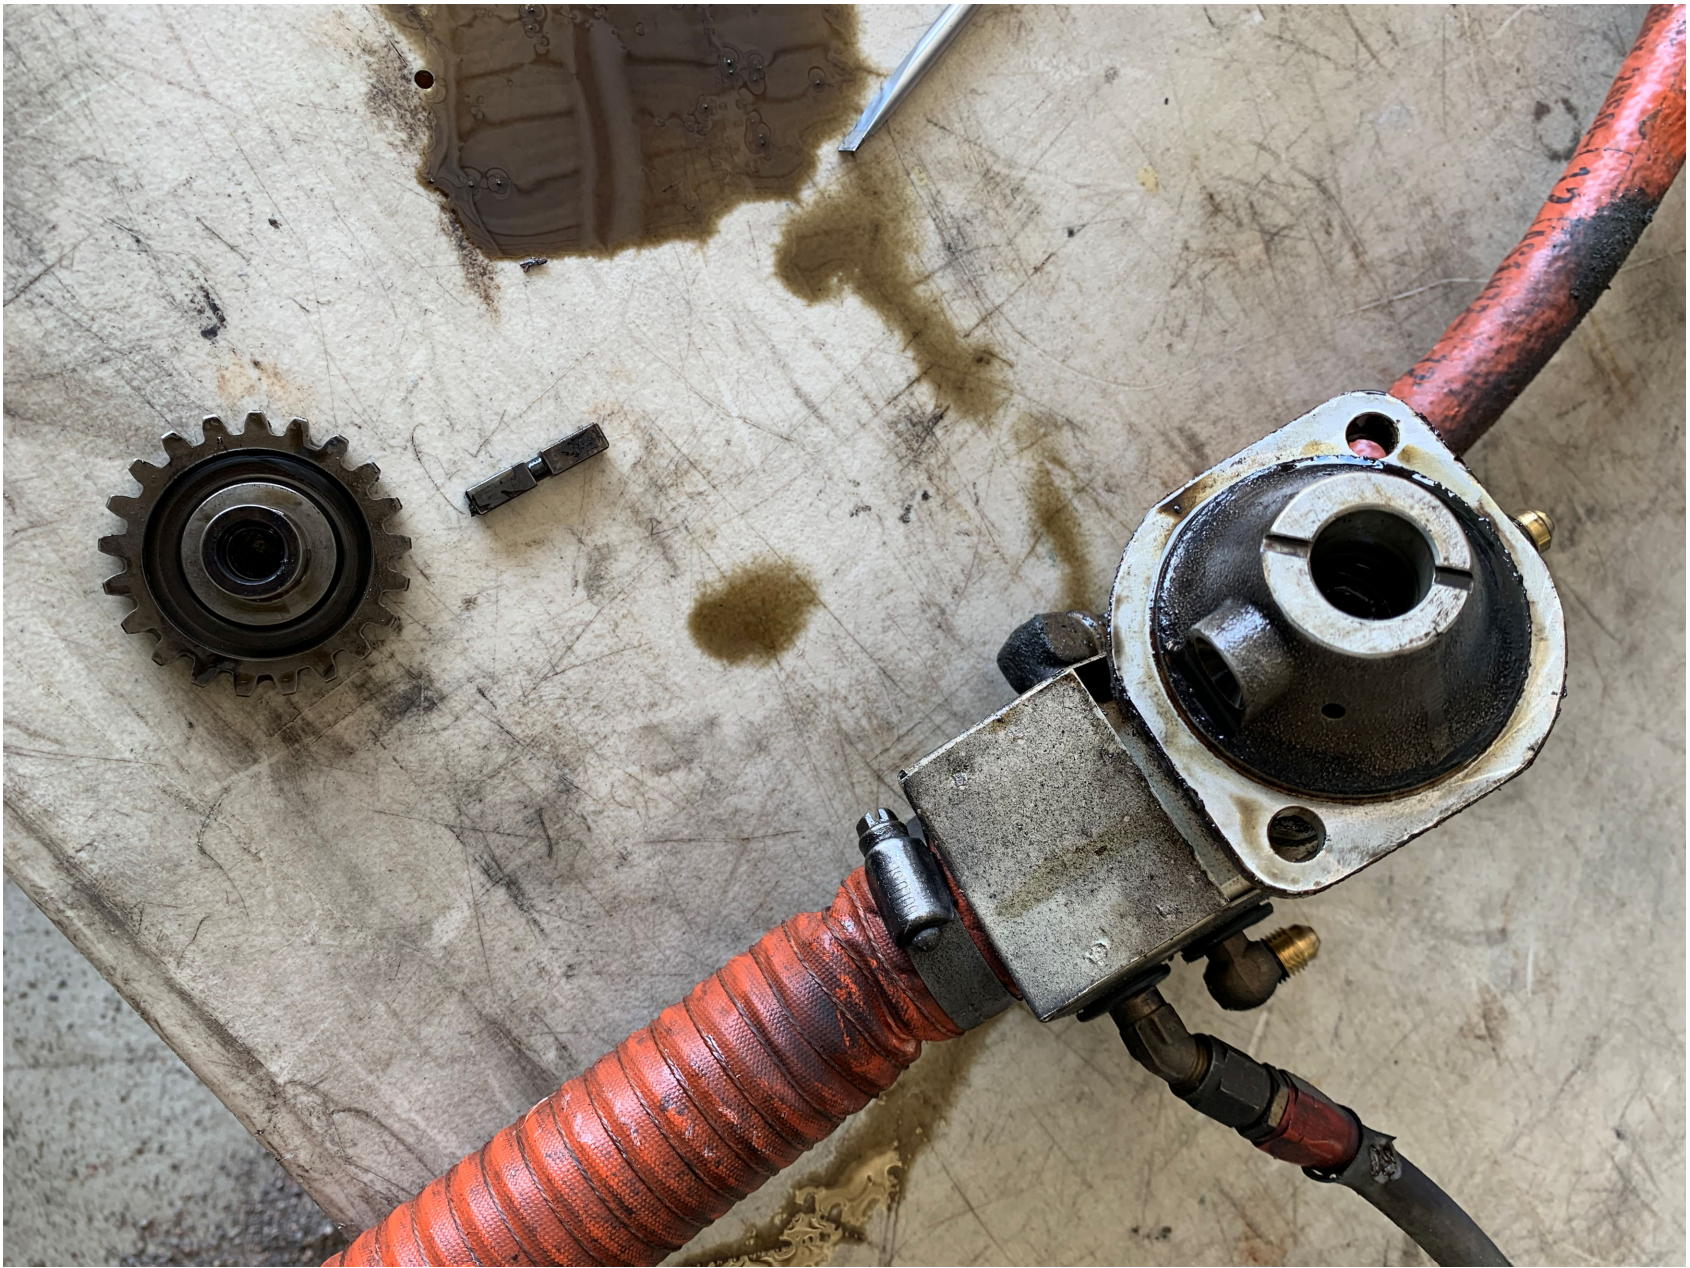
**Photo 9 – Engine-driven Fuel Pump**

The engine-driven fuel pump was removed for examination. The drive gear and coupling were undamaged. The pump internal components moved freely when rotated by hand.

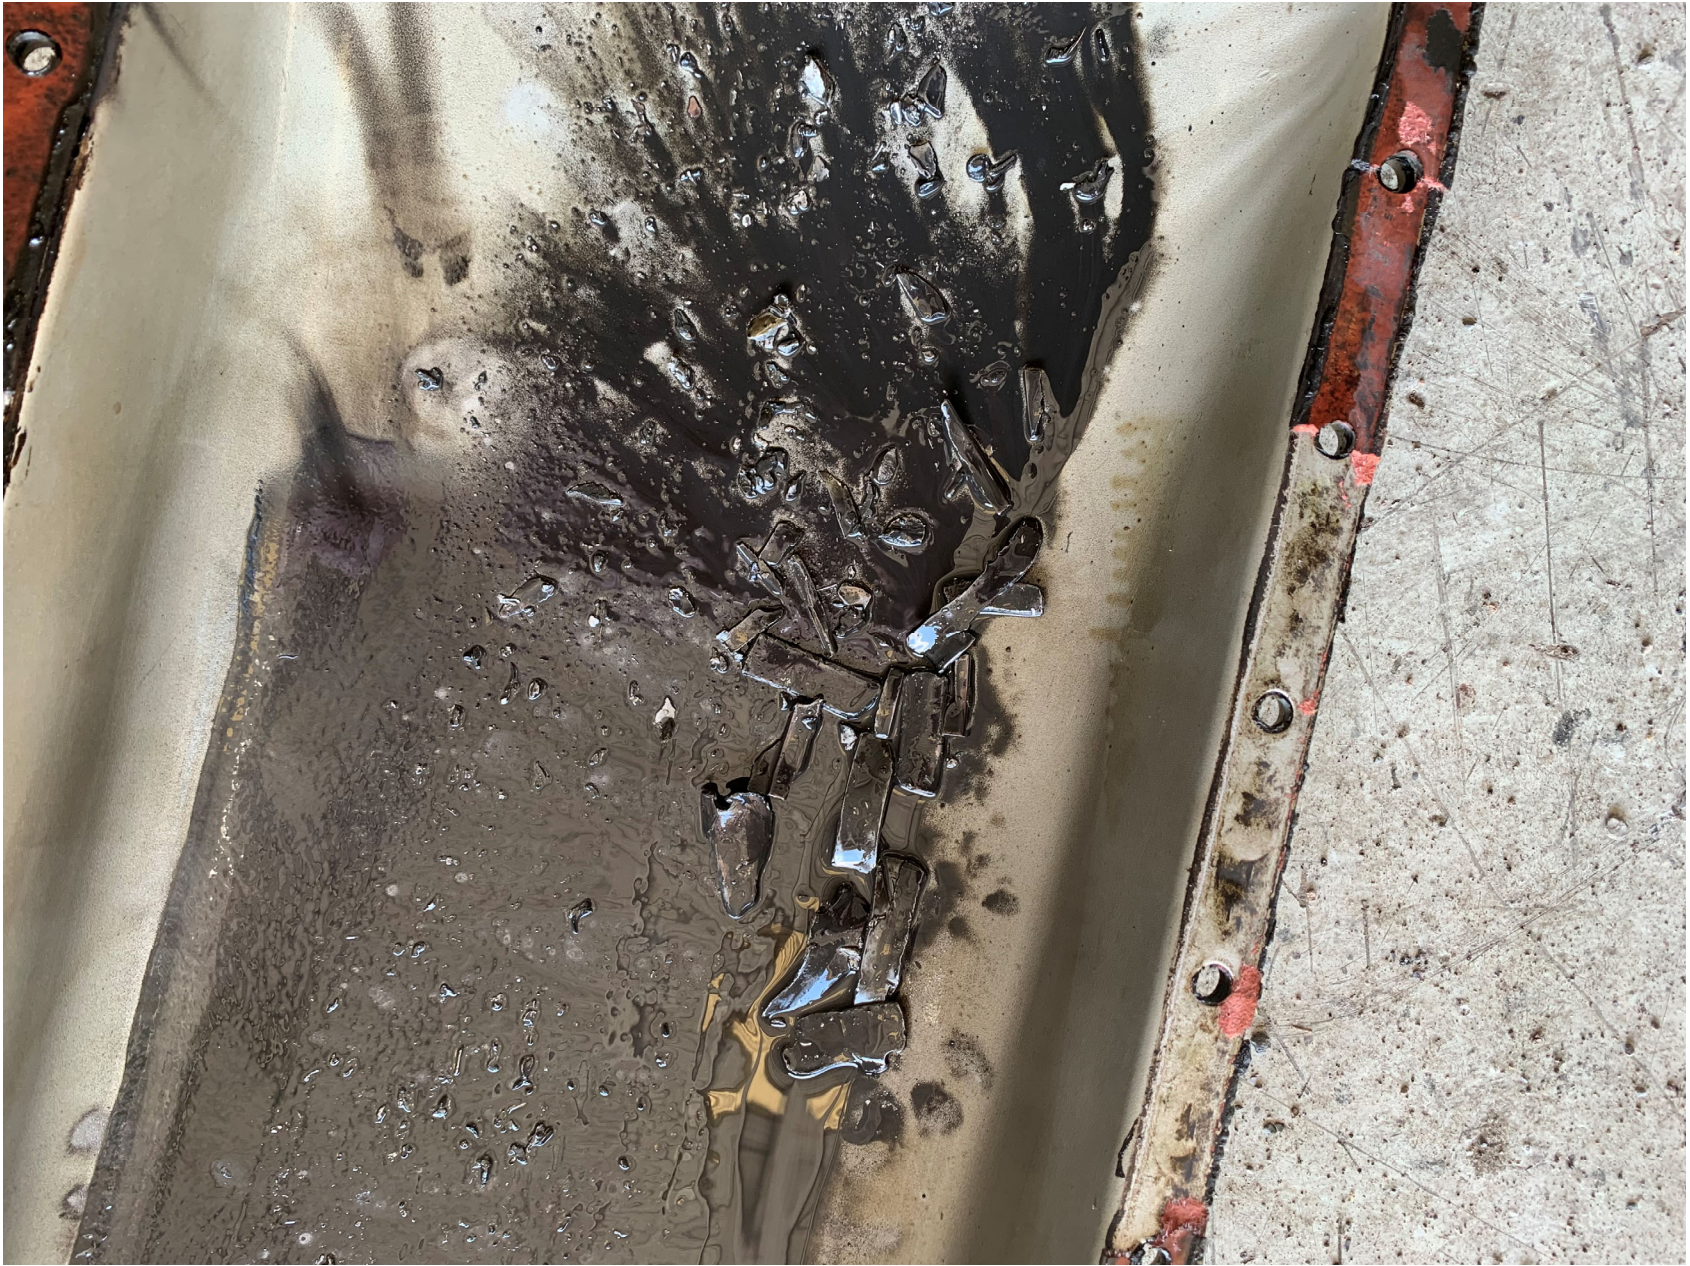
Disassembly of the case revealed that the no. 2 main bearing had spun, smearing metal into the oil ports on the bearing bore and deforming the bore. Numerous fragments of bearing material were found in the oil sump and inside the case, adjacent to the nos. 1 and 2 cylinders. The remaining main bearings were well lubricated and were normal in appearance.

**Photo 16 – Bearing Material Found in Oil Sump**

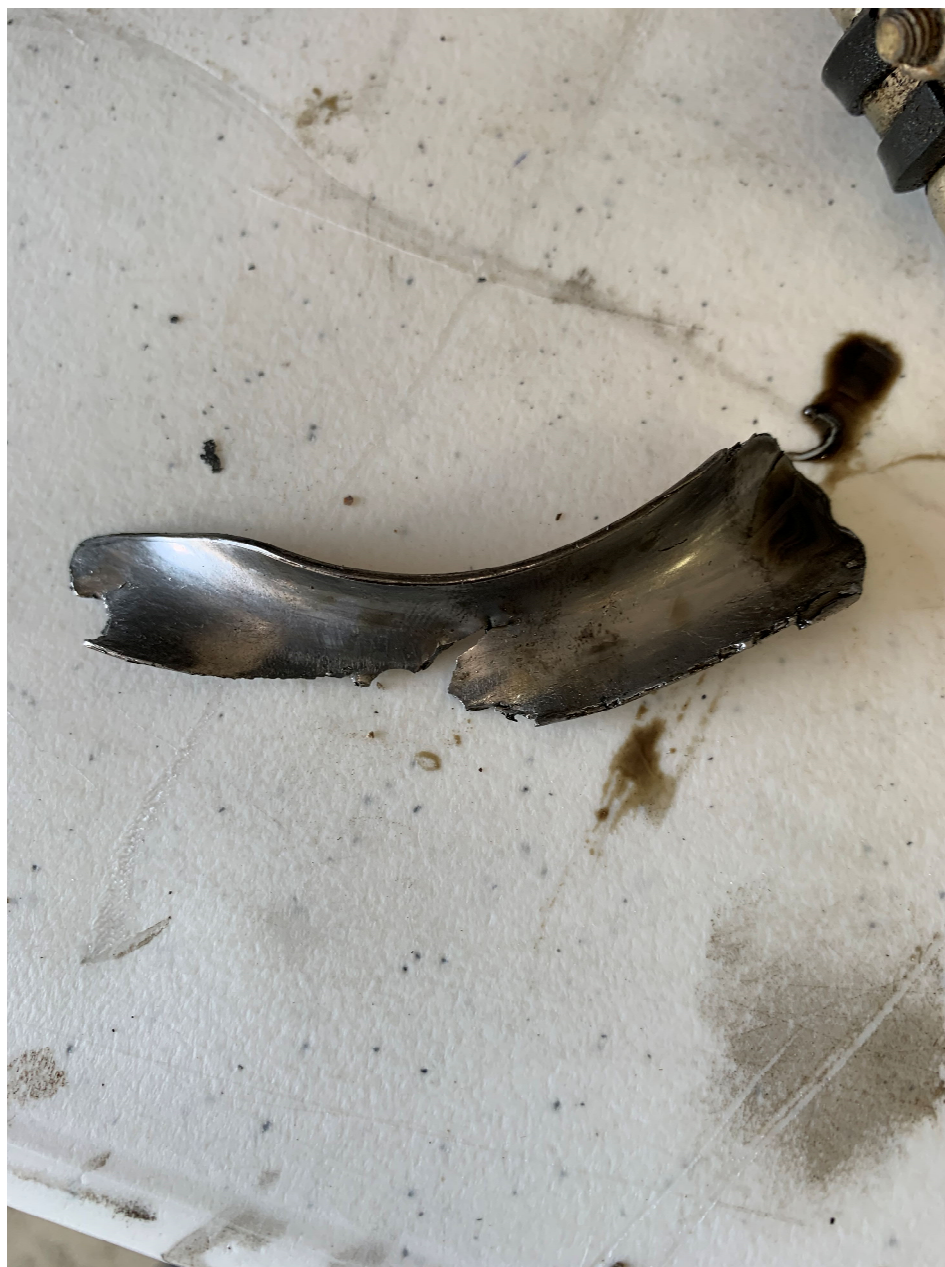
**Photo 17 – Bearing Material Found Inside Engine Case**

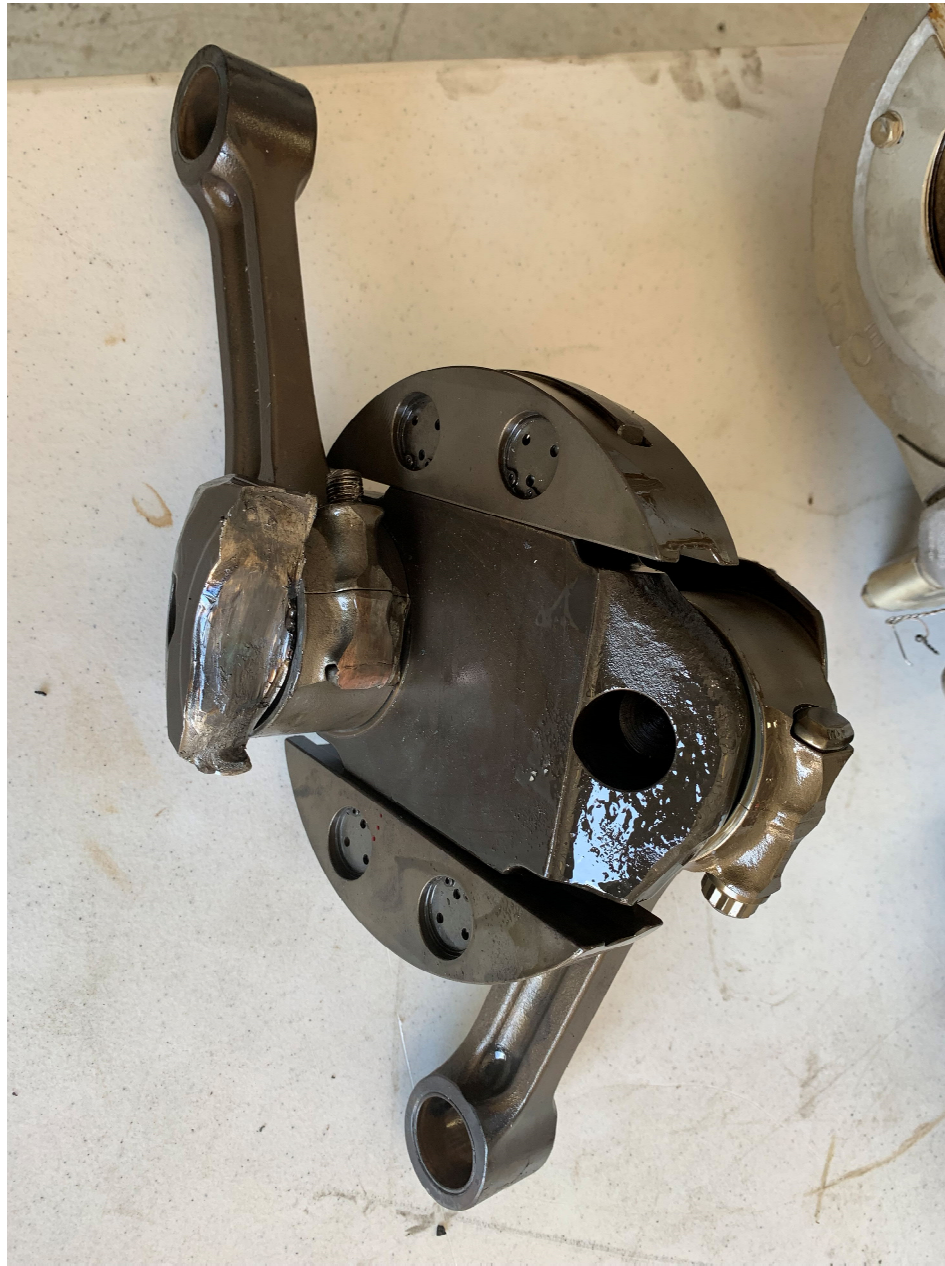
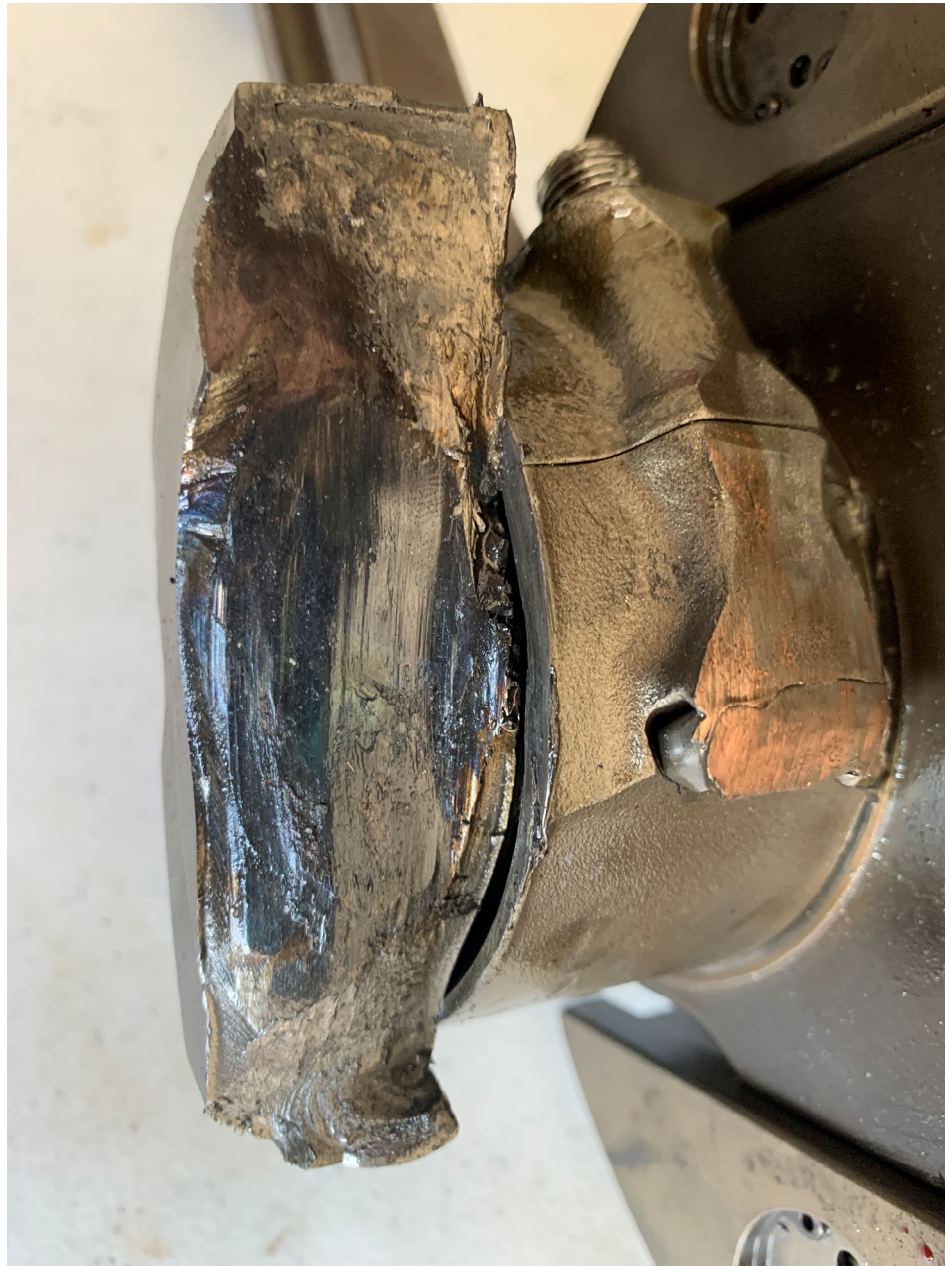
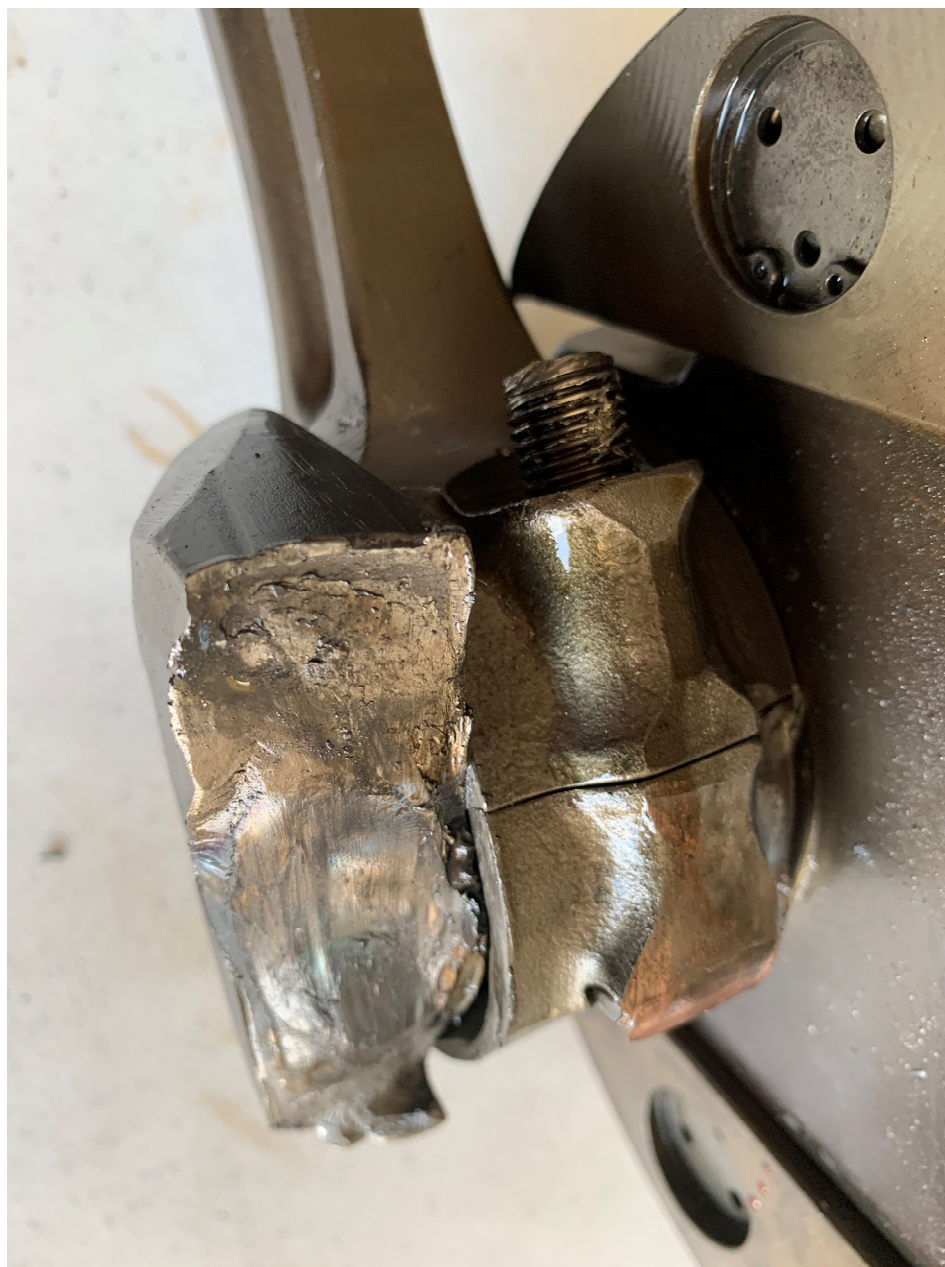
**Photo 21 – #2 Connecting Rod (Foreground) with Fractured Crankshaft**

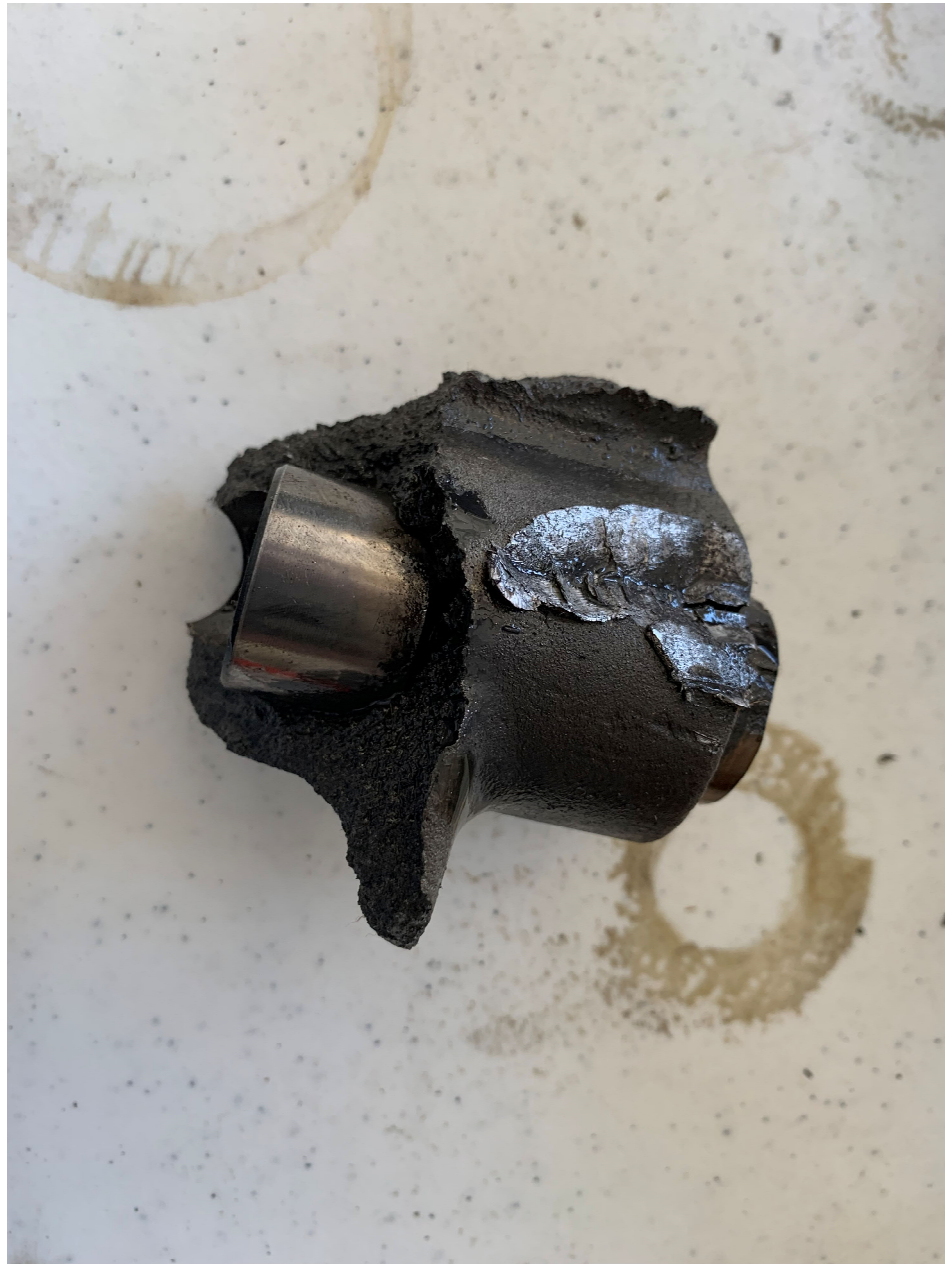
The engine case was disassembled to provide access to the crankshaft and camshaft. It was noted that the casting around the no. 2 cylinder intake valve hydraulic tappet and tappet guide was broken away and found in the oil sump. There was impact damage inside the case at this location.

**Photo 24- Separated Casting with #2 Cyl Intake Valve Tappet**

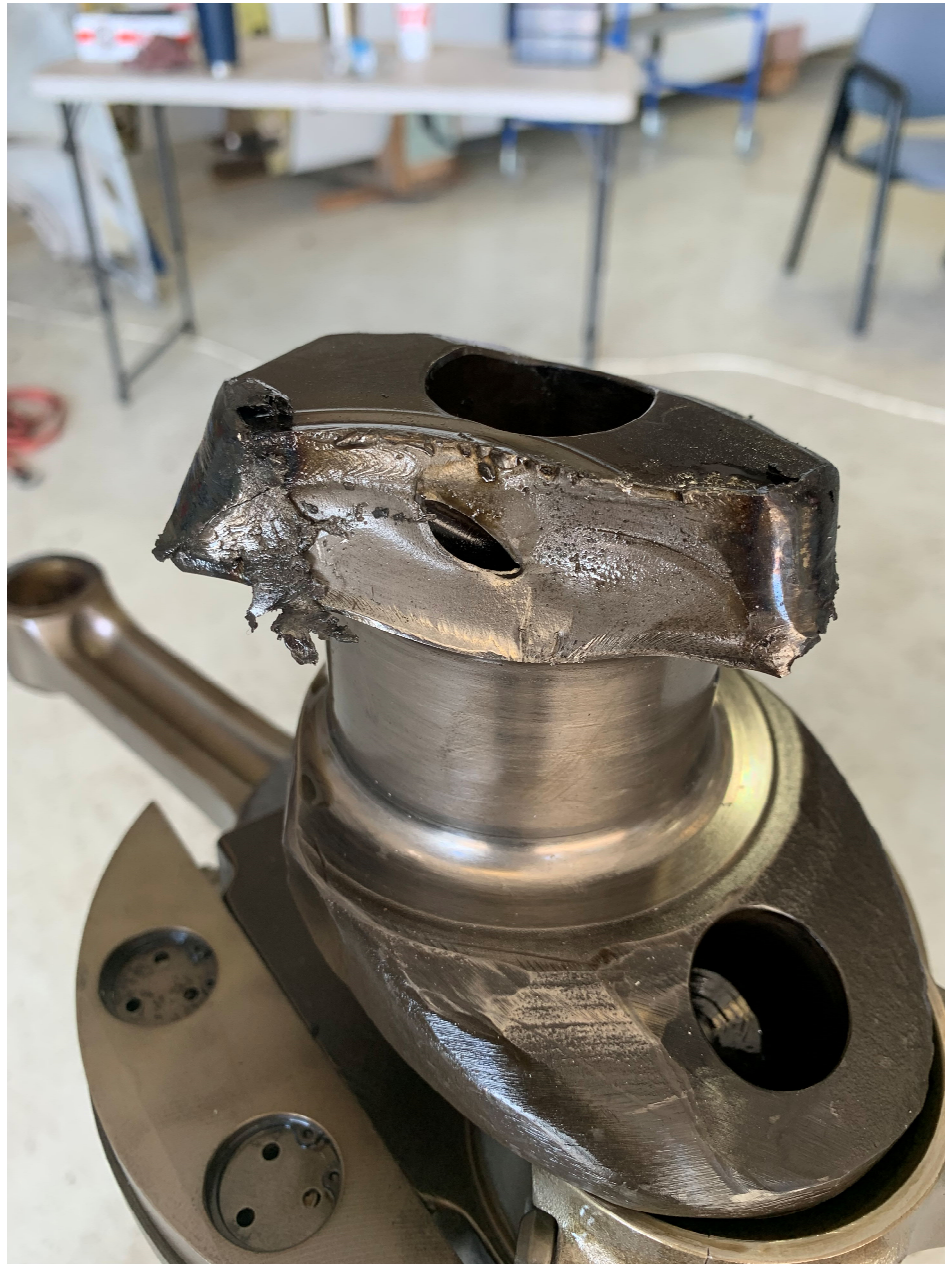
**Photo 27 – Crankshaft with Fracture Surface**
