# NATIONAL TRANSPORTATION SAFETY BOARD

MATERIALS LABORATORY FACTUAL REPORT

Report No. 22-023

Place : Forkston, Pennsylvania  
Date : April 22, 2021  
Vehicle : Robinson Helicopter R44, N4055N  
NTSB No. : ERA21LA191  
Investigator : Ralph Hicks, ASI – ERA

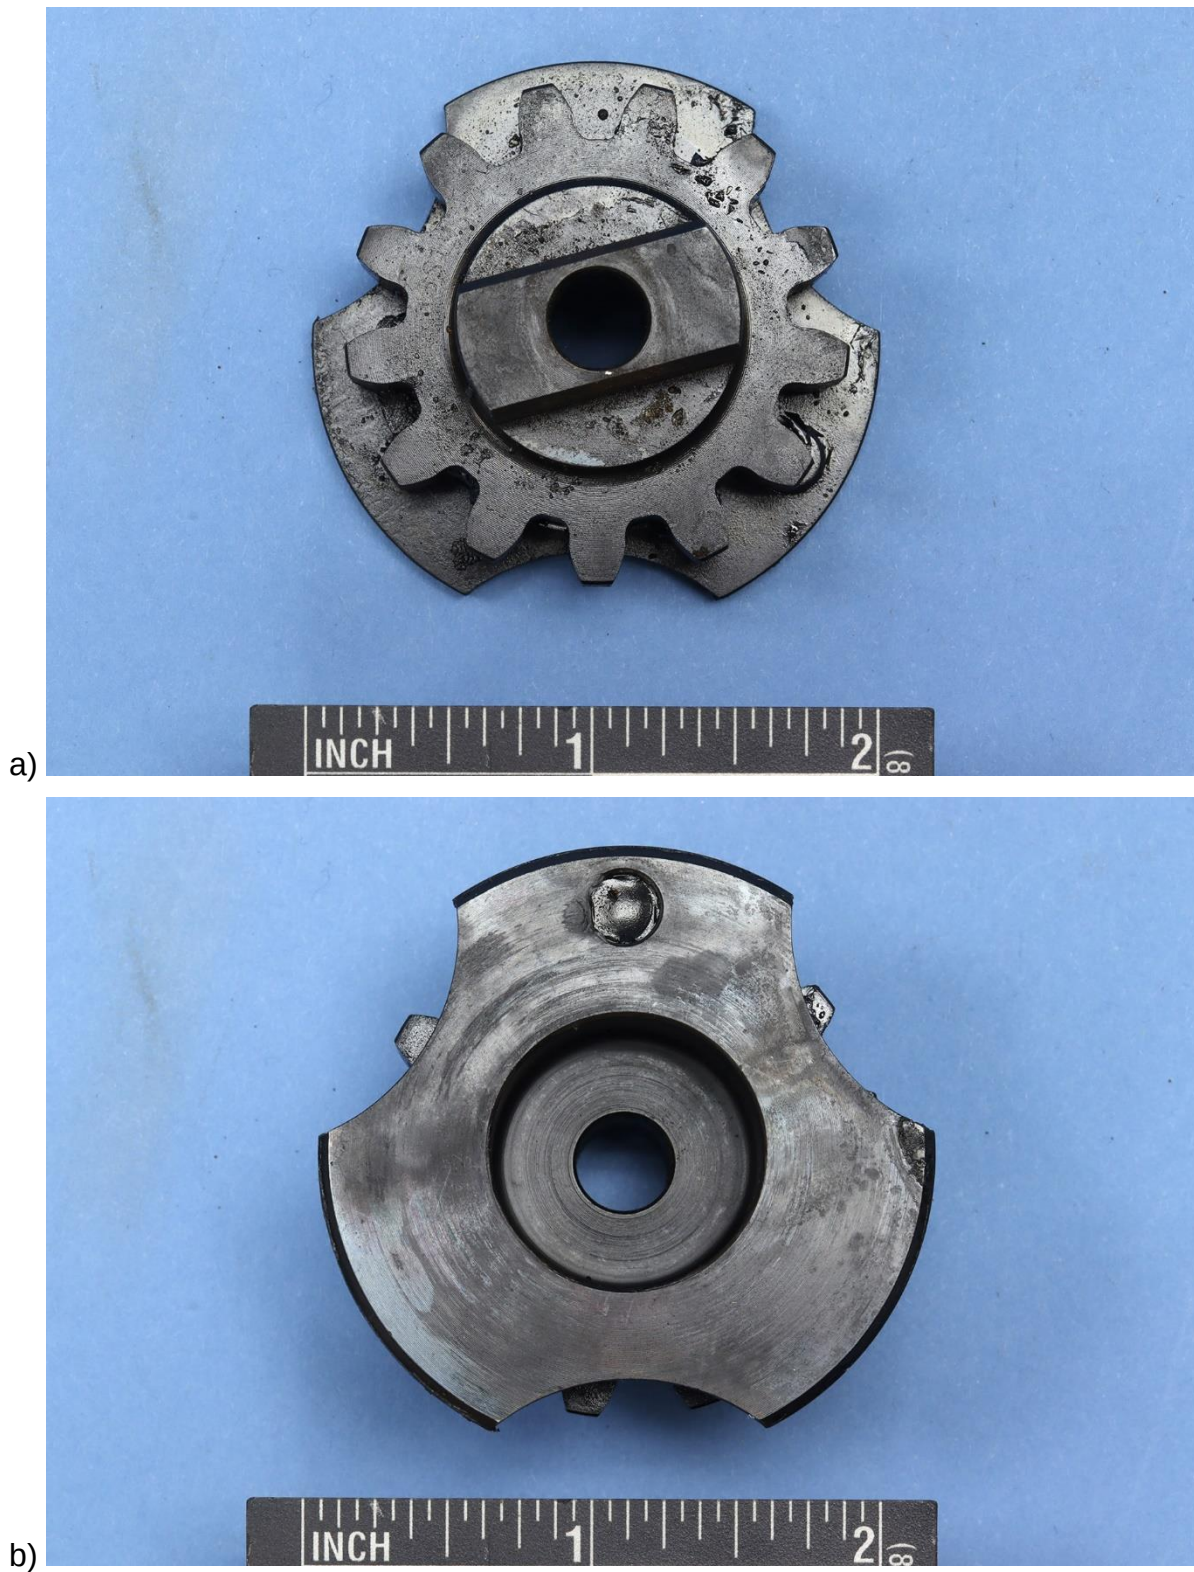
All components (except the tip of the bolt) had dark tinted surfaces, including the dowel fragment's fracture surface, consistent with exposure to elevated temperatures. The tip of the bolt had a shiny appearance and stripped threads, consistent with damage during extraction of the bolt. All surfaces were examined for indications of burnishing, rubbing, or wear, but none were found. The dowel's fracture surface, shown in figure 4, had a flat featureless appearance, with no apparent crack arrest marks. Shear lips were observed along the radially inward and outward edges of the fracture surface. The chamfer around the pilot flange hole exhibited deformation and metal transfer at the leading edge (the edge that leads during rotating of the crankshaft/gear assembly) as indicated in figure 4. The features were consistent with an overstress fracture of the dowel in shear and bending.

**Figure 1:** Images of the crankshaft gear as received. a) aft-facing side and b) forward-facing (crankshaft-facing) side.

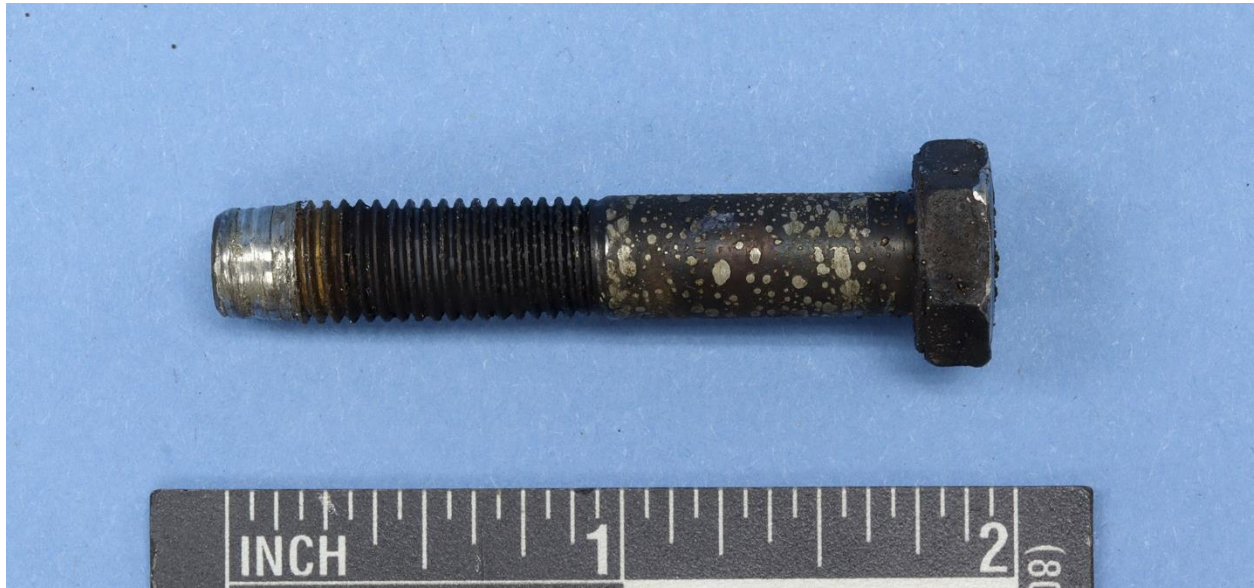
**Figure 2:** Image of the crankshaft bolt as received.

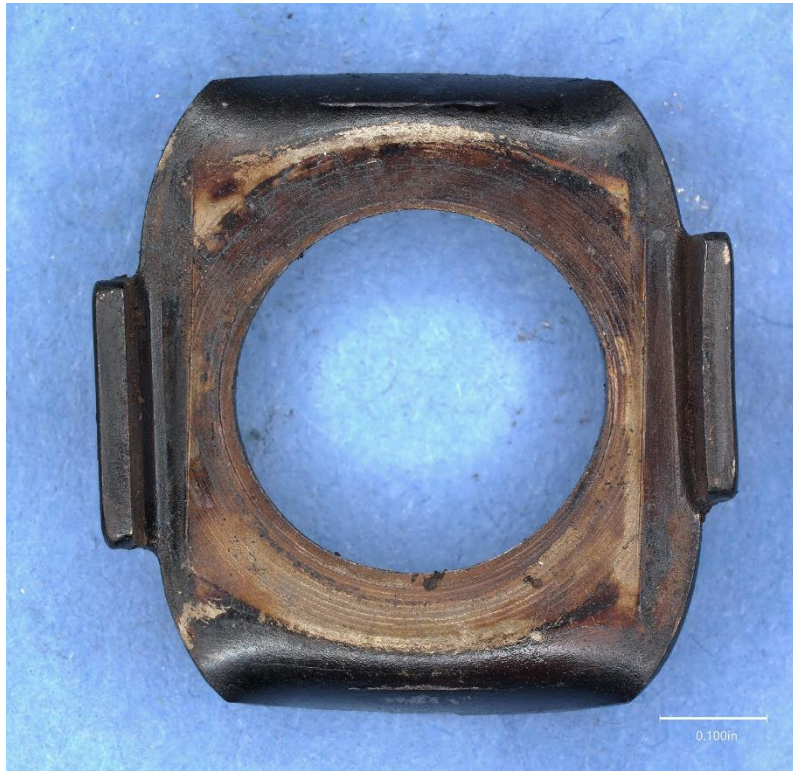
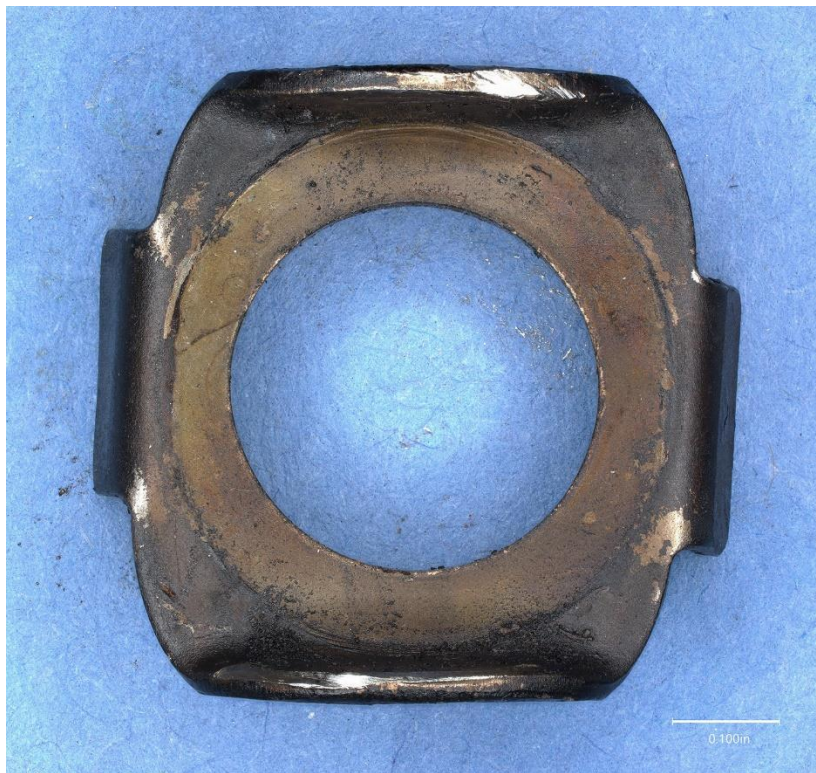
**Figure 3:** Images of the lockplate; a) gear-facing side and b) bolthead-facing side.

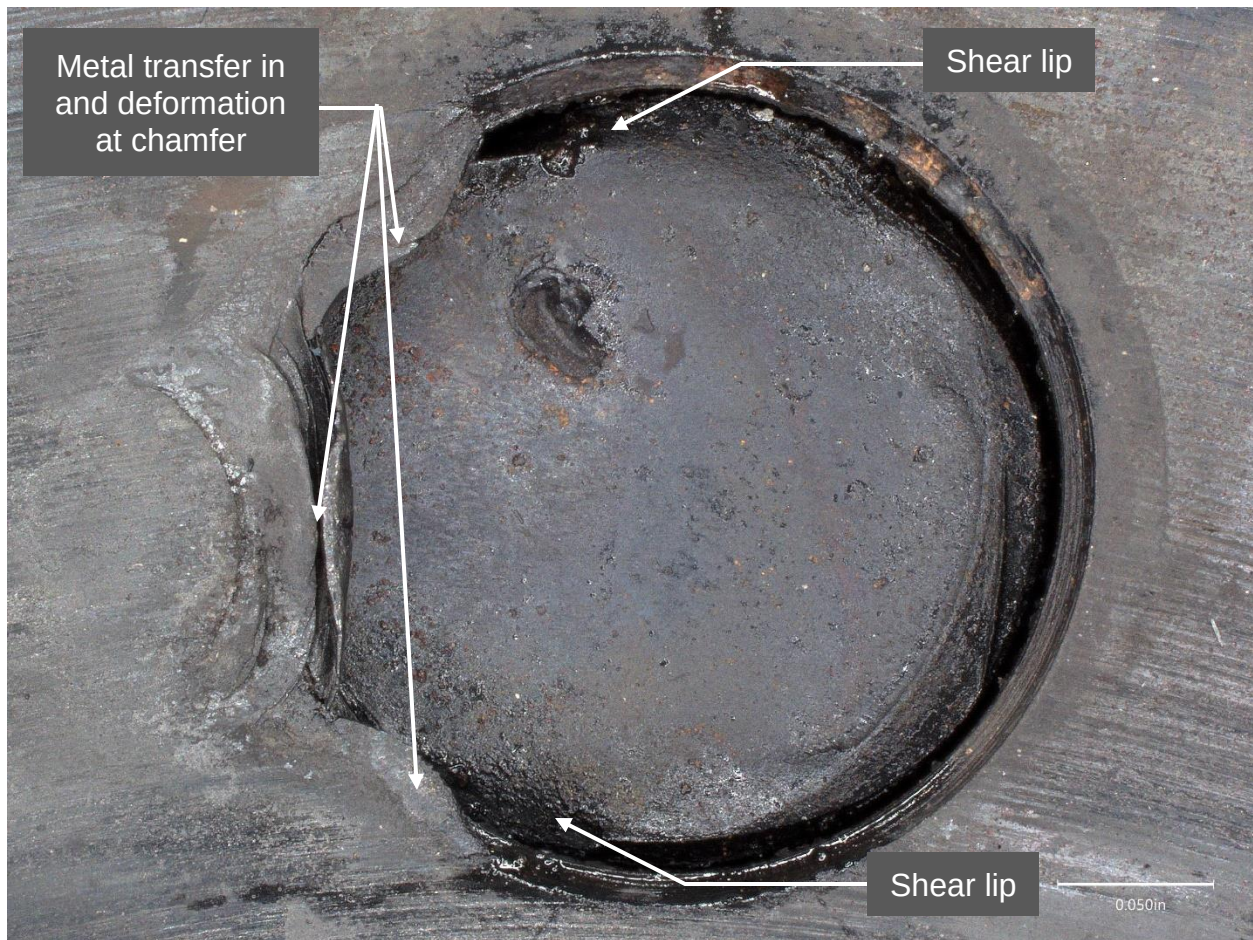
**Figure 4:** Image of the alignment dowel's fracture surface.
