## Inspectors Statement

My Name is Cornelius J. Baker, I am an Aviation Safety Inspector assigned to the West Columbia Flight Standards District Office and I am writing this from notes taken during the witnessing of the inspection of N90KF engine

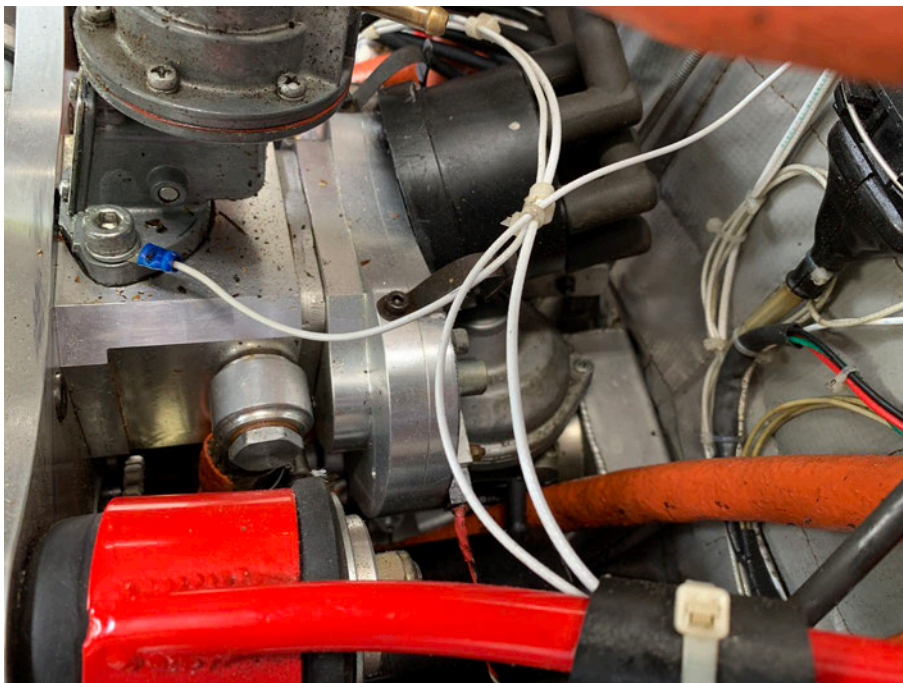
Figure 10: IMG-0184 Ignition System

found dislodged from their retaining clips and the rotor buttons were missing (see IMG-0184 and IMG\_0199). The ignition system could not be tested. After returning to the office, contact was made with the aircraft builder. He was asked if a carburetor heat source was ever installed on the aircraft. He stated that it didn't need it because it wasn't supplied.
