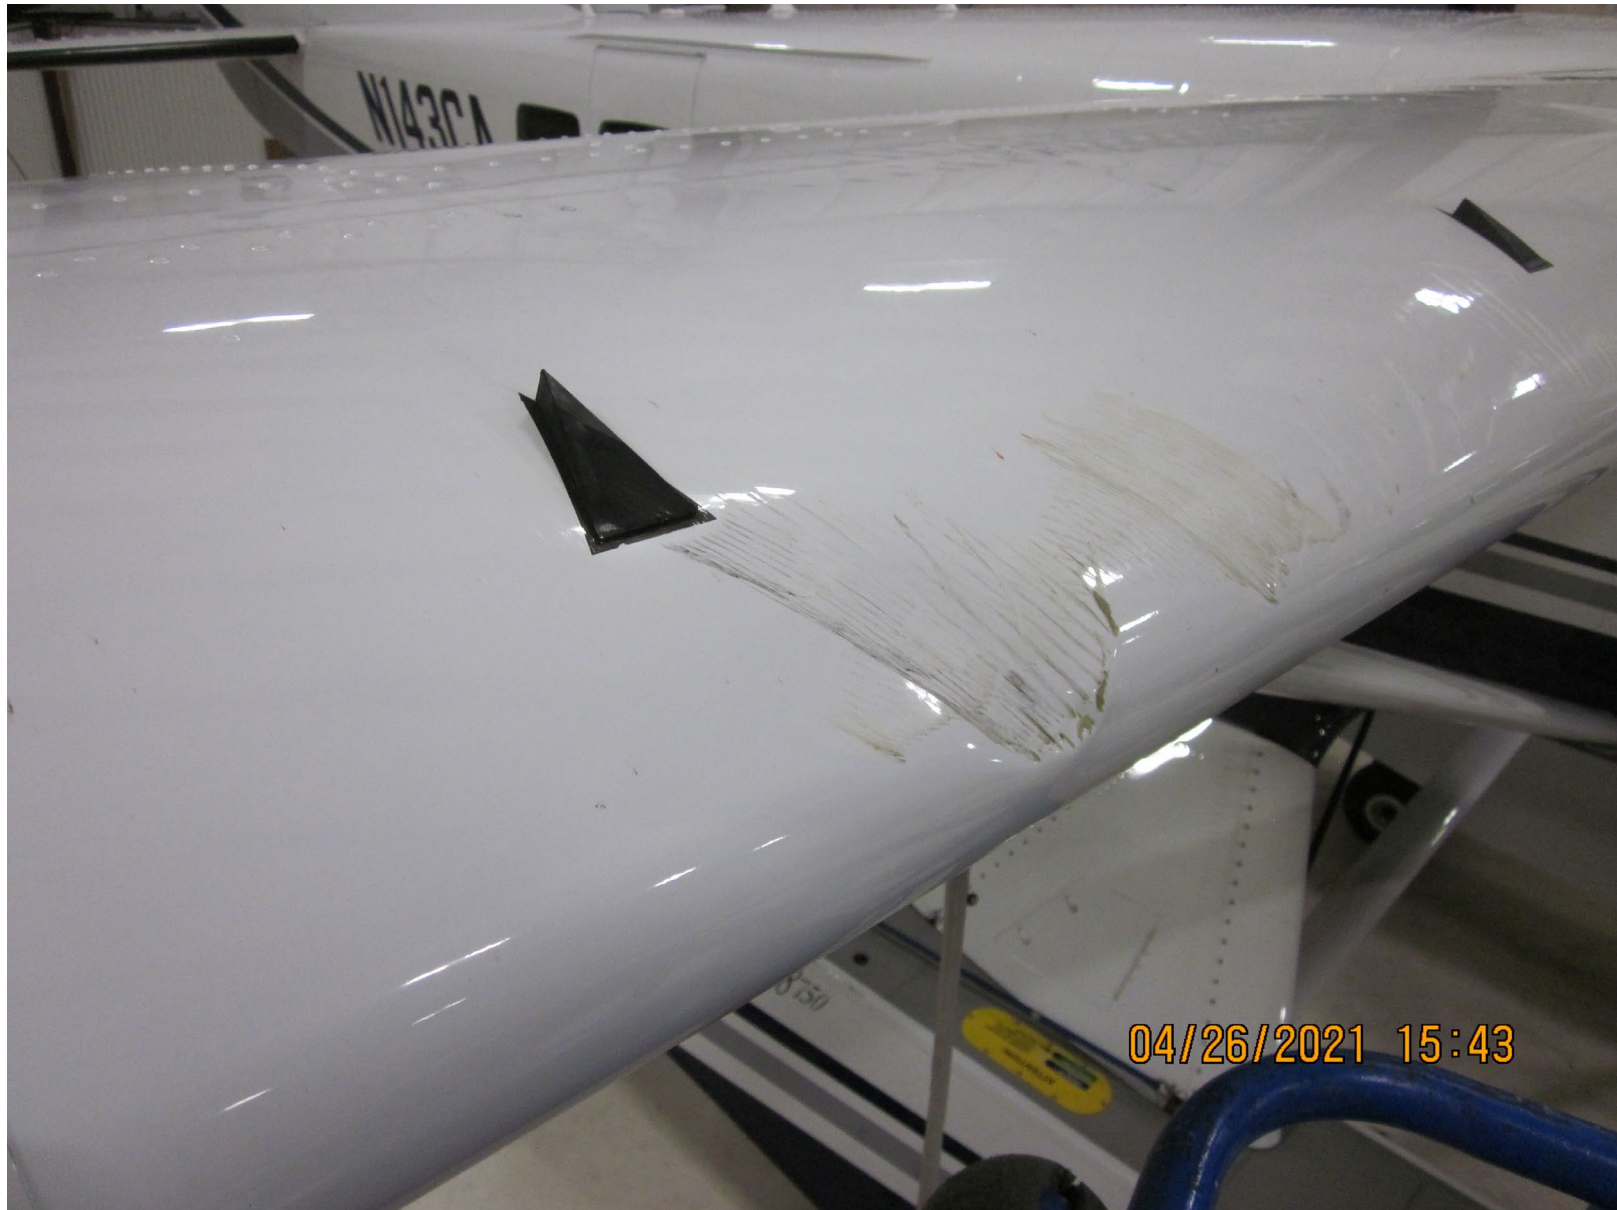
**Photo 1 – View of leading edge of right wing damage. Note dent and wire strike impression marks. (Courtesy of FAA)**

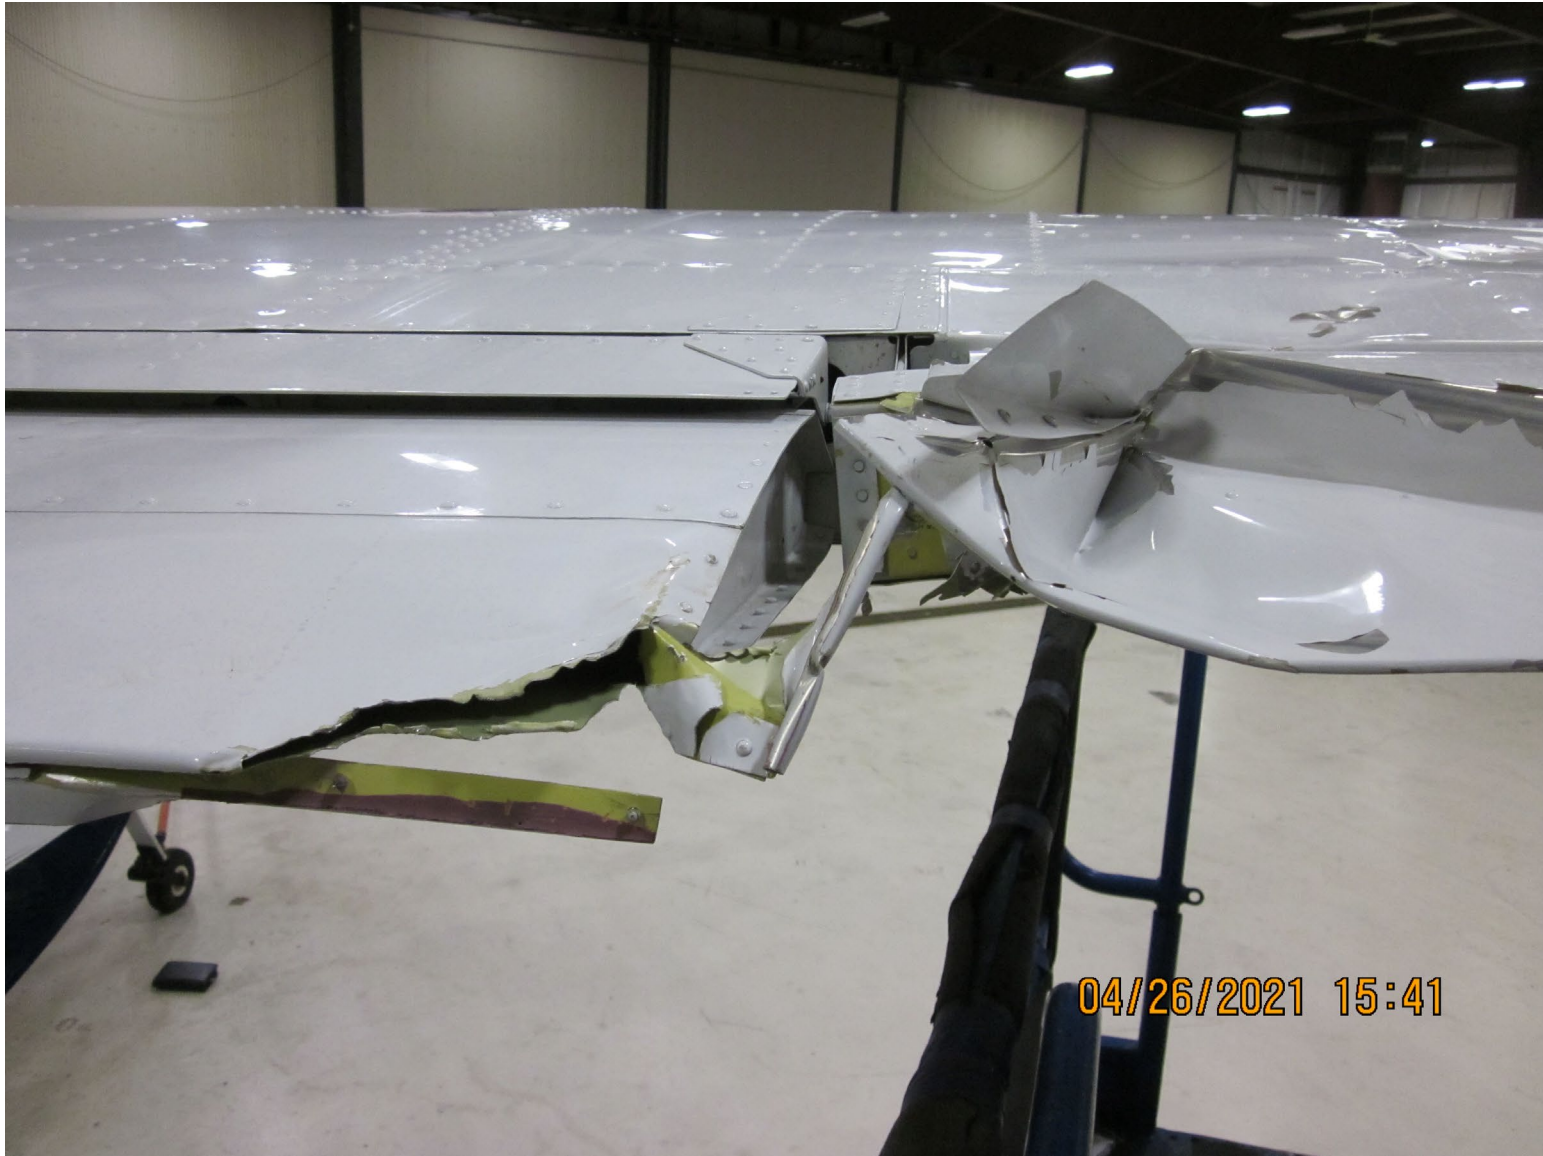
**Photo 2 – Aft view of right wing outboard flap and inboard aileron damage. (Courtesy of FAA)**

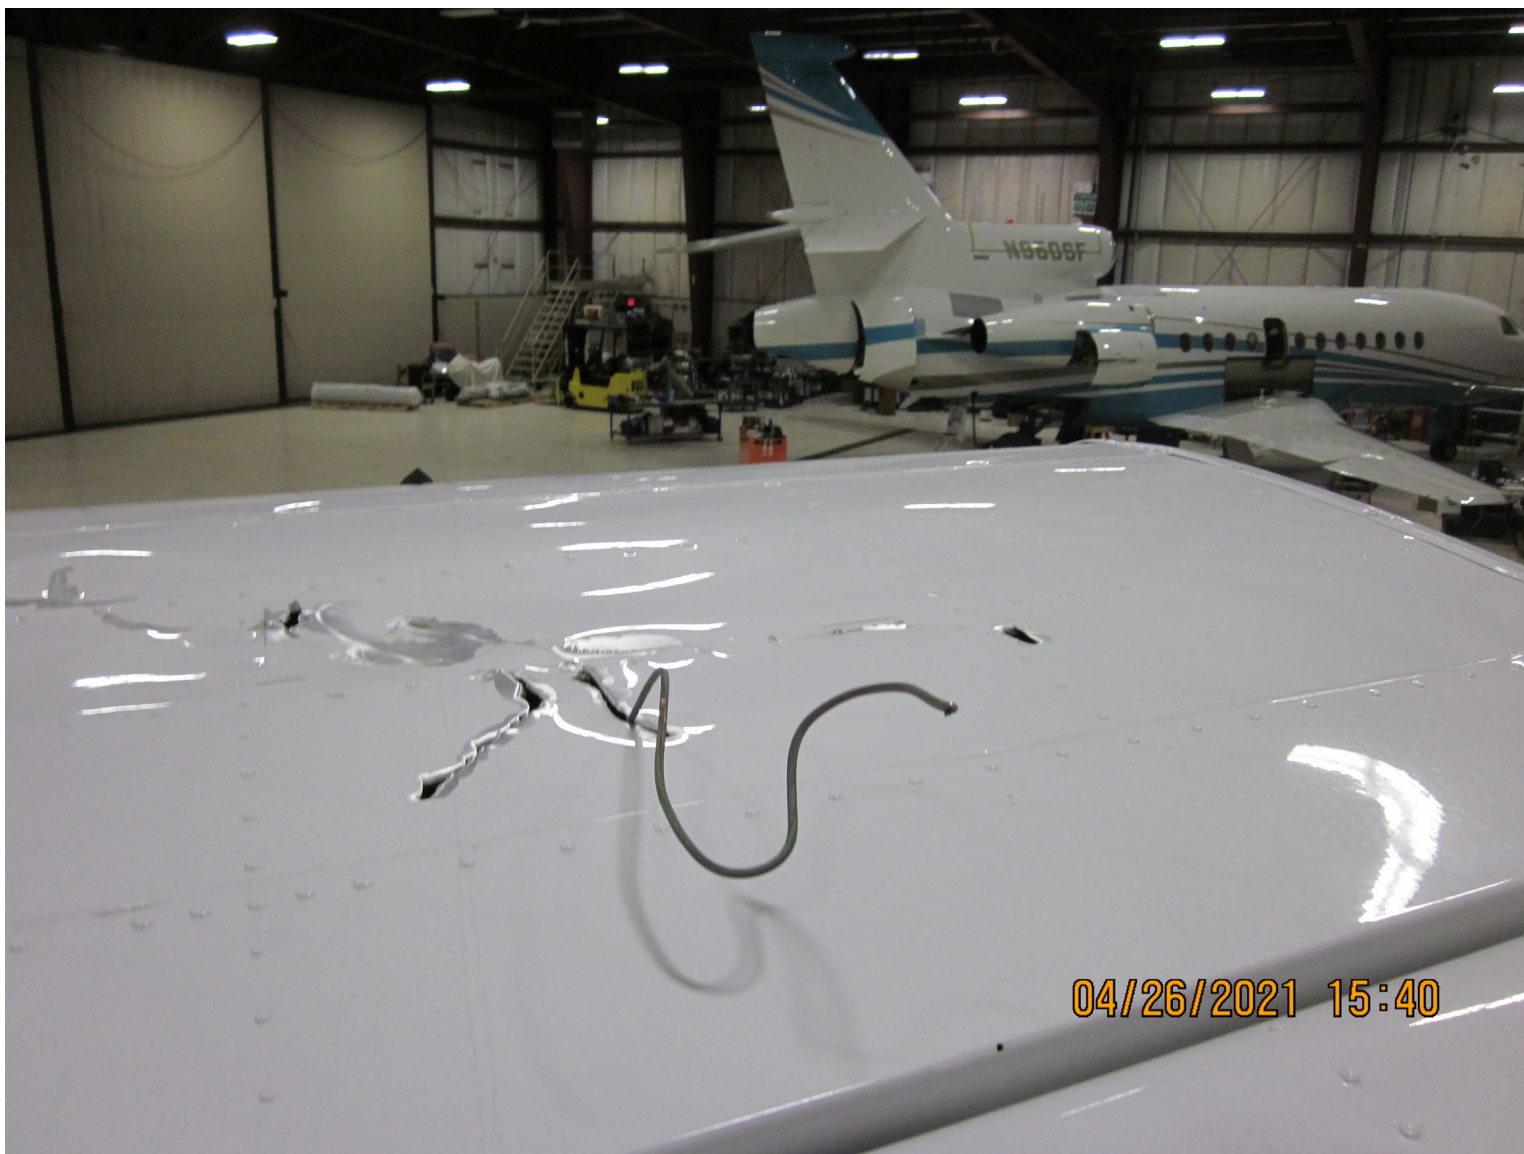
**Photo 3 – View of top surface damage to right wing. Note multiple dents and tears in the skin and foreign object/wire protruding from surface. (Courtesy of FAA)**

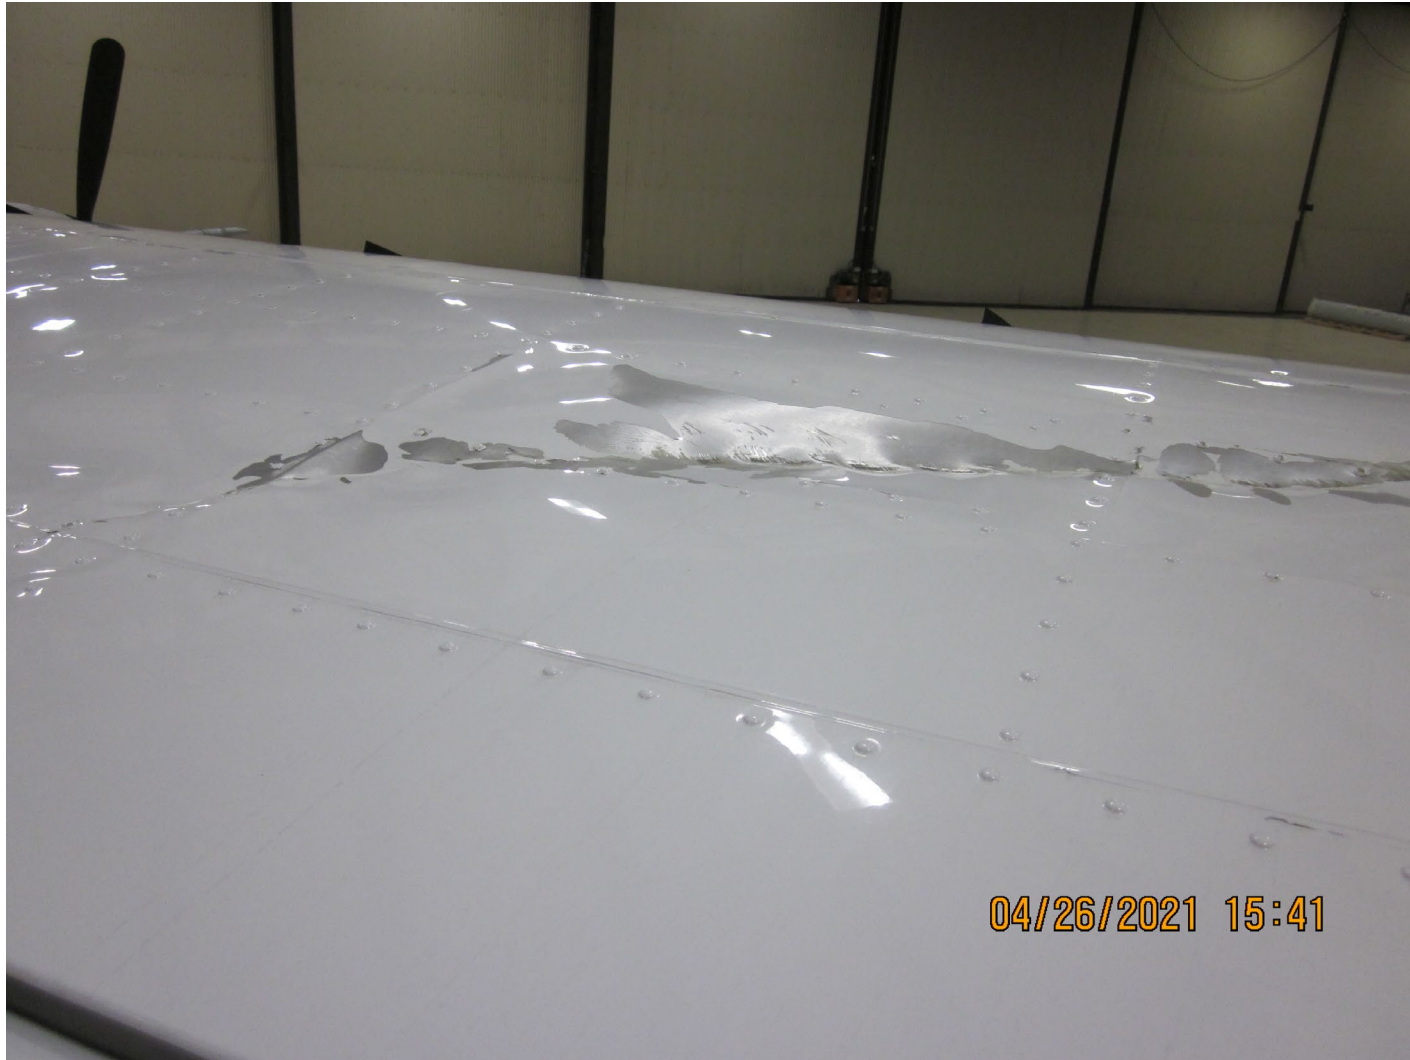
**Photo 4 – View of top surface of right wing. Impact damage mid span. (Courtesy of FAA)**

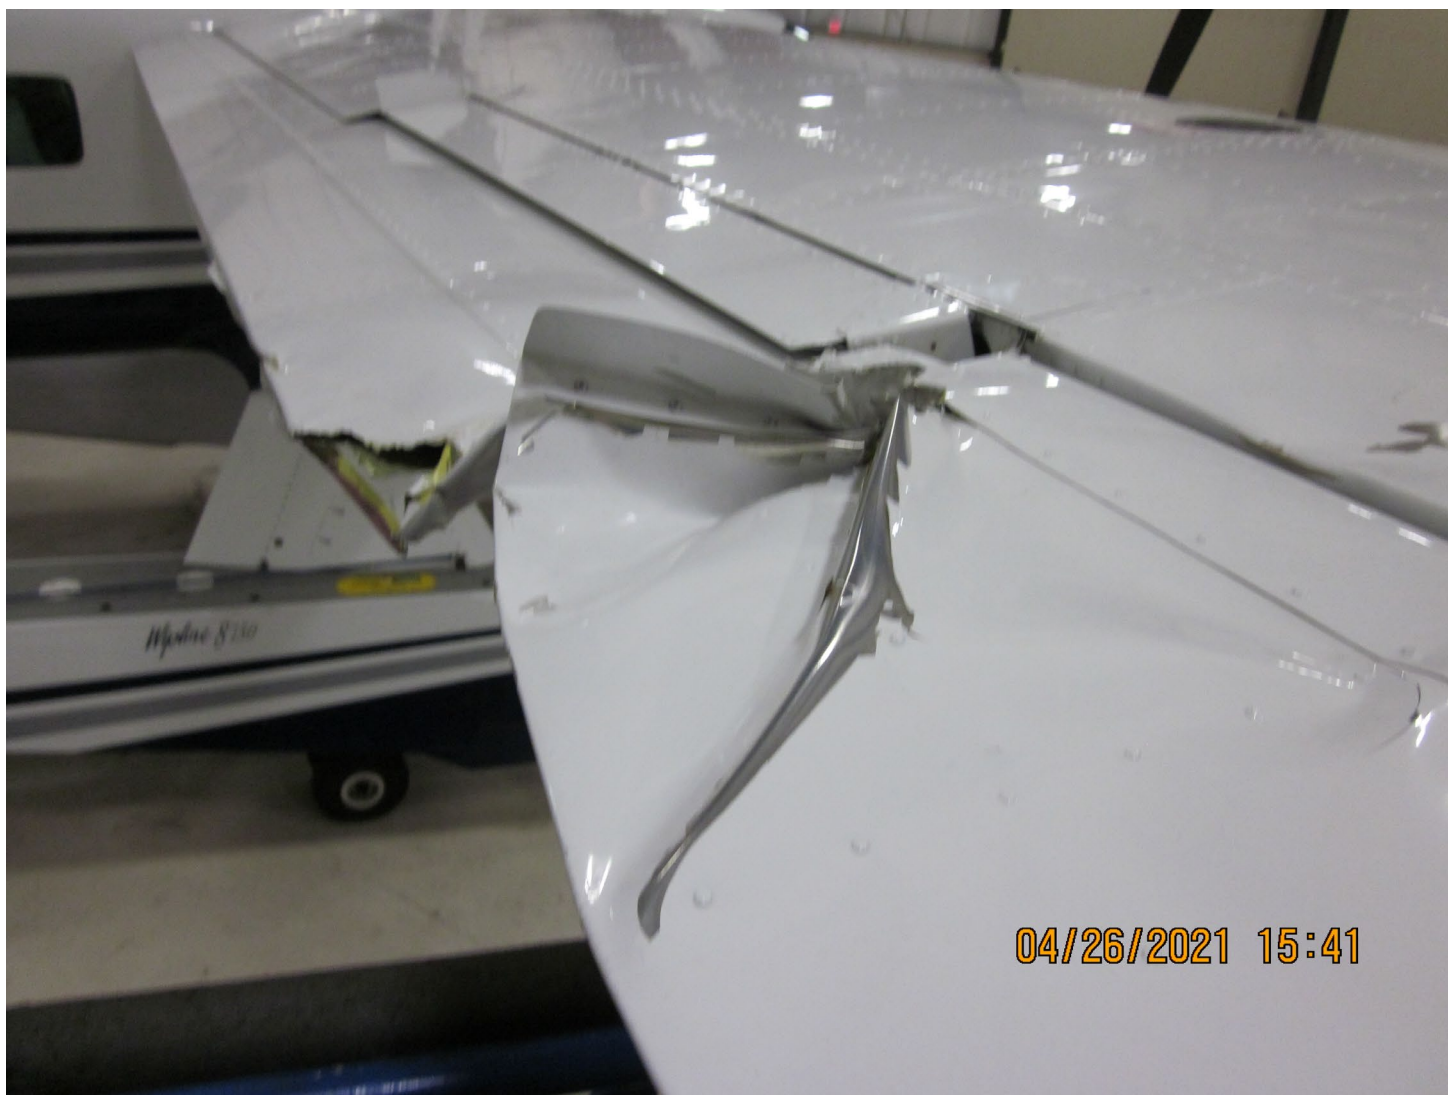
**Photo 5 – View of flap and aileron damage to right wing looking towards fuselage. (Courtesy of FAA)**

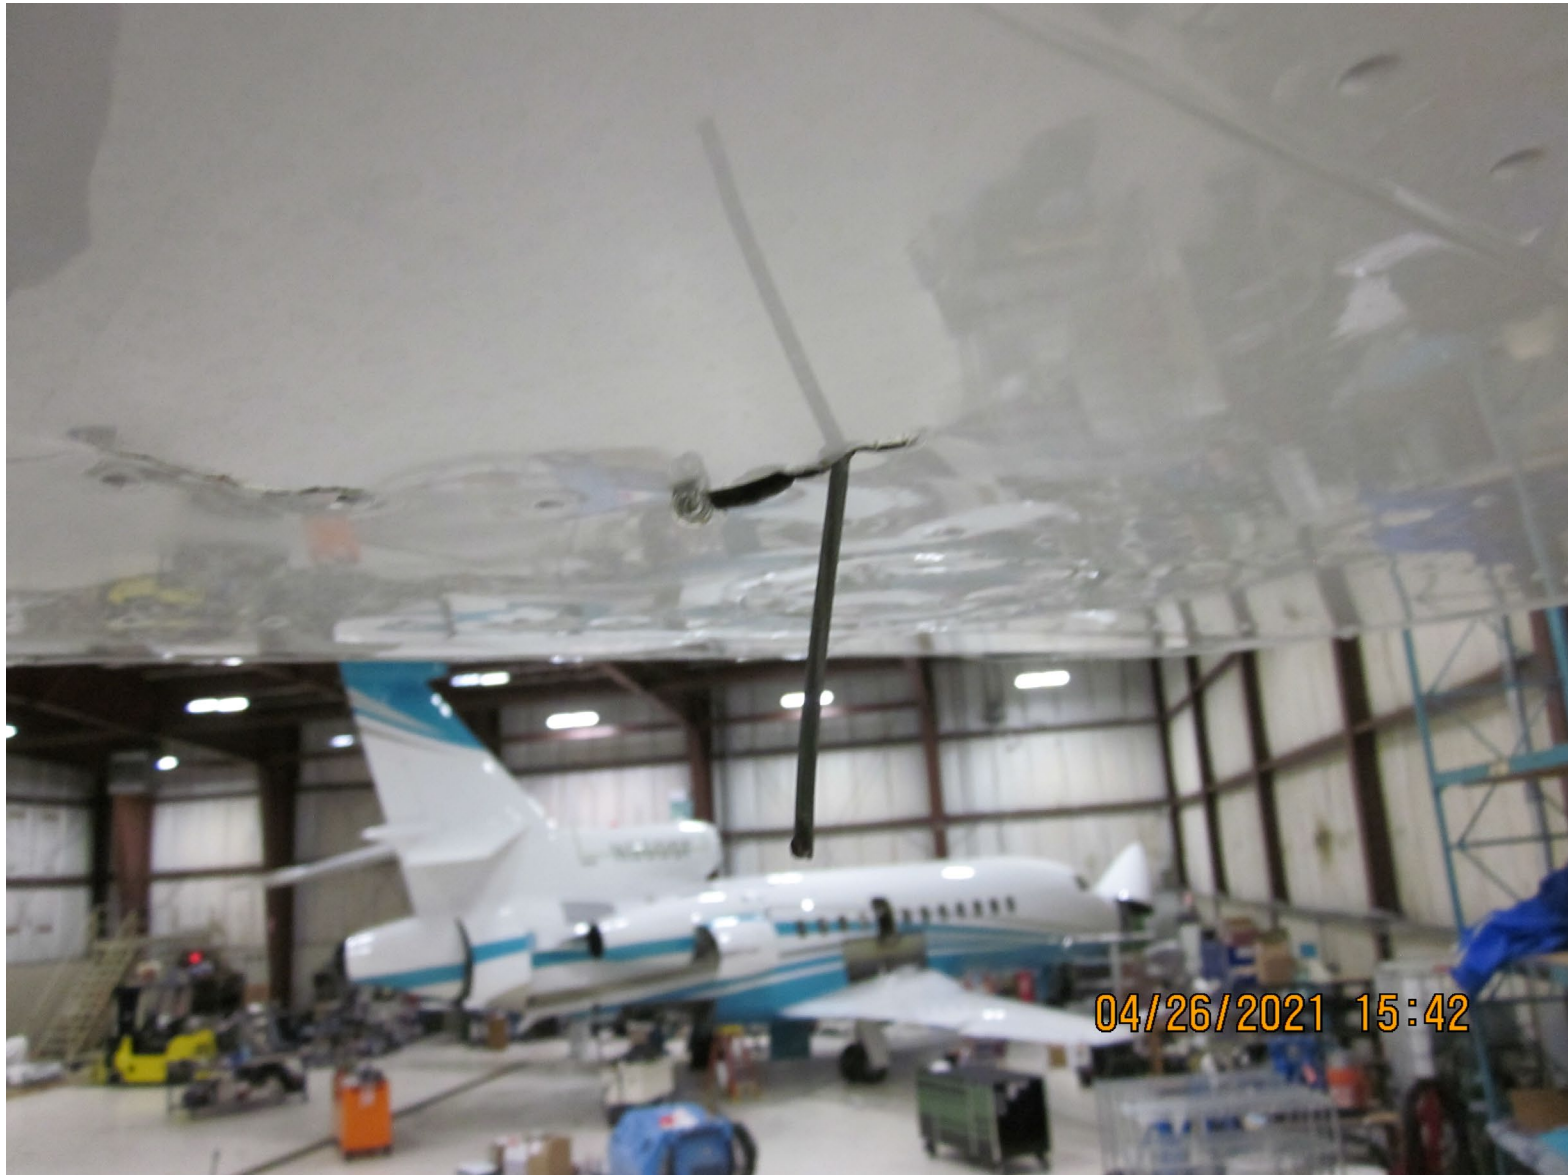
**Photo 6 – View of tear to underside of right wing and foreign object/wire protruding from the interior of wing.  
(Courtesy of FAA)**

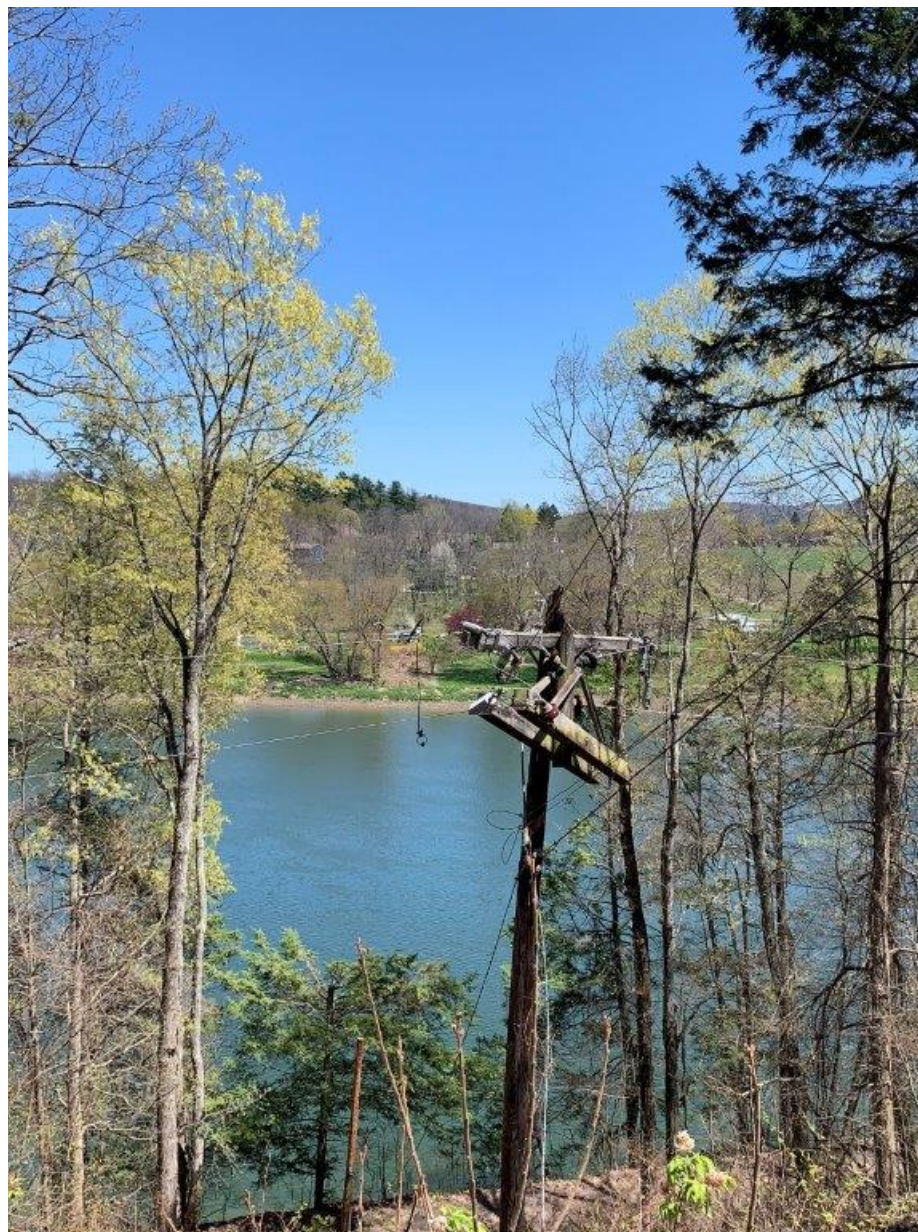
**Photo 7 – View of damaged transmission pole/wires. (Courtesy of First Energy)**

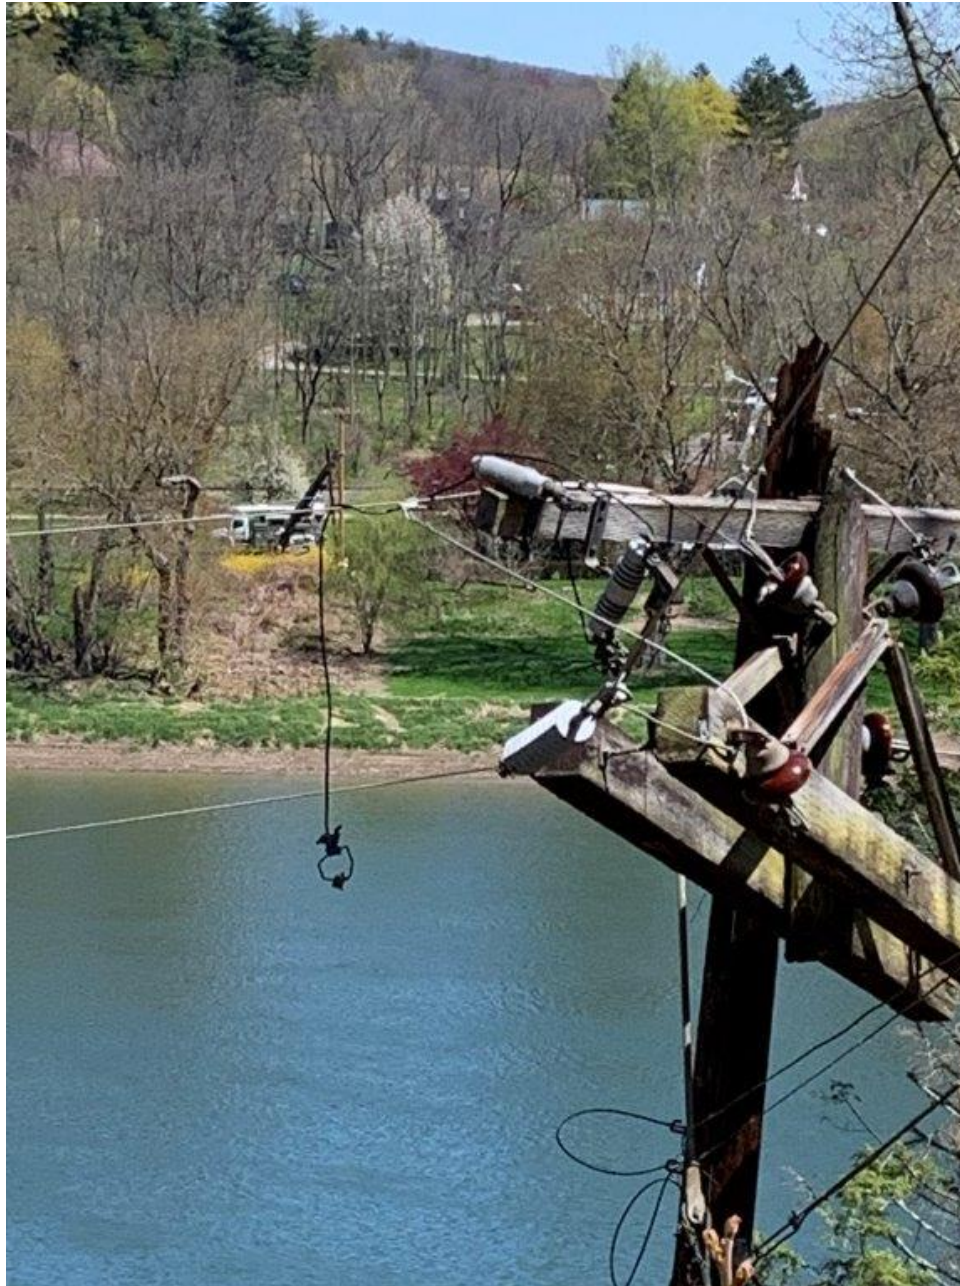
**Photo 8 – Close up view of damaged transmission pole/wires. (Courtesy of First Energy)**

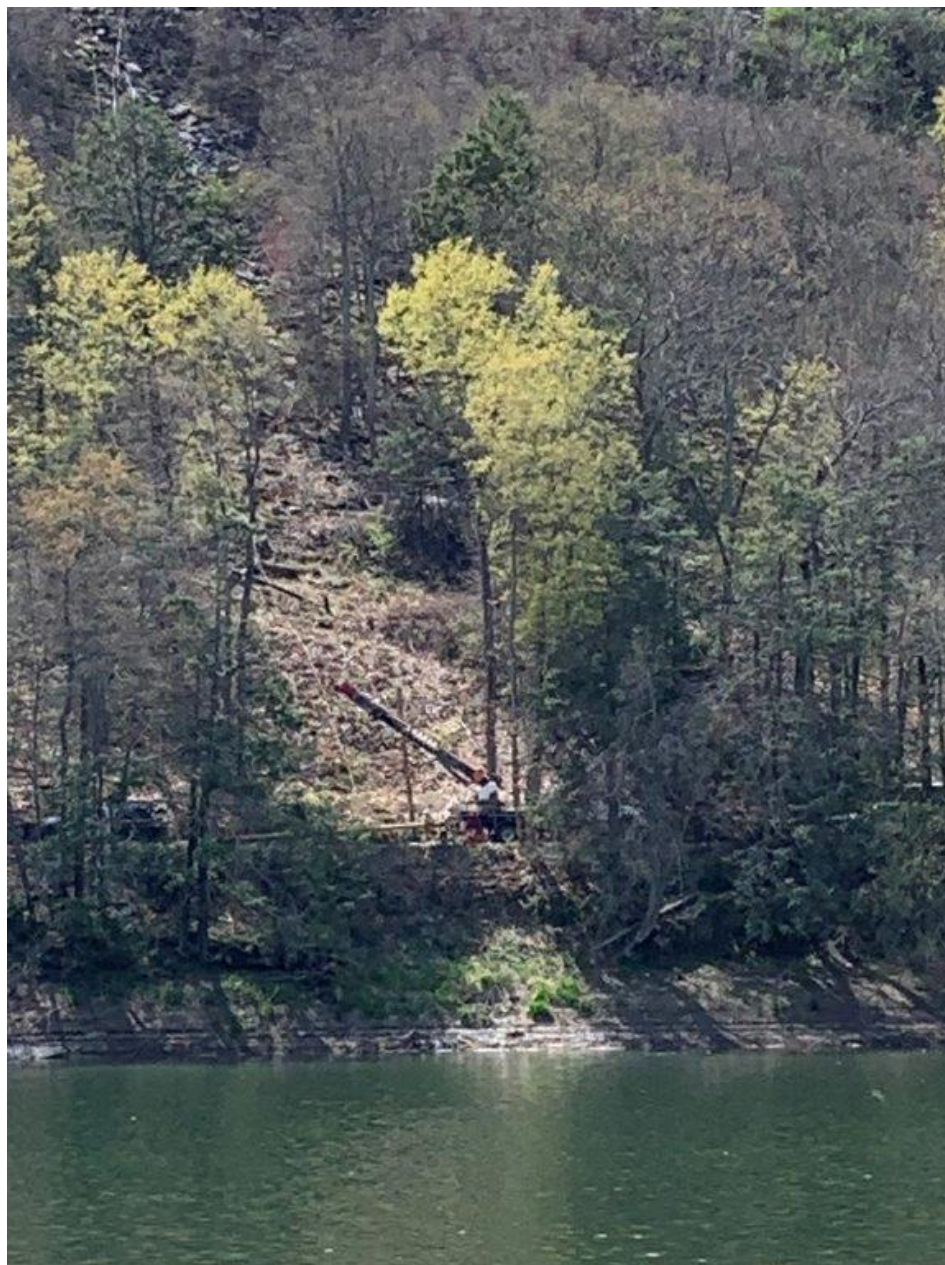
**Photo 9 – View of damaged transmission pole/wires taken from opposing shore. (Courtesy of First Energy)**
