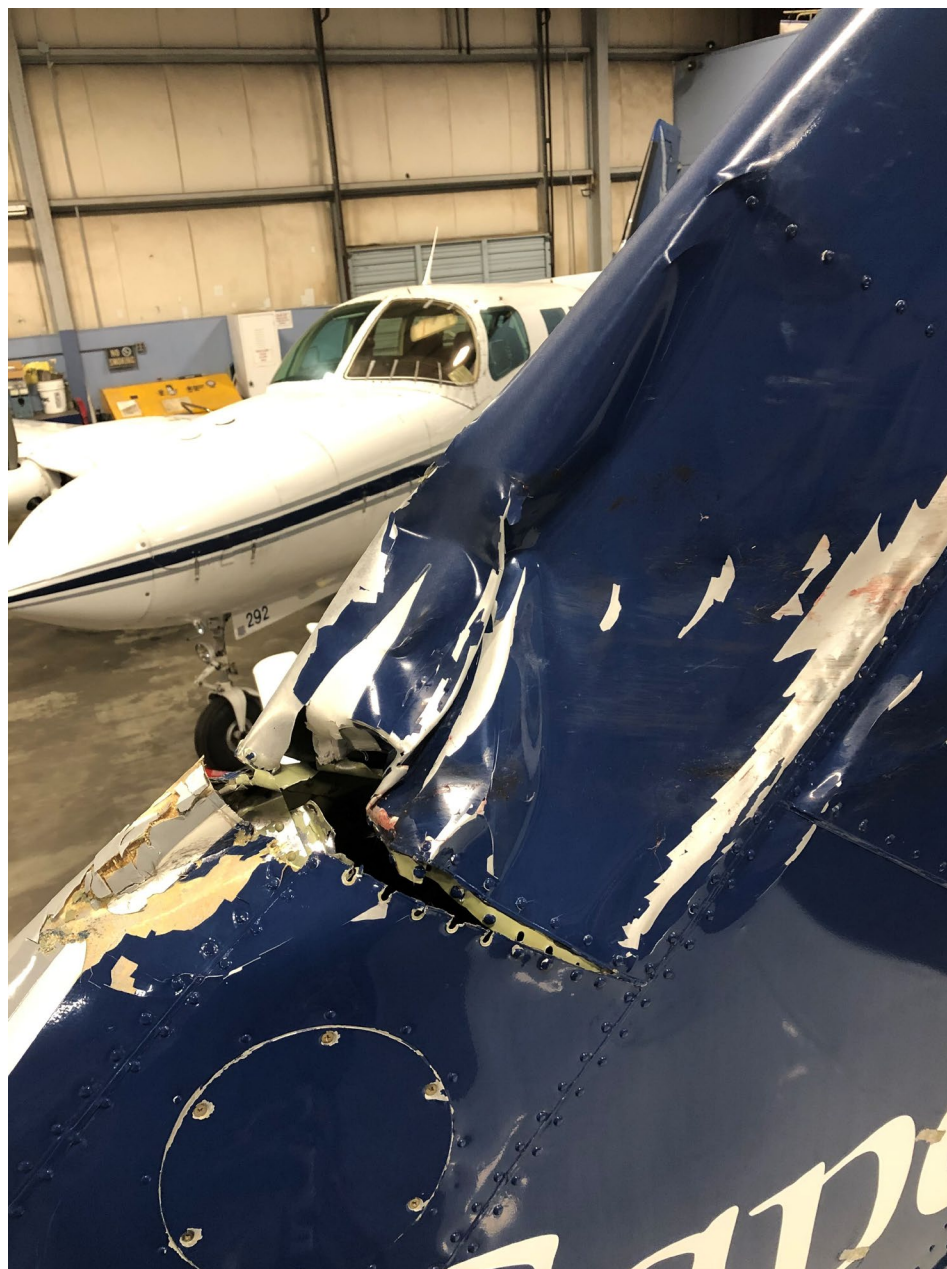
**Photo 1 – View of damaged leading edge of vertical stabilizer**

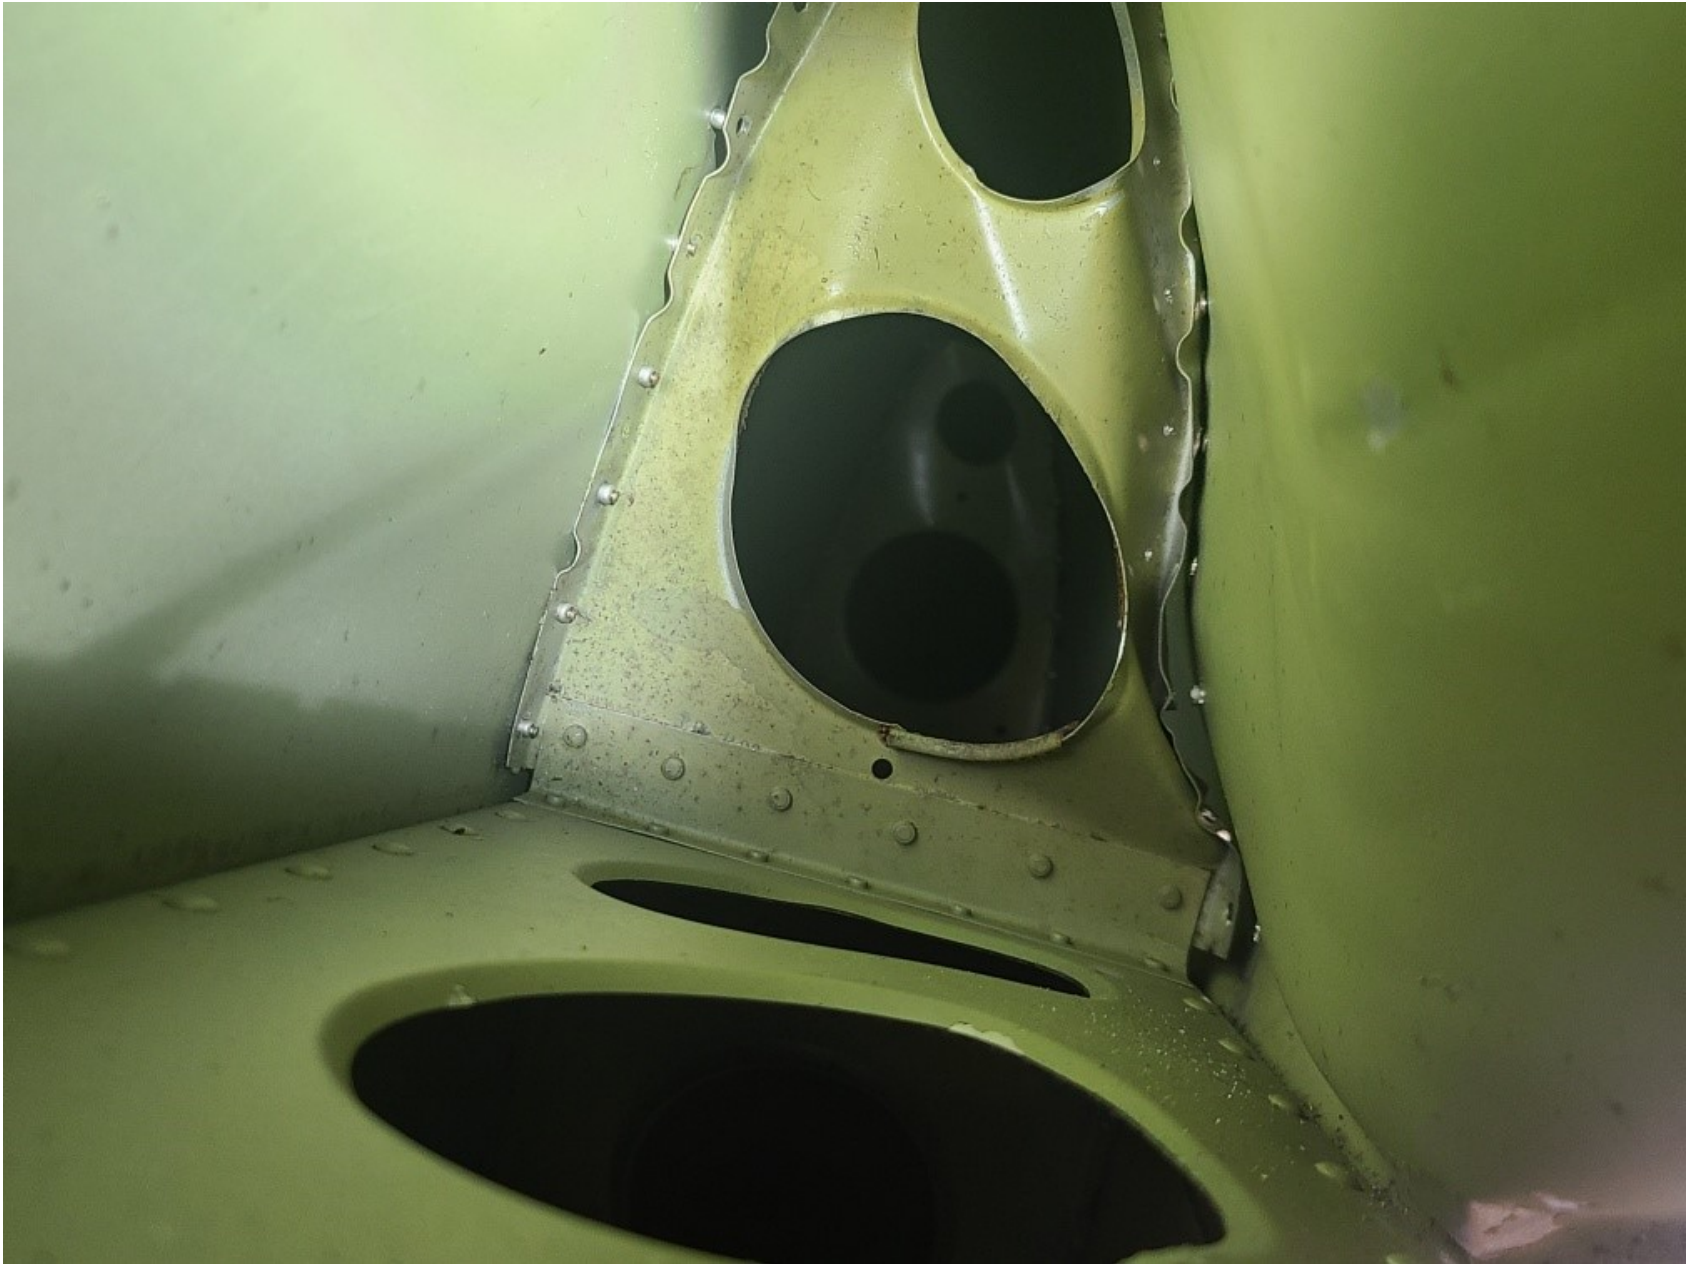
**Photo 2 -View of buckled vertical stabilizer spar.**
