## **NATIONAL TRANSPORTATION SAFETY BOARD**

Office of Aviation Safety  
Eastern Region

**Photo Array**

**ERA21LA198**

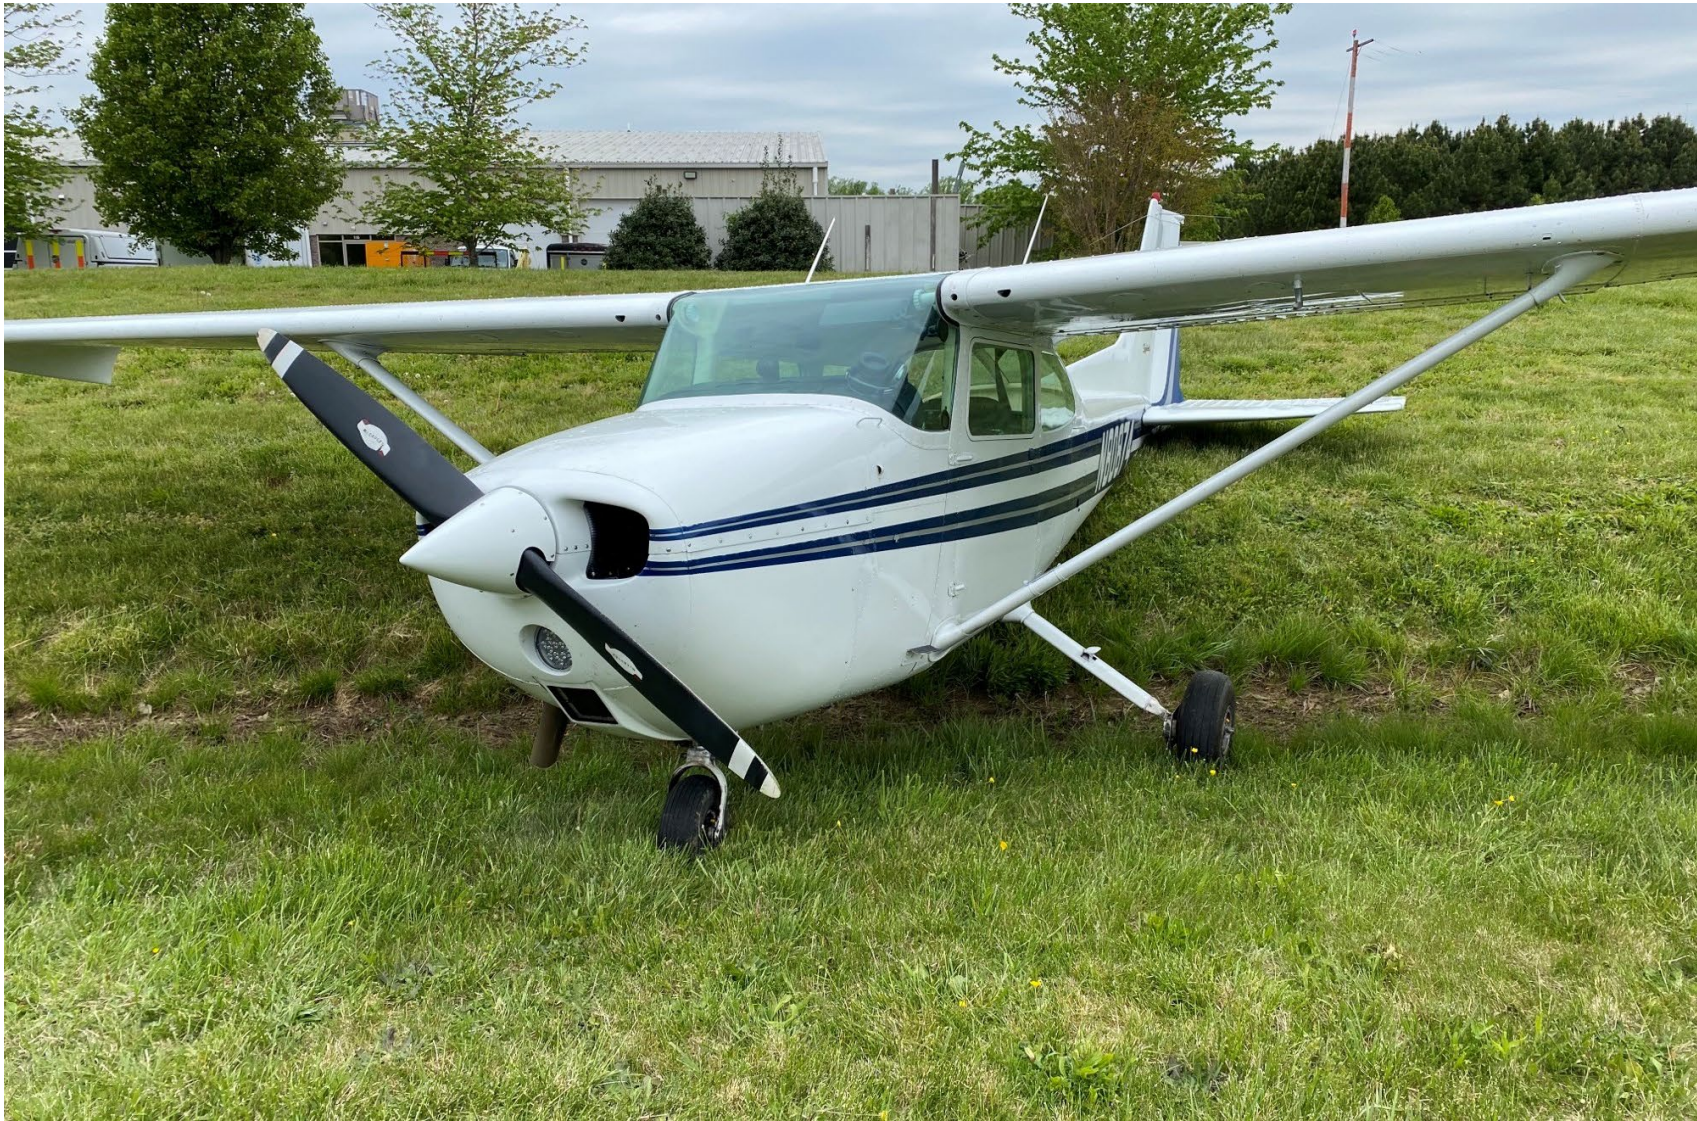
**Photo 1 – View of airplane from front (Photo Courtesy of FAA)**

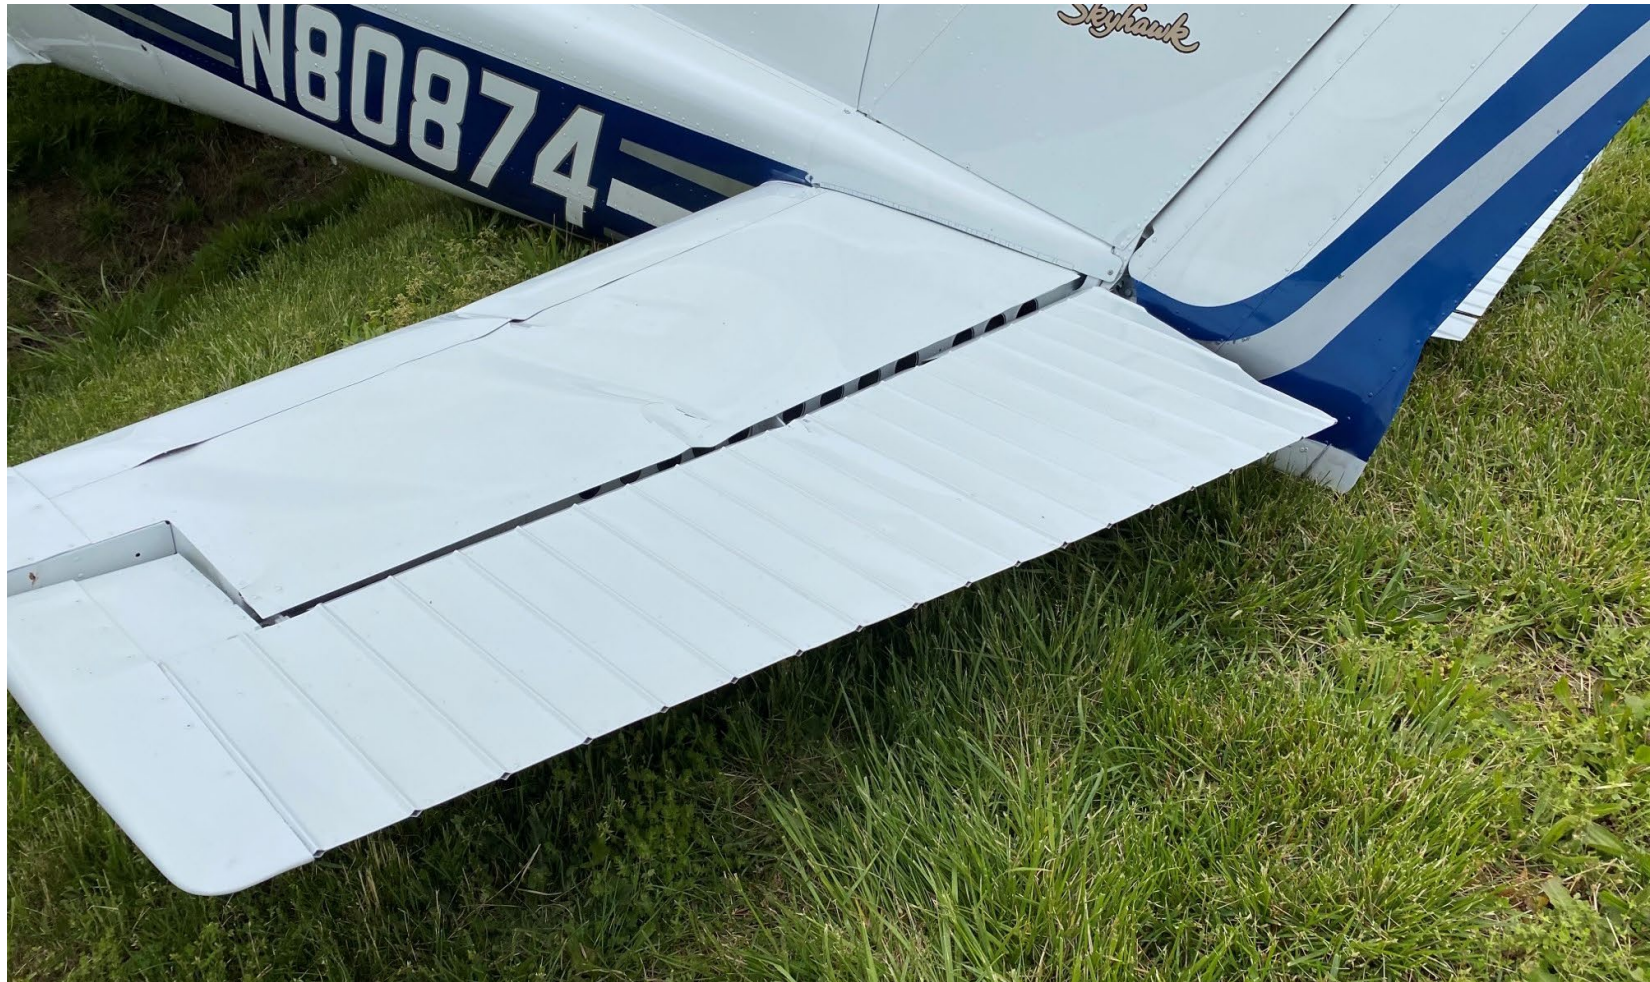
**Photo 2 – View of damage to the left horizontal stabilizer (Photo Courtesy of FAA)**
