## RECORD OF CONVERSATION

**Date: May 3, 2021**  
**Person Contacted: Sean Flanders**  
**NTSB Accident Number: ERA21LA201**

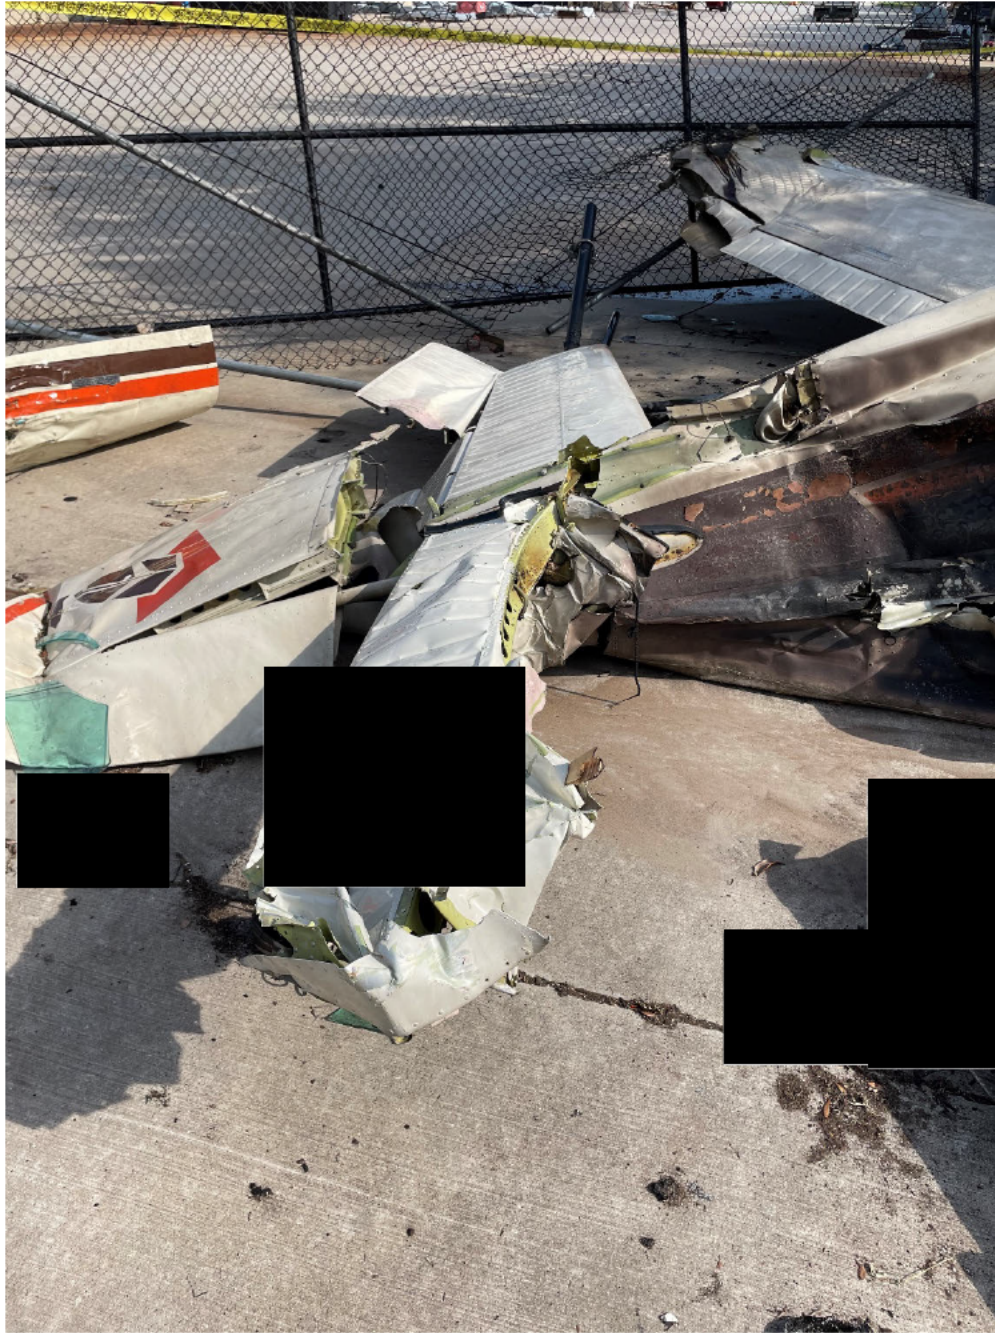
He indicated during the phone call that there were 2 control cables connected at the rear rudder bellcrank, and they were under tension. As part of his procedures, he spray painted both cables red and then cut them. He added that the two cables were the only thing connecting the structurally separated vertical stabilizer and rudder to the airplane.

Figure 1: Unretouched Photograph Provided by Sean Flanders. View of the Aft Empennage At the Accident Site.

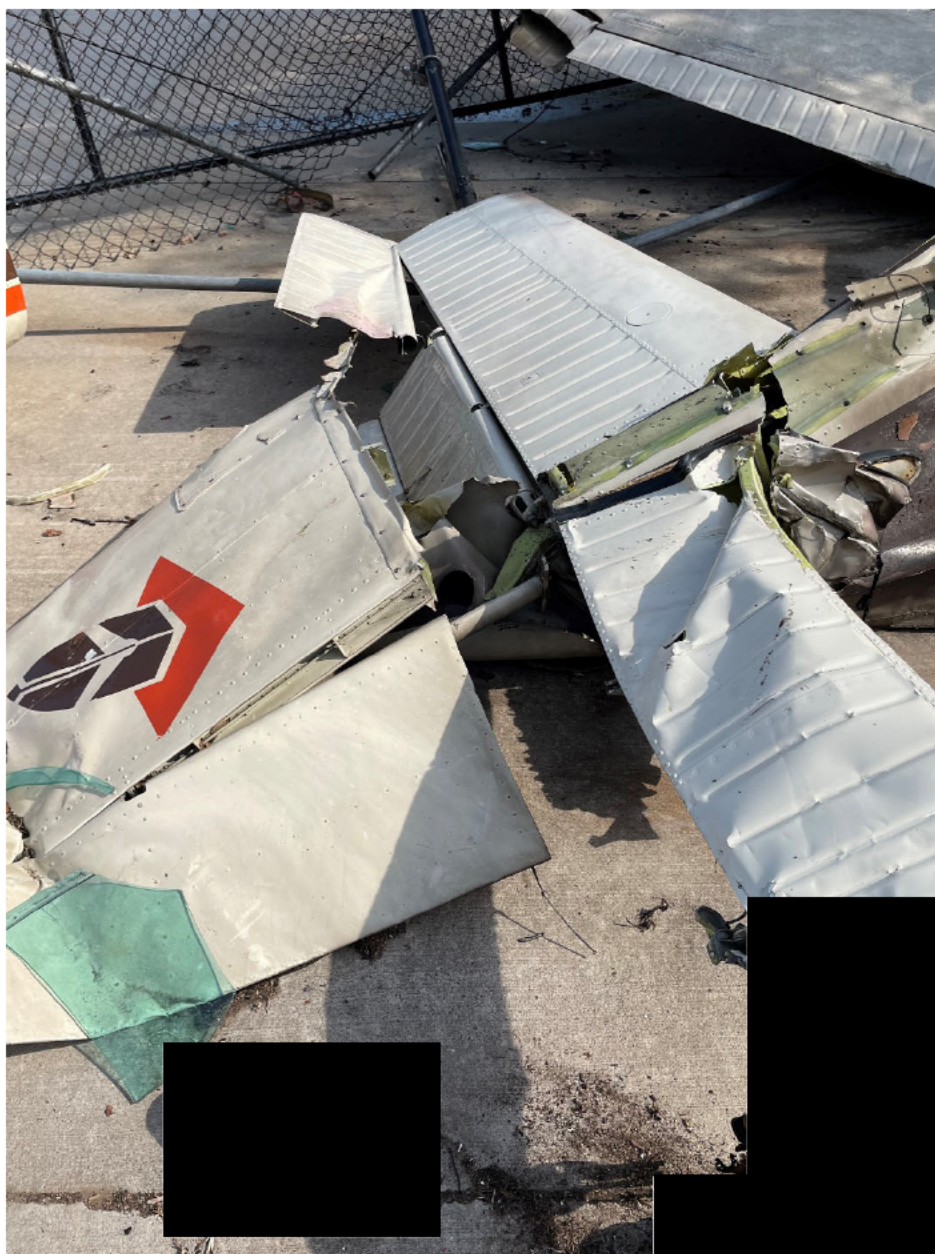
Figure 2: Unretouched Photograph Provided by Sean Flanders. View of the Aft Empennage At the Accident Site.

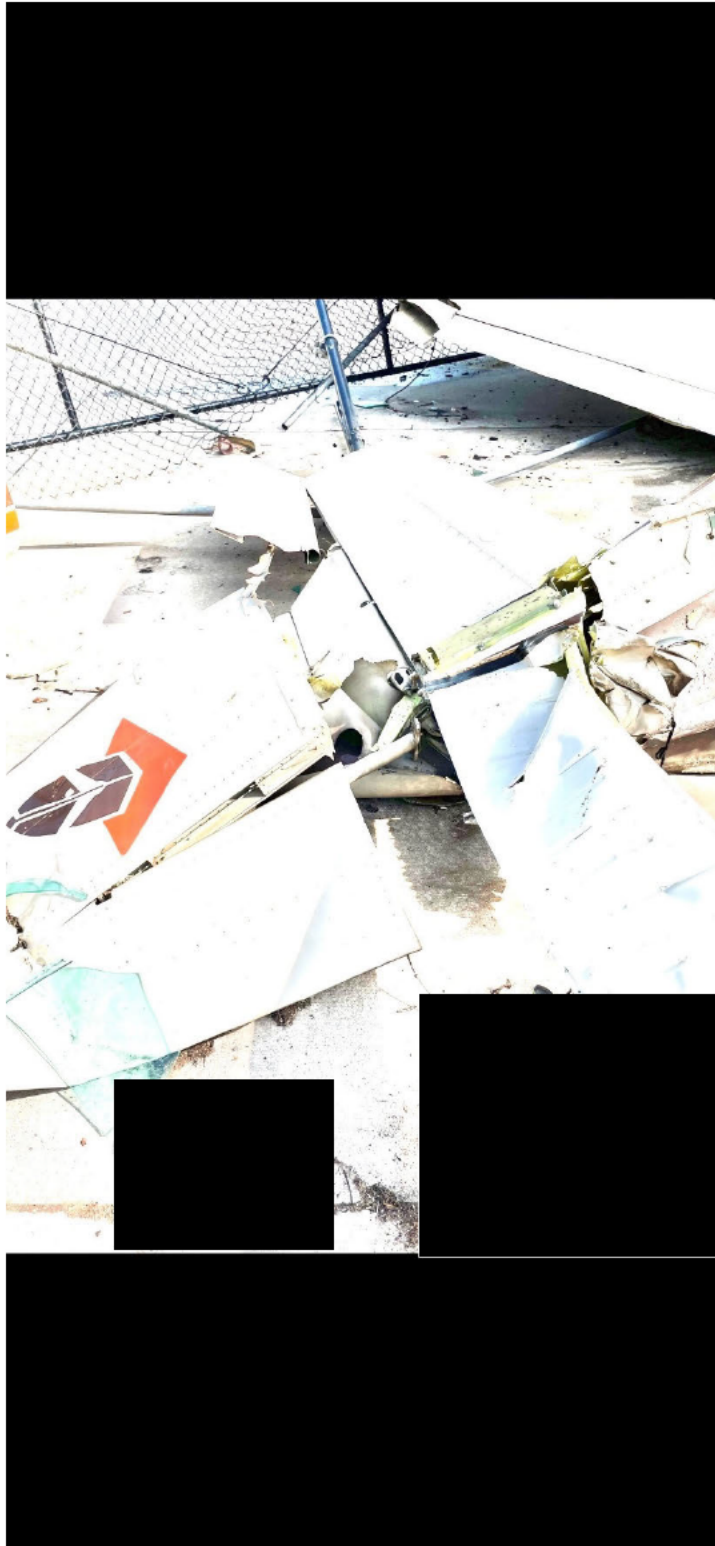
Figure 3: Lightened Photograph Provided by Sean Flanders.  
View of the Aft Empennage at the Accident Site.
