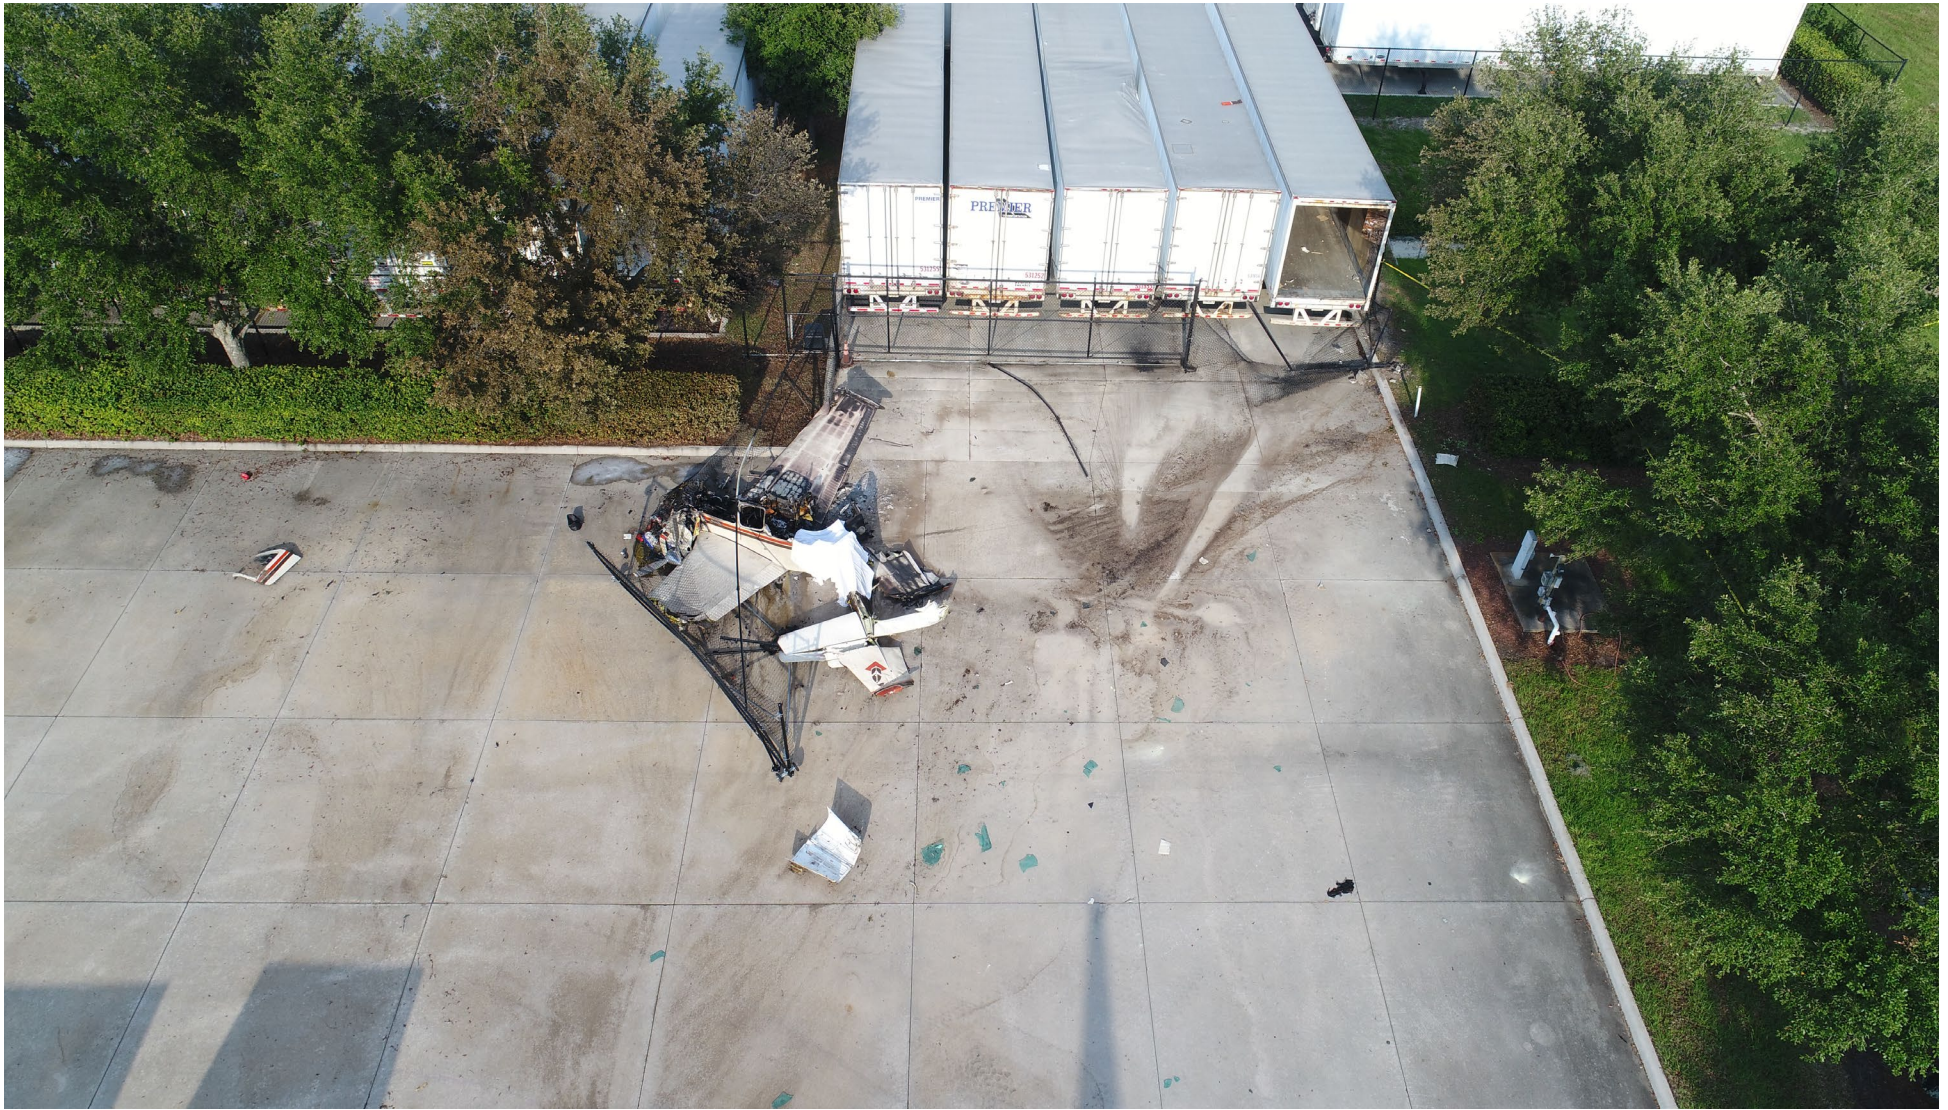
**Photo 1 – Drone Image Fm Lakeland Linder International Airport Individual. Aerial View of the Wreckage at the Accident Site. White Sheet Covering Registration Markings.**

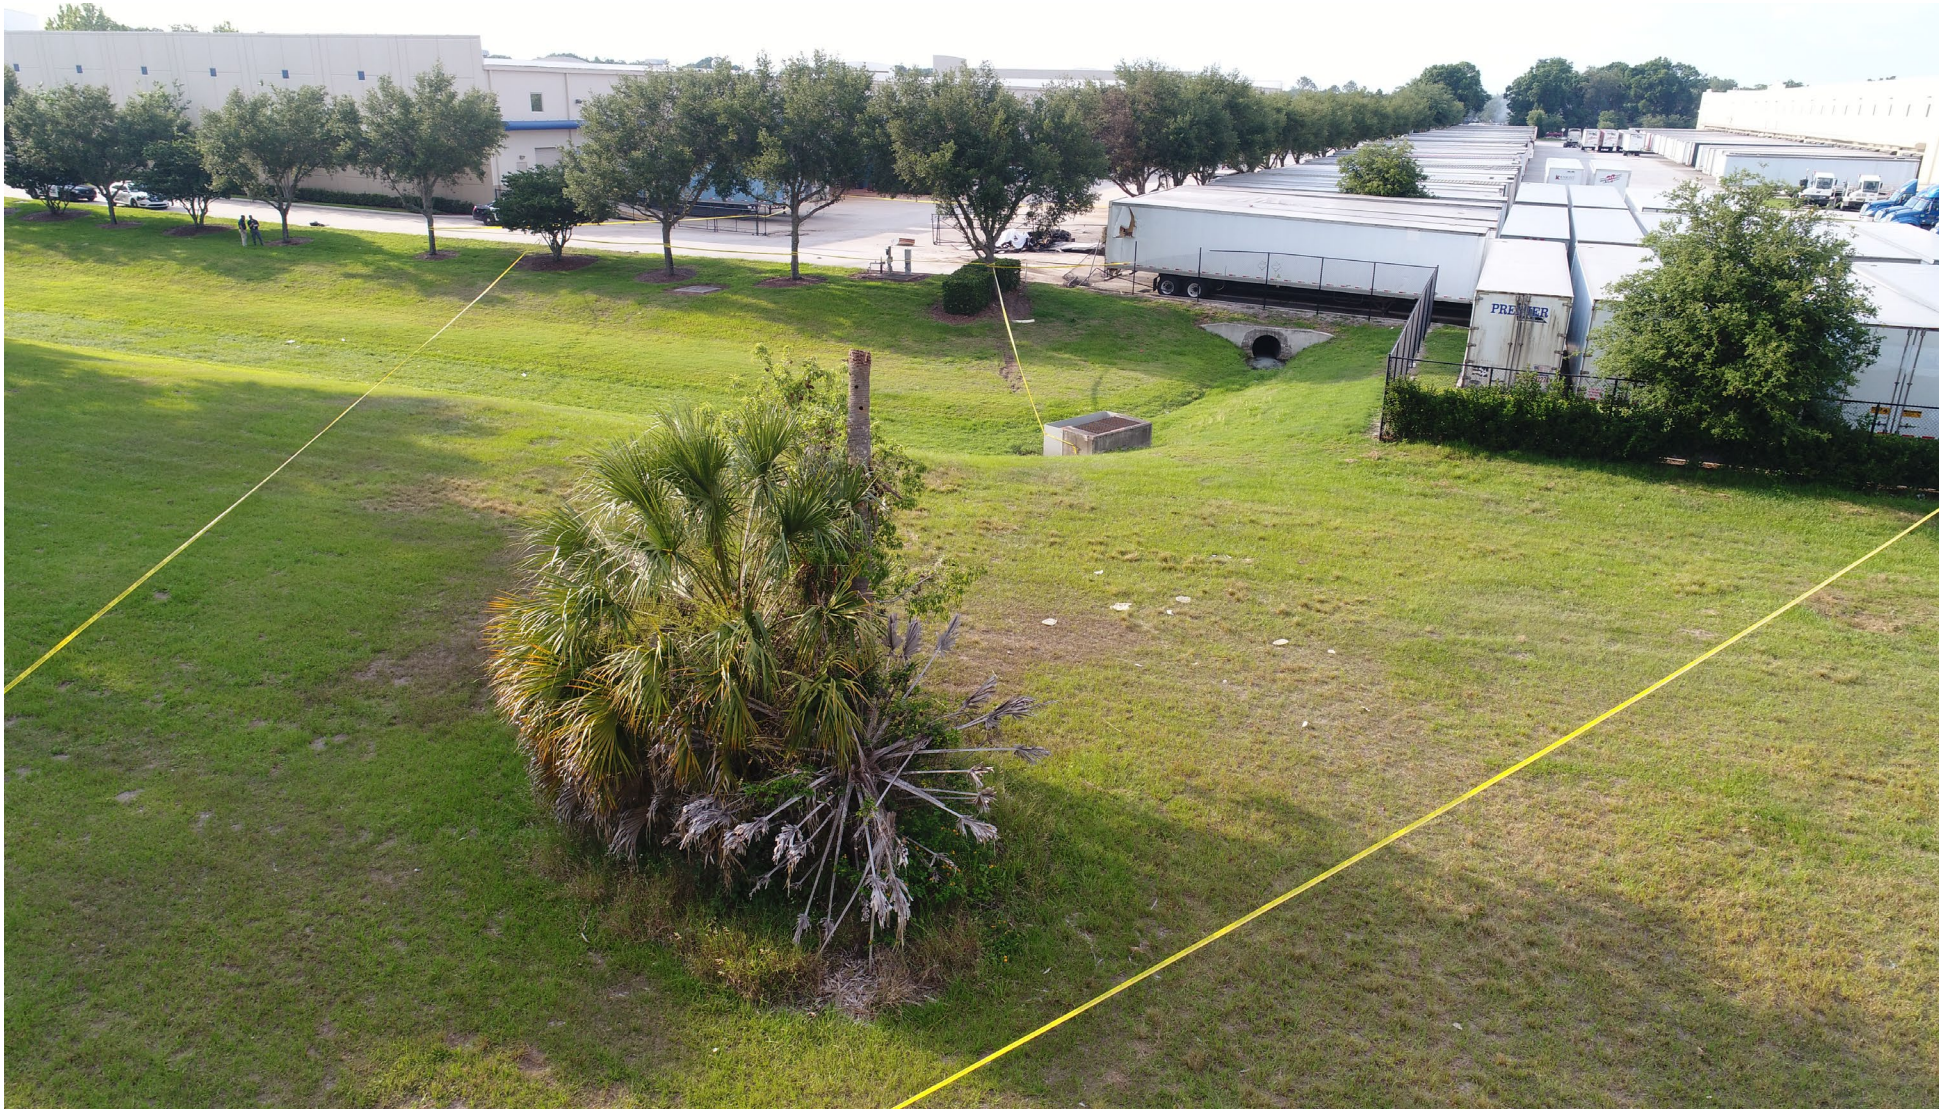
**Photo 2 - Drone Image Fm Lakeland Linder International Airport Individual. Aerial View Looking From near Impacted Palm tree Towards Resting Position of Main Wreckage.**

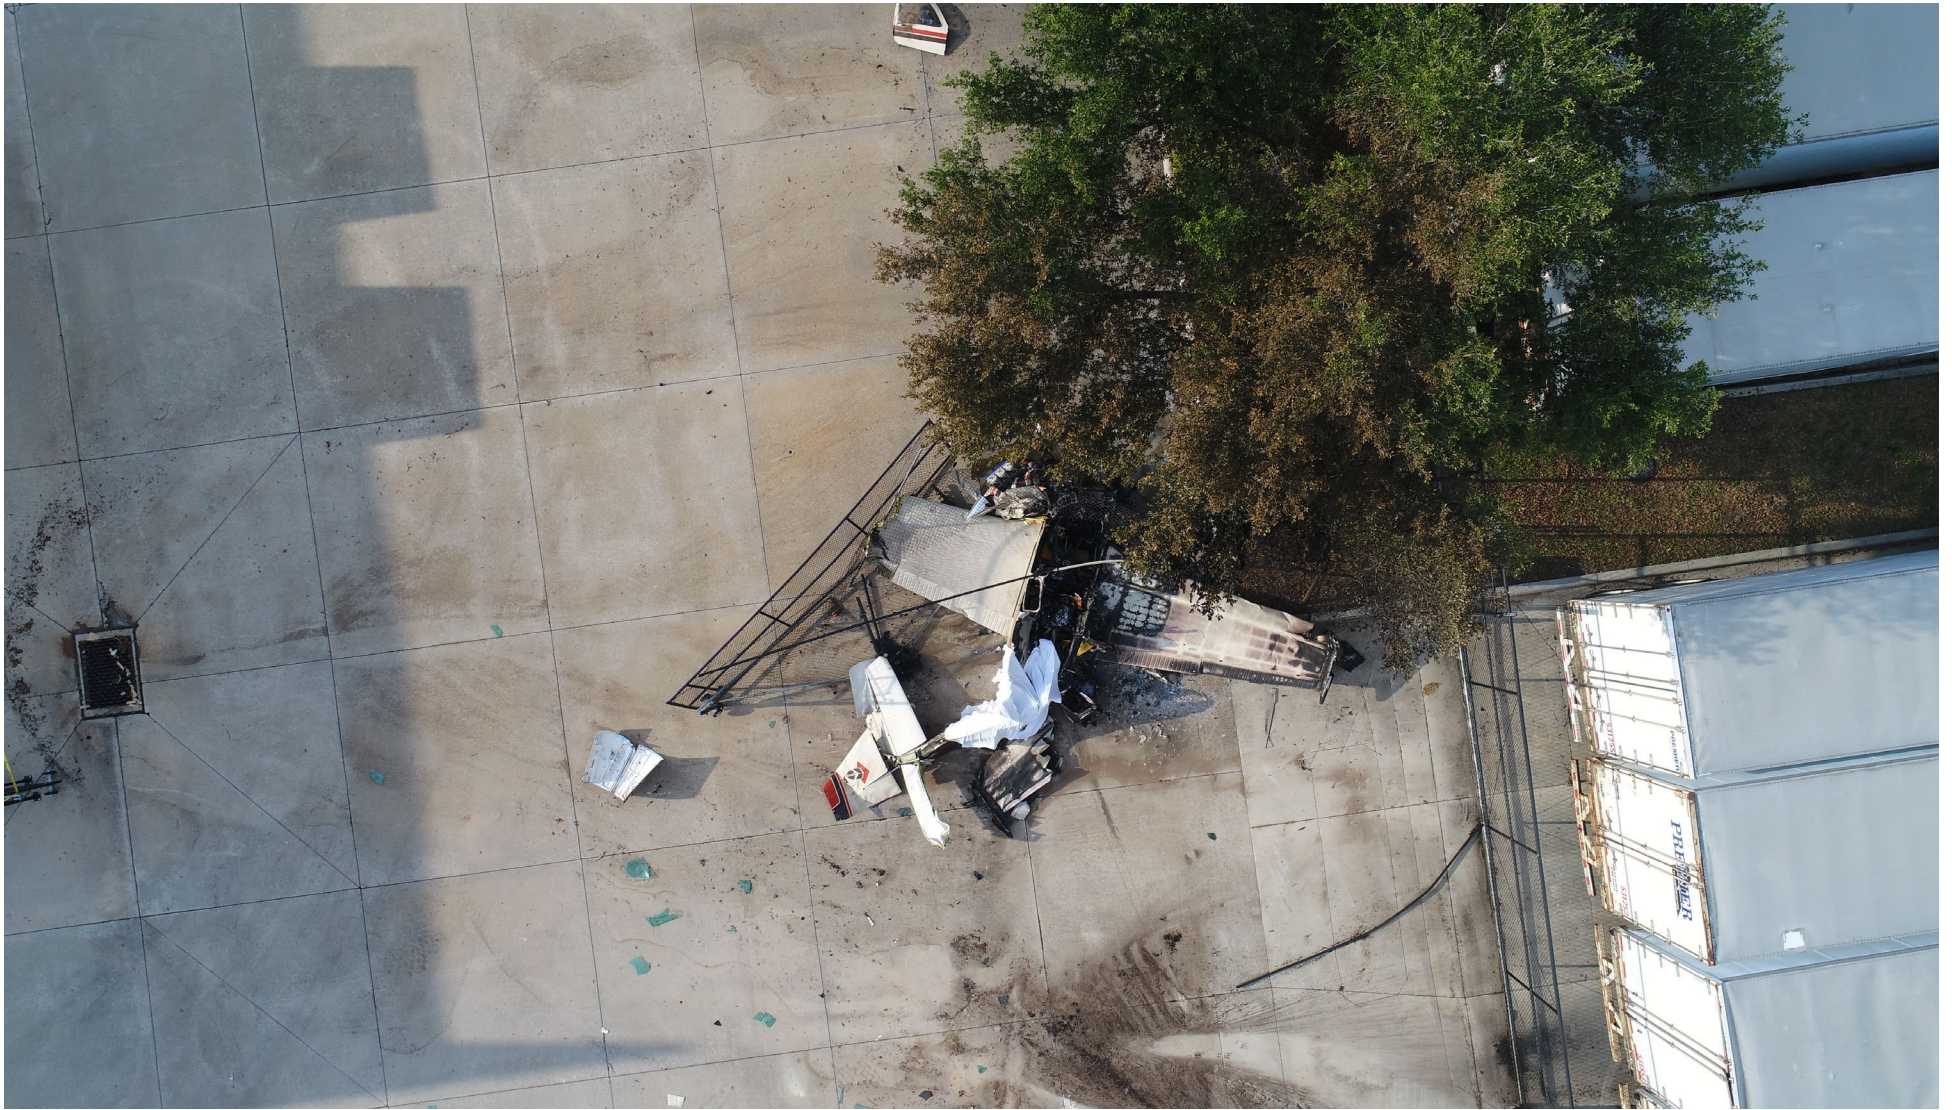
**Photo 3 - Drone Image Fm Lakeland Linder International Airport Individual. Aerial View Looking Down at Main Wreckage.**

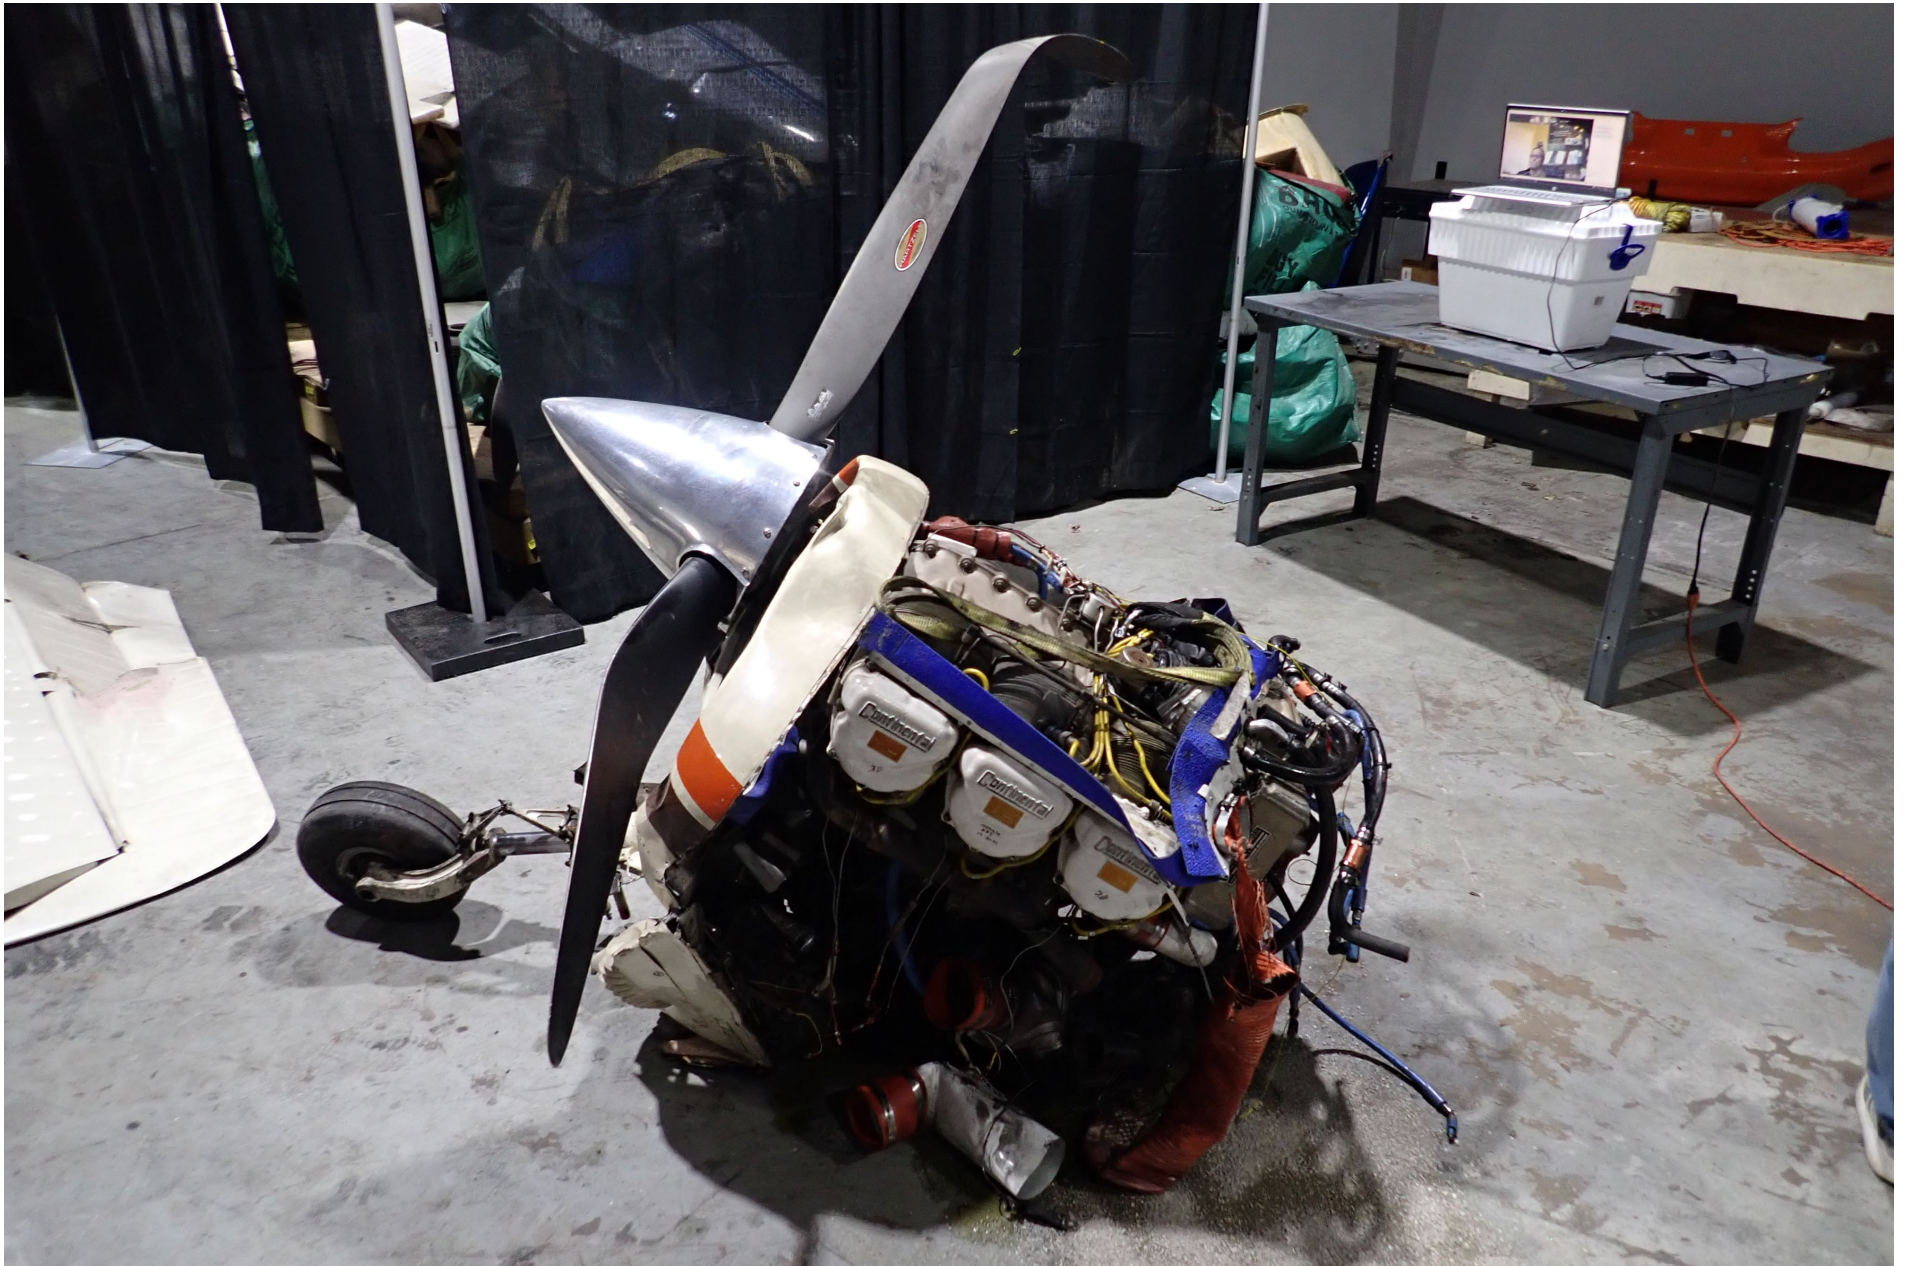
**Photo 4 – Textron Aviation Digital Photograph. Left Side View of the Engine Assembly with Attached Propeller Following Recovery. Note the Minimal Bending of Both Propeller Blades.**

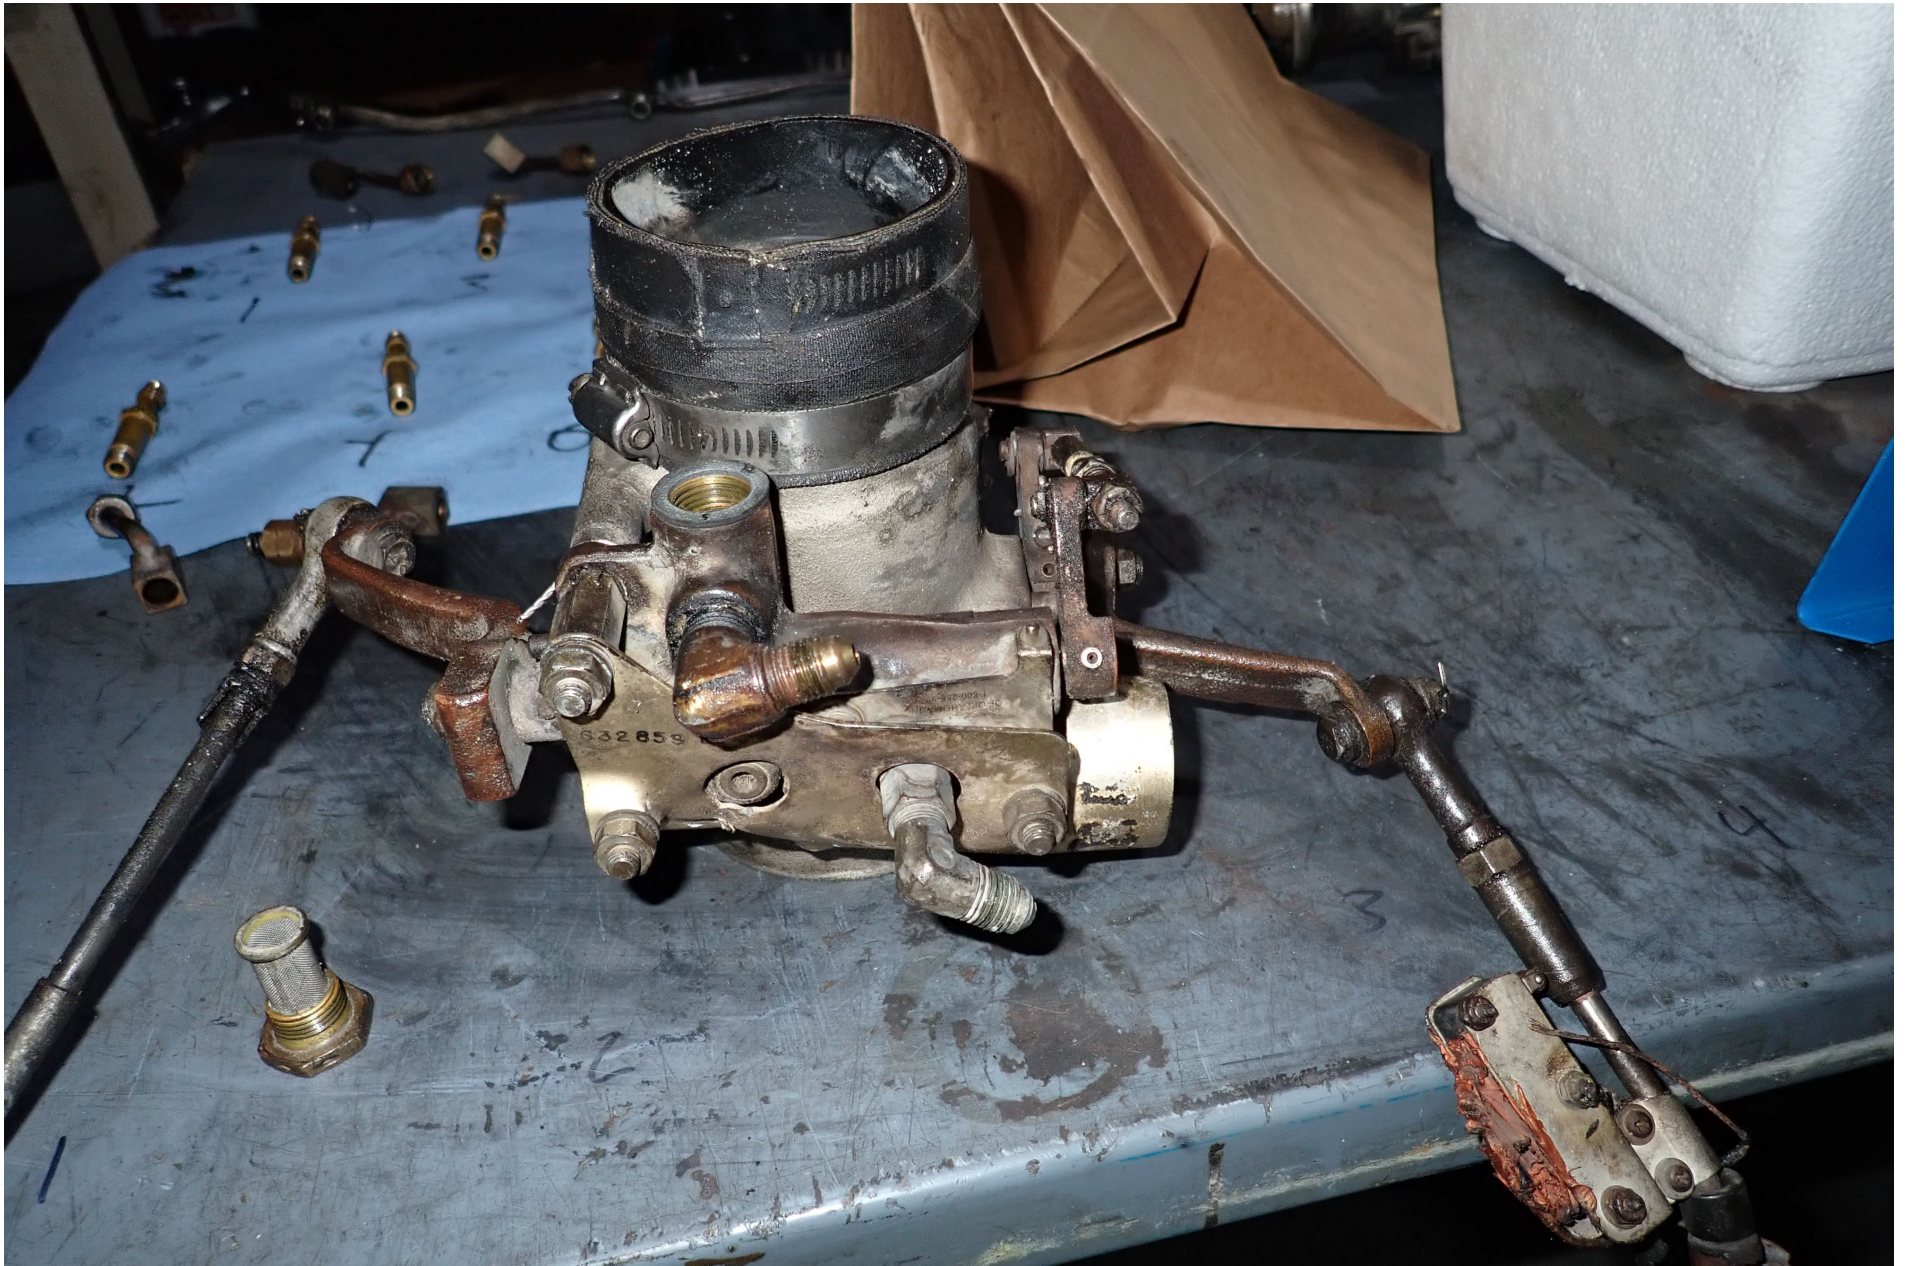
**Photo 5 - Textron Aviation Digital Photograph. View of the Throttle Body and Metering Valve.**

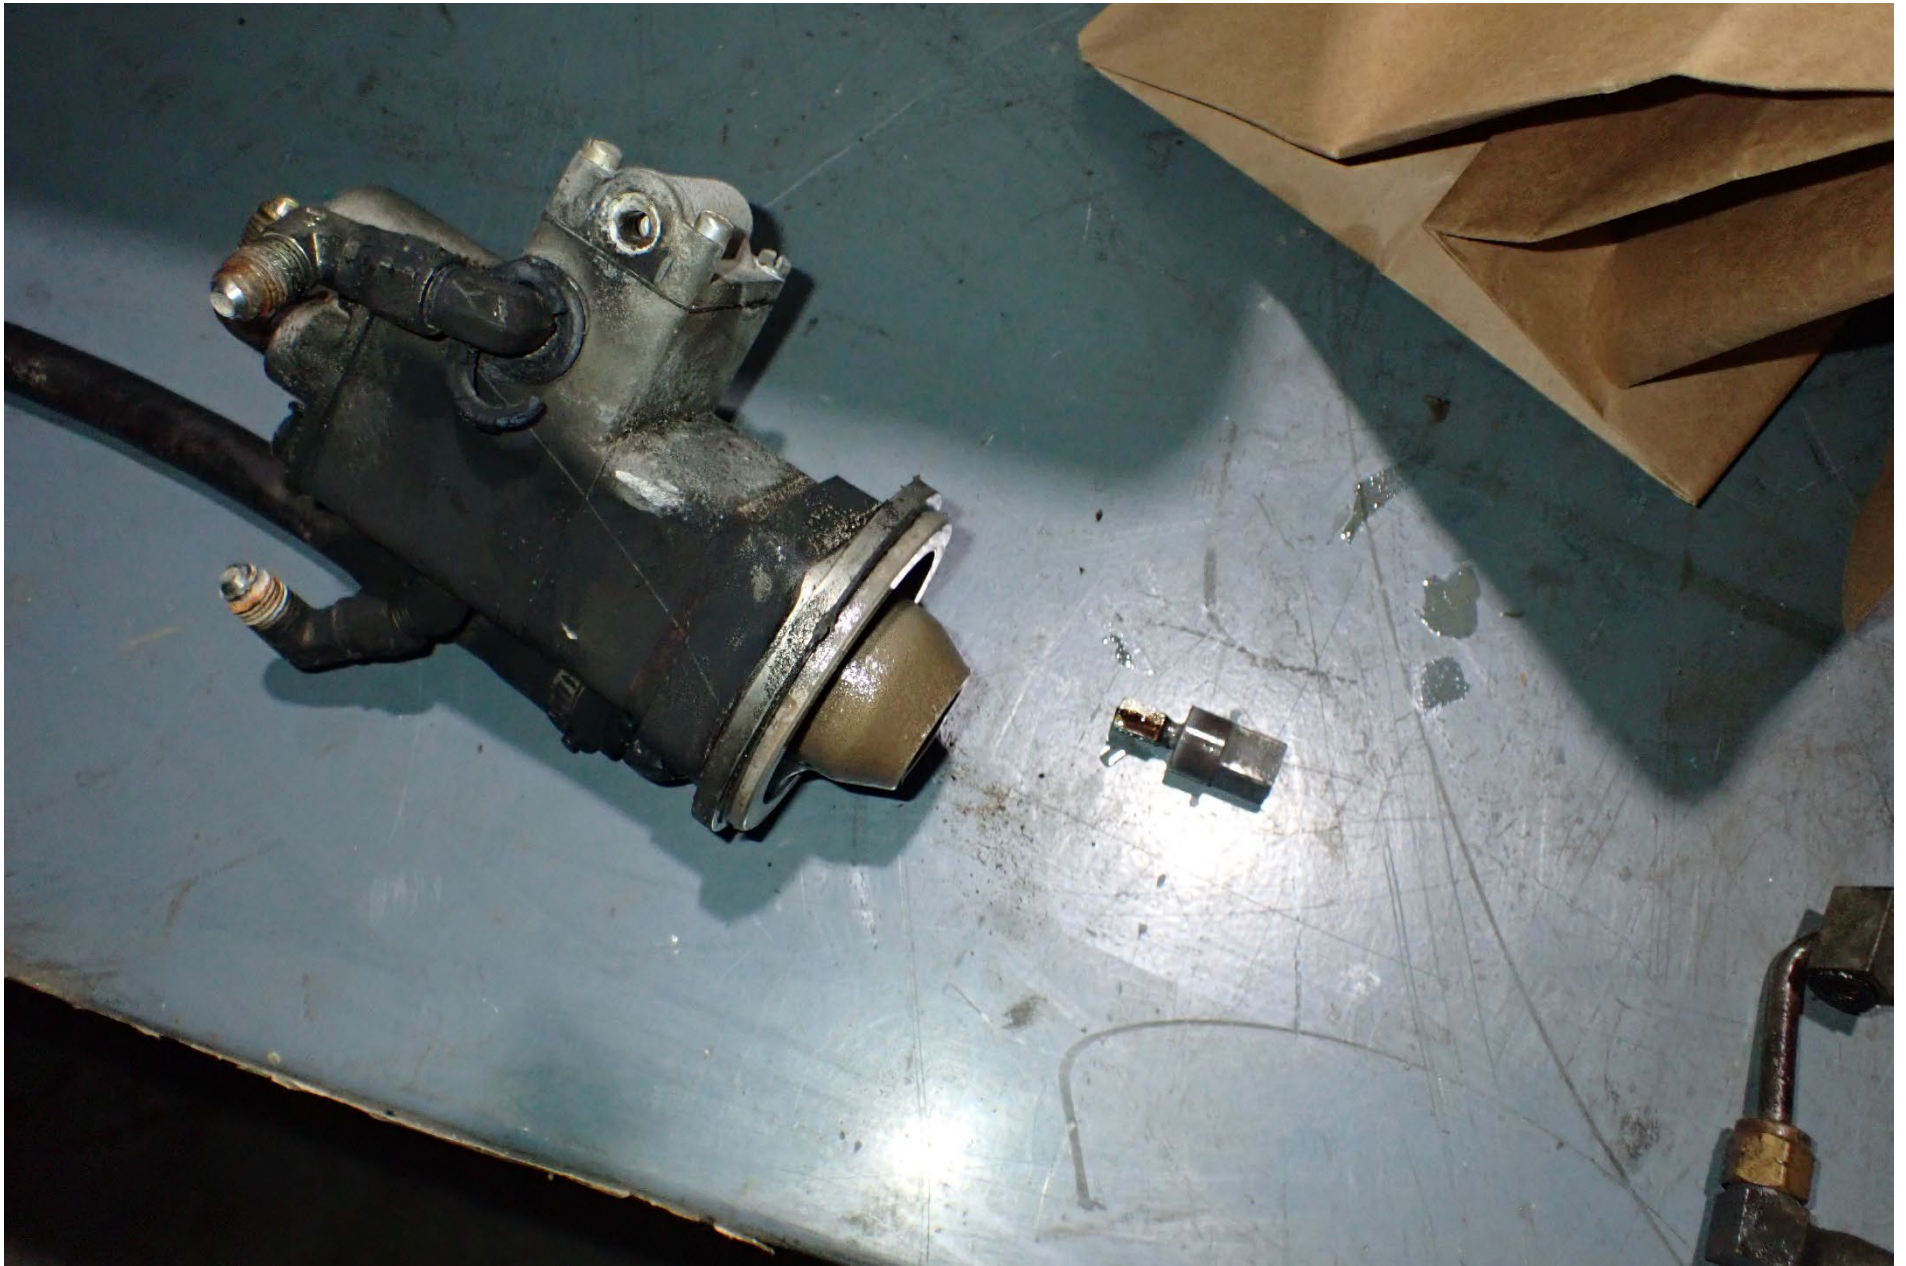
**Photo 6 - Textron Aviation Digital Photograph. View of the Engine-Driven Fuel Pump and Intact Drive Coupling.**

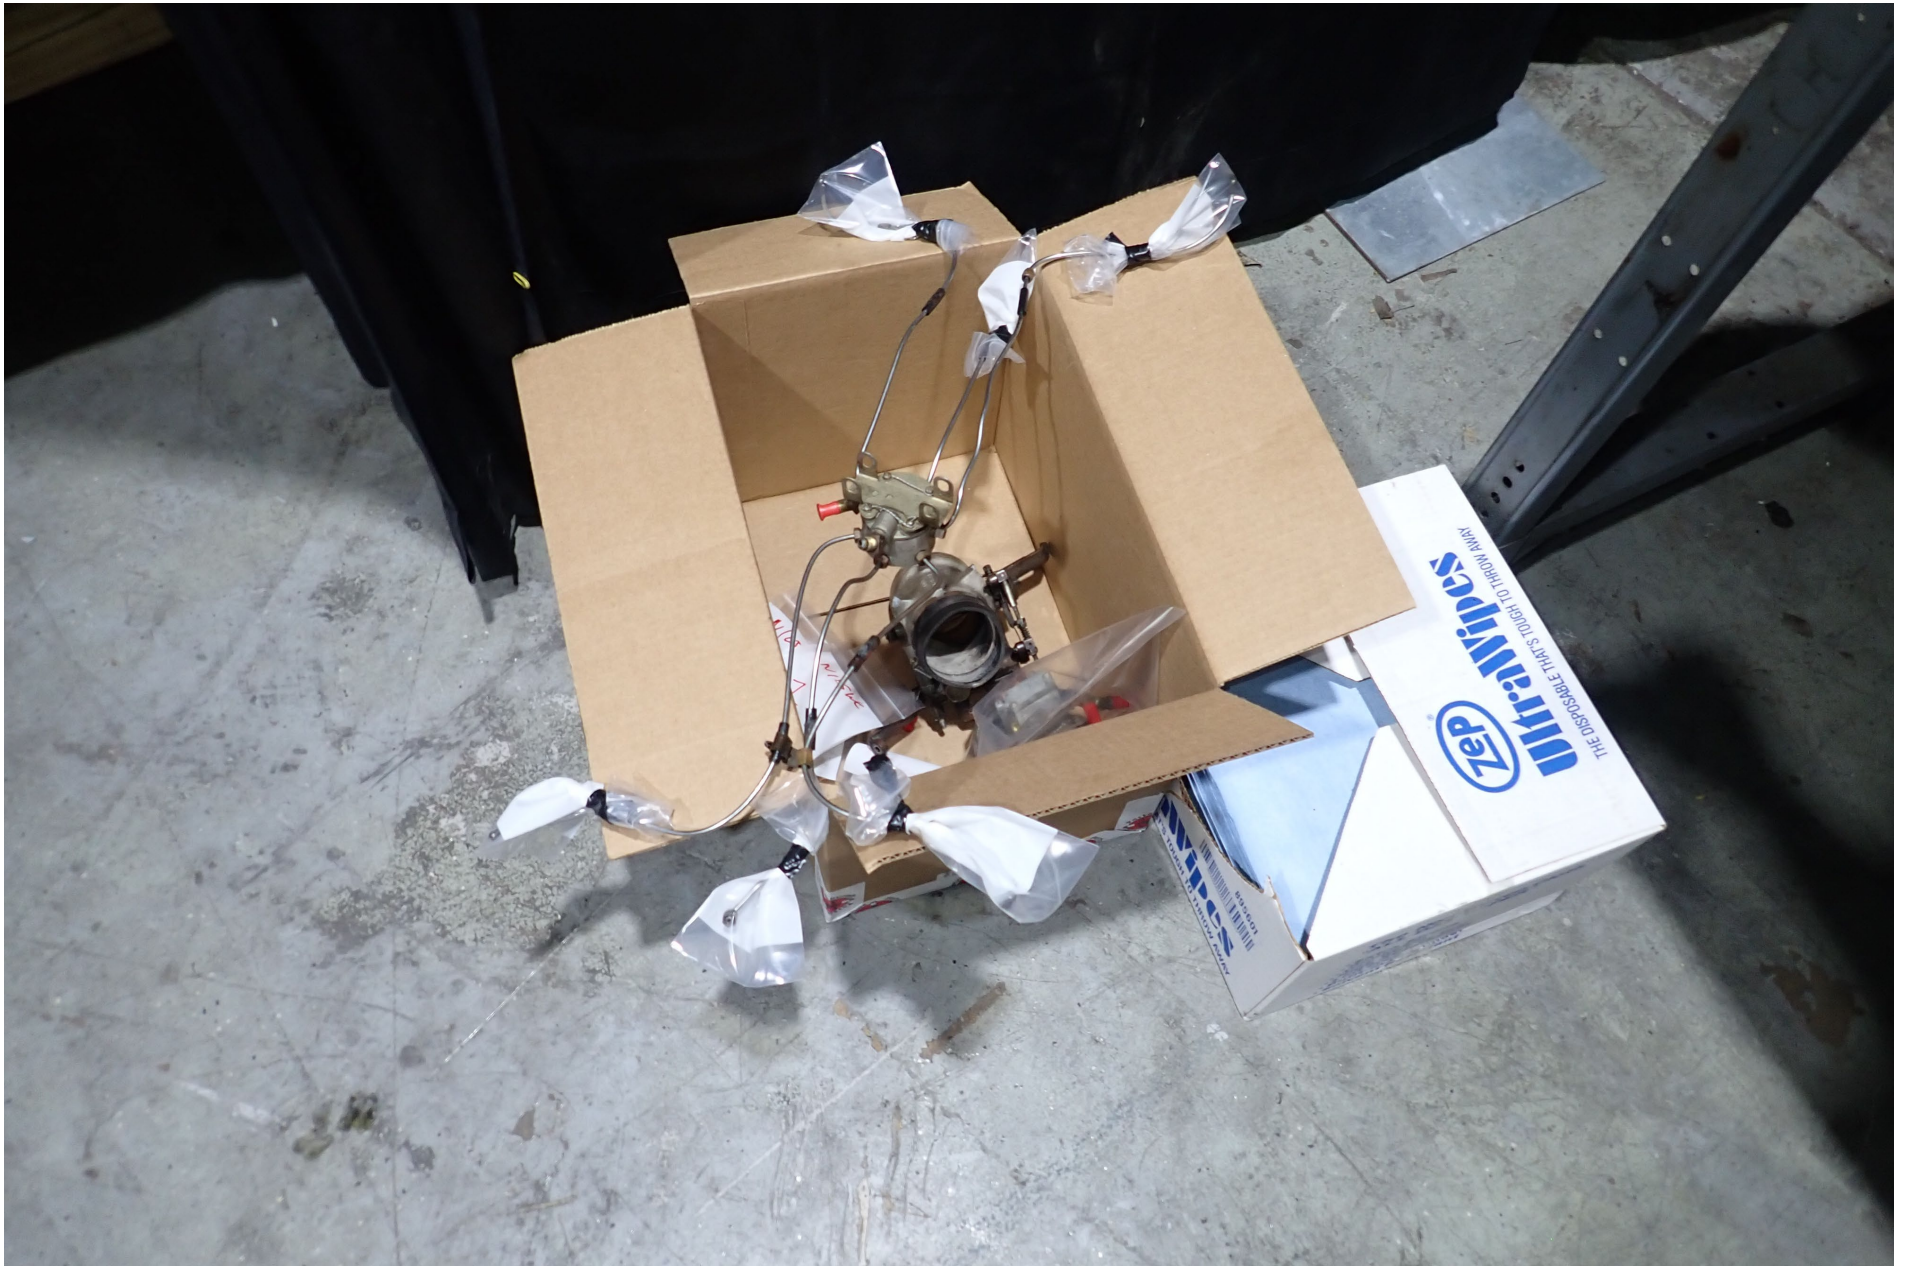
**Photo 7 - Textron Aviation Digital Photograph. View of the NTSB Retained Fuel System Parts for Testing at Continental Aerospace Technologies.**

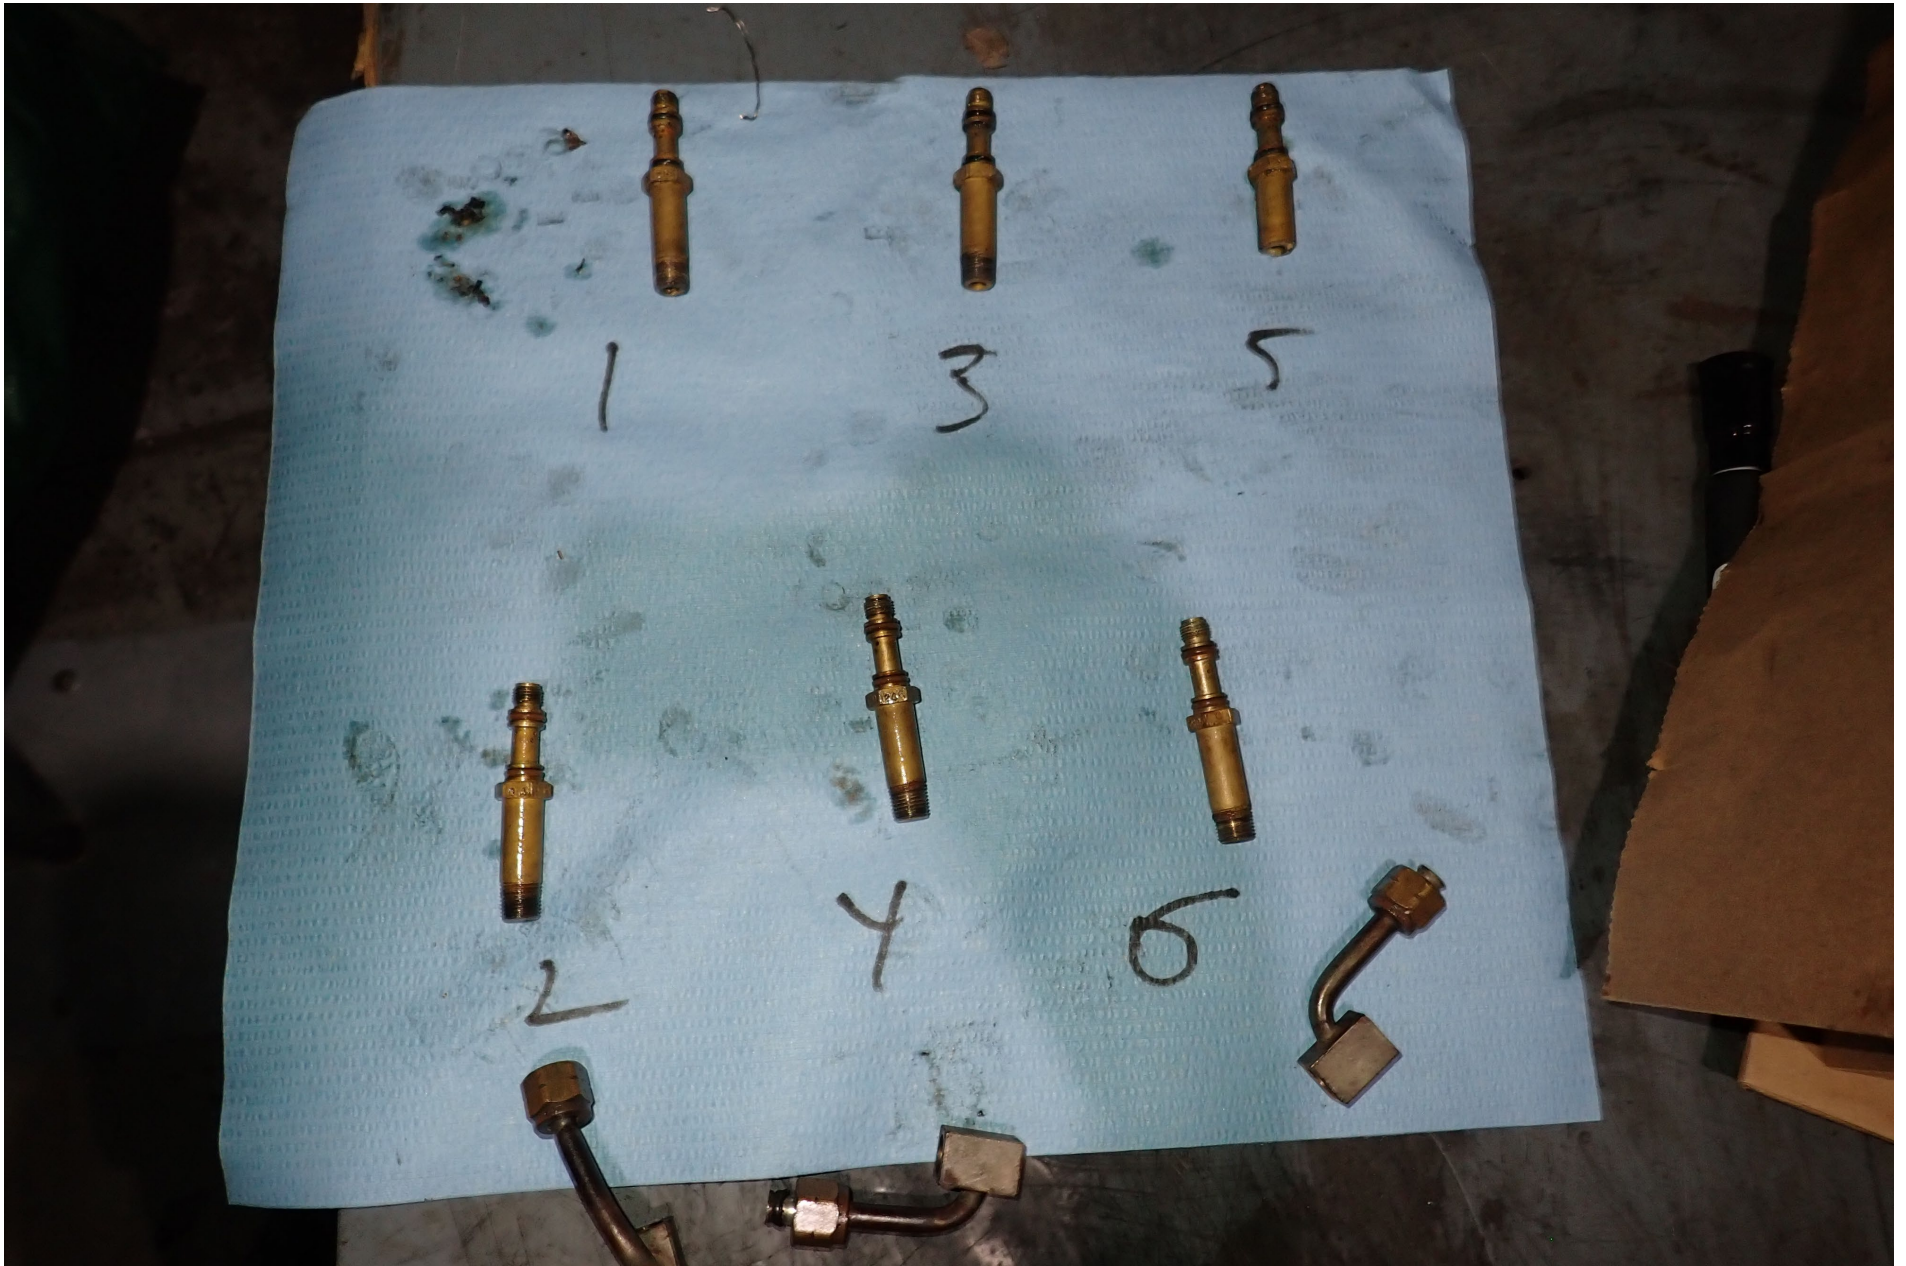
**Photo 8 - Textron Aviation Digital Photograph. View of the Fuel Injector Nozzles.**

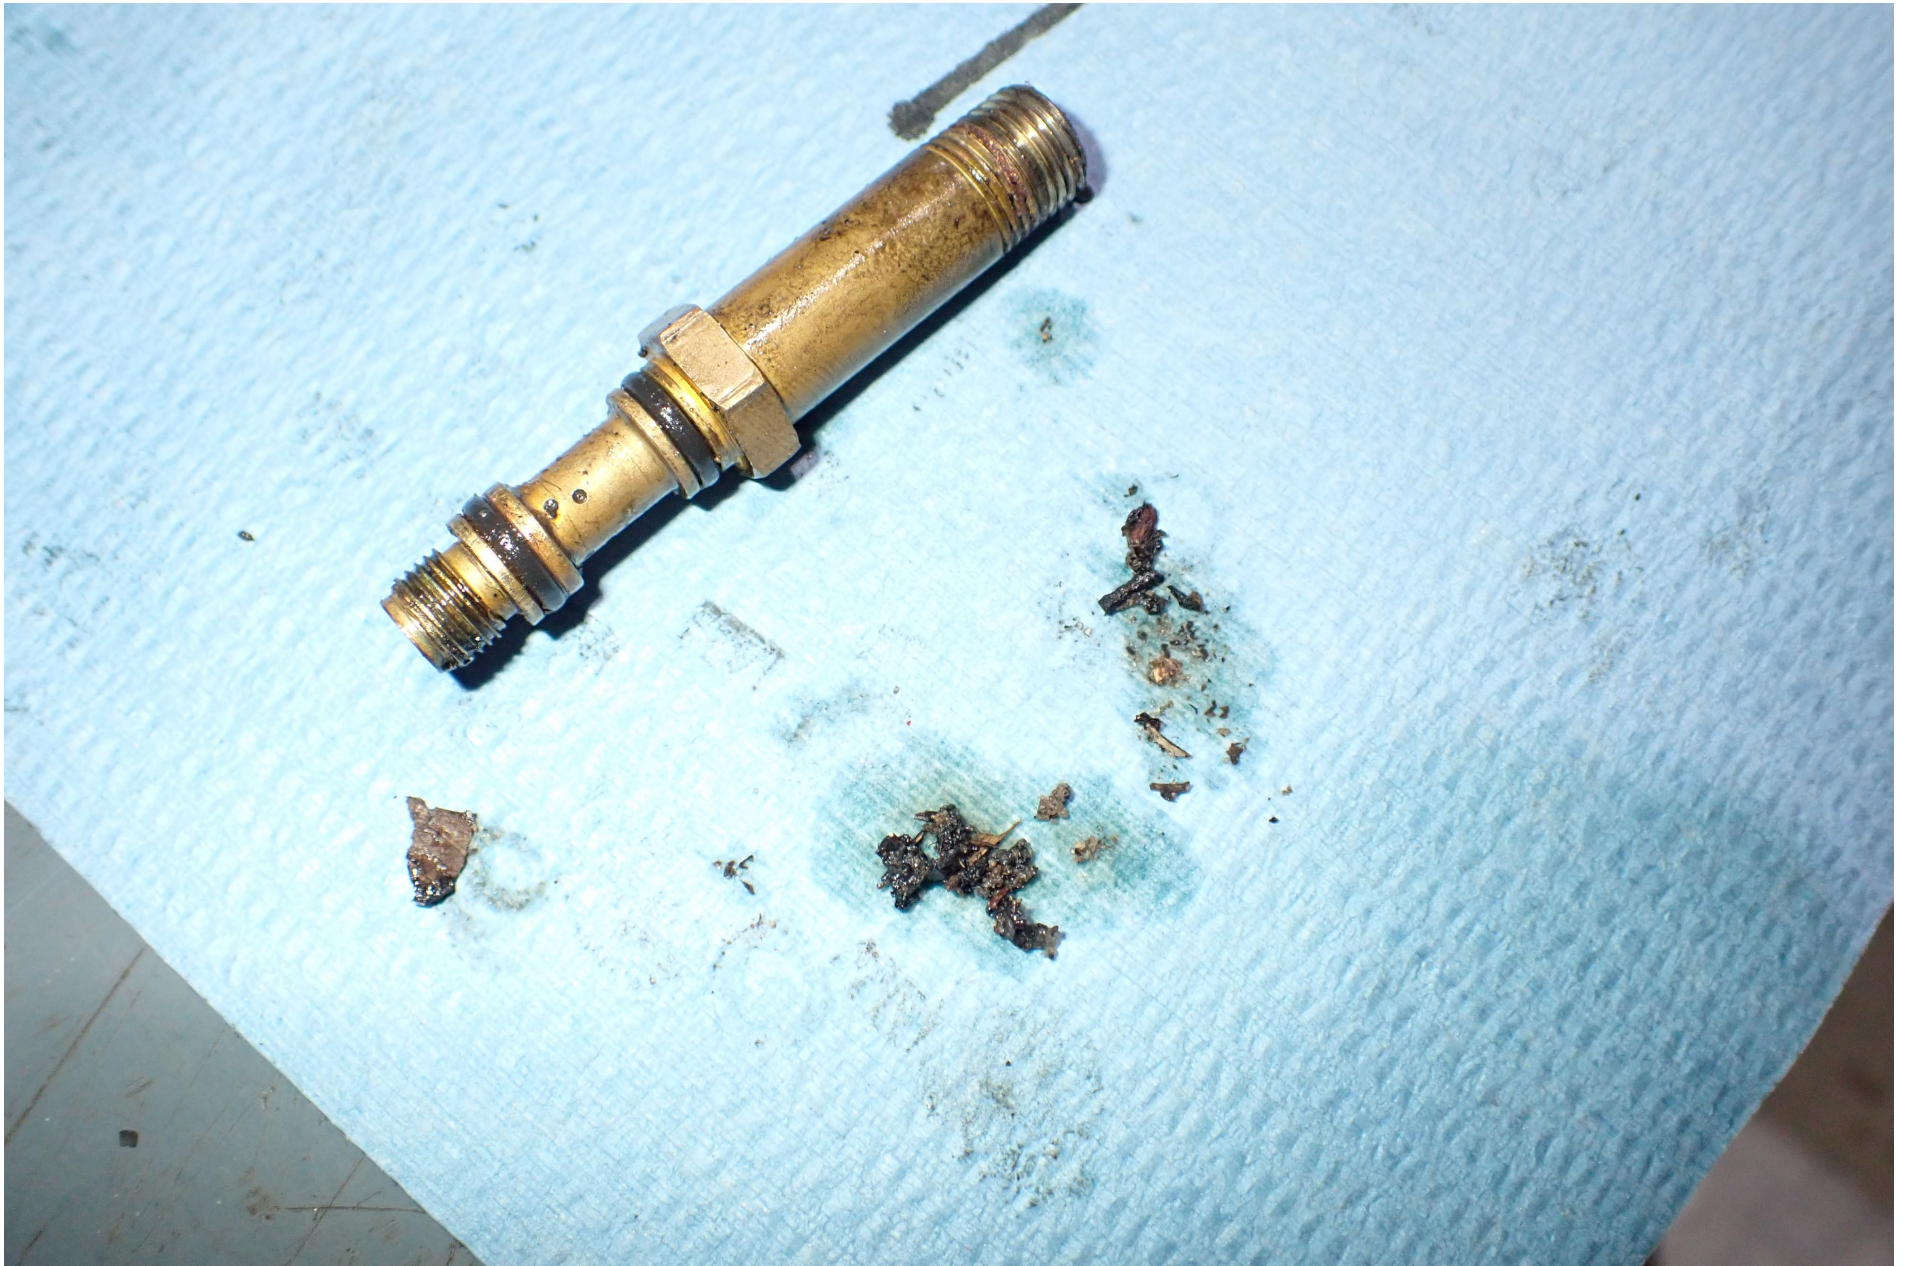
**Photo 9 - Textron Aviation Digital Photograph. View of the Organic Material Removed from the No. 1 Cylinder Fuel Injector Nozzle.**
