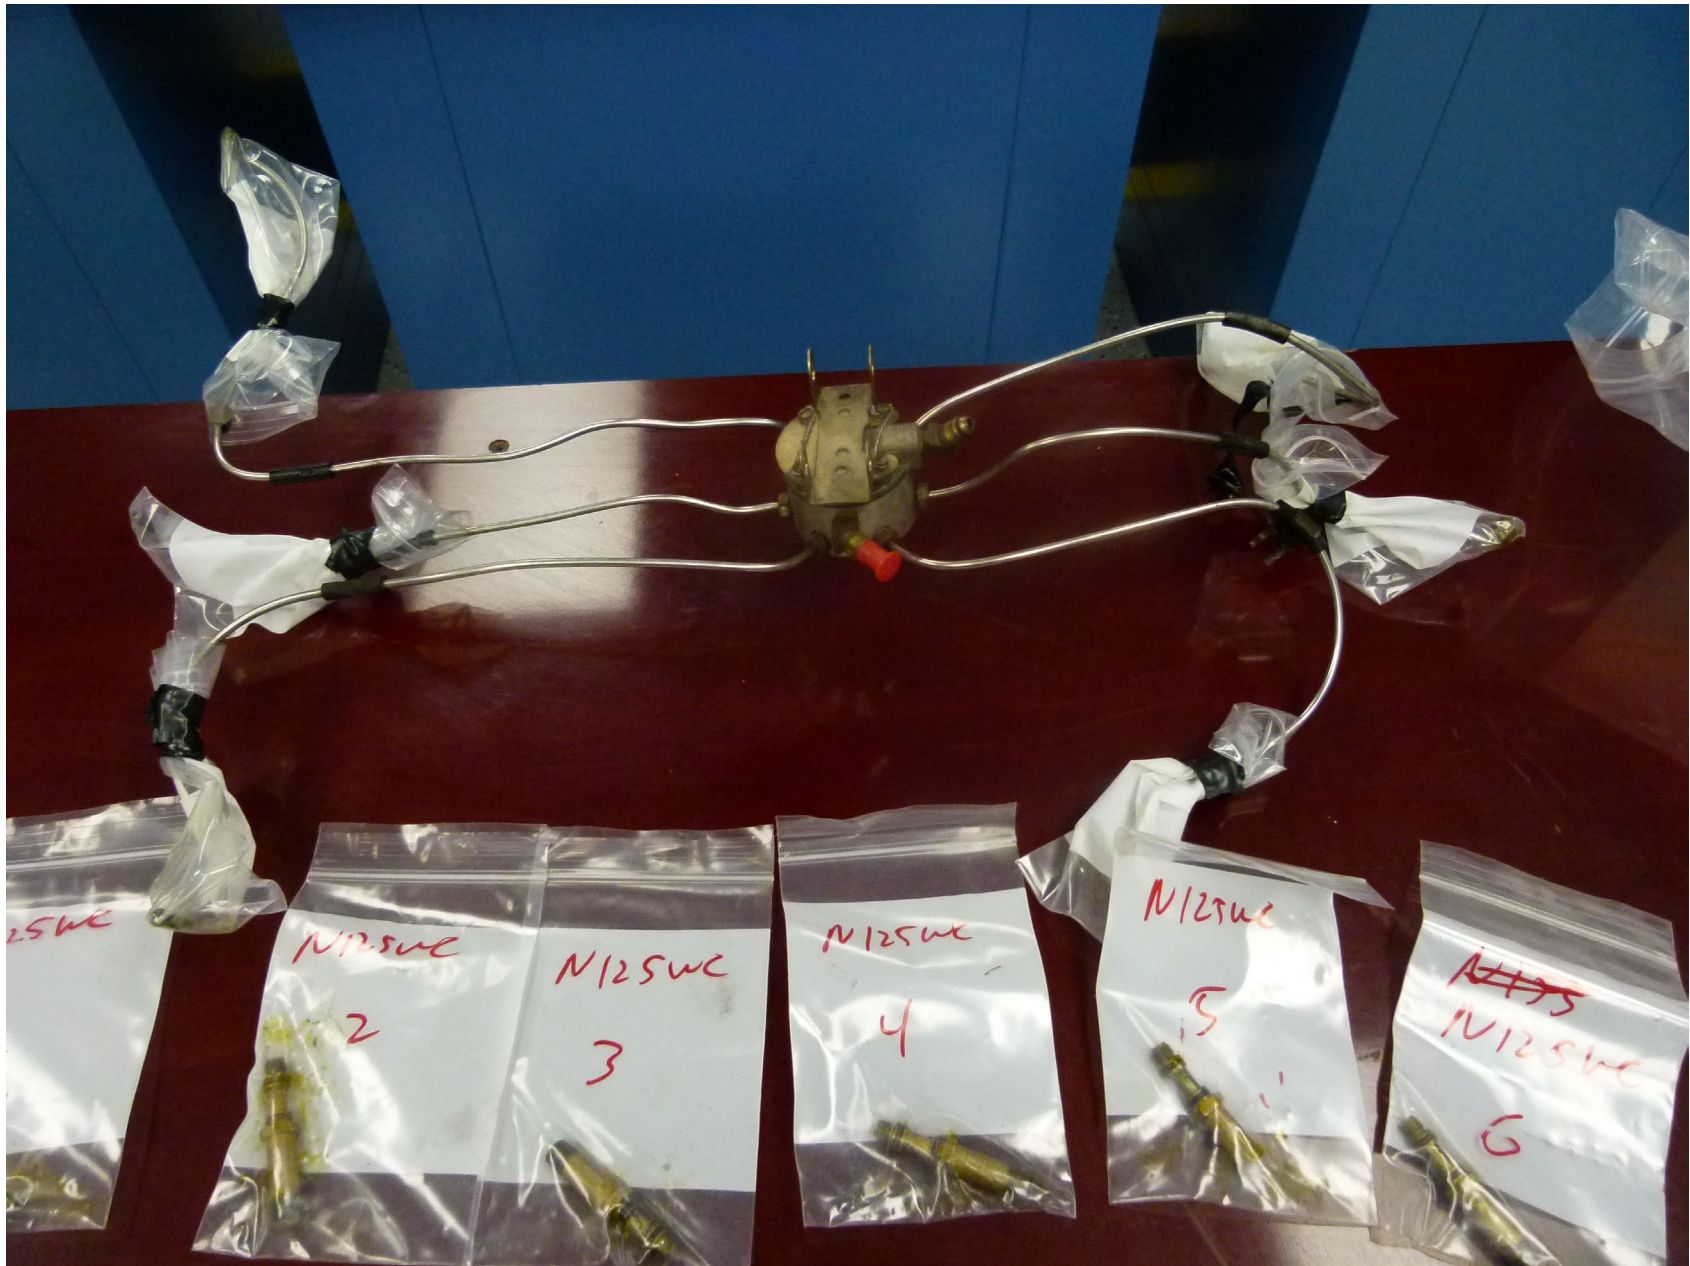
**Photo 10 – Continental Aerospace Technologies Digital Photograph. View of the Manifold Valve or Flow Divider with Attached Fuel Injector Lines and Separated Fuel Injector Nozzles Prior to Testing.**
