## Memorandum For Record

**Timothy W. Monville**  
**Sr. Air Safety Investigator**  
**Eastern Region**

**Date: March 13, 2023**  
**NTSB Accident Number: ERA21LA201**

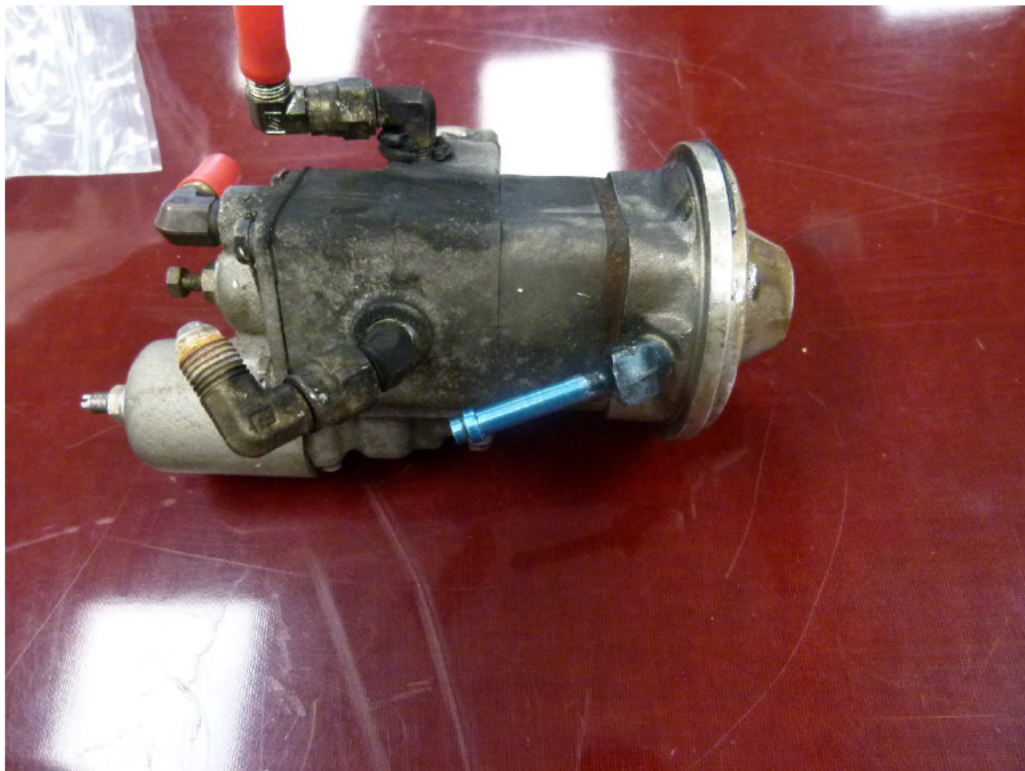
Examination of the engine-driven fuel pump (Figure 2), P/N FT-B8.5/632818-2-11, S/N 104 revealed the main inlet and the vapor return fittings were fractured, and the drive coupling was intact. The fractured fittings were removed and replaced for operational testing. The pump exterior had evidence of soot.

The engine-driven fuel pump was operationally tested as is with no adjustment and the results are included in Attachment 1<sup>1</sup>. During start up fluid flowed from the vapor ejector (normal). Slight leakage was noted from the seal drain. During testing four of the five test points were out of limits. During testing at 2,700 rpm with the aneroid pressure set to about 33 inches of Mercury (inHg) and the fuel flow set to between 198 and 202 PPH, and the supply pressure set to 15.48 psi, the pump discharge pressure was 2.05 psi less than the minimum specified, and the fuel flow was 1.265 PPH greater than the upper limit. During the same testing but with the exception that the aneroid pressure set to about 30 inHg, the pump discharge pressure was 6.35 psi greater than the maximum specified while the fuel flow was within limits. The pump was considered operational though no adjustments were made.

Figure 2: Digital Photograph from CAT. View of the Engine-Driven Fuel Pump As Received.

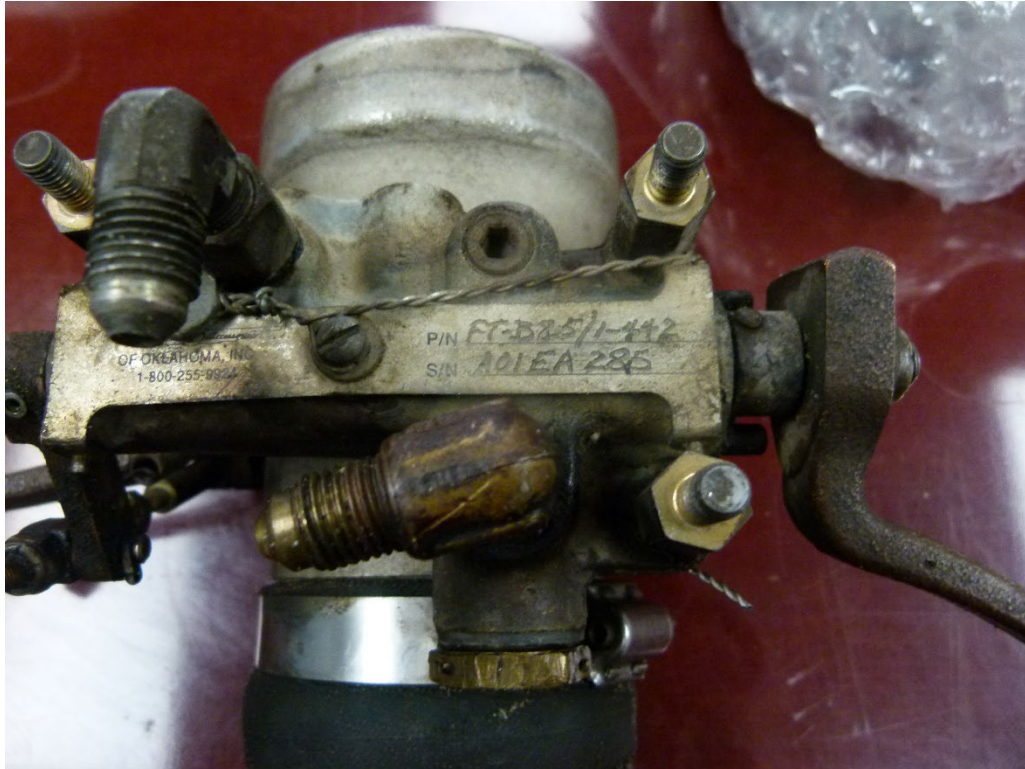
Examination of the Throttle Body and Metering Valve (Figure 3), P/N FT-B8.5/1-442, S/N A01EA285 revealed the mixture return fitting which was impact fractured was replaced with a 90° fitting for bench testing. The unit was heat damaged consistent with the postcrash fire. The nut securing the throttle lever to the shaft of the metering unit was threaded on 1.5 threads. The throttle lever was bent near the attach point at the metering valve from the normal 90° towards 45°. Movement of the throttle lever did not result in movement of the throttle shaft. Brass material transfer from the throttle lever was noted on the shaft. The throttle shaft also appeared bent. The fuel inlet screen was clean.

Figure 3: Digital Photograph from CAT. View of the Throttle Body and Metering Valve.

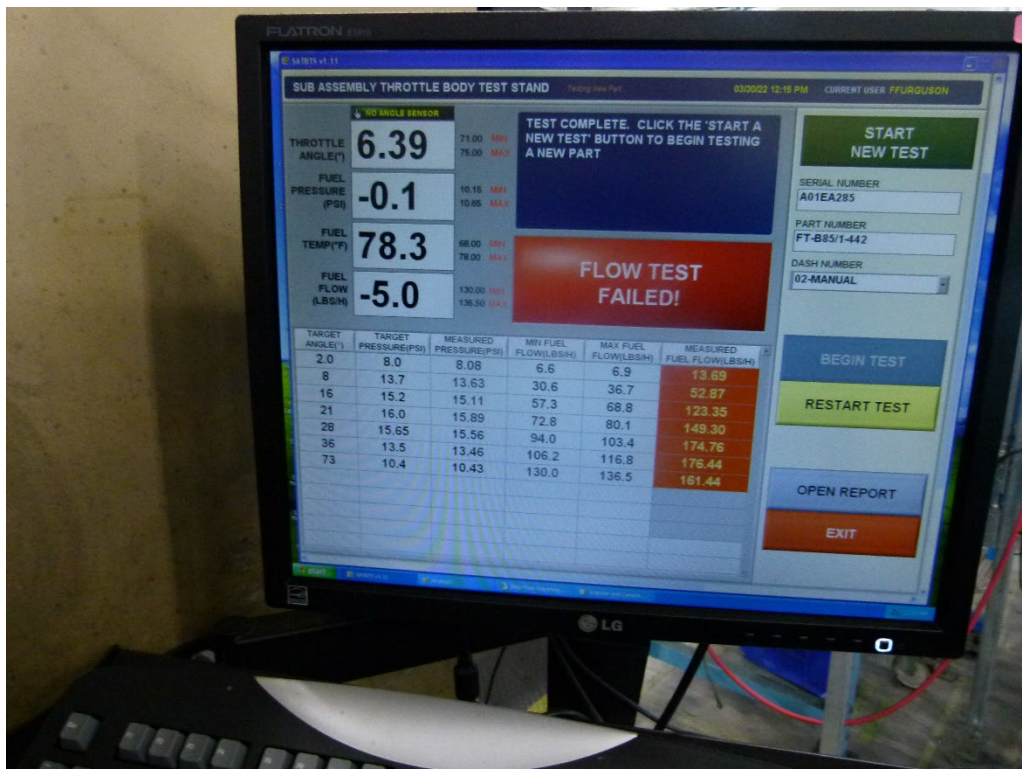
During bench testing of the throttle body and metering valve to a -2 cam, slight leakage was noted at the throttle shaft on the throttle side of the metering unit. The unit flowed high at all test points as noted below and in (Figure 4).

- 2° - Flowed 13.69 PPH (Specification 6.6 to 6.9 PPH)- Too High
- 8° - Flowed 52.87 PPH (Specification 30.6 to 36.7 PPH) - Too High
- 16° - Flowed 123.35 PPH (Specification 57.3 to 68.8 PPH) - Too High
- 21° - Flowed 149.3 PPH (Specification 72.8 to 80.1 PPH) - Too High
- 28° - Flowed 174.76 PPH (Specification 94.0 to 103.4 PPH) - Too High
- 36° - Flowed 176.44 PPH (Specification 106.2 to 116.8 PPH) - Too High
- 73°<sup>2</sup> - Flowed 161.44 PPH<sup>3</sup> (Specification 130.0 to 136.5 PPH) - Too High

Figure 4: Digital Photograph from CAT. View of the Test Results of the Throttle Body And Metering Valve.

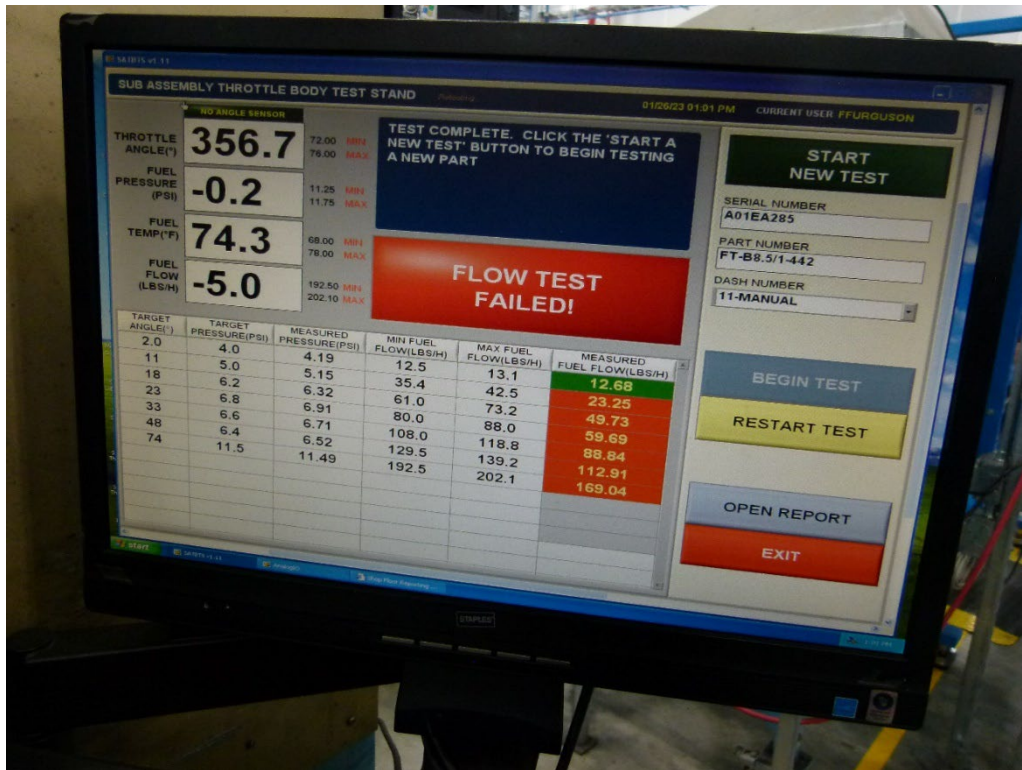
Subsequent testing of the throttle body and metering valve to a -11 cam was performed. The following results were noted at the various throttle shaft/plate angles (Figure 5):

- 2° - Flowed 12.68 PPH (Within Specification)
- 11° - Flowed 23.25 PPH (Specification 35.4 to 42.5 PPH) - Too low
- 18° - Flowed 49.73 PPH (Specification 61.0 to 73.2 PPH) - Too low
- 23° - Flowed 59.69 PPH (Specification 80.0 to 88.0 PPH) - Too low
- 33° - Flowed 88.84 PPH (Specification 108.0 to 118.8 PPH) - Too low
- 48° - Flowed 112.91 PPH (Specification 129.1 to 139.2 PPH) - Too low
- 74°<sup>4</sup> - Flowed 169.04 PPH<sup>5</sup> (Specification 192.5 to 202.1 PPH) - Too low

Figure 5: Digital Photograph from CAT. View of the Throttle Body and Metering Valve Subsequent Test Result to a -11 Cam.

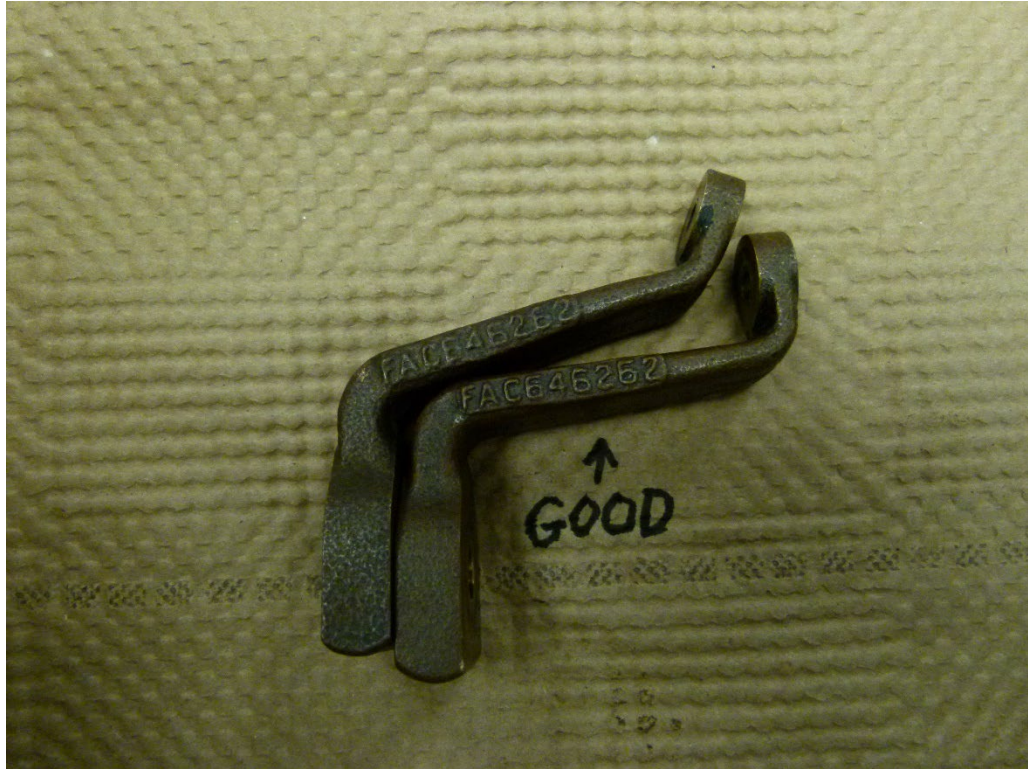
An exemplar throttle lever was obtained and compared with the accident throttle lever. The accident throttle lever was bent near both ends (Figure 6).

Figure 6: Digital Photograph from CAT. View of the Accident Throttle Control Lever on Top and Exemplar Lever on the Bottom. Note the Impact Damage to The Accident Lever Near Both Ends.

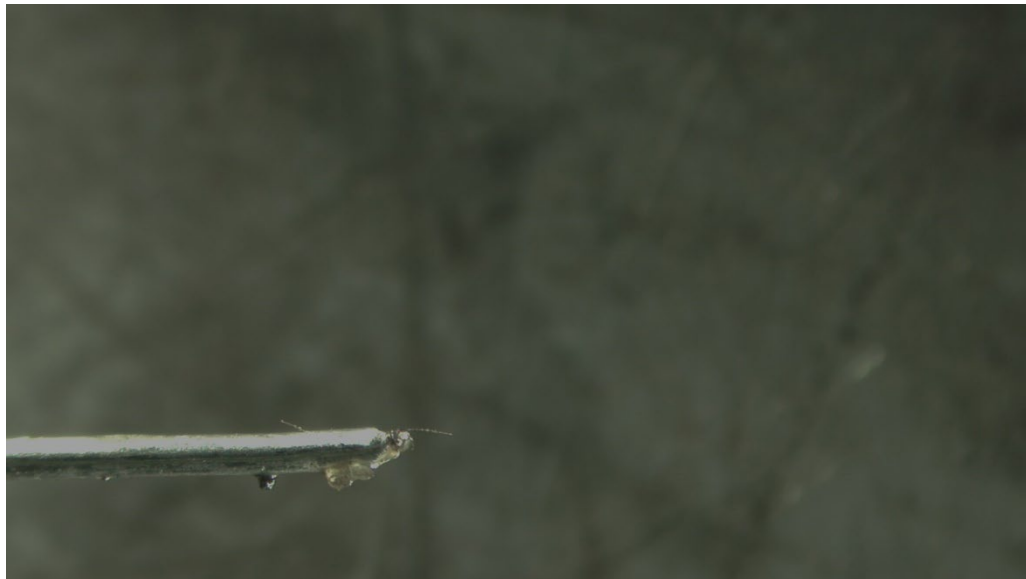
No. 1 nozzle - Appeared to have some foreign debris inside<sup>6</sup>. A small diameter stainless steel safety wire was pushed through, and the material was captured. It was placed under a microscope and appeared to be the diameter of a hair (Figure 7).

Figure 7: Microscope Image From CAT. View of the Debris removed from the No. 1 Fuel Injector Nozzle. The horizontal component holding the object is a piece of safety wire no more than 0.032 inch in diameter.

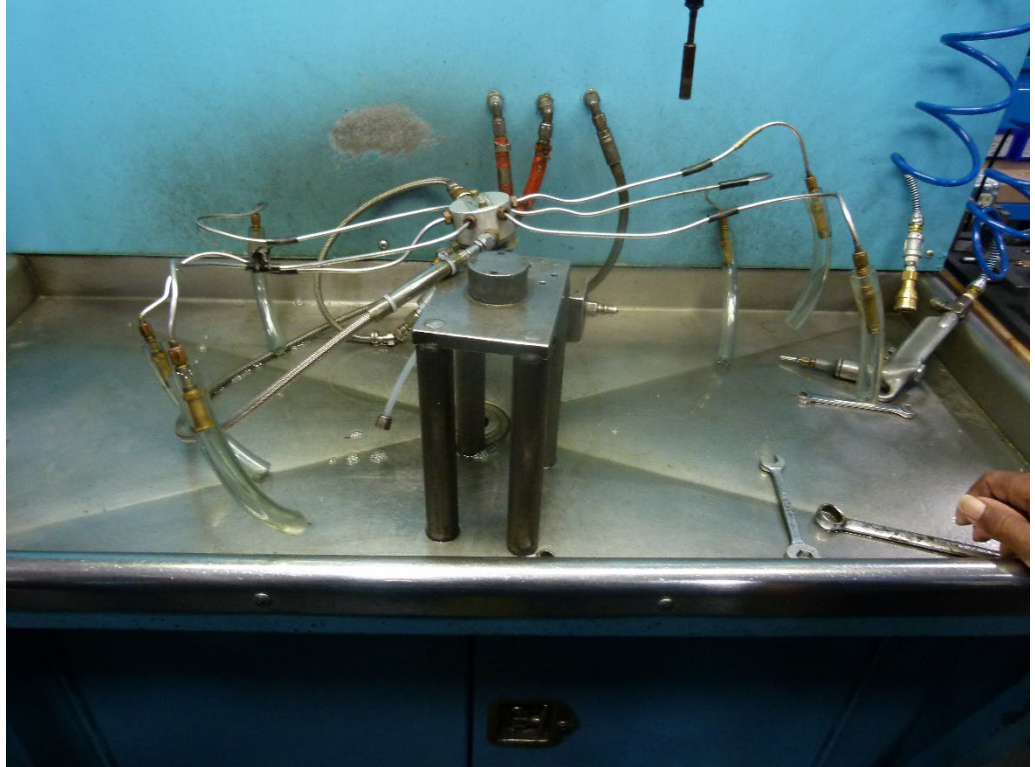
The manifold valves with attached lines and nozzles were tested to production limits (Figure 8). The flow from all nozzles appeared equal. The No. 1 nozzle was flowed separately, and the pressure was low; the machine automatically sets the pressure. The fuel injector line for the No. 3 cylinder was slightly kinked at the nozzle connection.

The machine operator manually adjusted the test points and the manifold valve spool did not open at 4.1 psi as specified, rather, it opened at 4.2 psi<sup>7</sup>.

Figure 8: Digital Photograph from CAT. View of the Testing of the Manifold Valve Injector Lines and Injector Nozzles.
