# National Transportation Safety Board

ERA21LA208

## **AIRWORTHINESS AND SYSTEMS FACTUAL REPORT**

Location: Ridgeland, South Carolina  
Date: May 5, 2021  
Time: 1033 Local  
1433 UTC  
Airplane: Israel Aerospace Industries LTD Gulfstream G150, N22ST

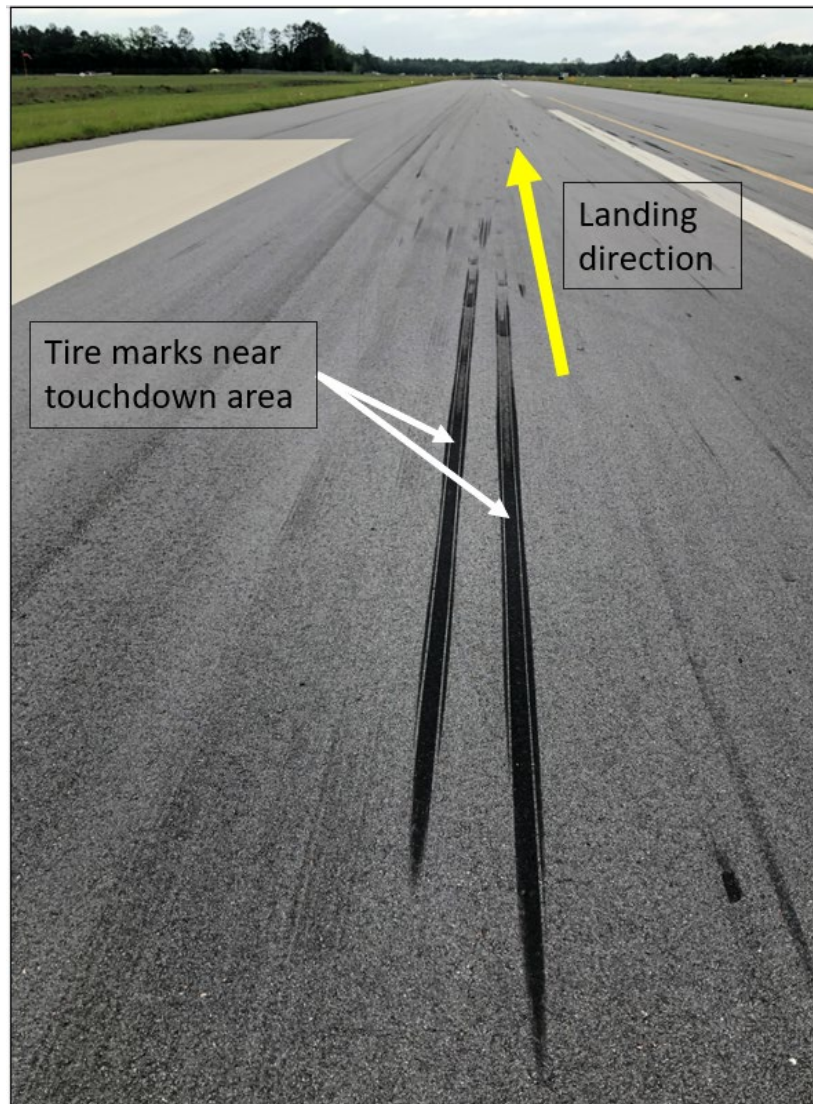
Tire marks located on the runway were measured and correlated to the accident airplane's main landing gear orientation and tire width. Initial touchdown tire marks showed that the airplane landed approximately 1000 -1200ft down the runway, near taxiway alpha 4 (A4). Symmetrical tire tracks were visible down a large percentage of runway.

**Figure 2: Overview of tire marks on runway**

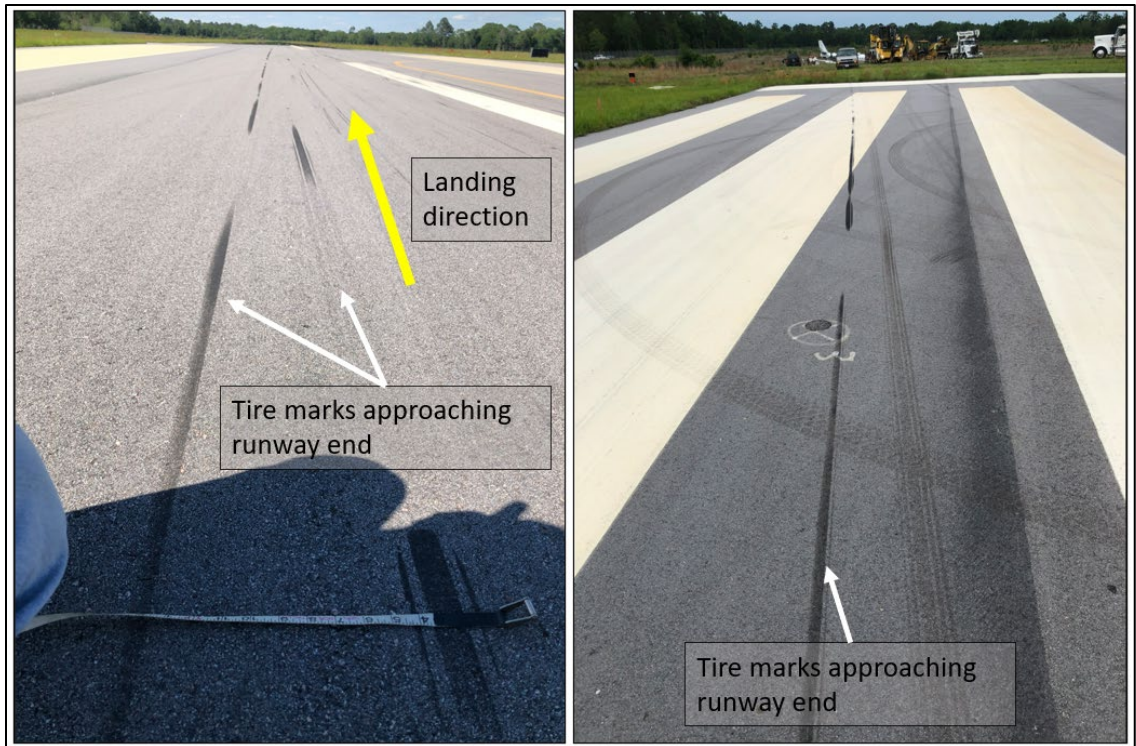
The majority of tire tread marks were viewed to be light and were not consistent with heavy braking or anti-skid operation, until the tracks reached the taxiway alpha 2 (A2) area about 1,000 ft from the end of the runway. Heavy braking tire marks were observed for about 50 ft in length in this area. The second area of heavy braking was identified at the runway identification numerical markings for runway 18 continuing off the runway. Tire marks consistent with heavy braking and anti-skid intermittent braking tire marks were observed.

**Figure 3: Overview of tire marks on runway.**

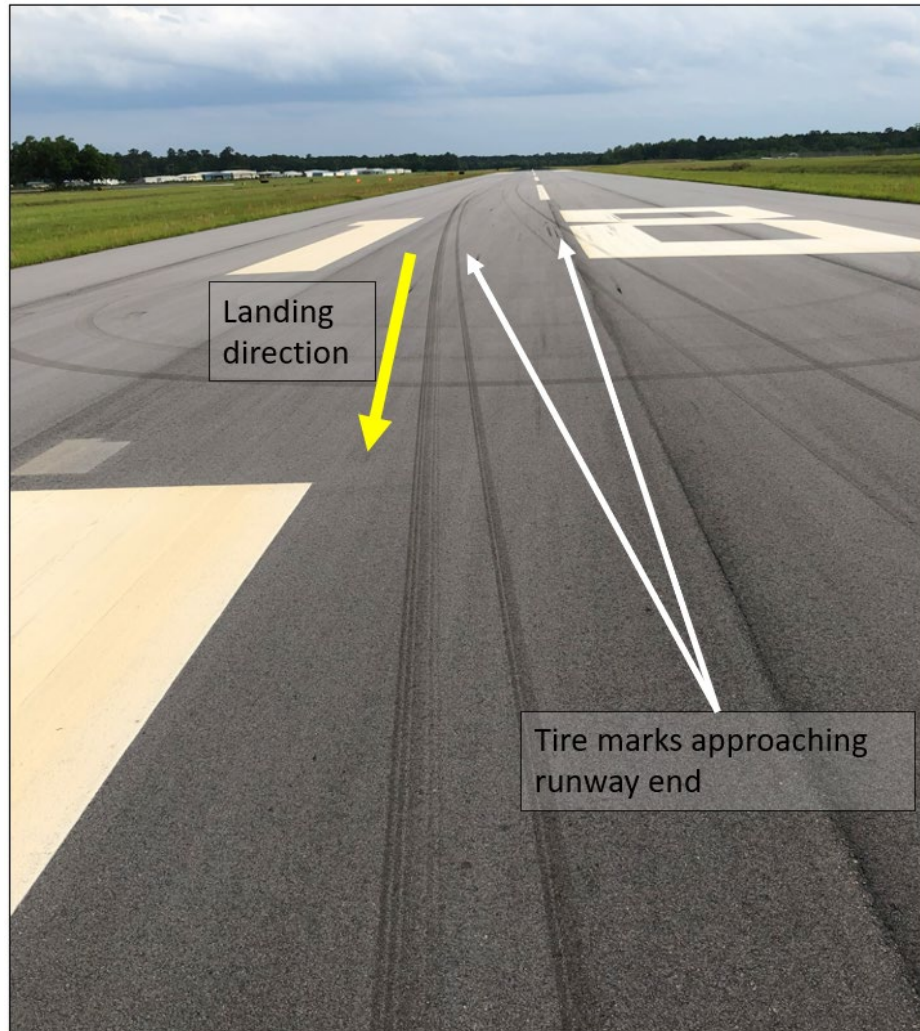
**Figure 4: Overview of tire marks on runway.**

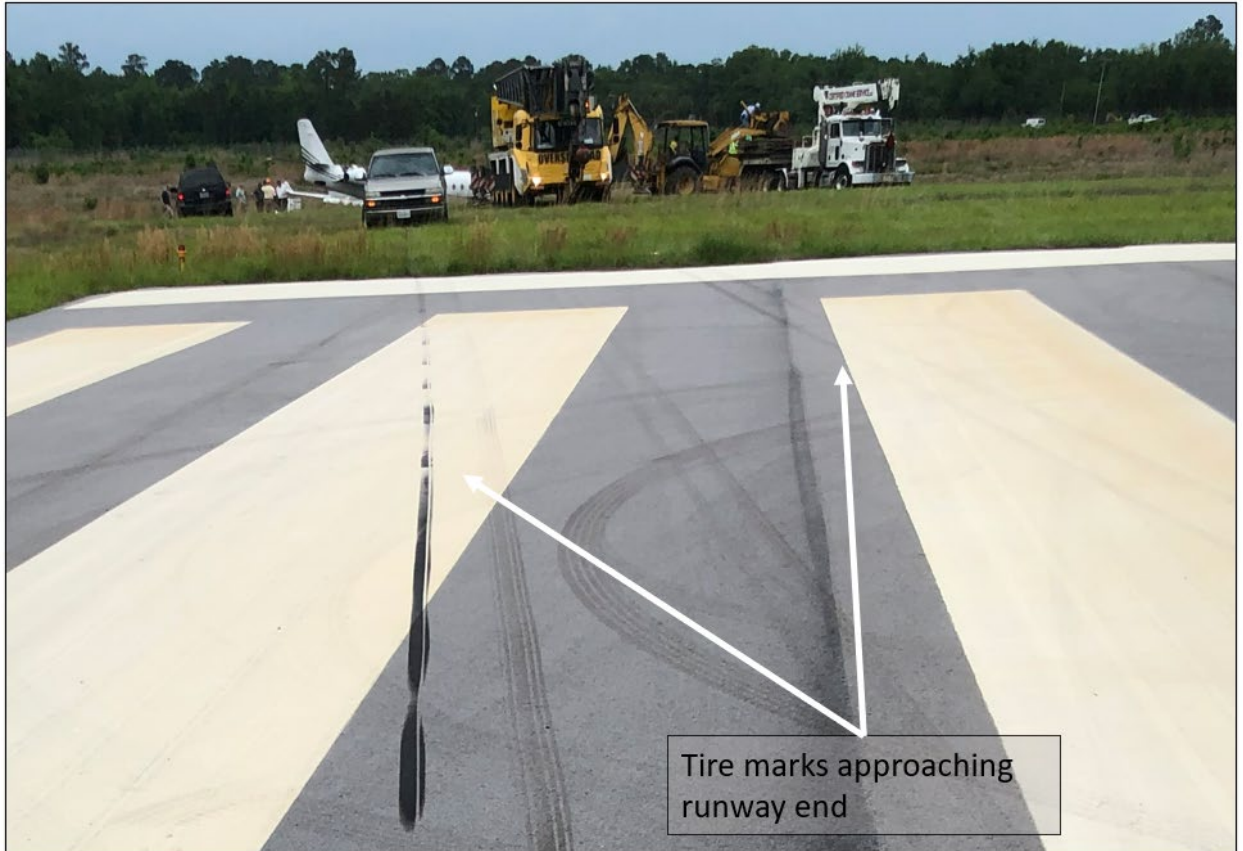
**Figure 5: Tire marks approaching runway end.**

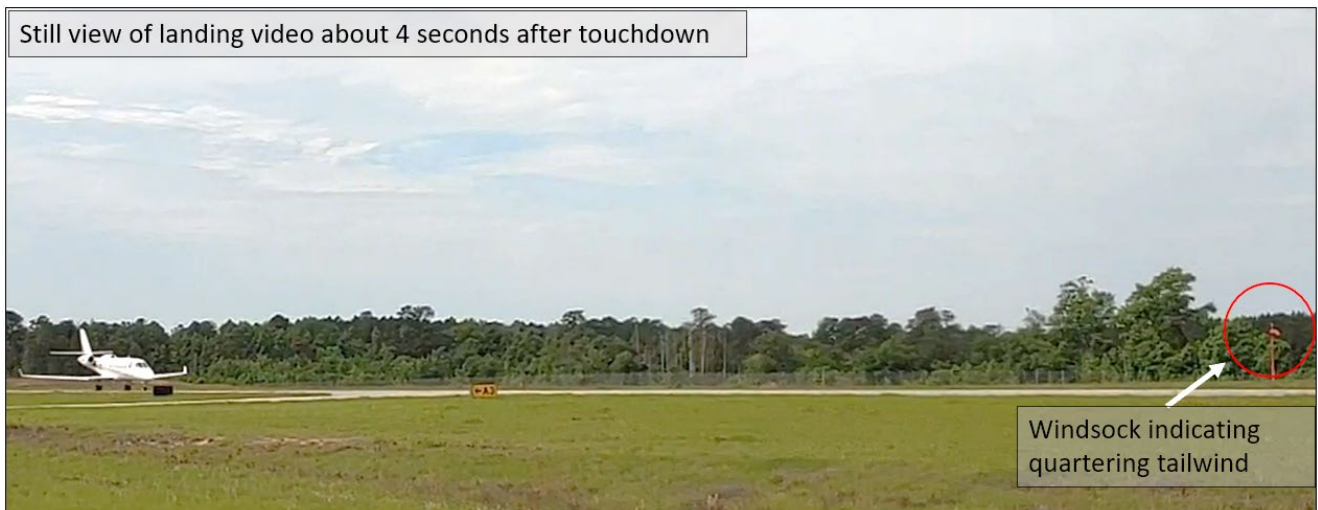
When the airplane touched down, smoke was briefly observed to emanate from the main landing gear tires. About four seconds after touchdown, the airport's windsock comes into view. The windsock while in camera view throughout the ground roll indicated a quartering tailwind at varying speeds. At moments, the windsock was nearly fully extended.

**Figure 6: Still view of landing video about 4 seconds after touchdown.**

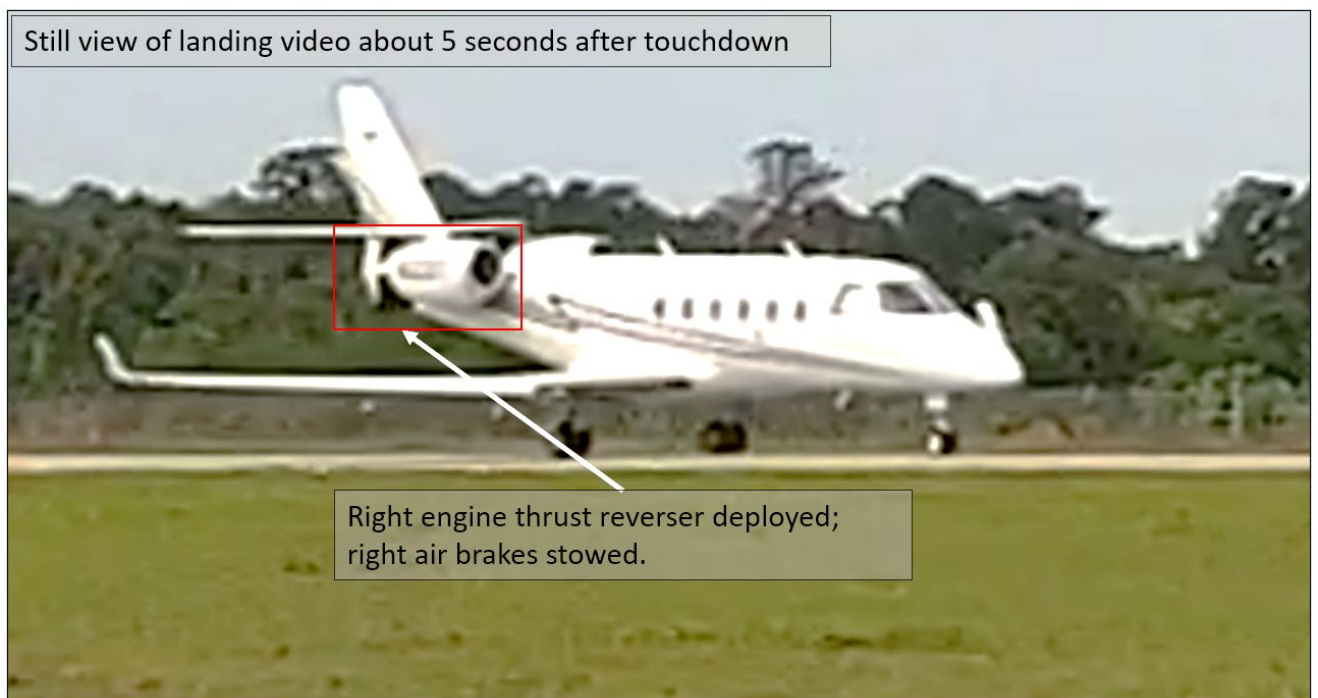
About five seconds after touchdown, the right engine came into view and the thrust reverser was observed to be deployed. The video captured sound that was consistent with engine thrust reversers deploying. The left engine thrust reverser did not come into view until 11 seconds after touchdown, and it was observed to be deployed. Throughout the entirety of the landing roll, the air brakes were not observed to deploy on either wing.

**Figure 7: Still view of landing video about 5 seconds after touchdown.**

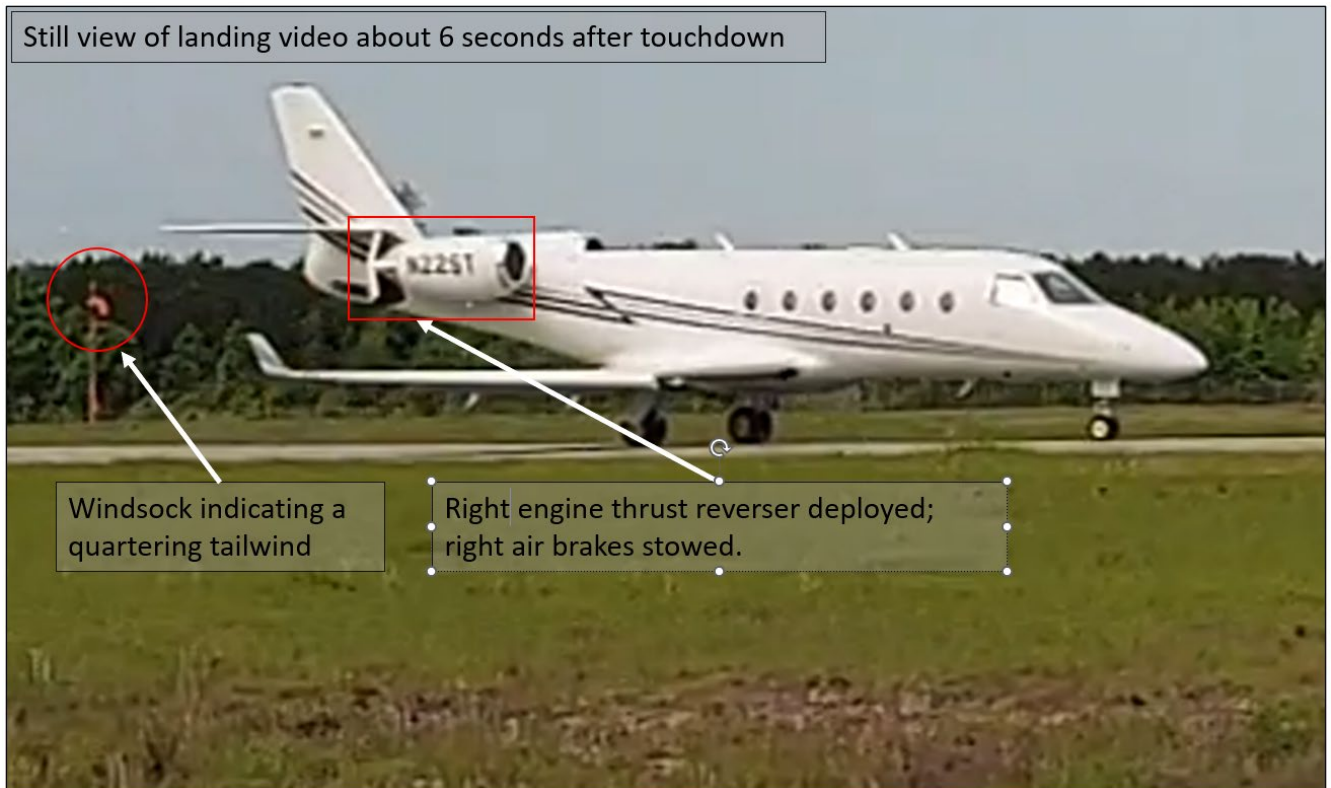
**Figure 8: Still view of landing video about 6 seconds after touchdown.**

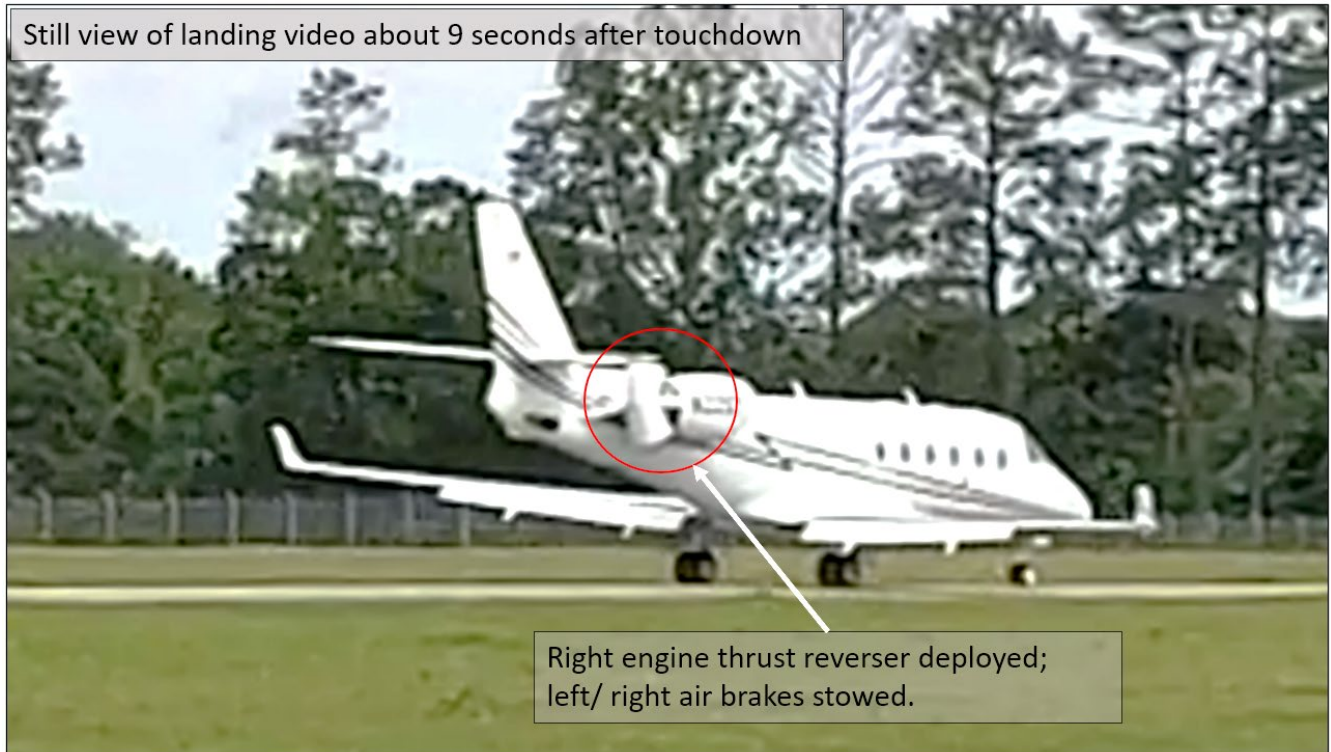
**Figure 9: Still view of landing video about 9 seconds after touchdown.**

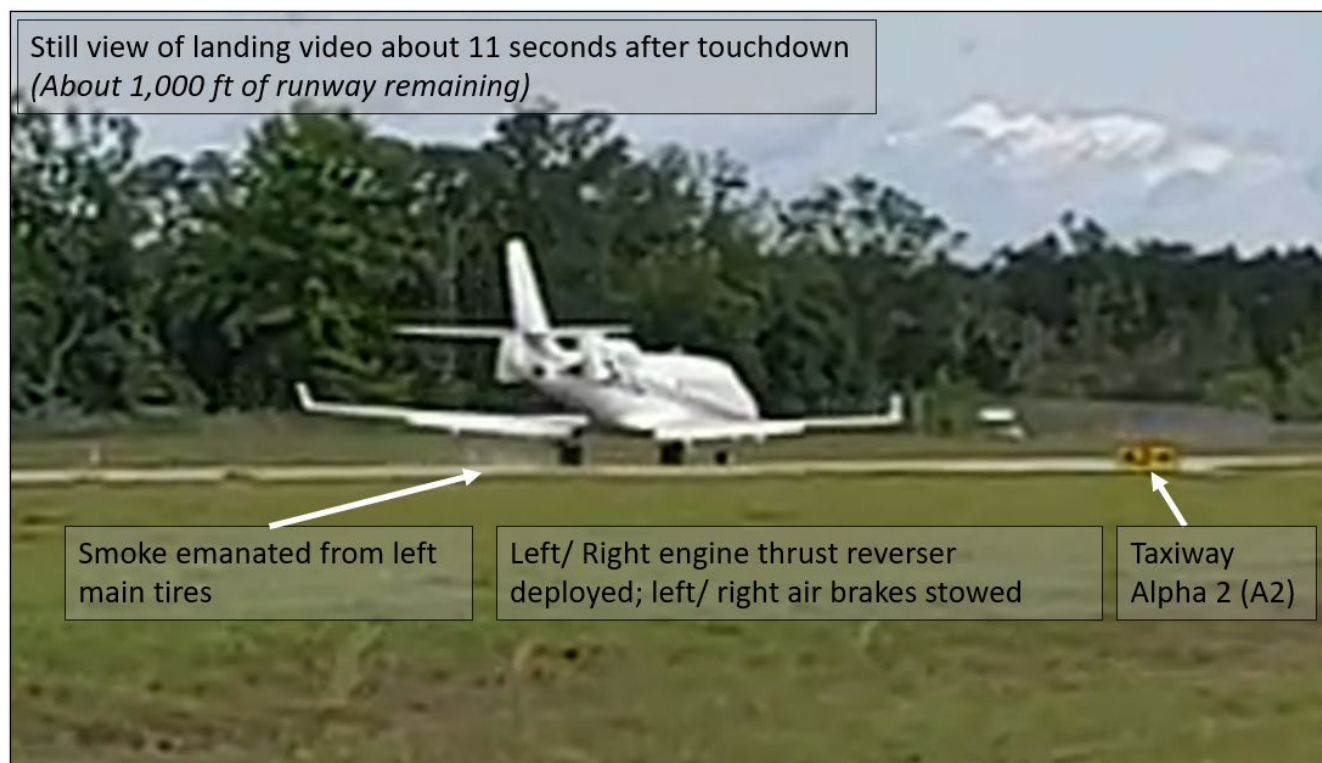
**Figure 10: Still view of landing video about 11 seconds after touchdown (About 1,000 ft of runway remaining).**

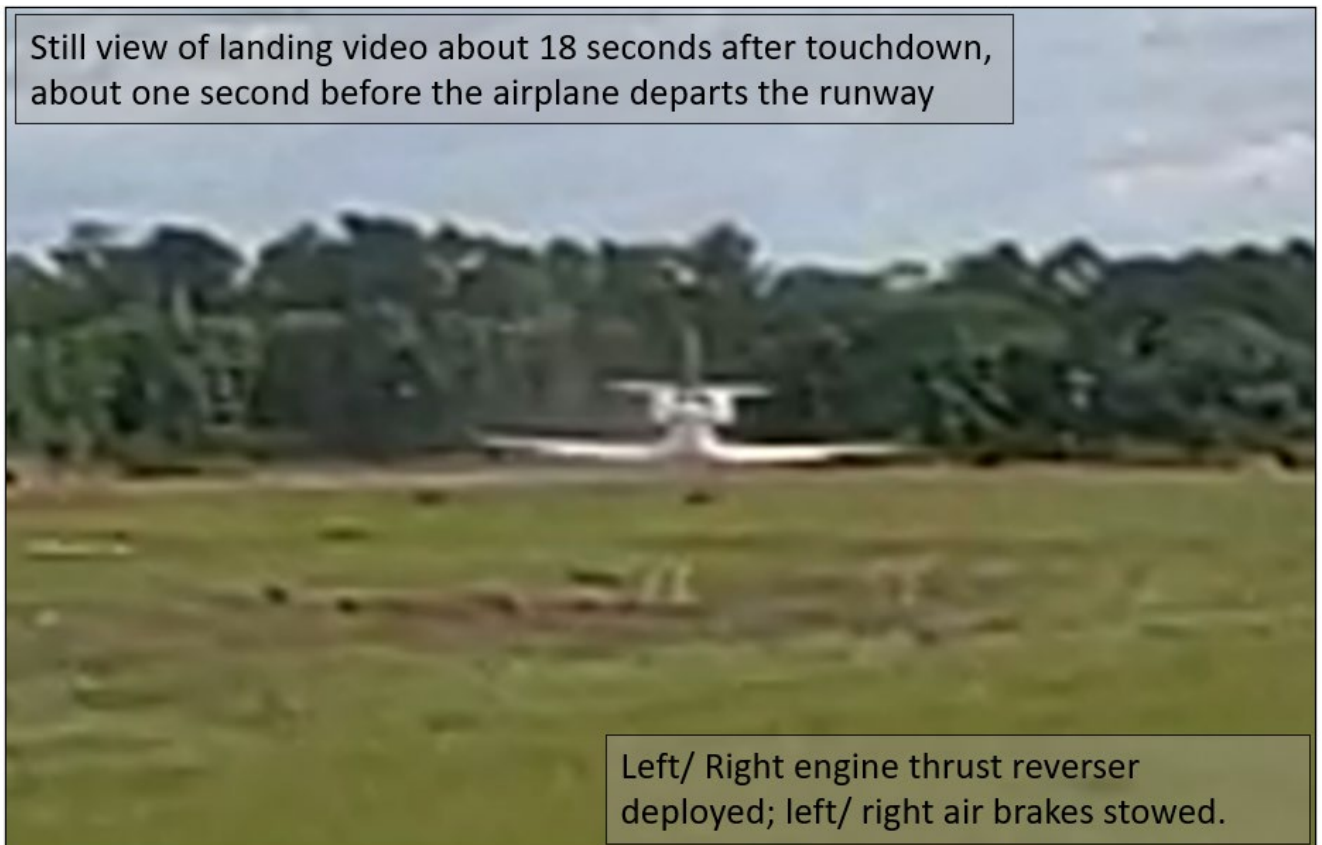
**Figure 11: Still view of landing video about 18 seconds after touchdown, about one second before the airplane departs the runway.**

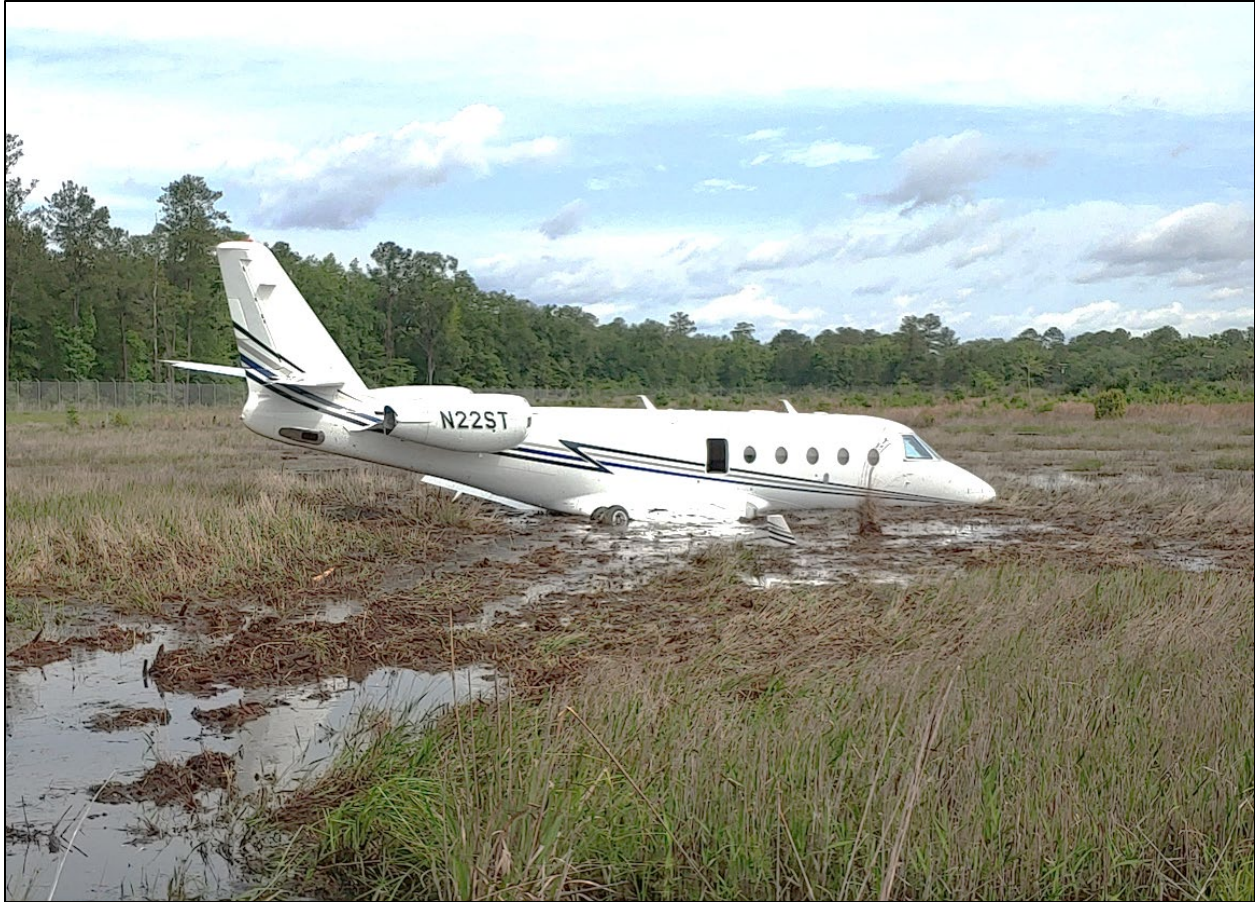
The airplane landed on runway 36 at 3J1 airport and subsequently came to rest about 400 ft past the end of runway 36 in marshy and wet terrain. The airplane sustained substantial damage to the wings and fuselage. Runway 36-18 was an asphalt runway measuring 4,200 ft long and 75 ft wide at an elevation of 85 ft. A precision approach path indicator (PAPI) with a 3° glidepath was located on the left side of the runway and a windsock<sup>3</sup> was located near the middle of the runway.

**Figure 12: View of the airplane at the accident site.**

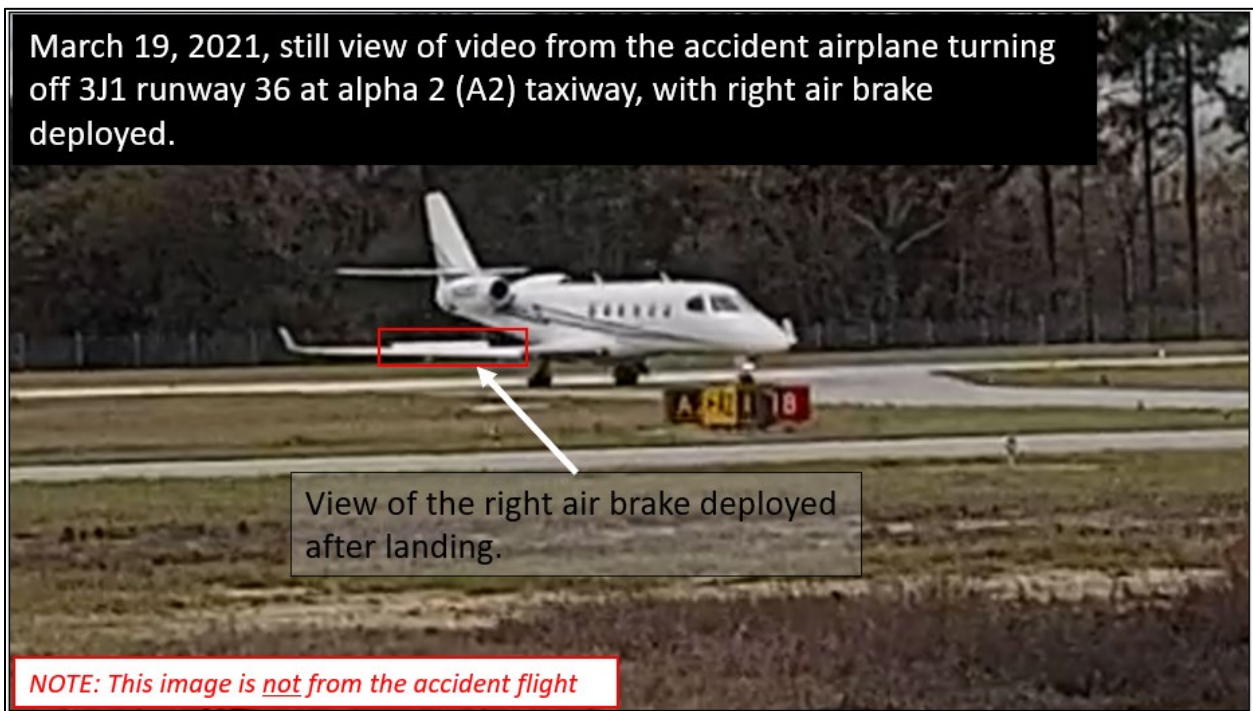
**Figure 13: March 19, 2021, still view of video from the accident airplane turning off 3J1 runway 36 at alpha 2 (A2) taxiway after landing, with air brakes deployed.**

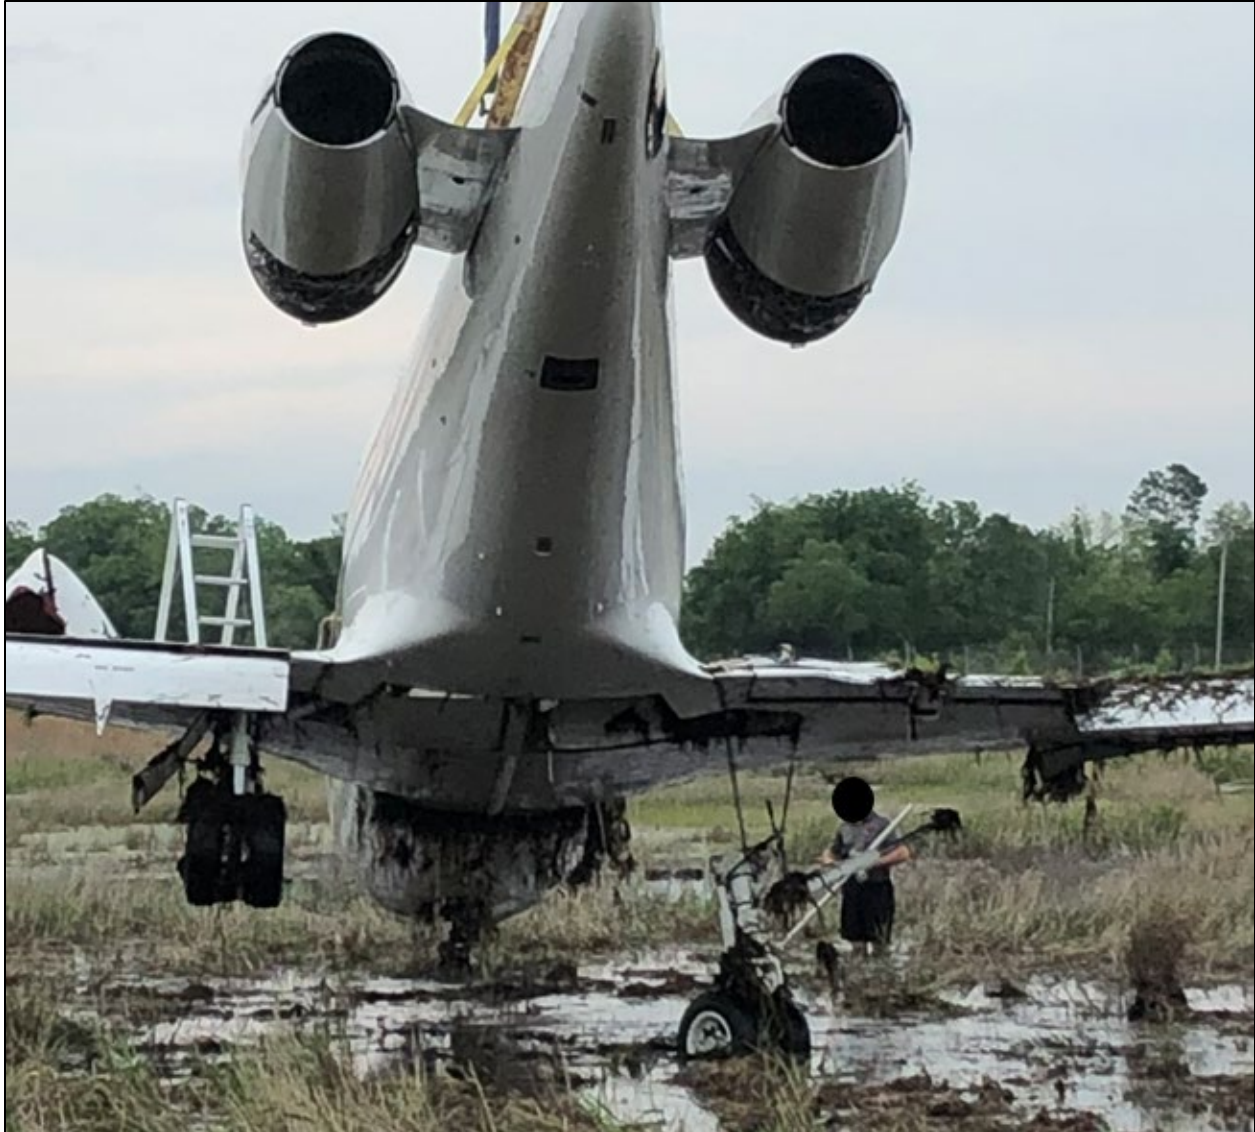
The nose gear appeared folded under the aircraft and the nose gear tires were detached from the gear. The left main landing gear (MLG) and doors remained intact. The right MLG was sheared from the airplane and only remained attached to the aircraft via one wire electrical harnesses and two flexible hydraulic lines.

**Figure 14: View of the left and right MLG as viewed during the recovery operation.**

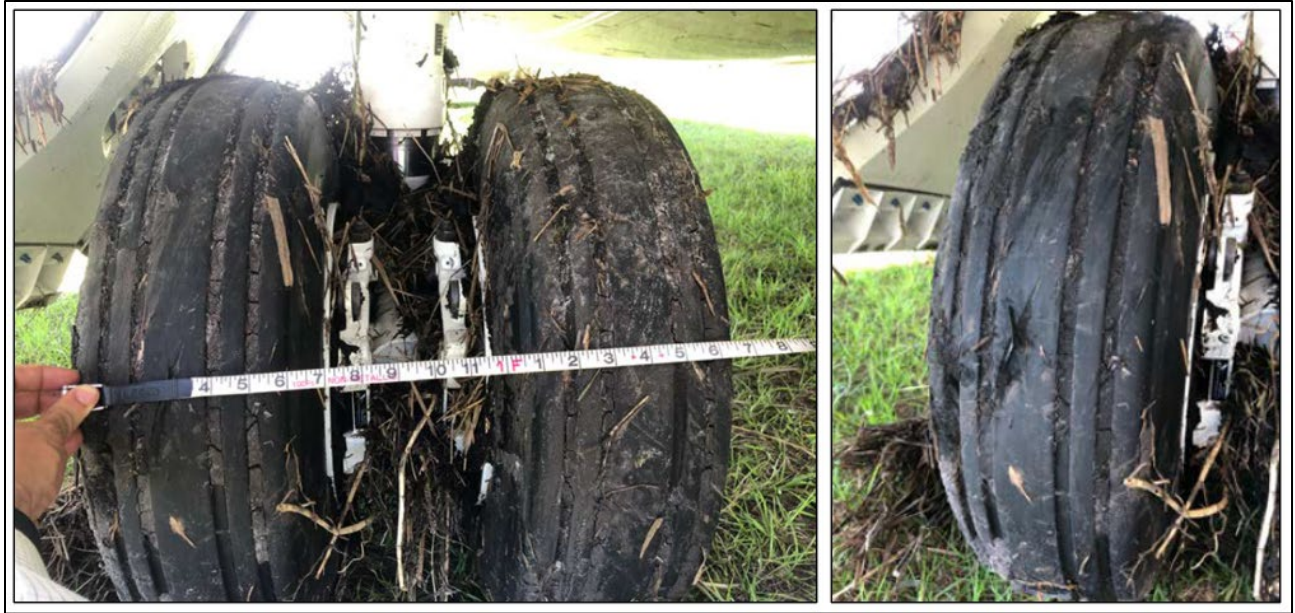
**Figure 15: Views of the left MLG post-recovery.**

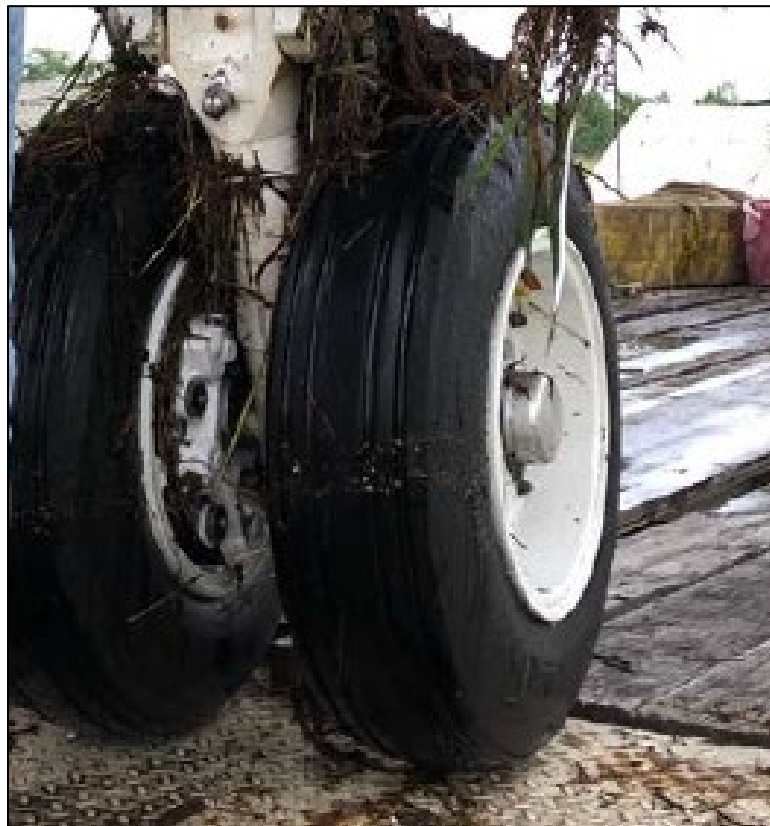
The right MLG wiring harness for the Weight on Wheels (WOW) switch and wheel speed sensors were found disconnected. Visual inspection indicated no obvious damage to the wire harness connector. Further inspection at the accident site found that the airplane's connector bayonets were sheared consistent with the connector detaching during the runway departure.

The main hydraulic reservoir sight glass was viewed to be empty. No fluid was observed on the runway. Note, the right MLG hydraulic lines were sheared during the runway excursion which compromised the hydraulic system and its ability to retain fluid. The auxiliary hydraulic reservoir was found full, and the accumulator had pressure one day after the accident.

**Figure 16: View of the right MLG post-recovery.**

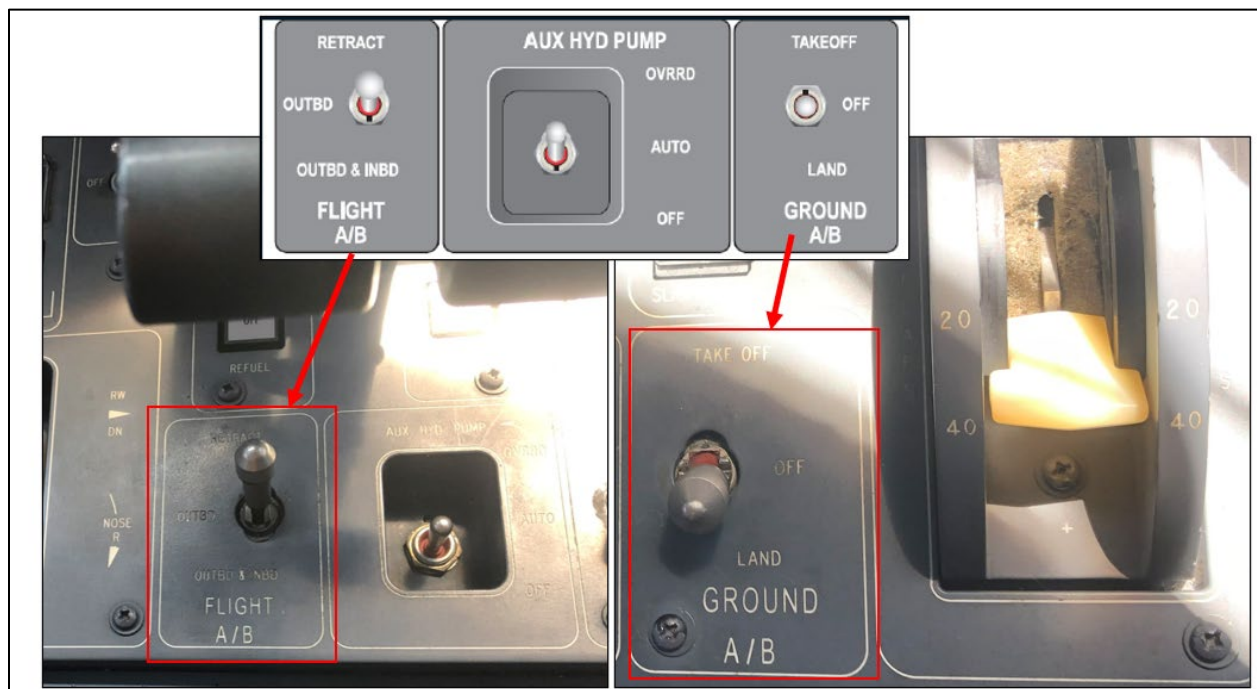
The flap selector was found set to flaps full 40°. The air brake switches as found were as follows: The flight A/B switch was found set to the retract position and the ground A/B switch was found set to land. The air brake switches when tested with an electrical multimeter at the accident site both produced normal currents.

**Figure 17: View of the air brake switches as found post-accident.**
