**SPECIALIST'S FACTUAL REPORT OF INVESTIGATION**

**ERA21LA208**

## **Cockpit Voice Recorder**

Location: Ridgeland, South Carolina  
Date: May 05, 2021  
Aircraft: Gulfstream G150  
Registration: N22ST  
Operator: Snider Fleet Solutions  
NTSB Number: ERA21LA208

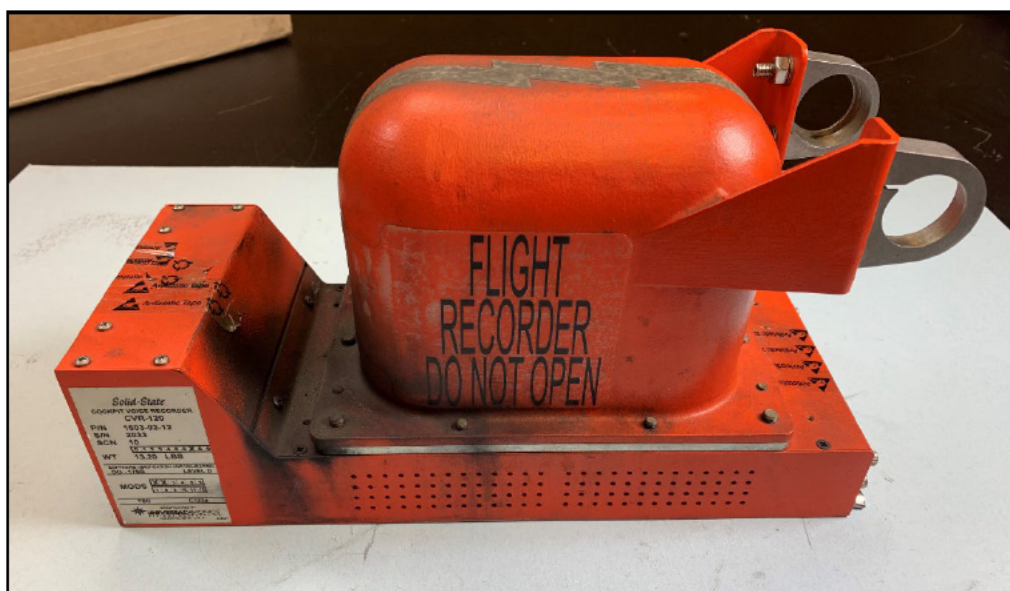
**Figure 1.** Universal CVR-120, as received.

Upon arrival at the laboratory, it was evident that the CVR had not sustained any heat or structural damage, and the audio information was extracted from the recorder normally, without difficulty. The CVR, as received, is shown in Figure 1.
