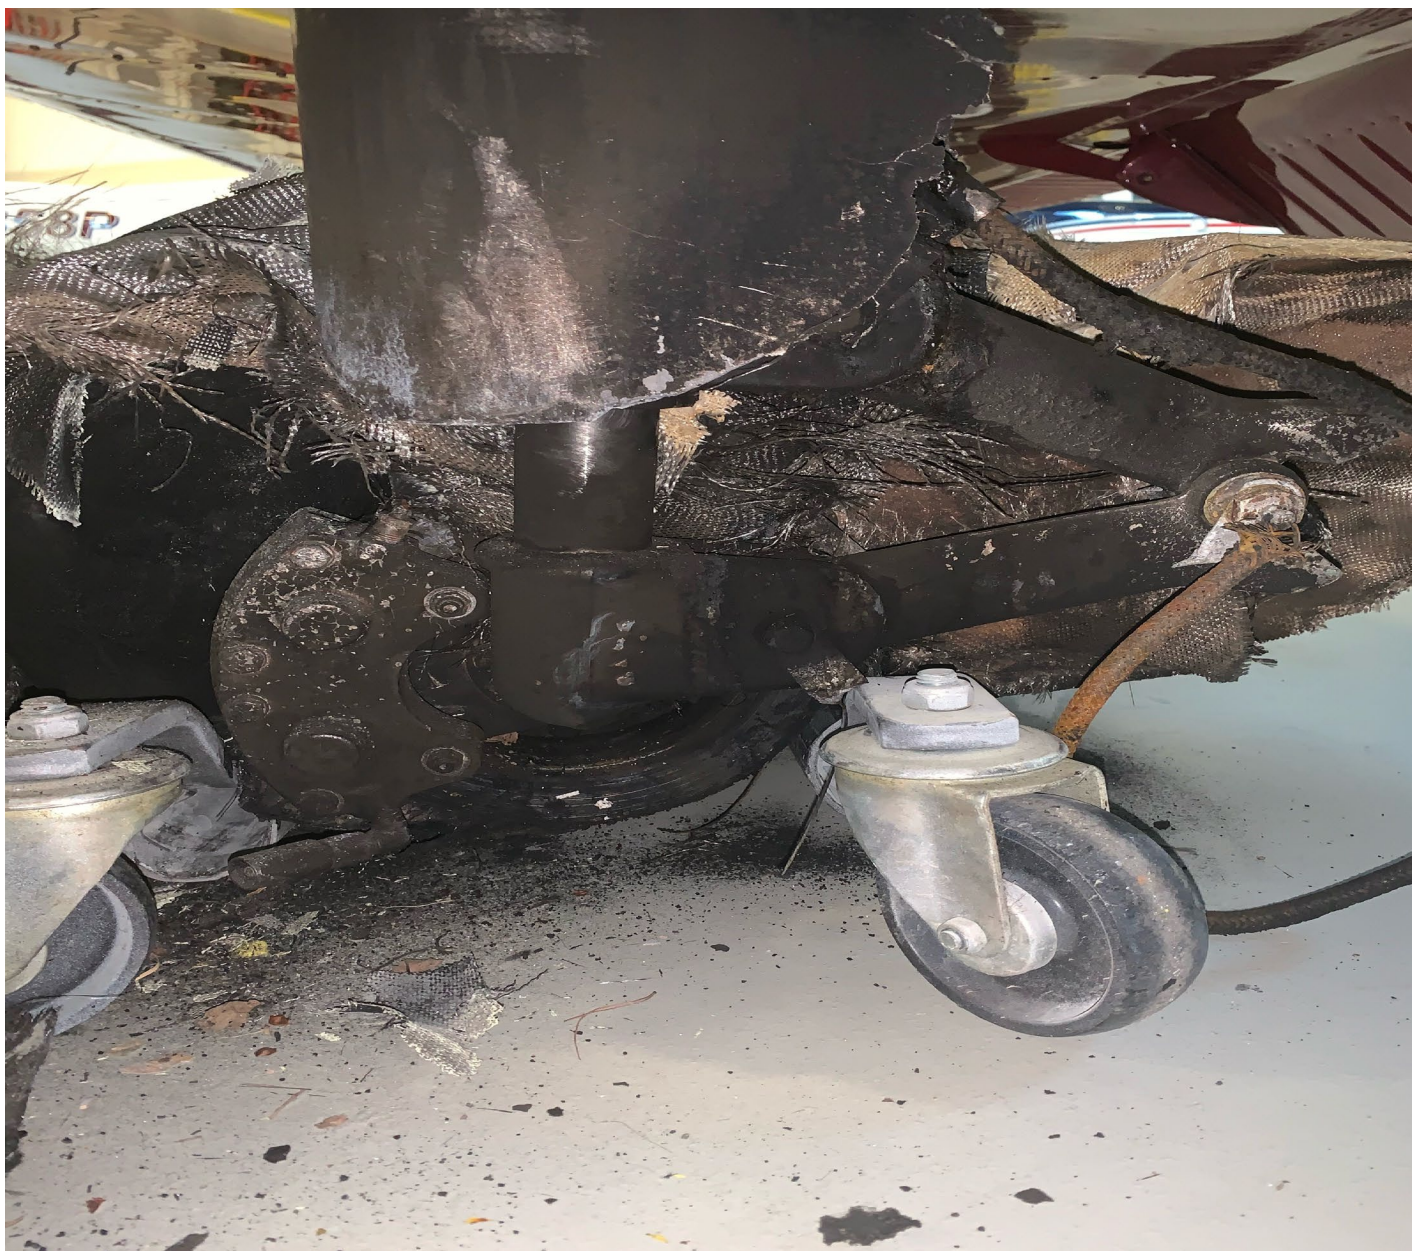
**Photo 1 – View of right main landing gear brake assembly showing fire damage**

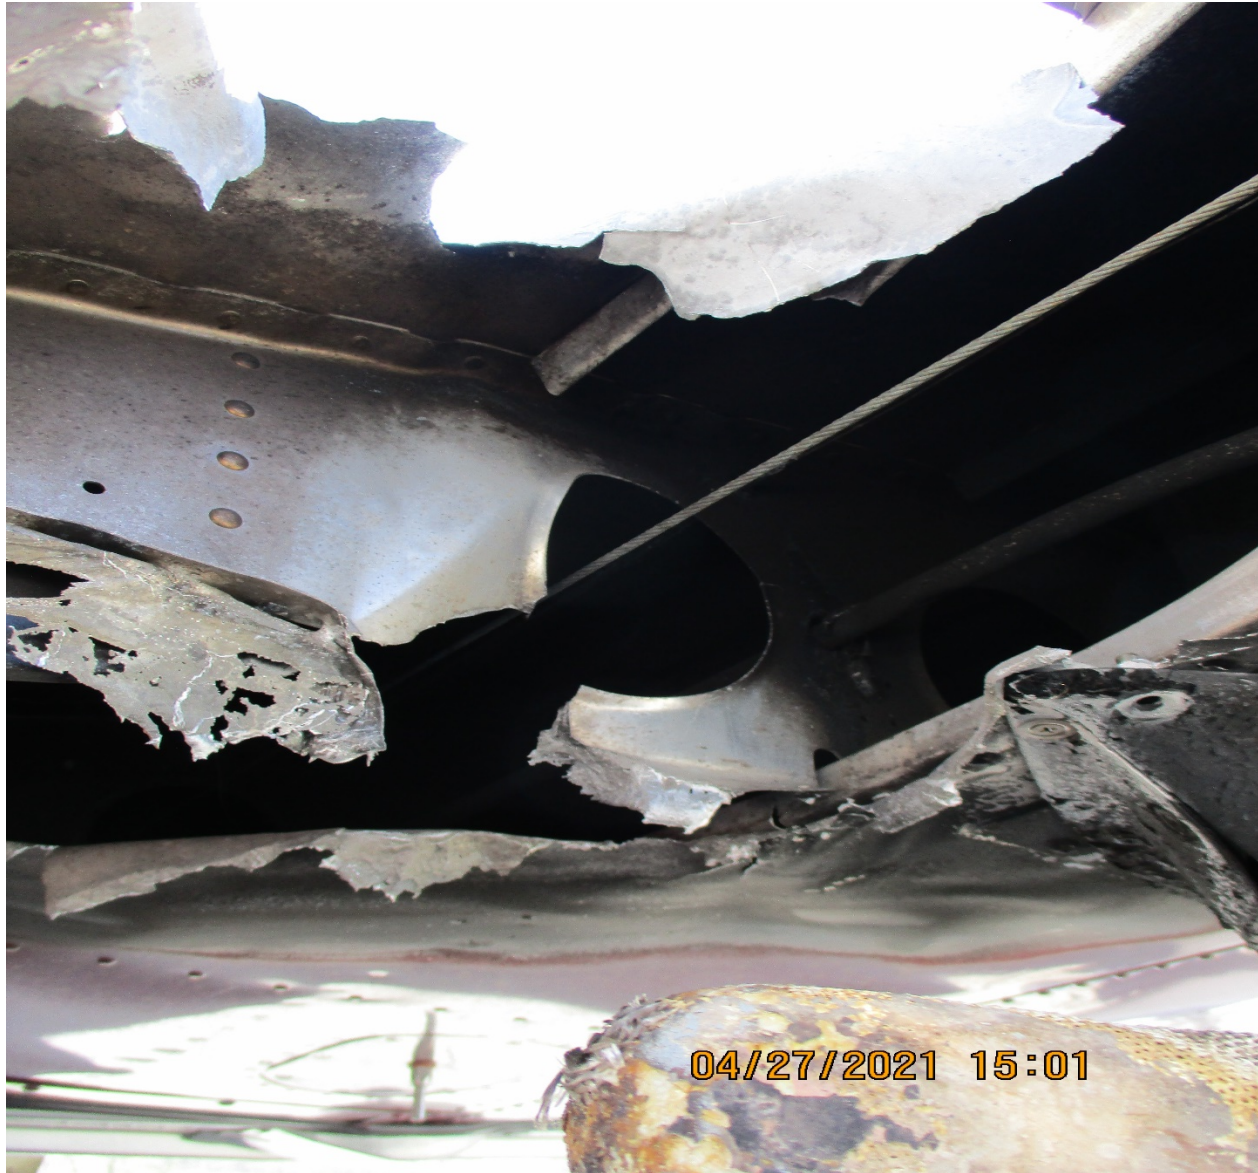
**Photo 2 – View of right wing assembly showing fire damage**

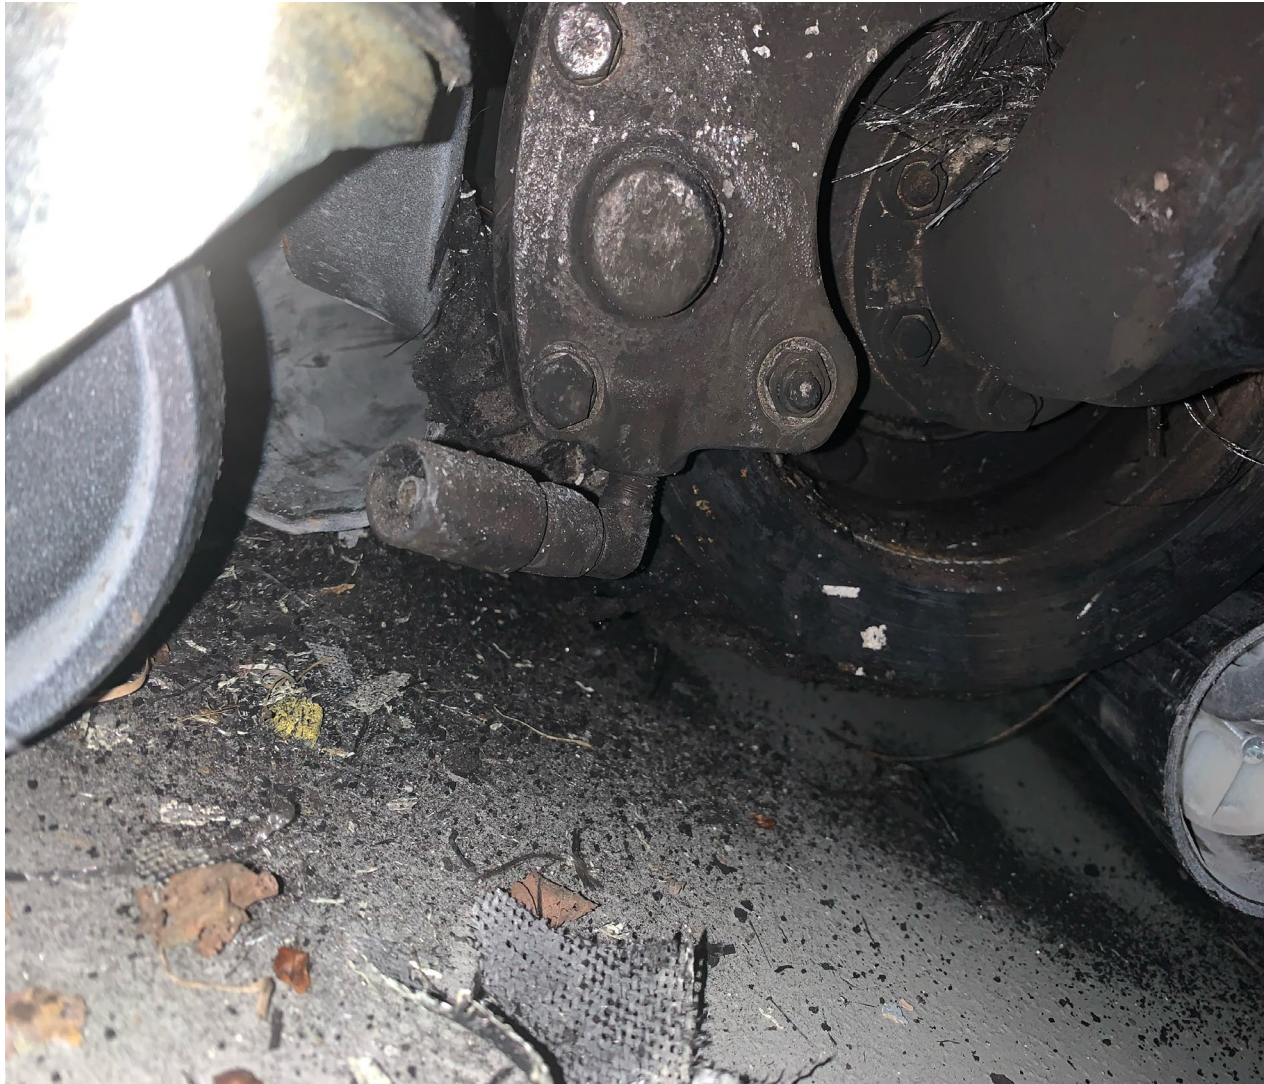
**Photo 3 – View of right brake assembly hydraulic hose fitting, showing fire damage**
