## **NATIONAL TRANSPORTATION SAFETY BOARD**

Office of Aviation Safety  
Eastern Region

**Photo Array**

**ERA21LA213**

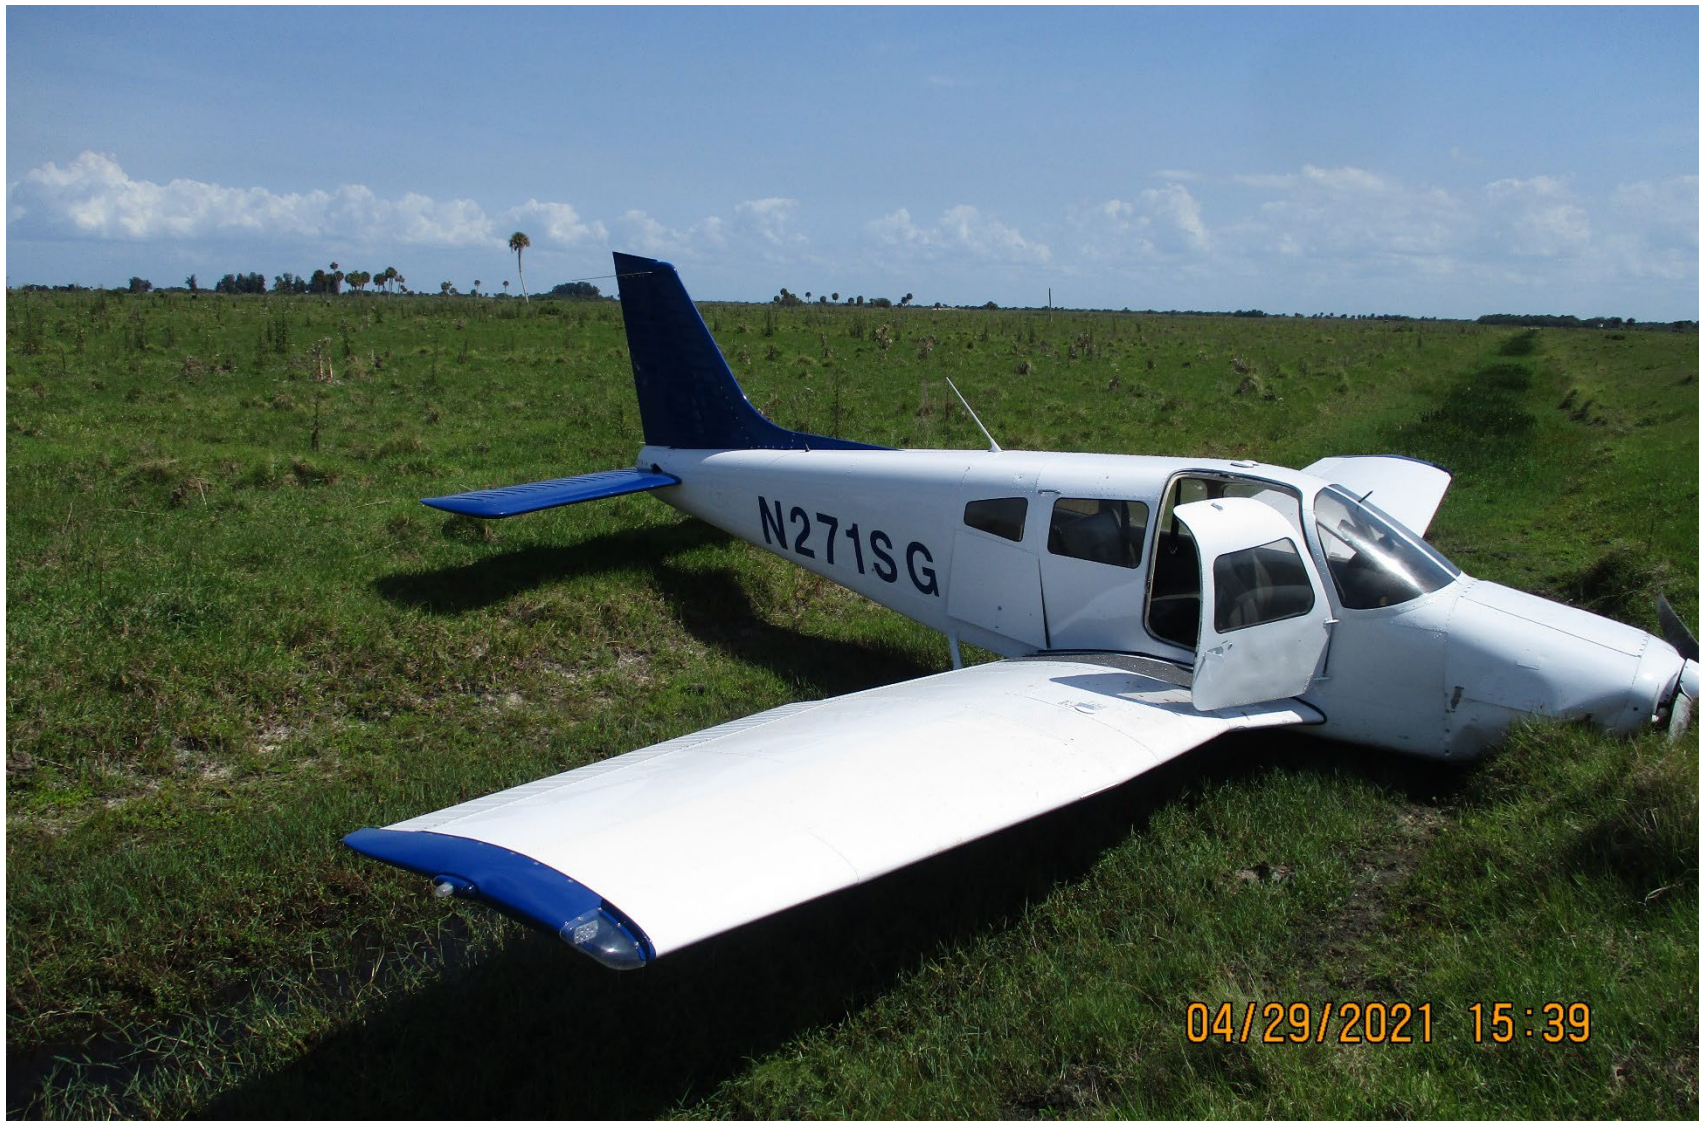
**Photo 1 – View of airplane from right (Photo Courtesy of FAA)**

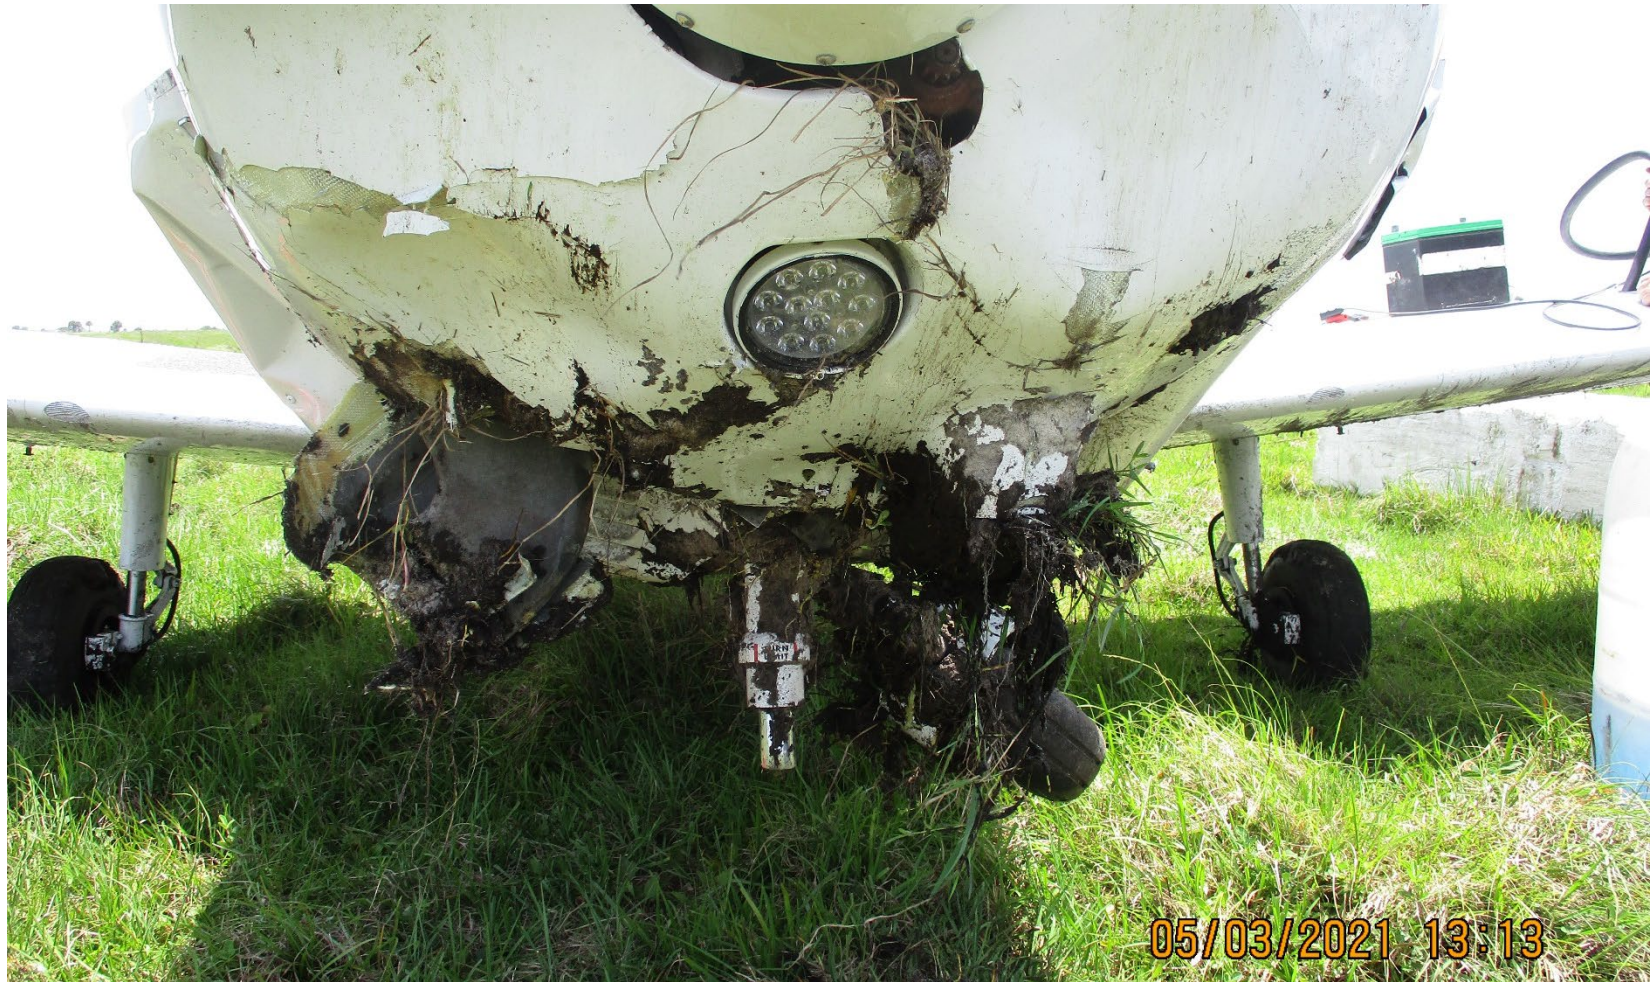
**Photo 2 – View of damage to the bottom of the cowling (Photo Courtesy of FAA)**

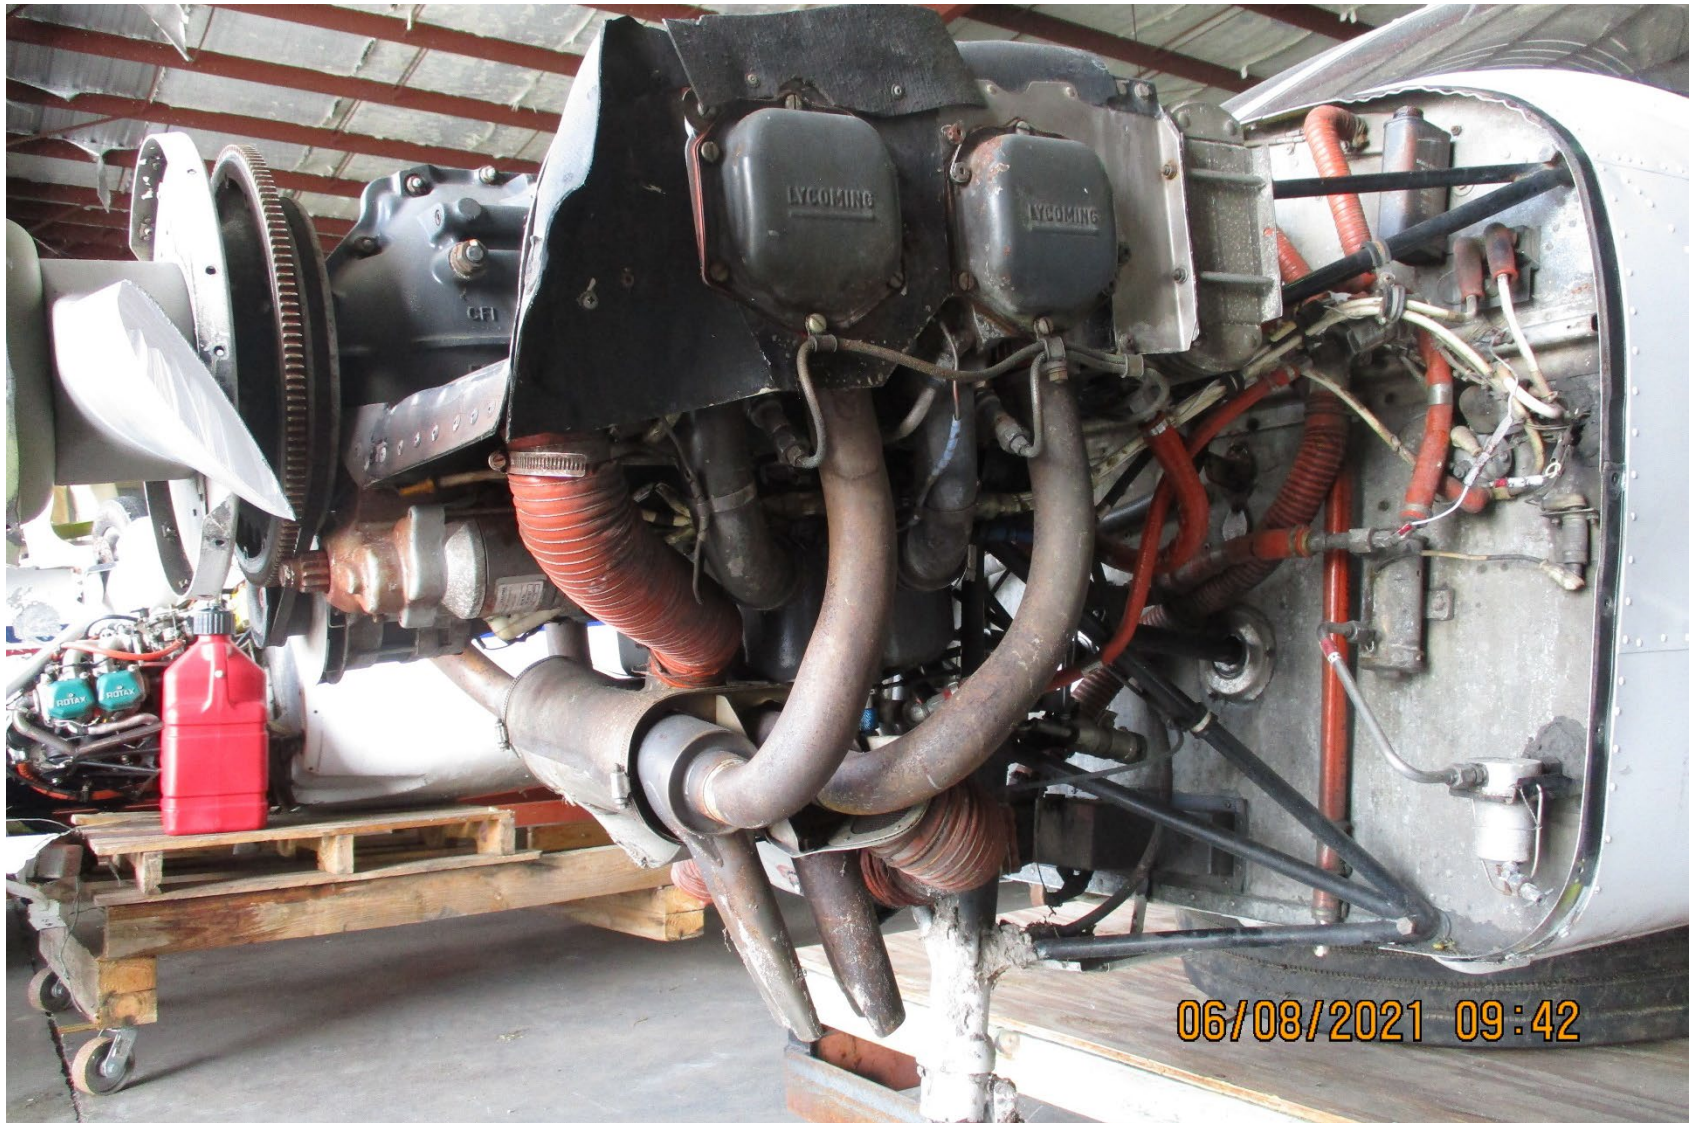
**Photo 3 – View of engine with cowling removed (Photo Courtesy of FAA)**

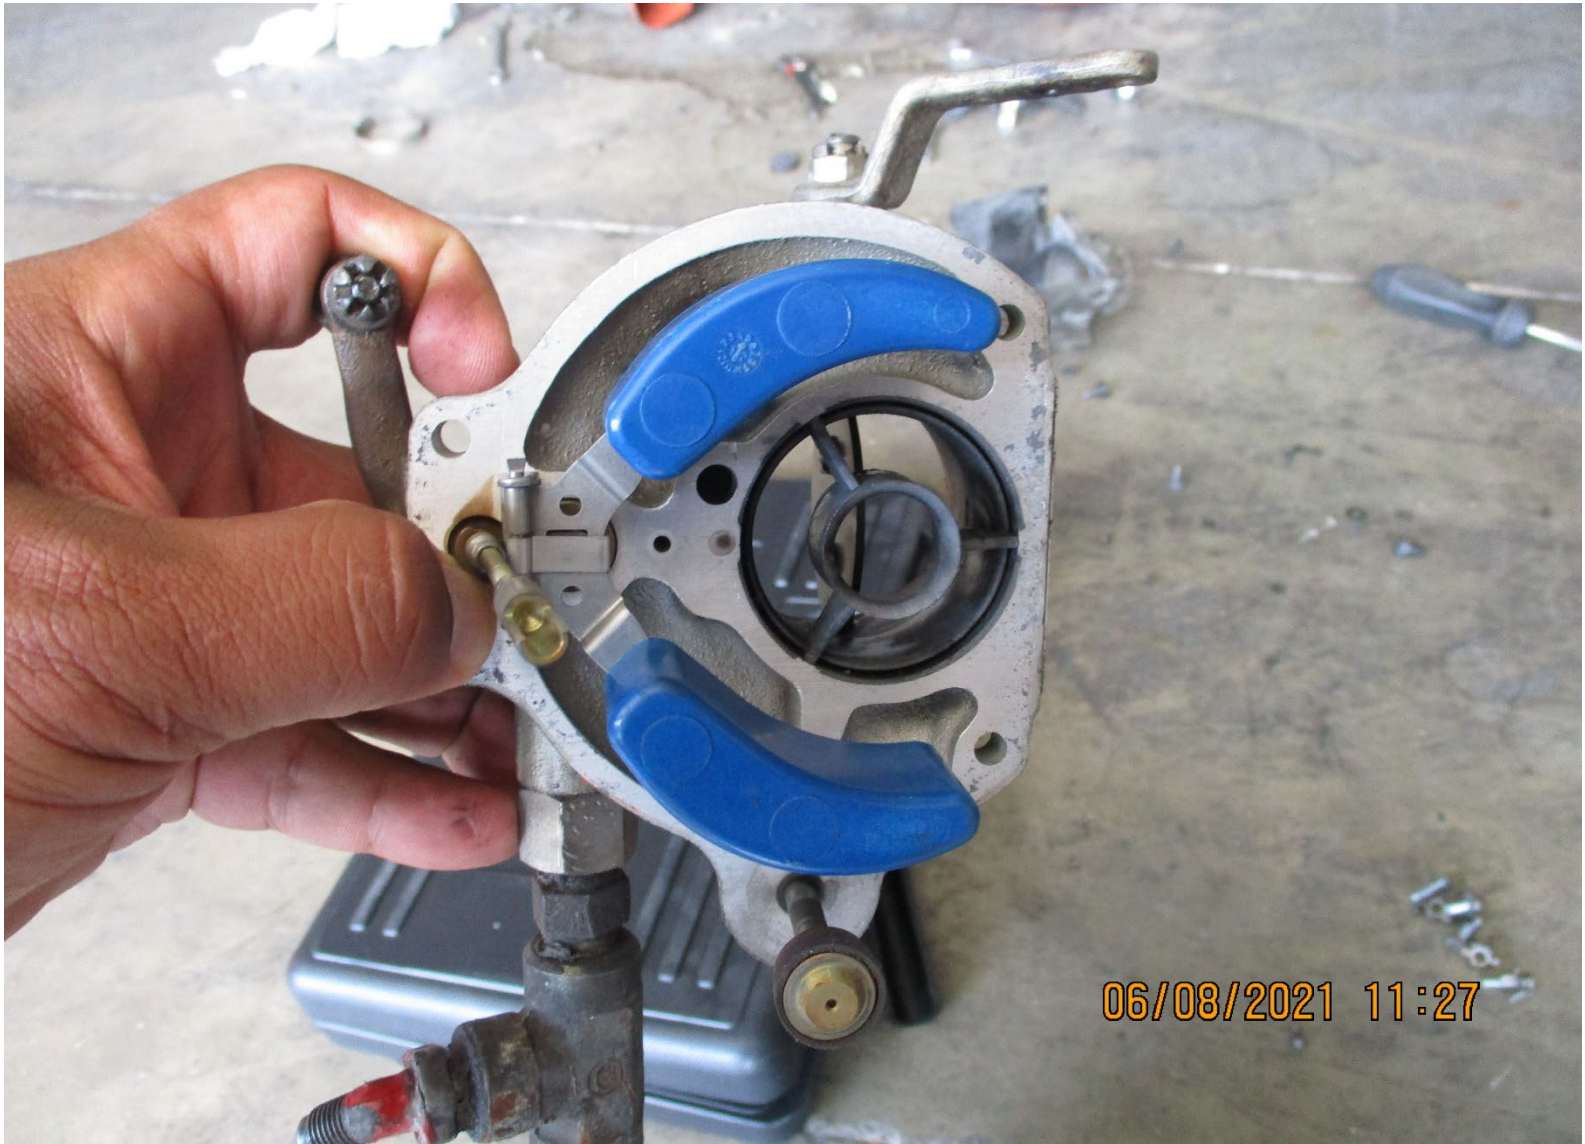
**Photo 4 – View of disassembled carburetor (Photo Courtesy of FAA)**
