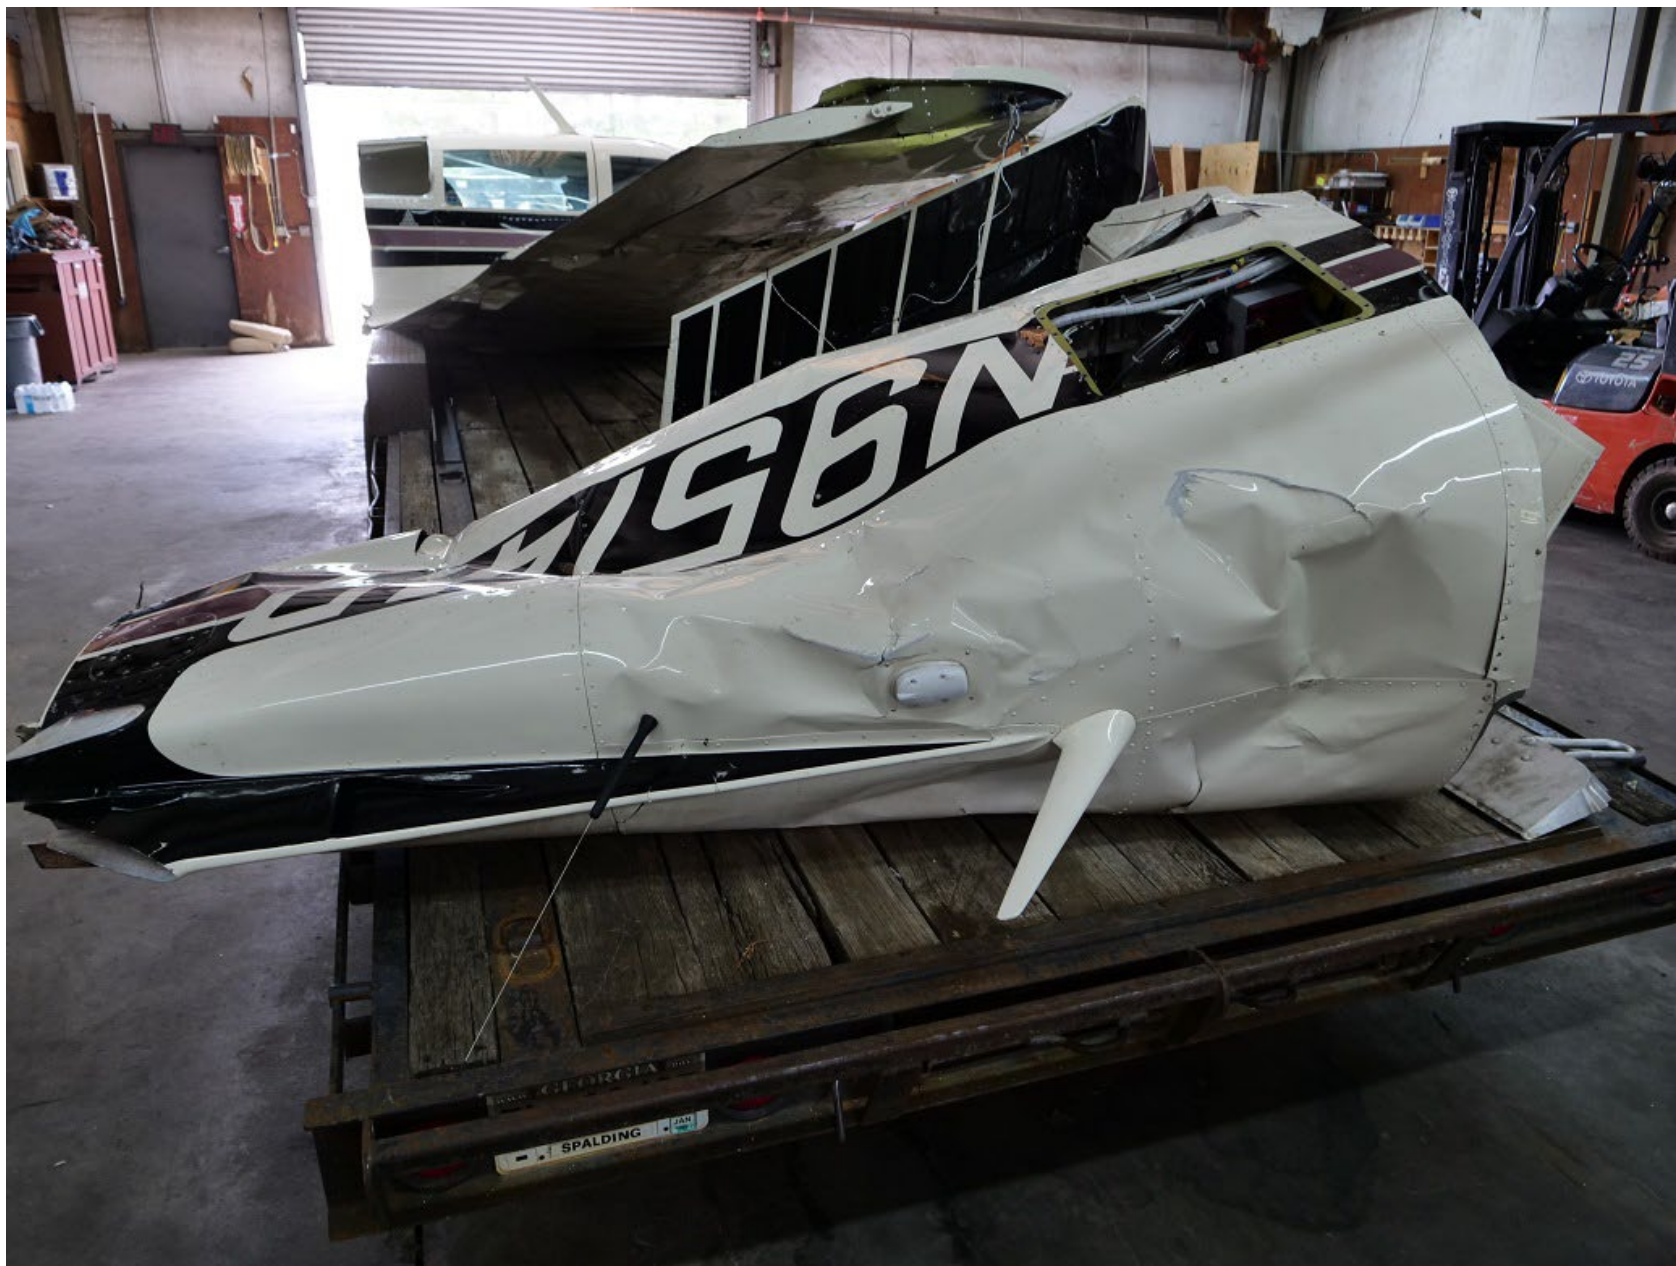
**Photo 1 – Fuselage Damage**

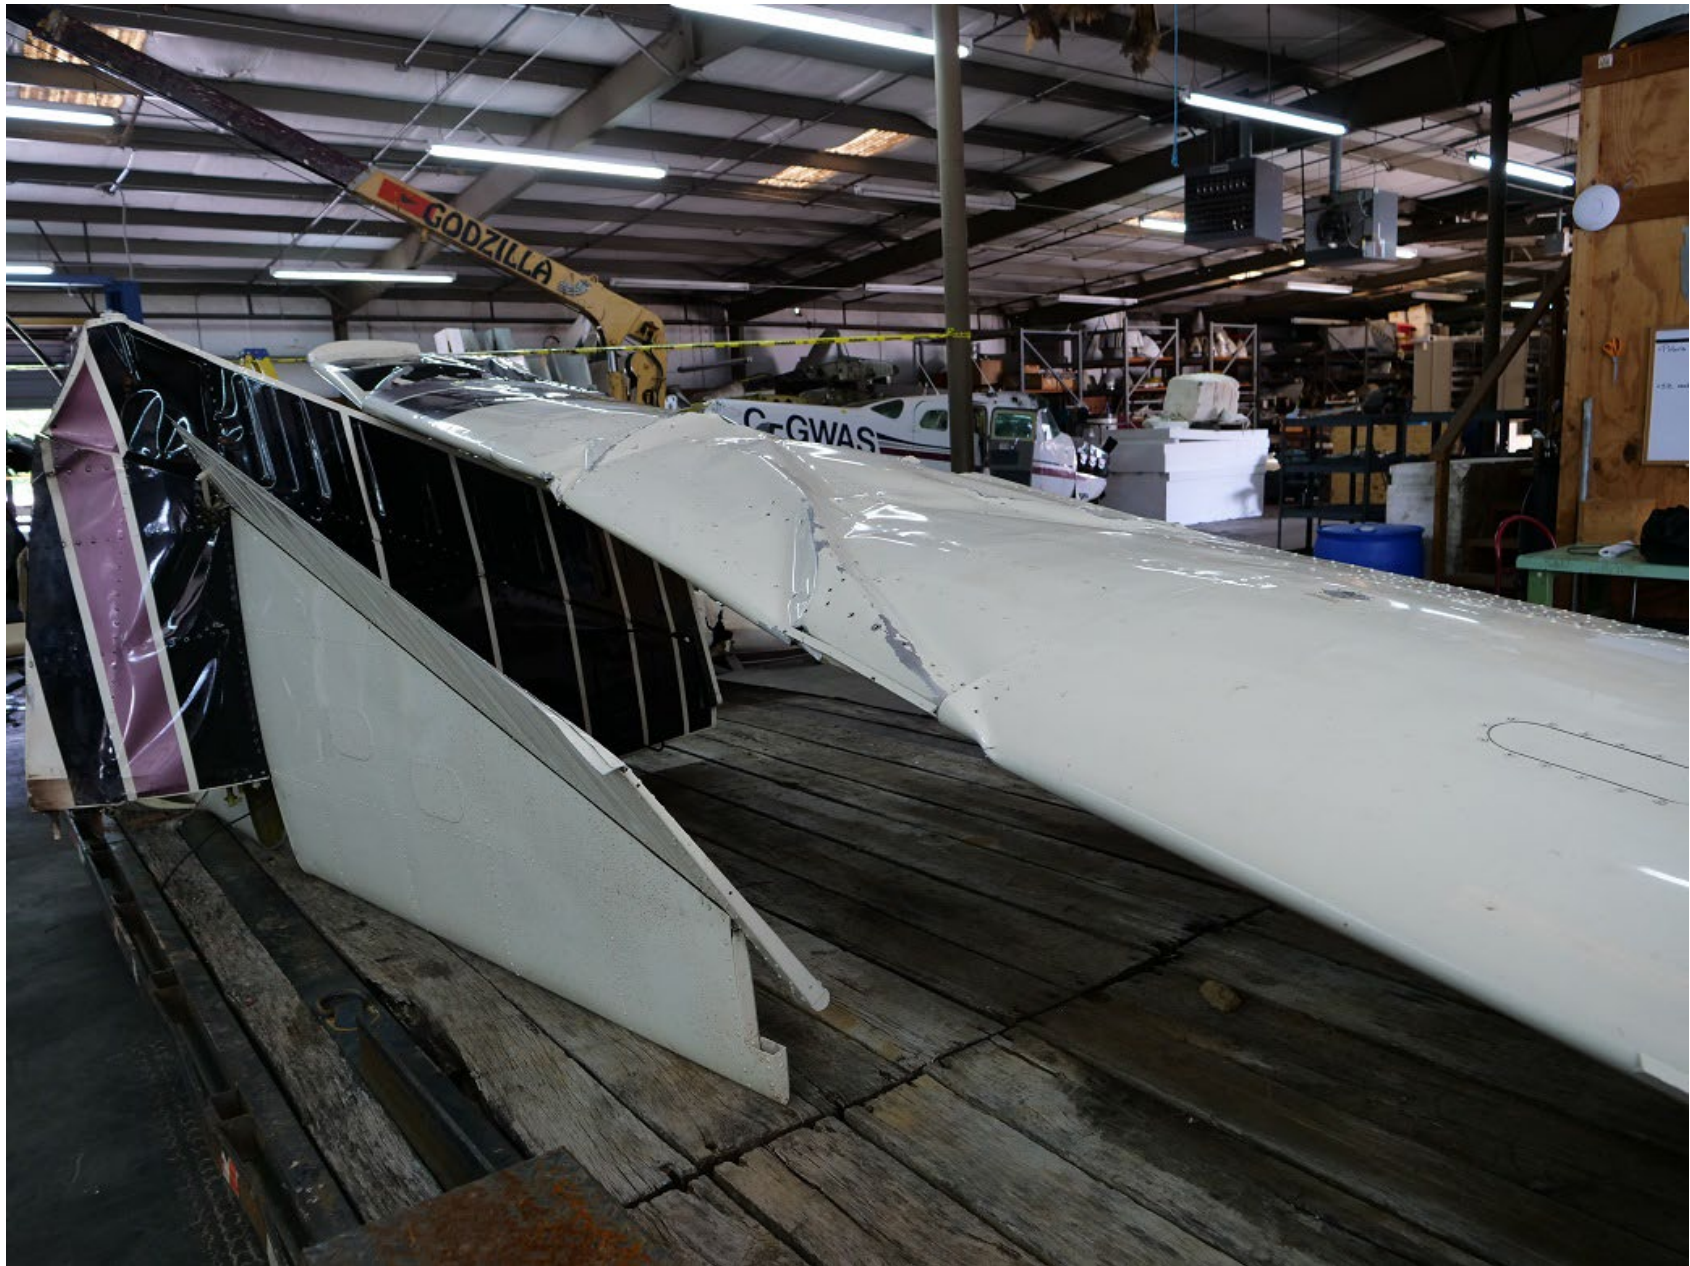
**Photo 2 – Right Wing Damage**

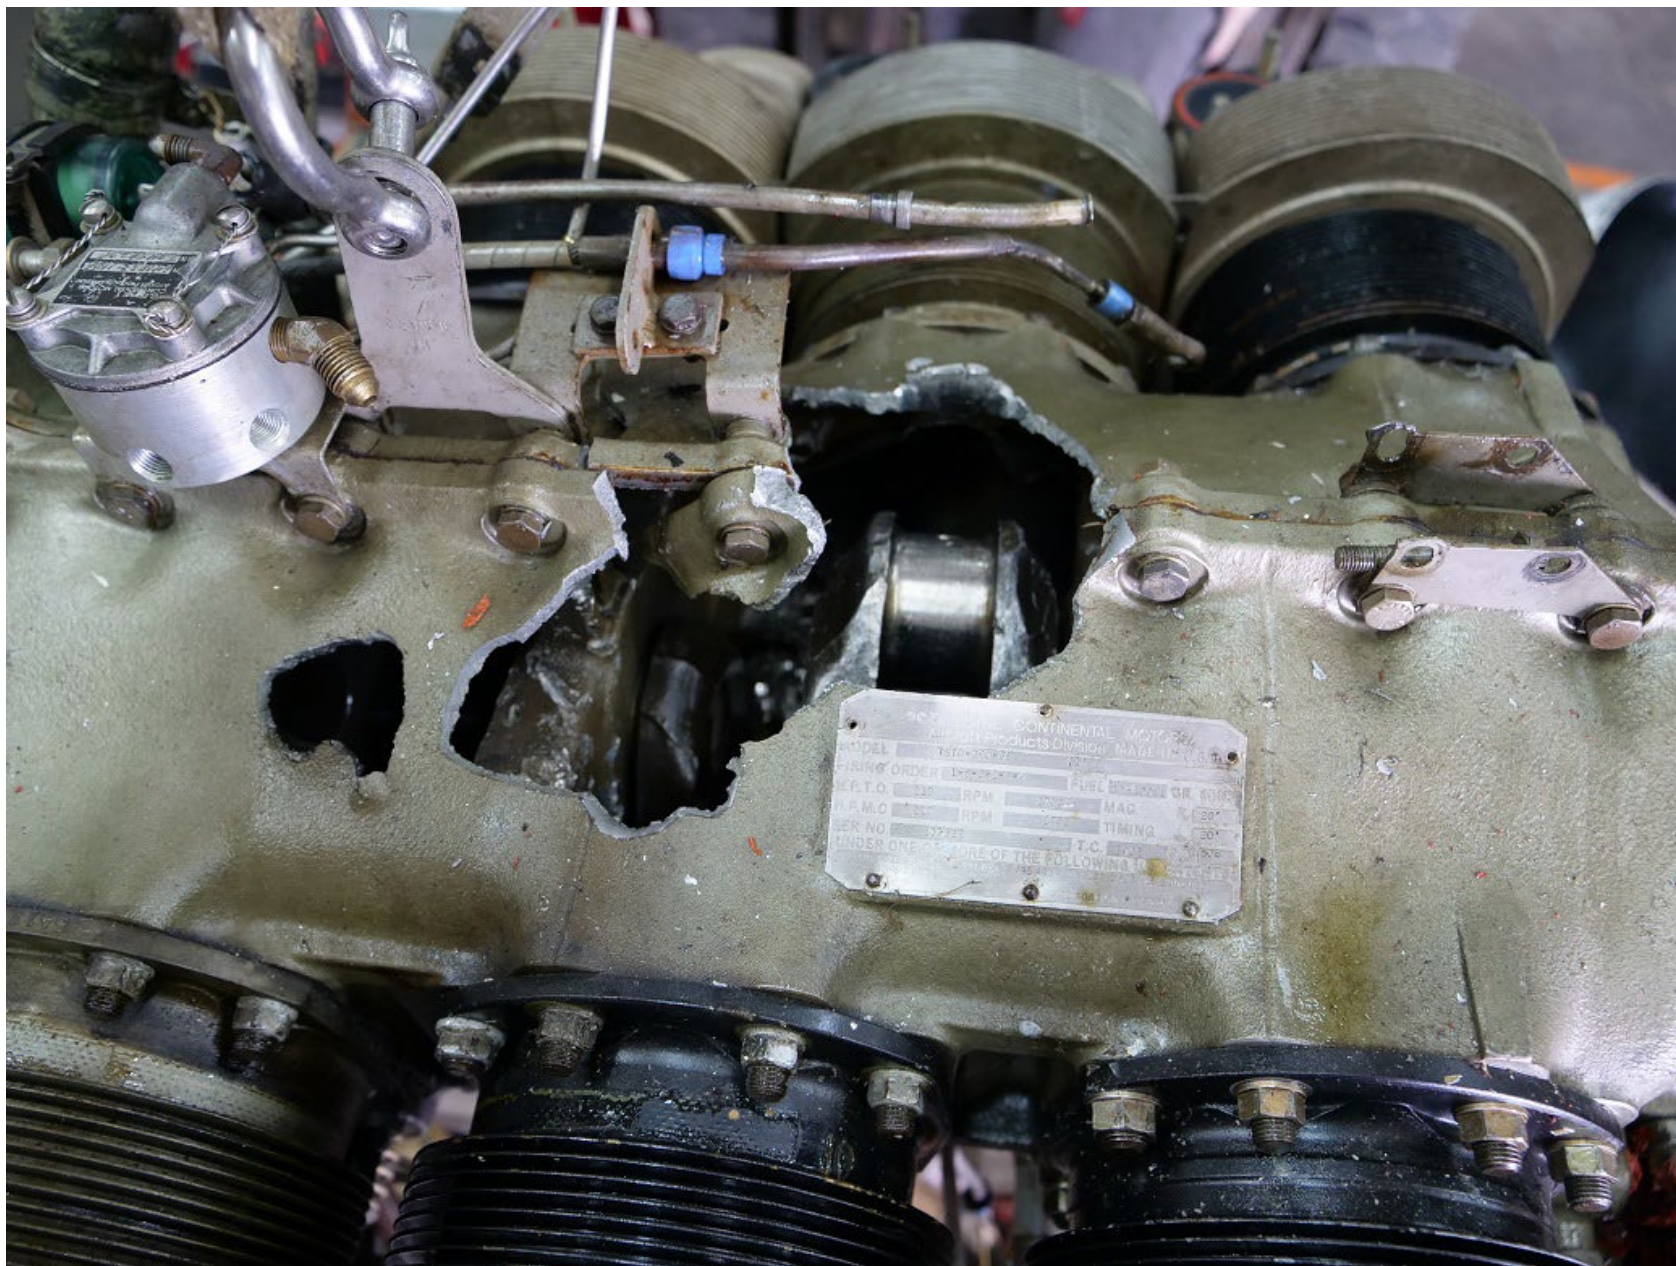
Photo 3 – Hole In Crankcase

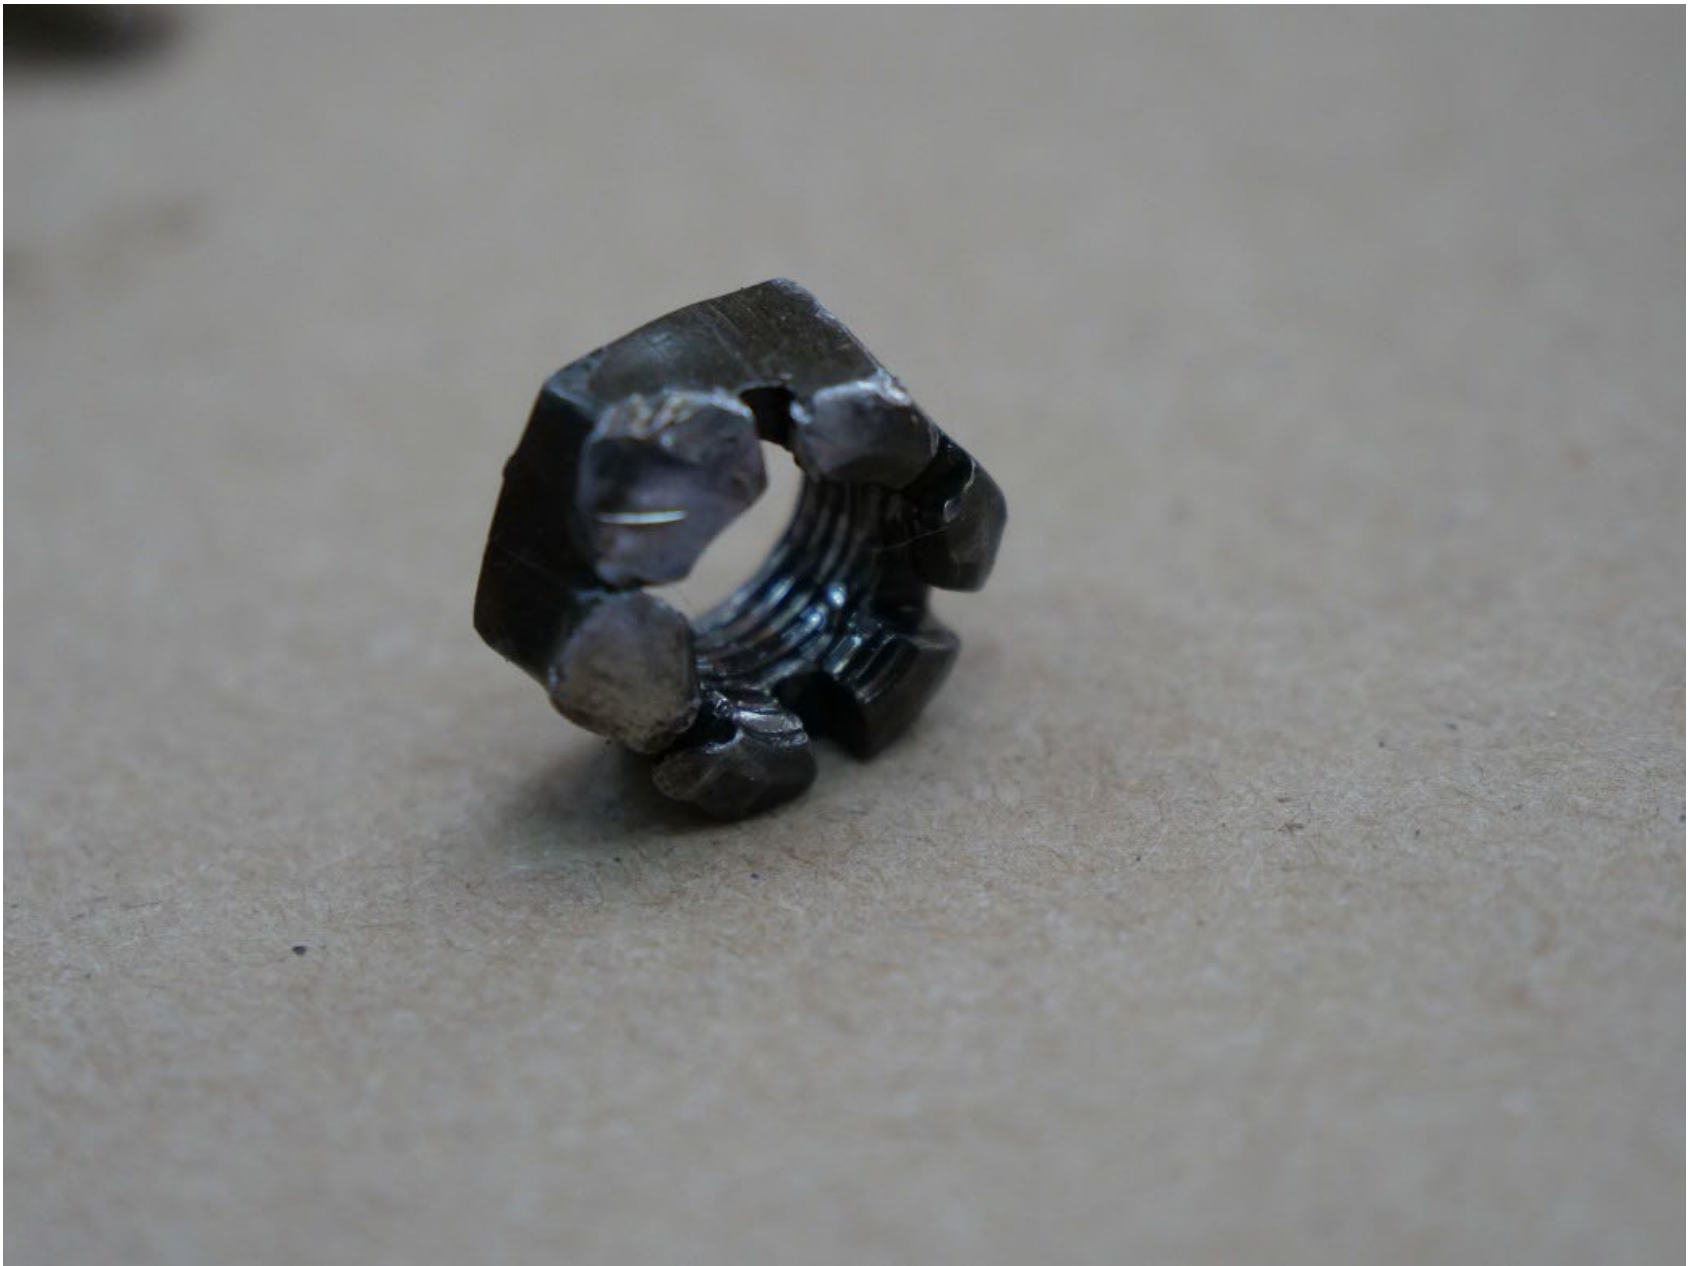
**Photo 7 – No. 4 Connecting Rod Cap Nut (no bolt or cotter pin)**
