# National Transportation Safety Board

ERA21LA222

## **ENGINE EXAMINATION**

Location: Dawson, Georgia  
Date: May 20, 2021  
Time: 0945 EDT  
1345 UTC  
Airplane: N9514R, Mooney M20K19

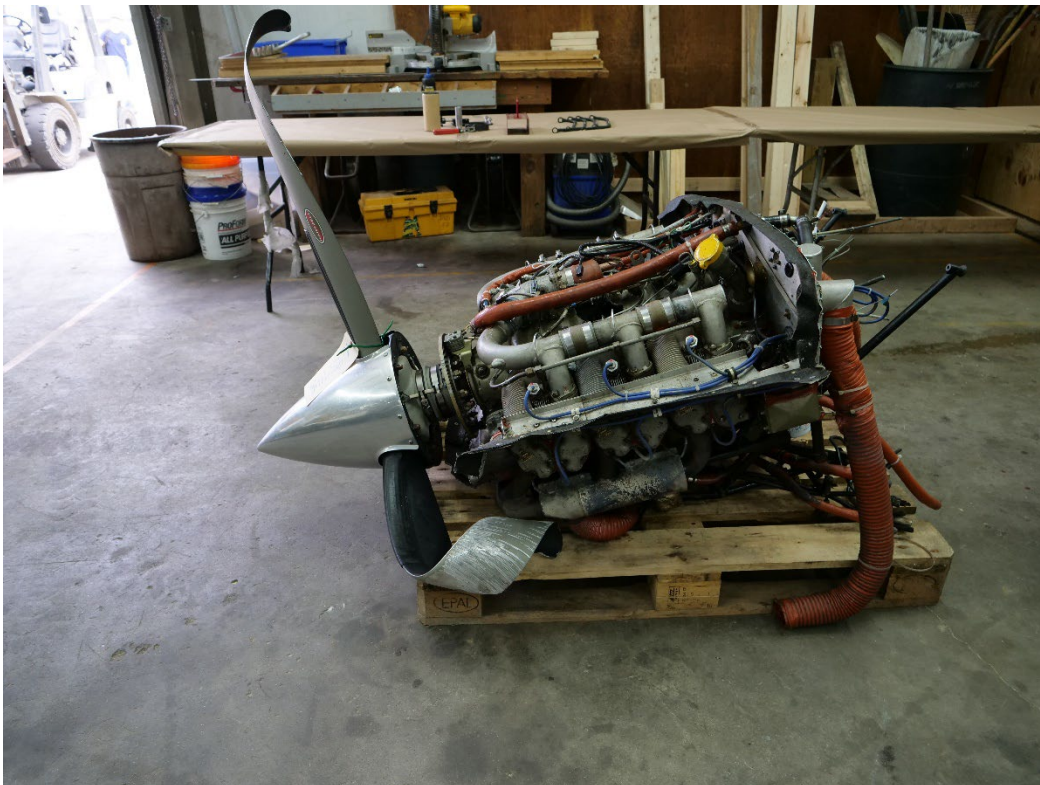
**Photo 1: The engine as it was found upon arrival at the salvage facility.**

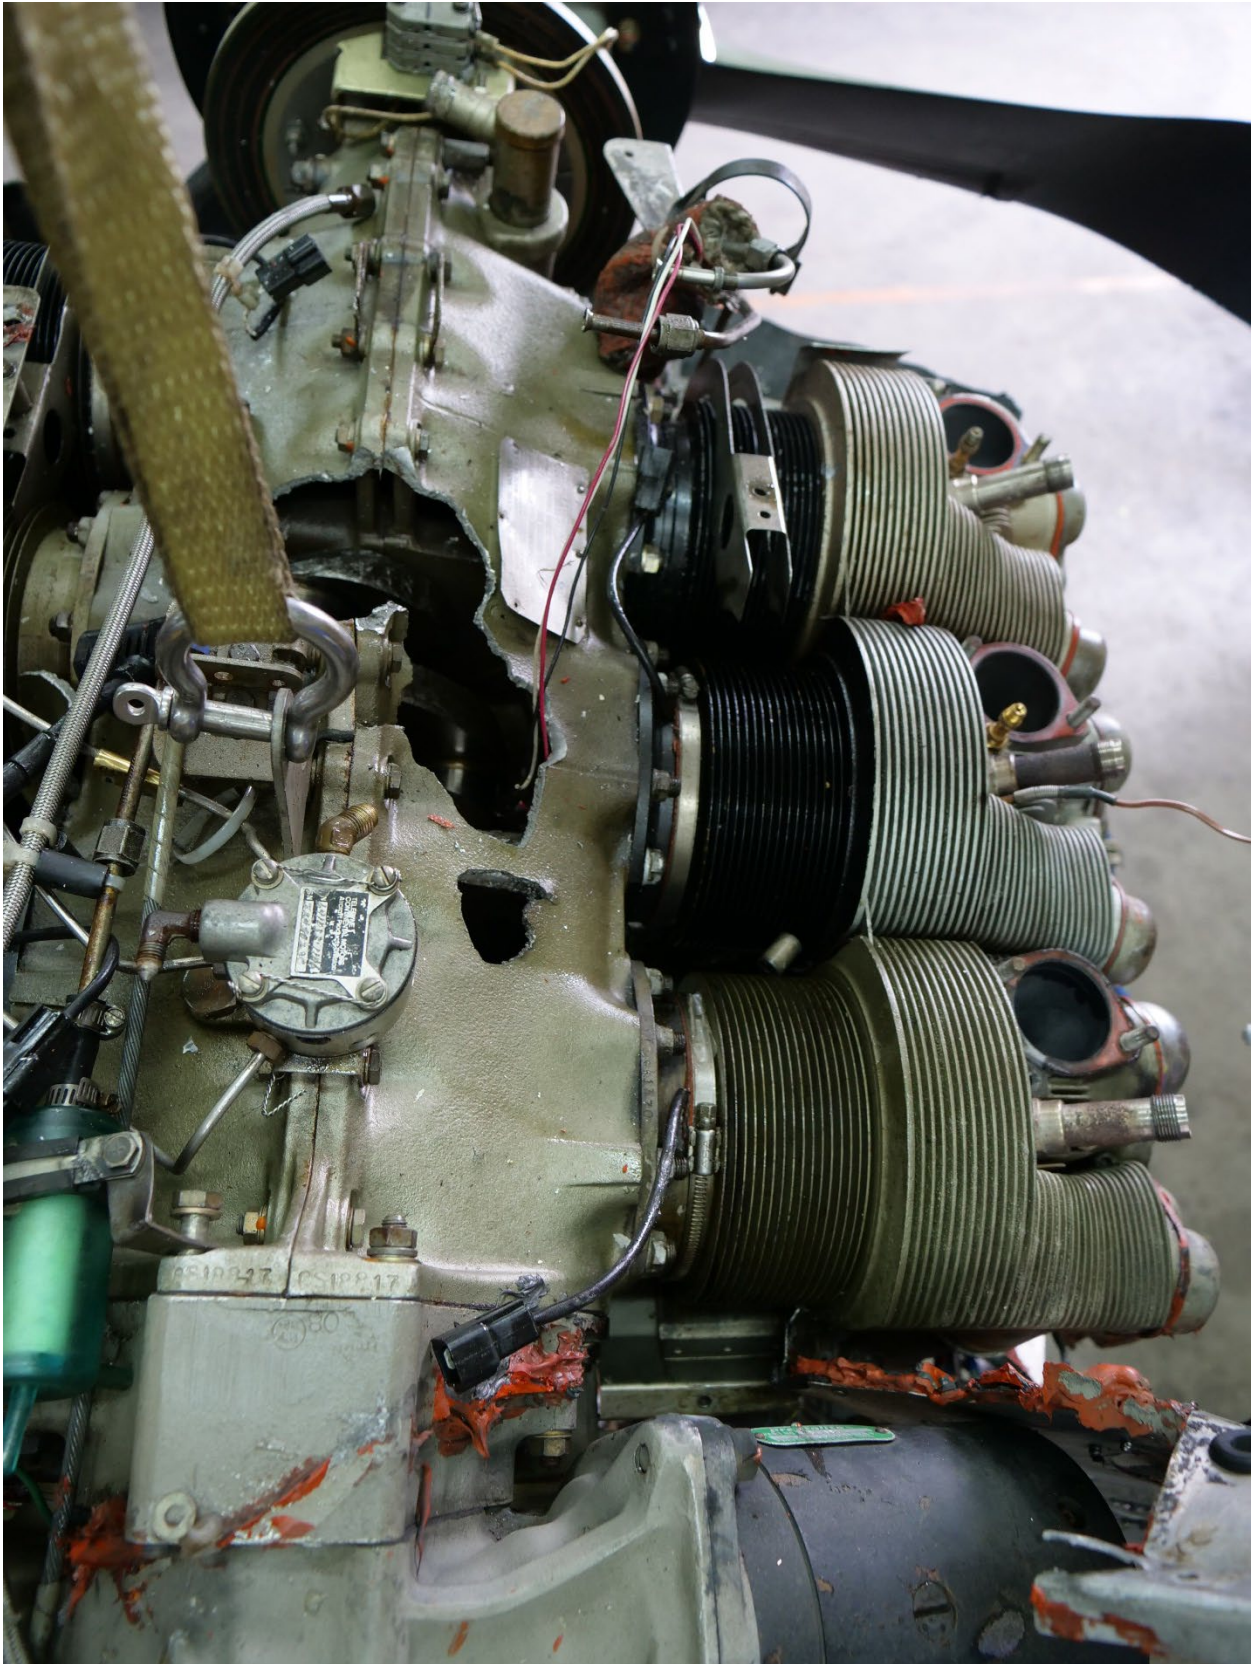
- Upon arrival the engine had already been removed from the airframe and was sitting on a shipping pallet.
- The propeller remained attached to the flange.
- Two holes were present on the top of the crankcase (near the center of the crankcase and aft of center on the right side).

**Photo 2: Two holes in the crankcase from the aft looking forward.**

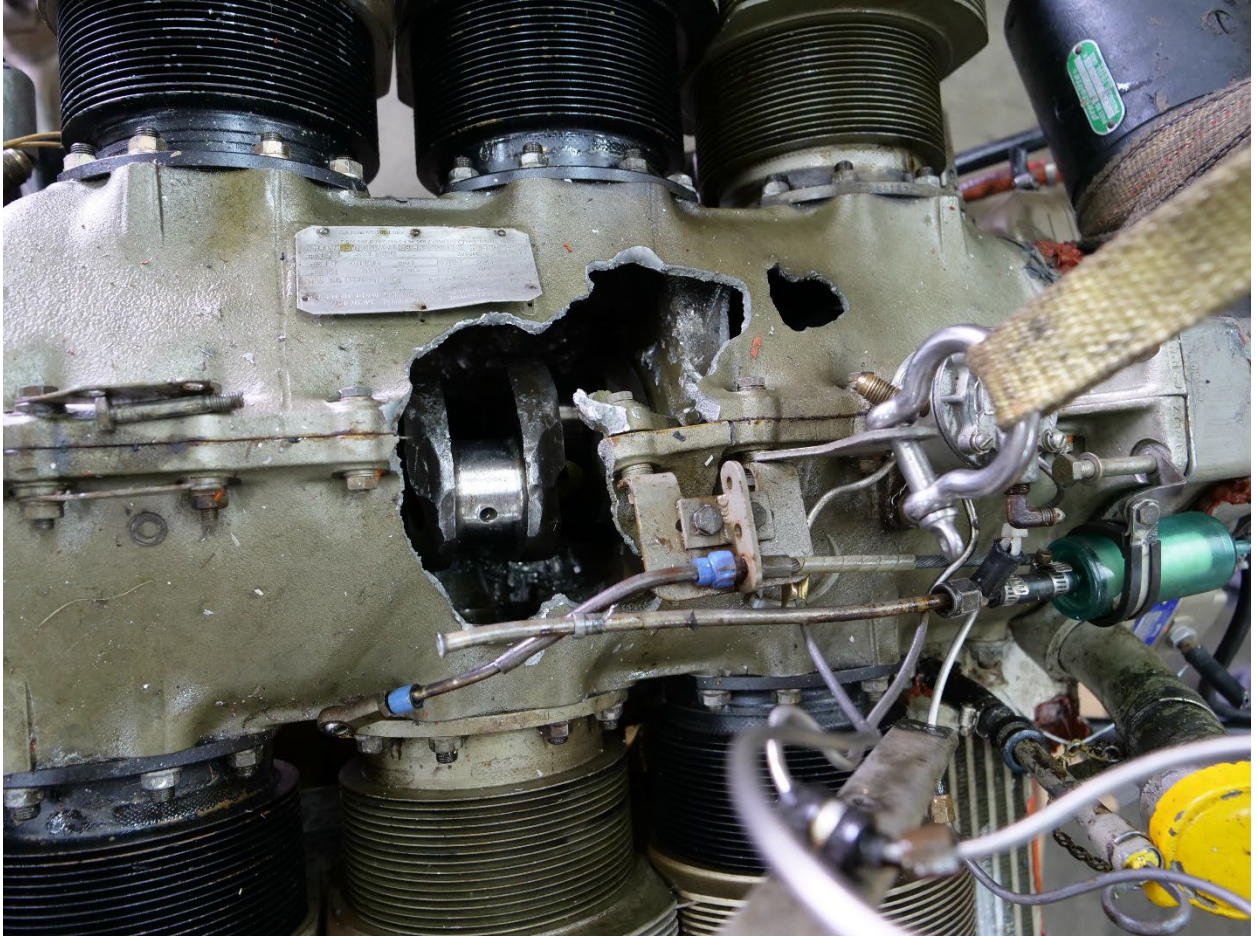
**Photo 3: Top view of the holes in the crankcase.**

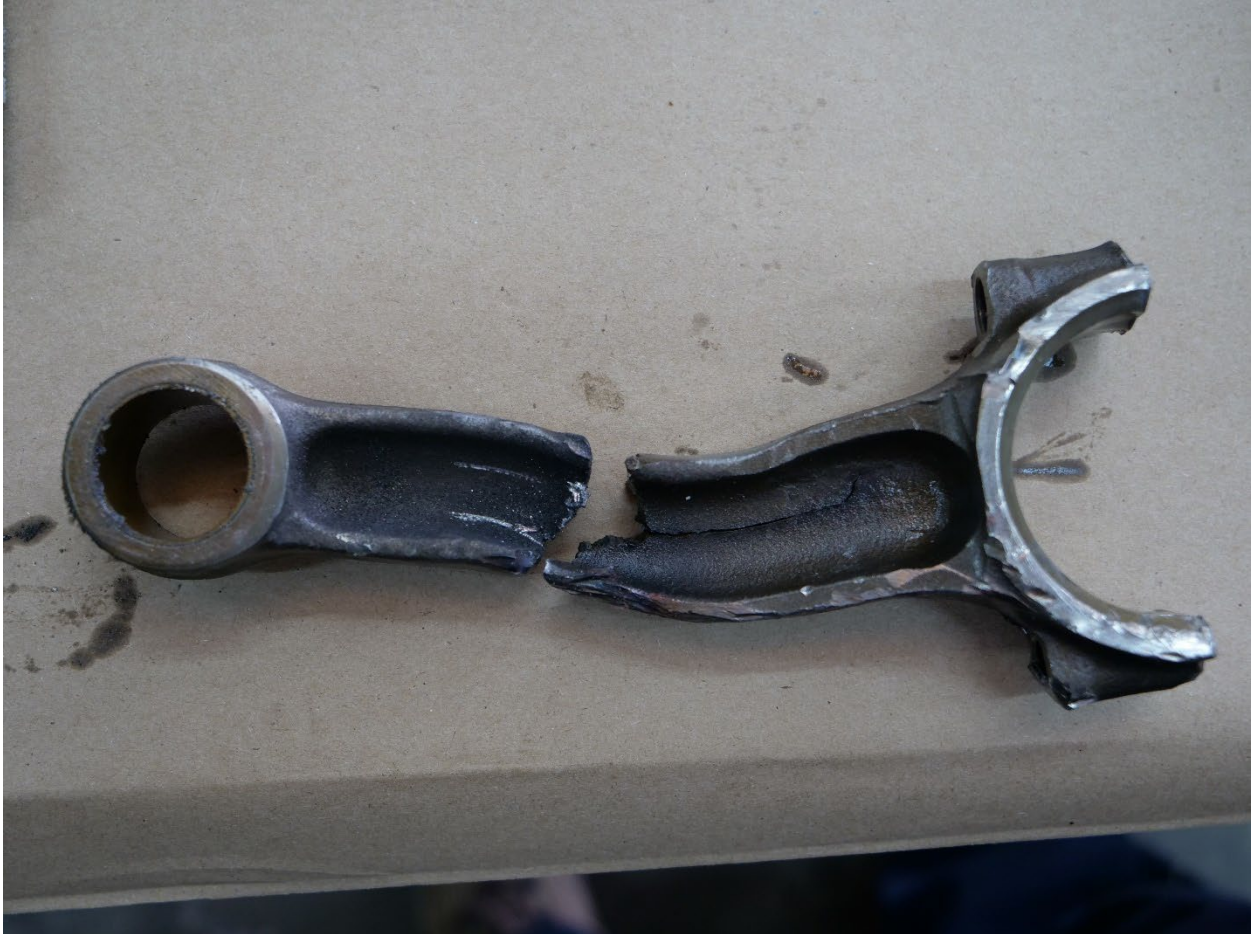
- The cylinders remained attached to the crankcase.
- A no. 4 connecting rod bolt nut was found in the oil pan.
  - This nut did not exhibit any signs of impact damage or damage which would be consistent with separation during the engine failure.
  - A cotter pin associated with the nut was not found in the oil pan debris.
- All other connecting rod bolt nuts remained attached to their respective bolts with cotter pins in place.
- No. 4 connecting rod was found fractured midspan.

**Photo 4: No. 4 connecting rod**

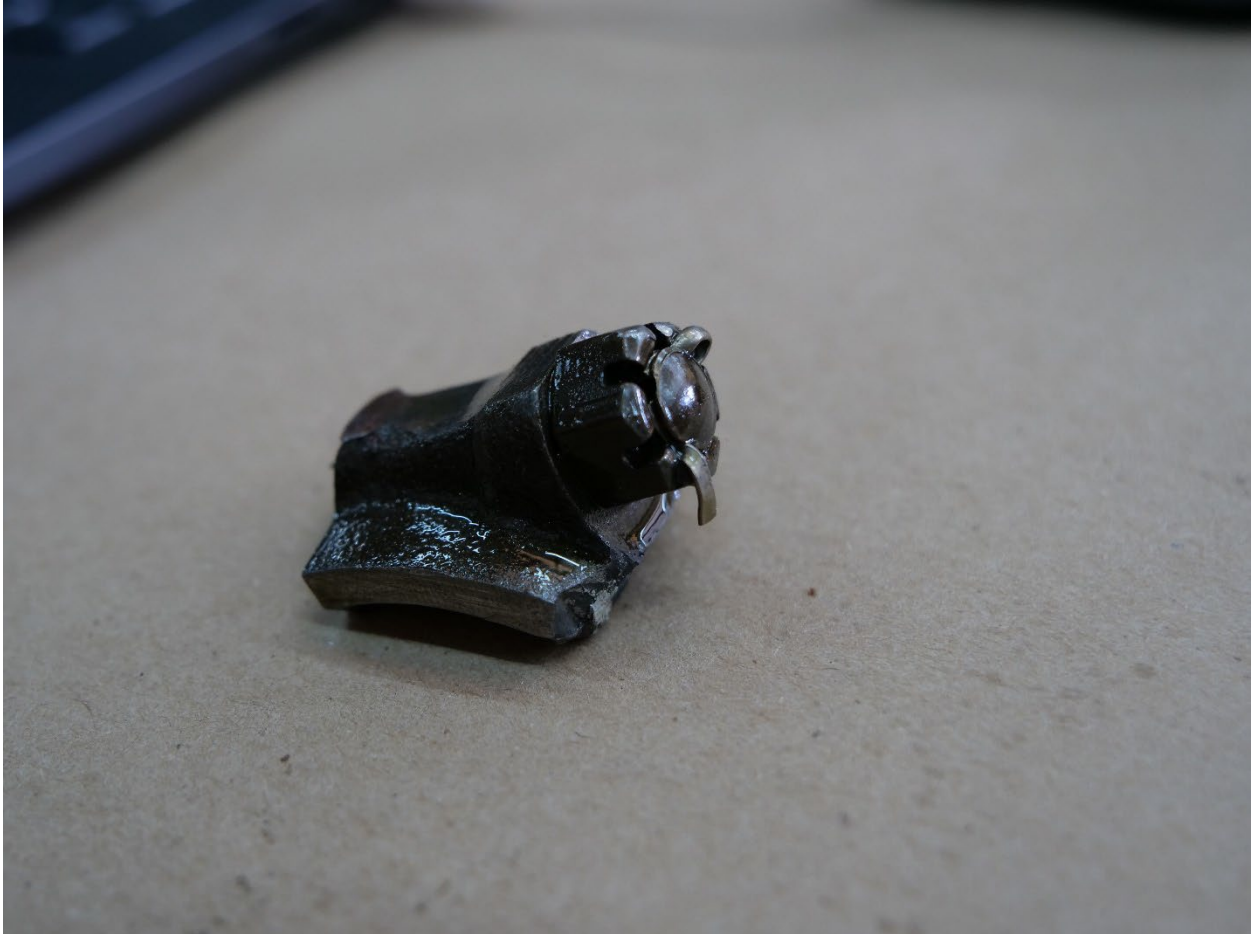
**Photo 5: No. 4 Connecting Rod Cap Bolt, Nut, And Cotter Pin**

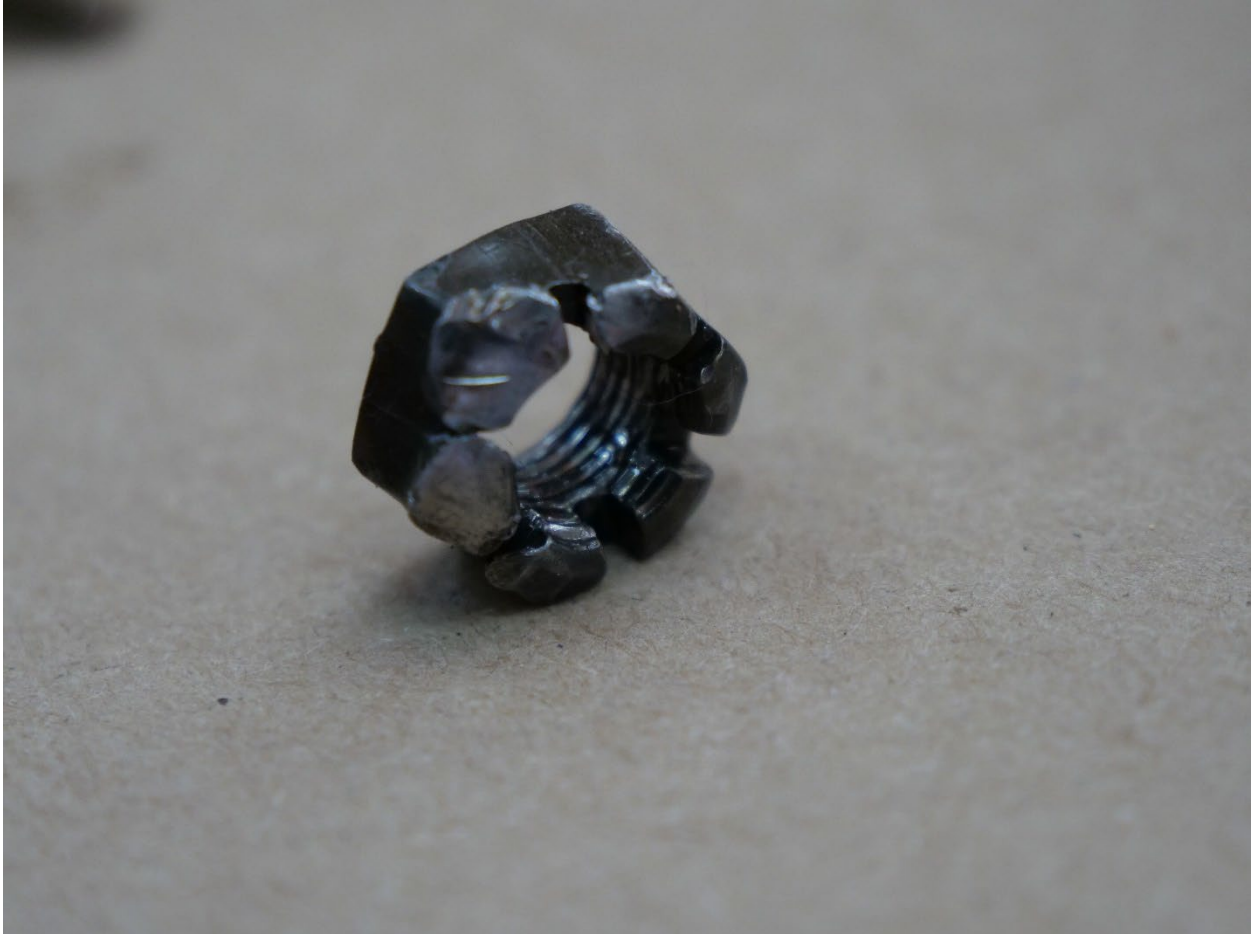
**Photo 6: No. 4 Connecting Rod Cap Nut (no bolt or cotter pin)**

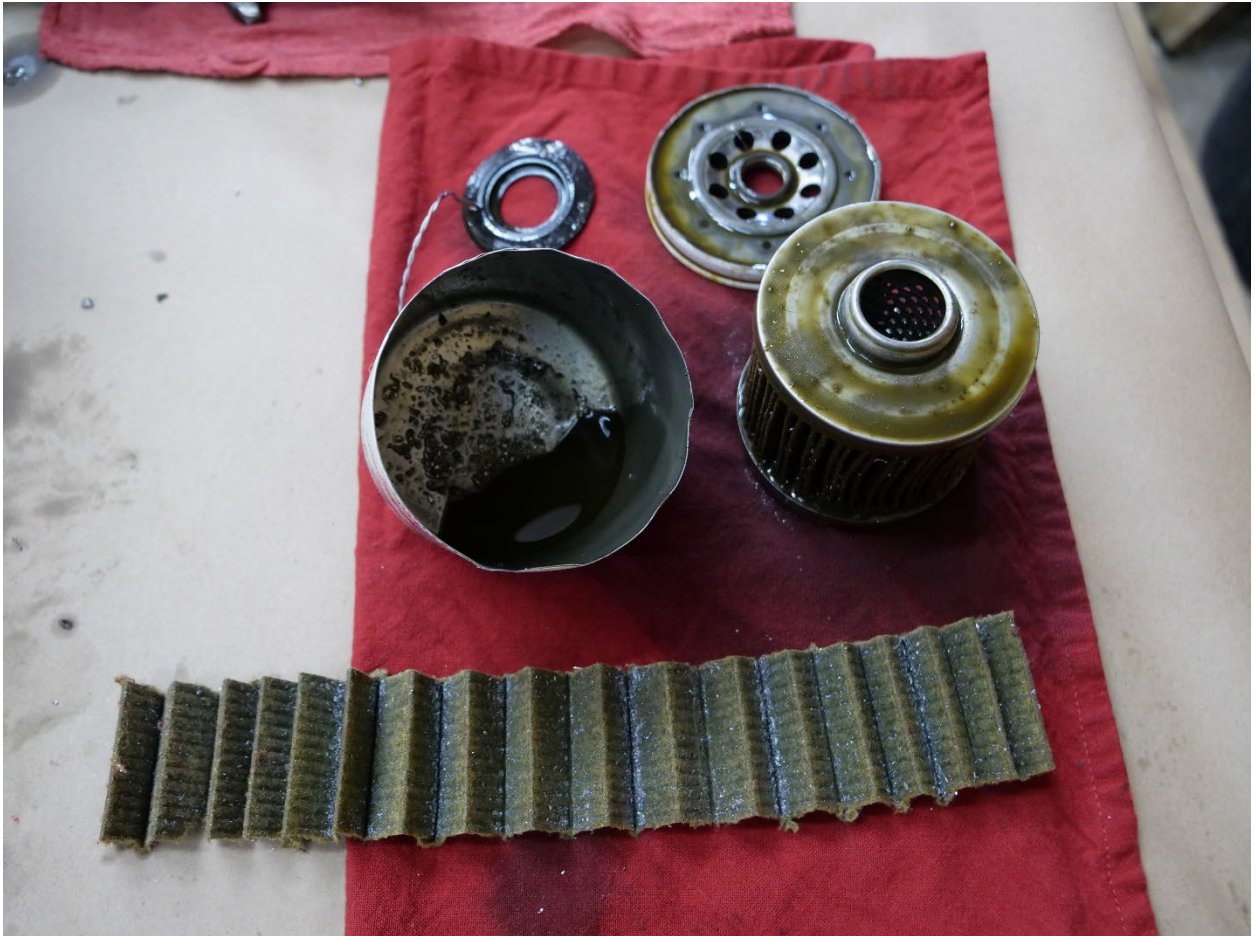
The oil filter pleats and oil sump contained large amounts of metallic debris.

**Photo 7: Oil filter pleats containing a large amount of metallic debris.**

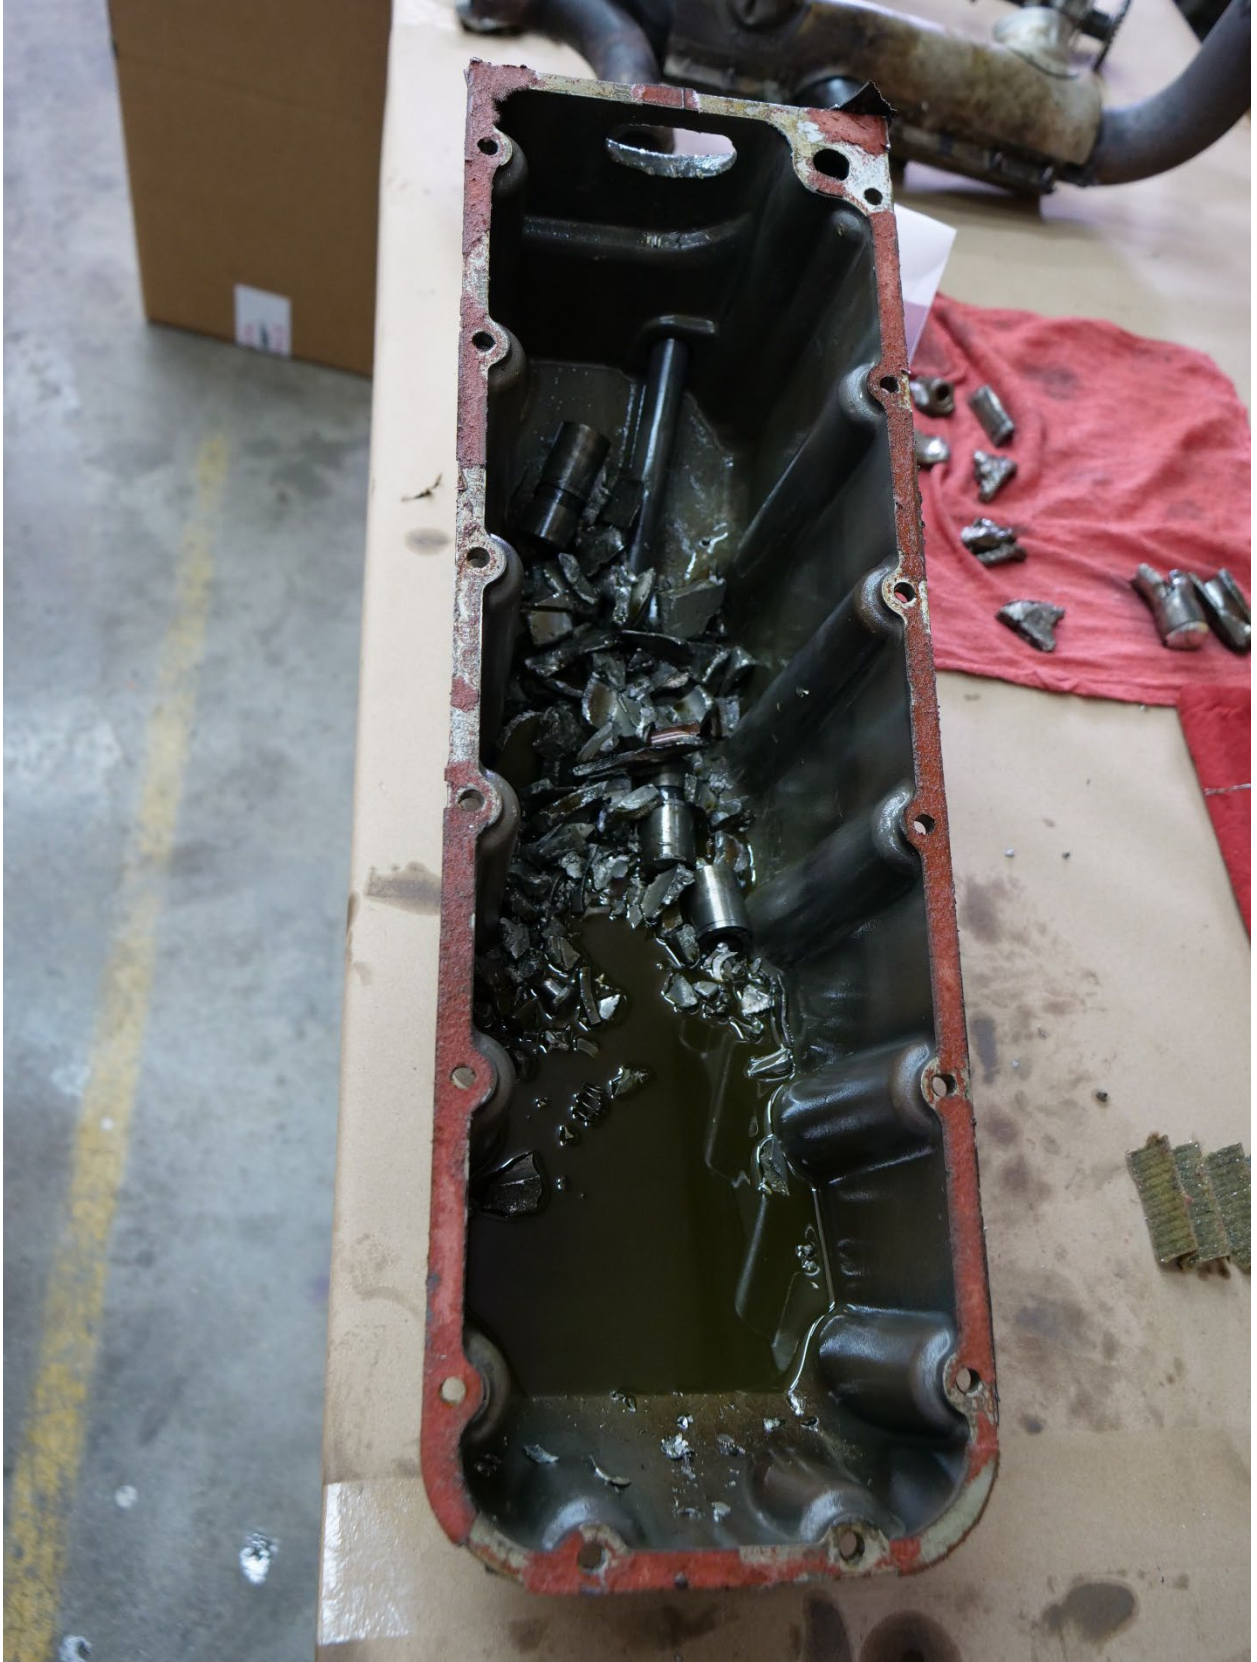
**Photo 8: Oil pan containing a large amount of metallic debris.**

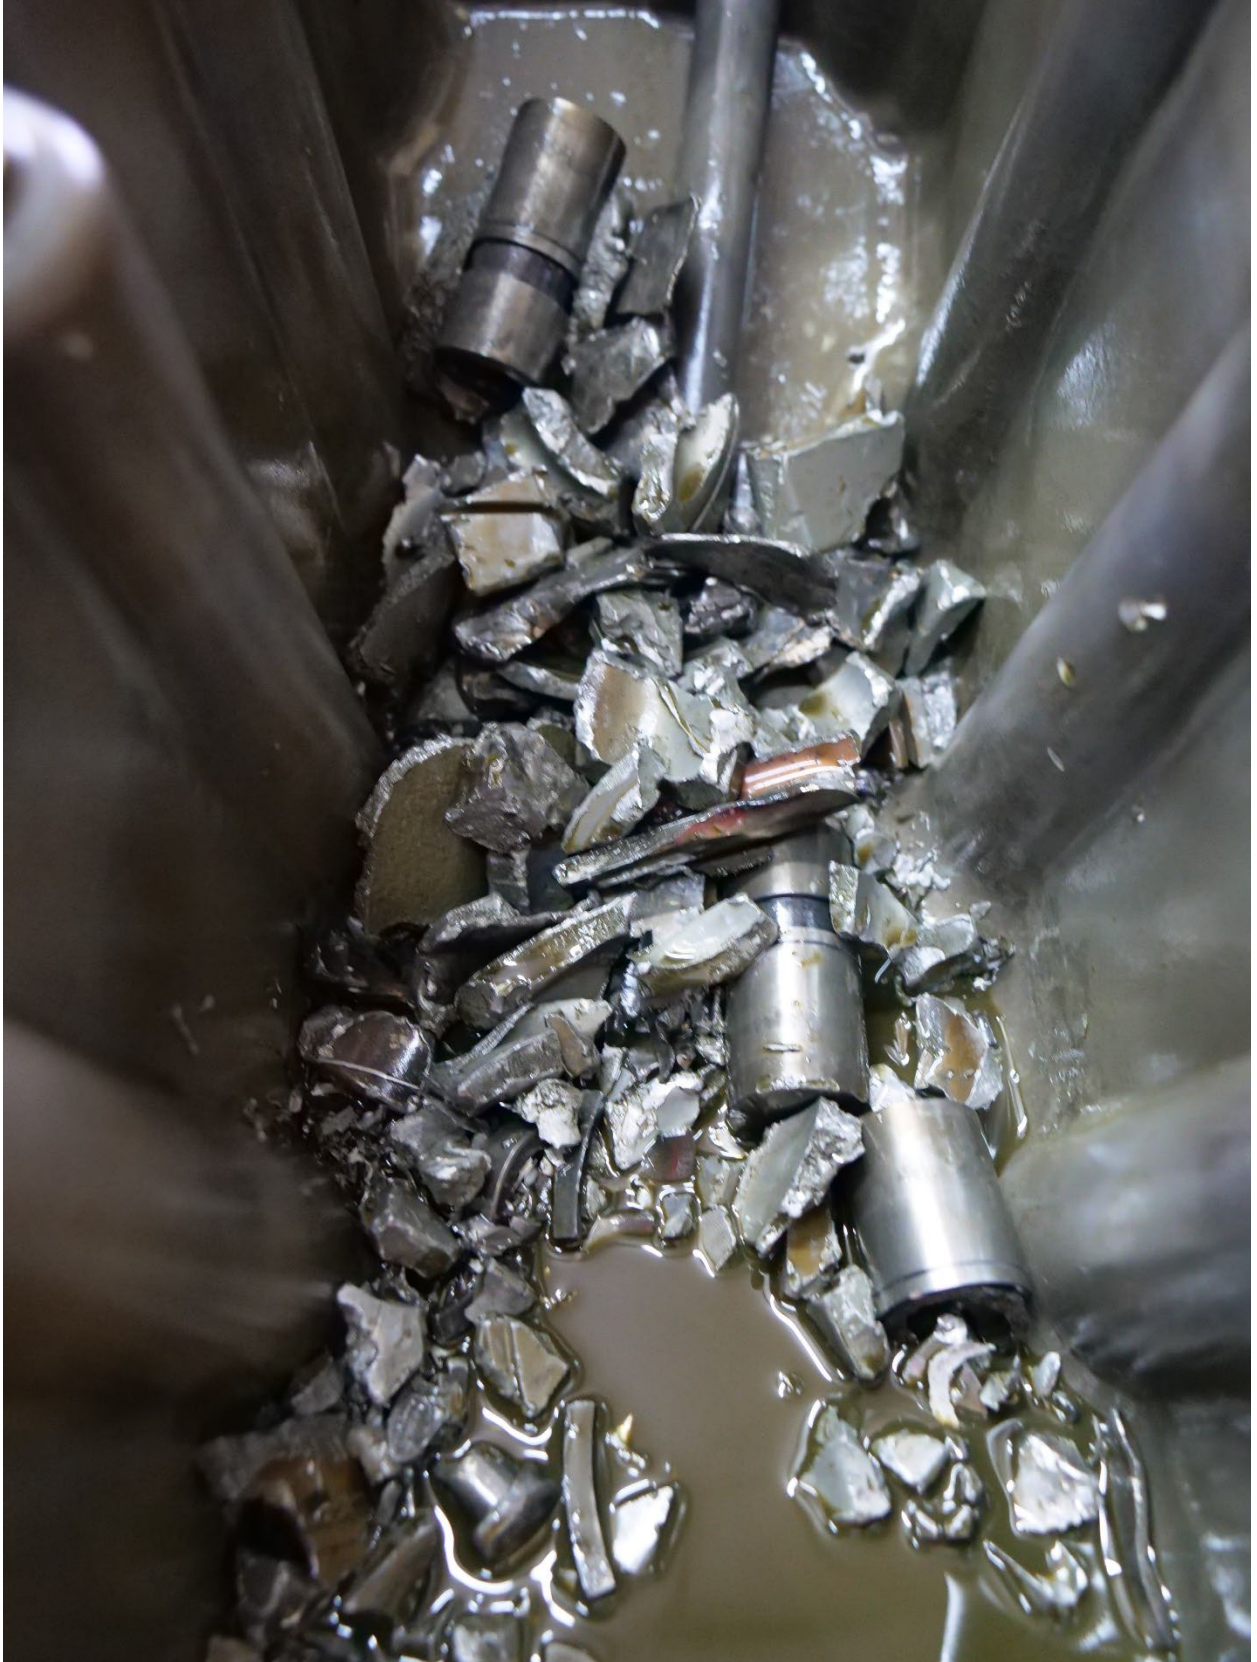
**Photo 9: Metallic debris located in the oil pan.**
