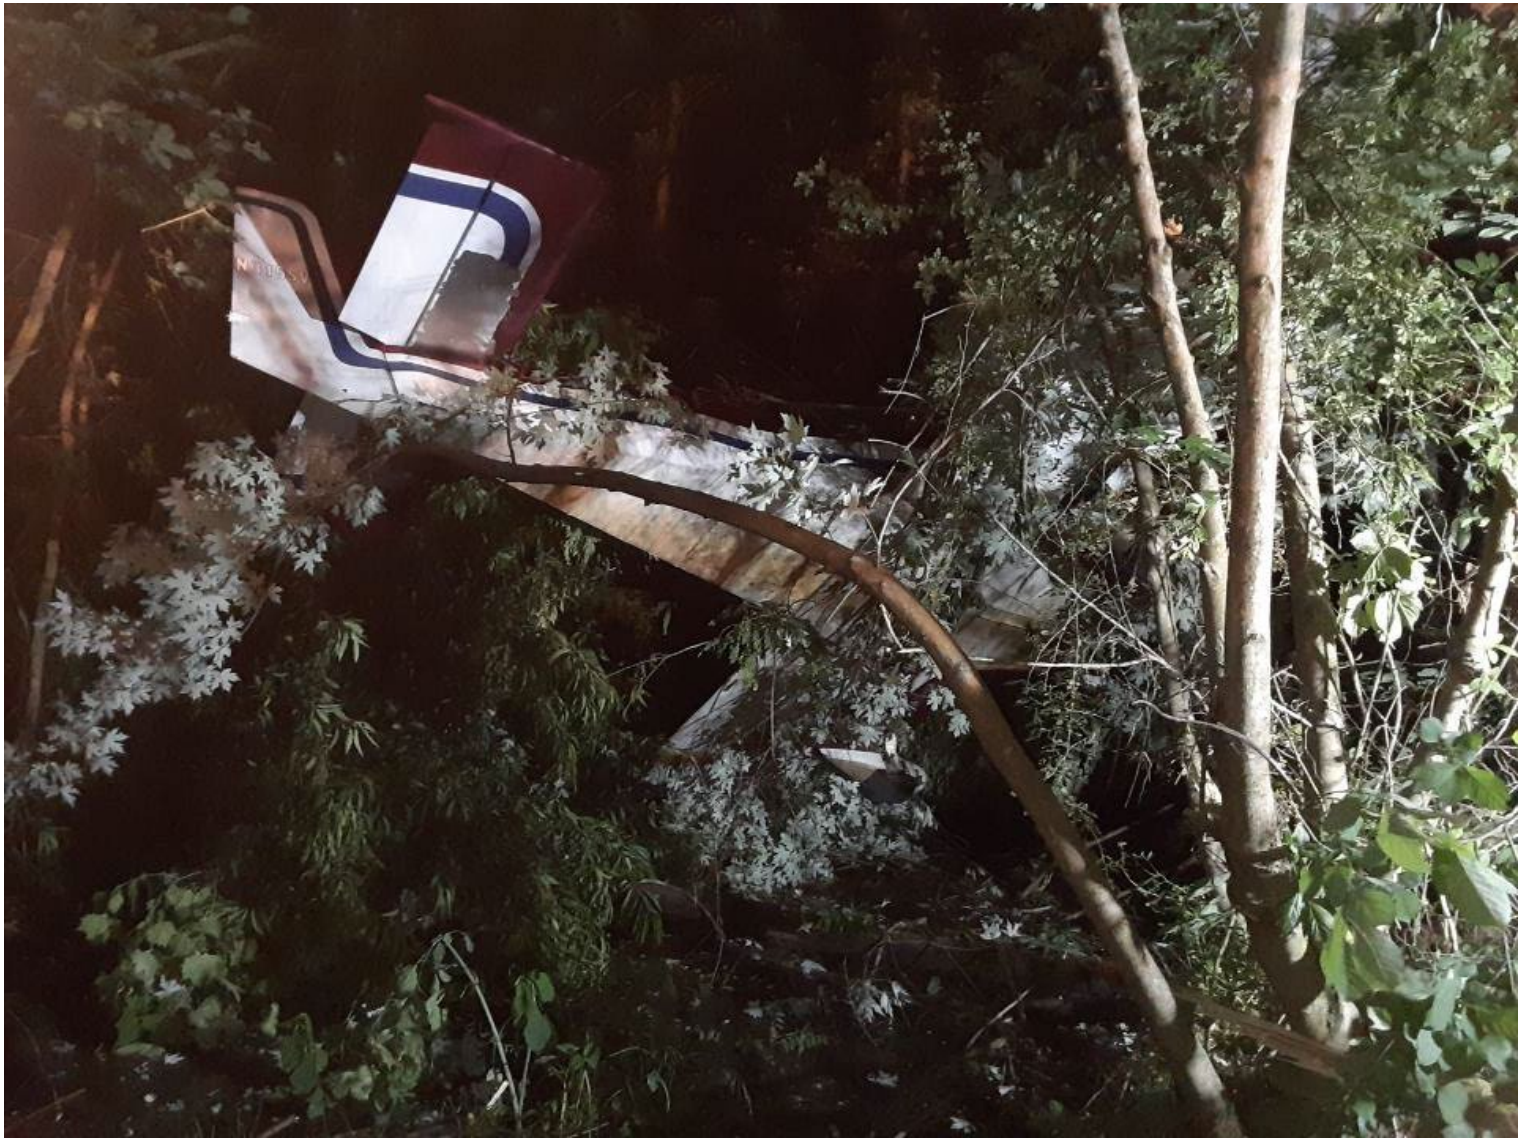
**Photo 1 – Right aft view of airplane in the trees. (Courtesy of Cumberland Fire Rescue)**

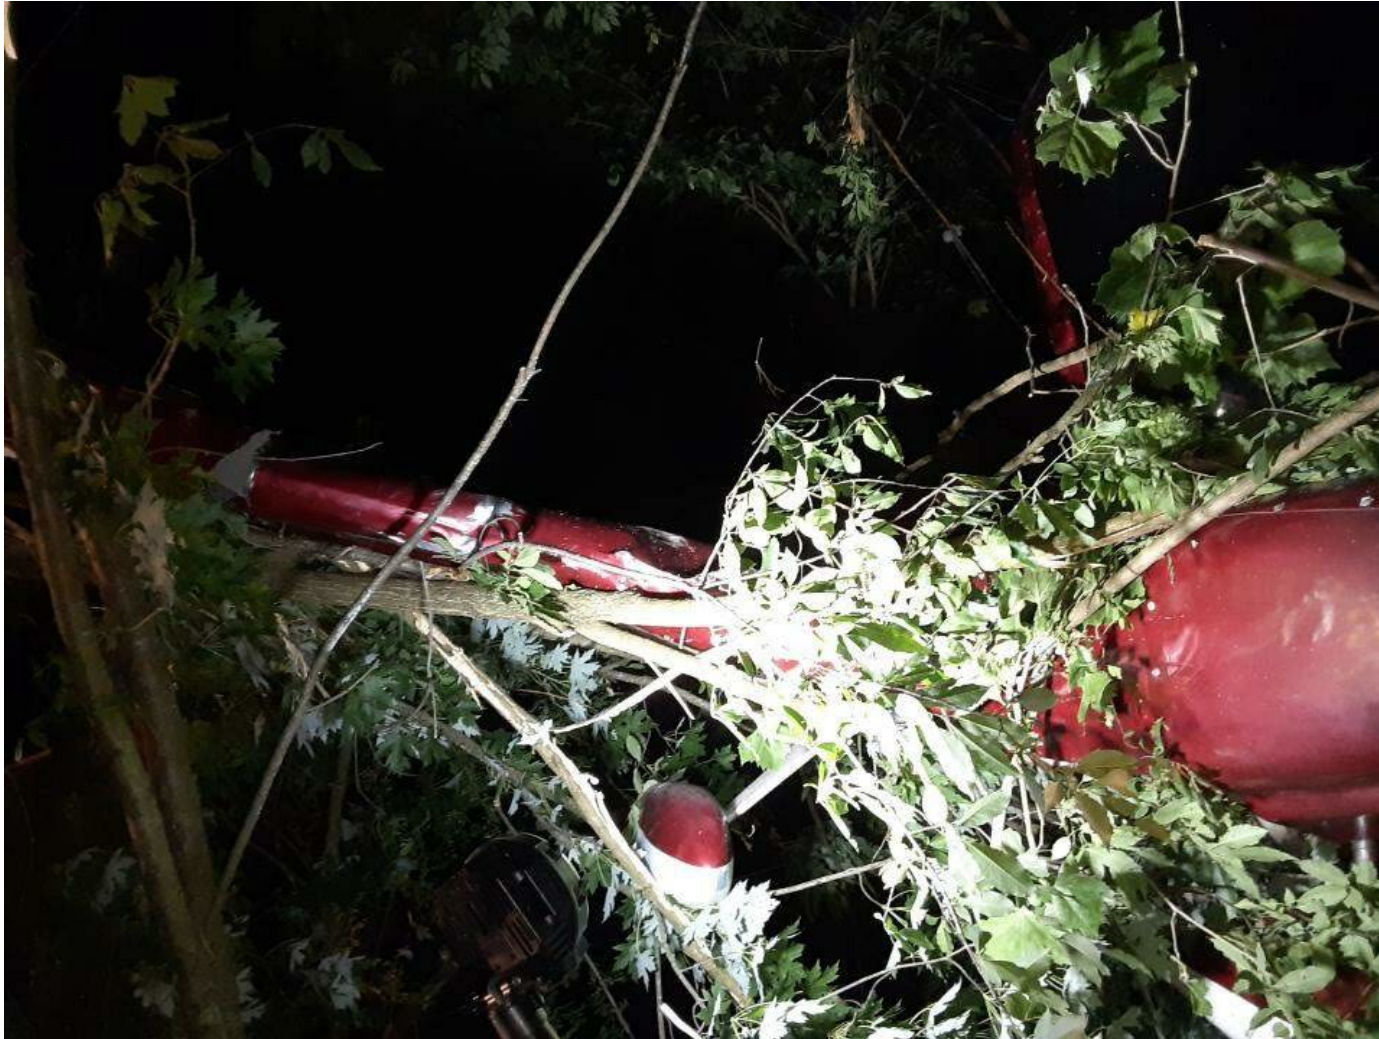
**Photo 2 – View of right wing damage. (Courtesy of Cumberland Fire Rescue)**

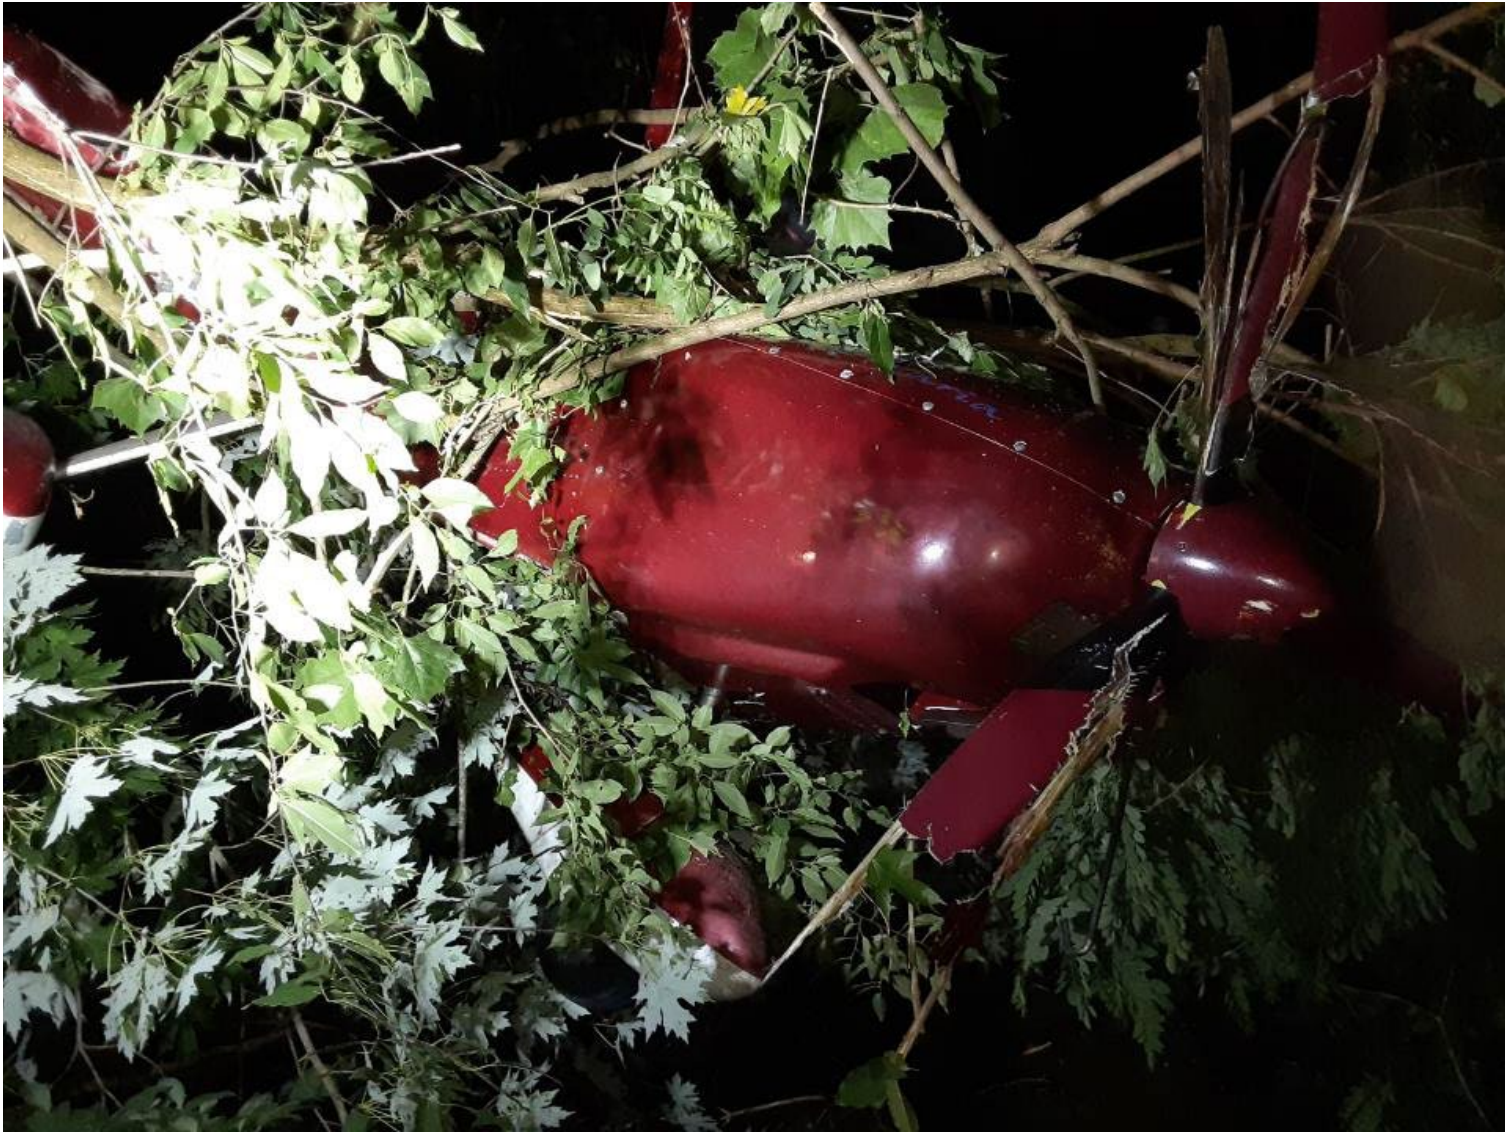
**Photo 3 – View of propeller damage. (Courtesy of Cumberland Fire Rescue)**

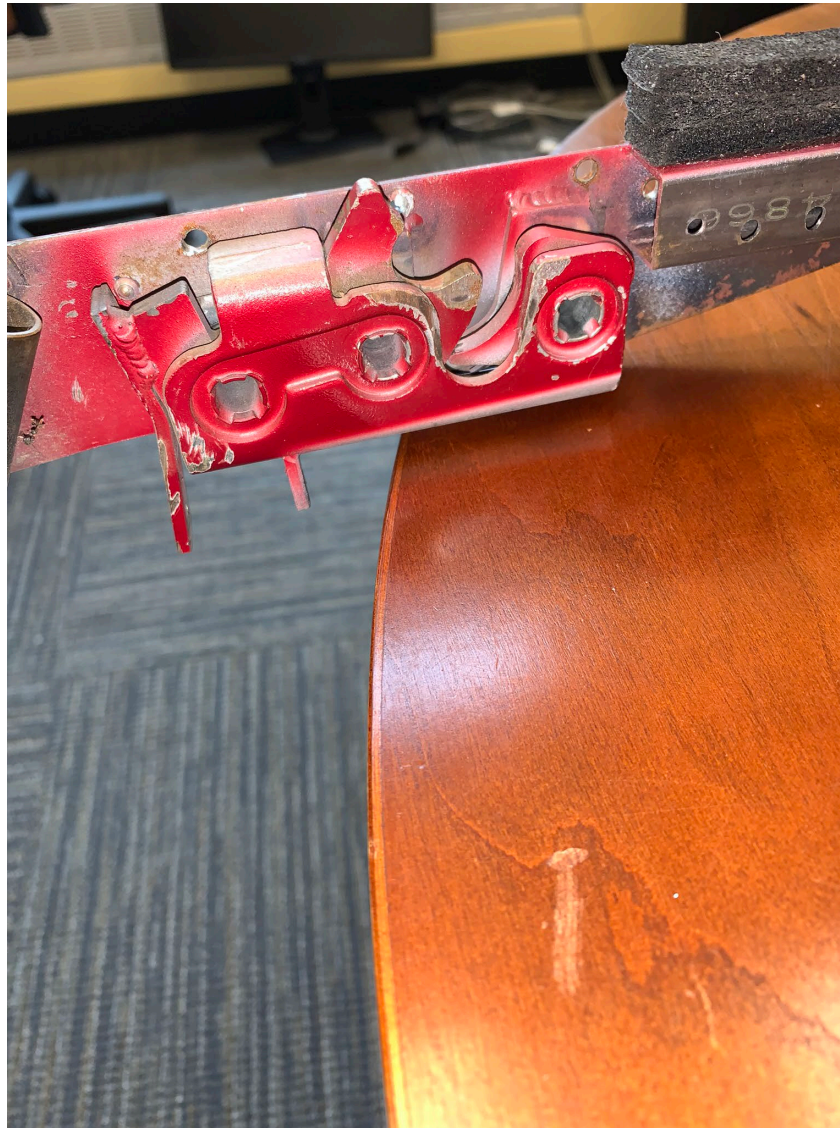
**Photo 4 – View of right canopy frame and latch assembly without striker pin installed. Note weatherstripping.**

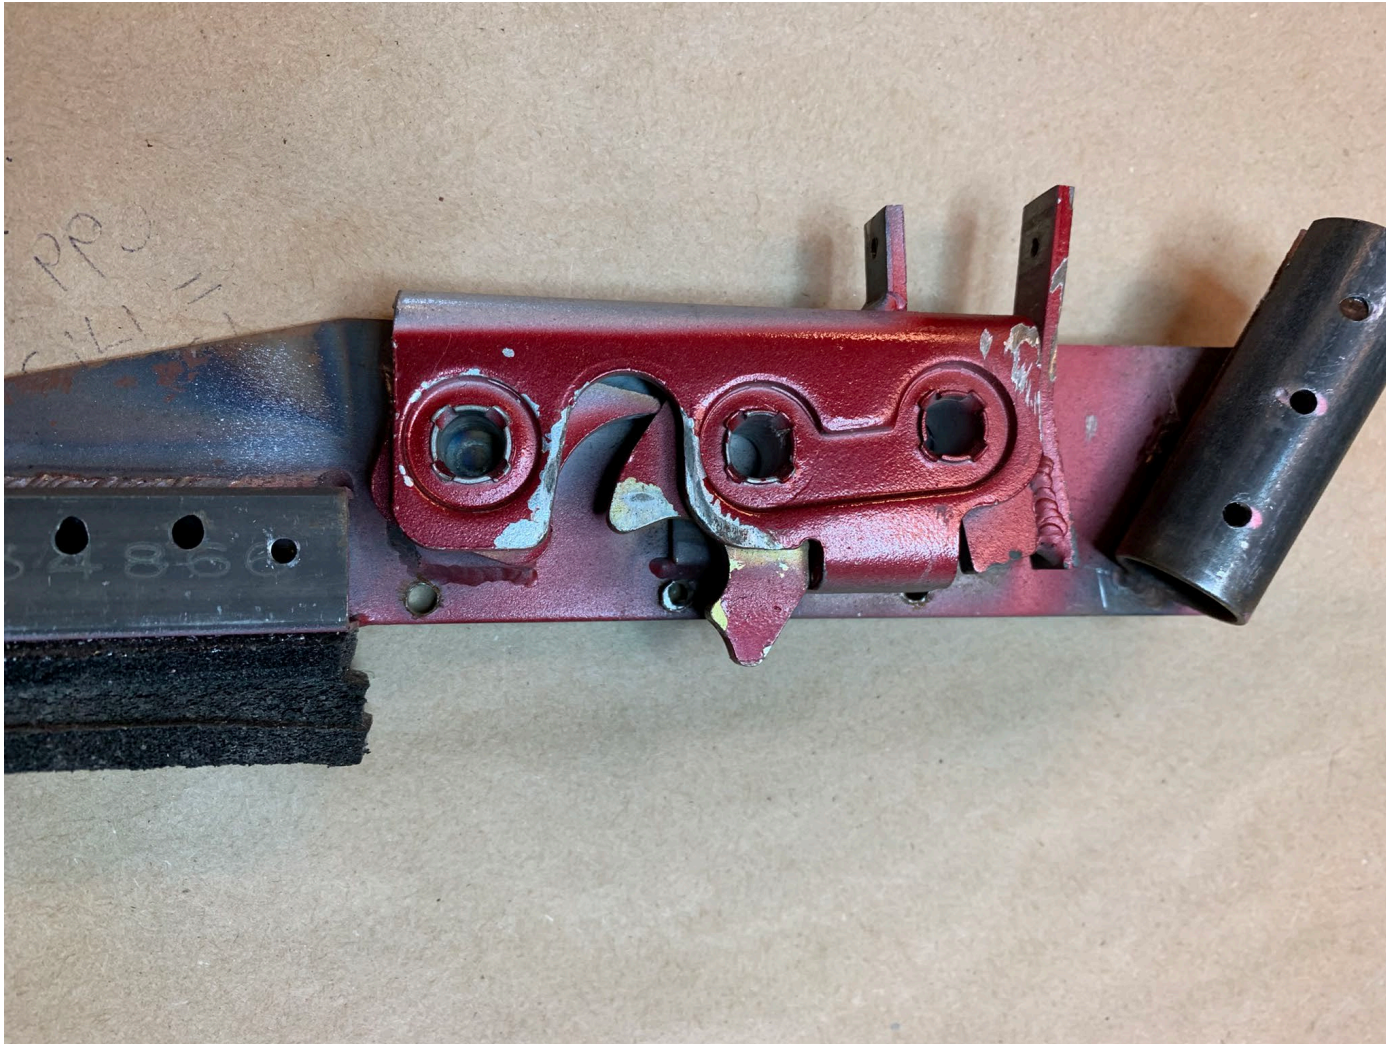
**Photo 5 – Closeup view of canopy latch without striker pin. Photograph is in correct orientation.**

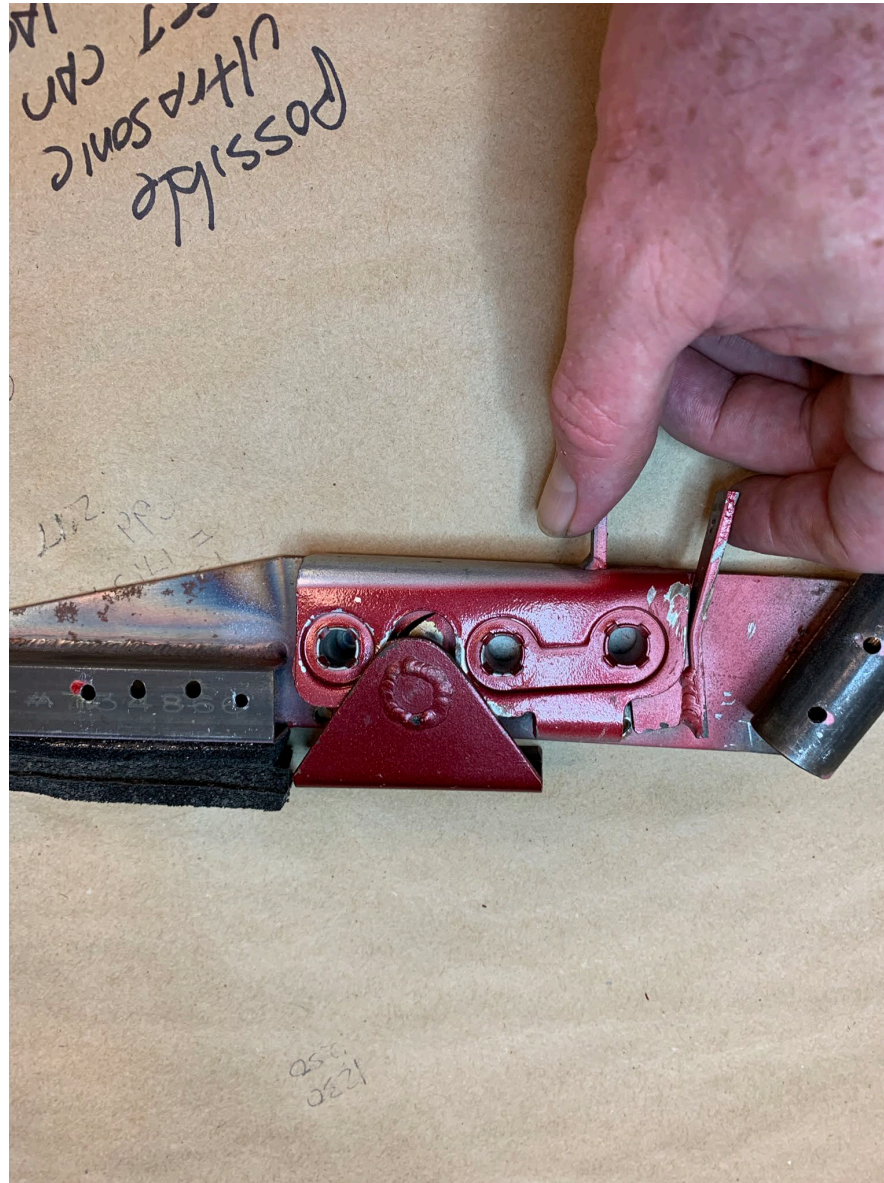
**Photo 6 – Closeup view of canopy latch with striker pin in the latch mechanism. Note fingers on the trigger for scale.**

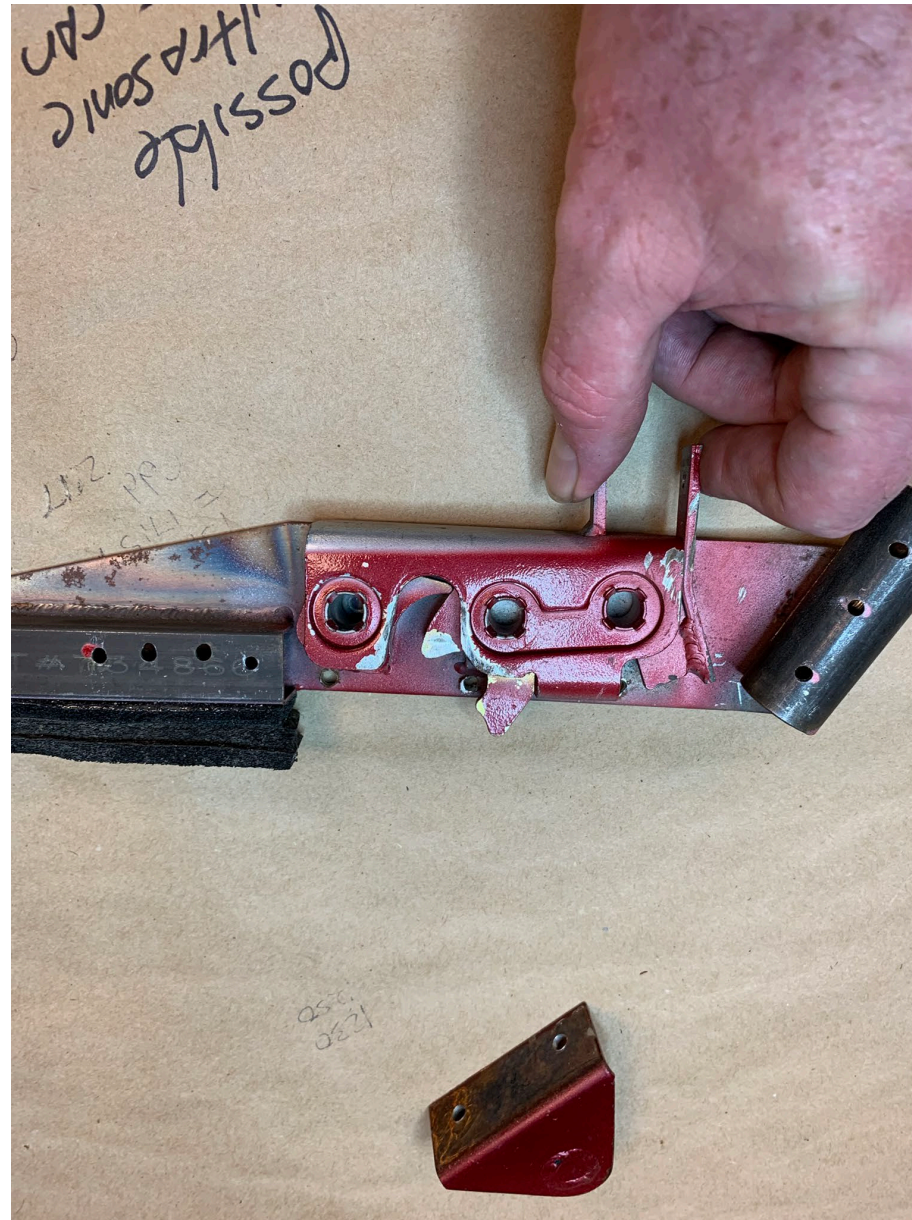
**Photo 7 – Closeup view of canopy latch with striker pin ejected after applying pressure to trigger.**
