## **NATIONAL TRANSPORTATION SAFETY BOARD**

**Photo Array**

**ERA21LA248**

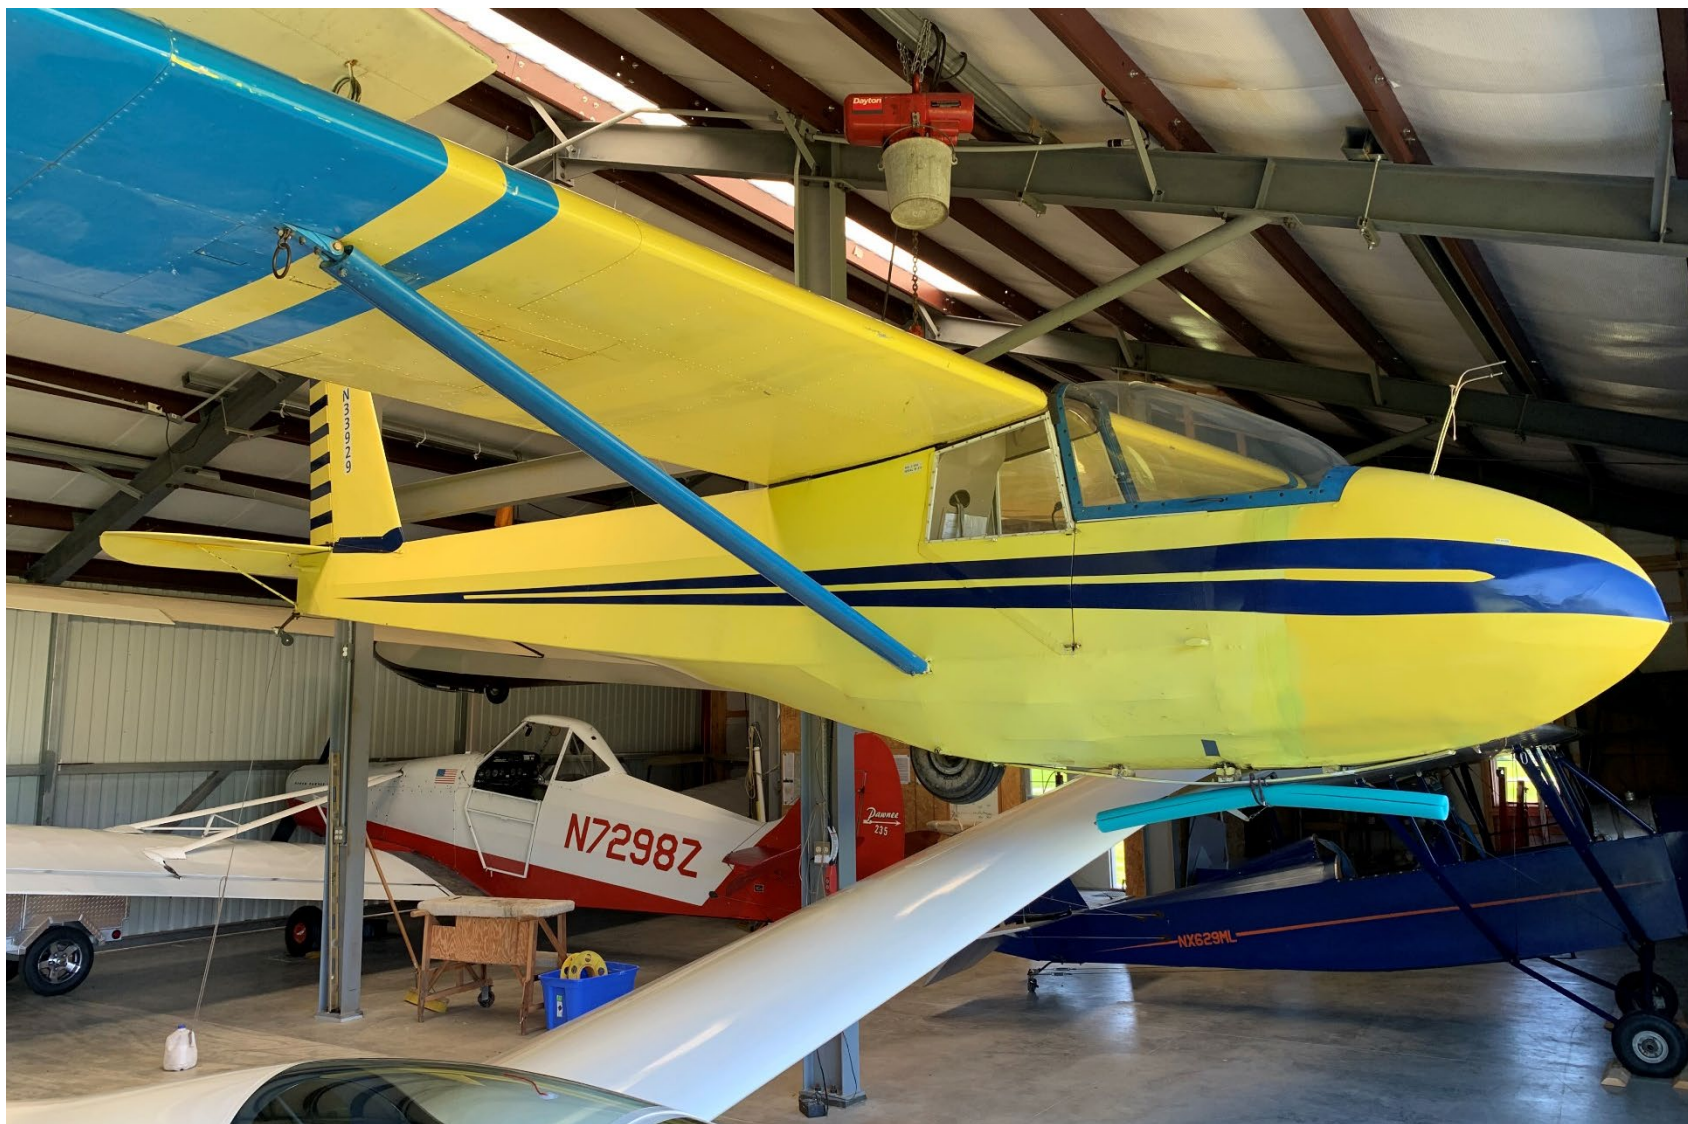
**Photo 1 – View of undamaged glider. (Photo courtesy of FAA)**
