**ERA21LA250**

**Matthews, VA**

**Diamond DA20-C1**

**NTSB ENGINE EXAMINATION REPORT**

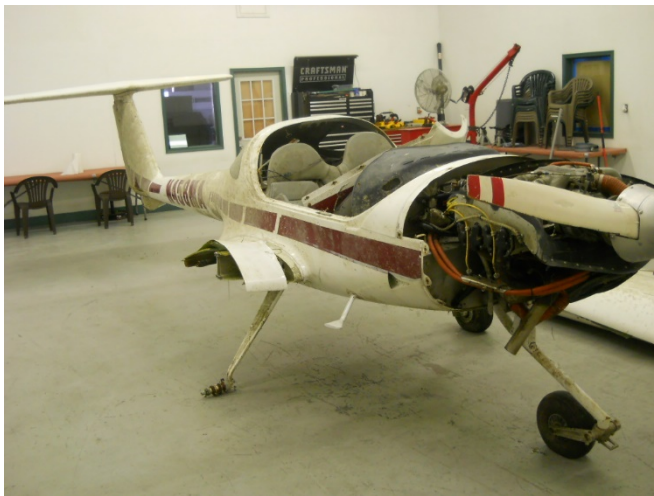
- The engine remained attached to the airframe through all engine mounts.
- The propeller remained attached to the flange.
- Two holes were present on the top of the crankcase (rear left and rear right).
- The cylinders remained attached to the crankcase.
- The drain plug was missing from the bottom of the oil sump and no oil was observed in the engine.

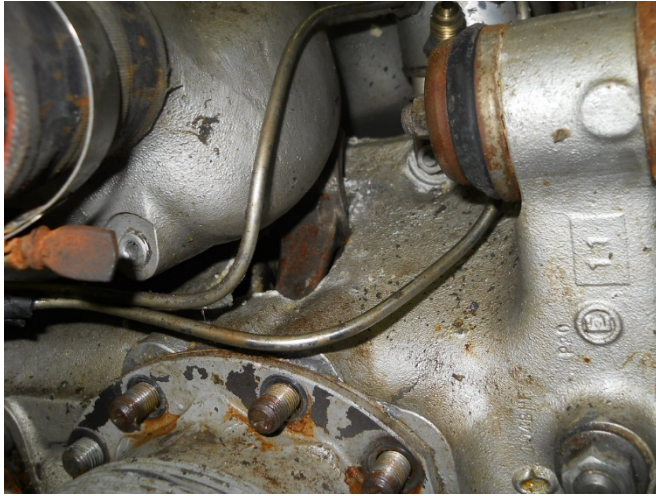
The baffling was removed from the left side to facility access to the cylinders. The No. 2 cylinder could not be removed, and a section of its fractured connecting rod was protruding through the hole on the top left side of the crankcase. The Nos. 3 and 4 cylinders were removed to provide further access to the crankshaft. The No. 1 cylinder could also not be removed; however, inspection through the left crankcase hole revealed that its connecting rod had fractured also.

The examination revealed that oil sump drain plug was missing and the Nos. 1 and 2 connecting rods fractured due to oil starvation.

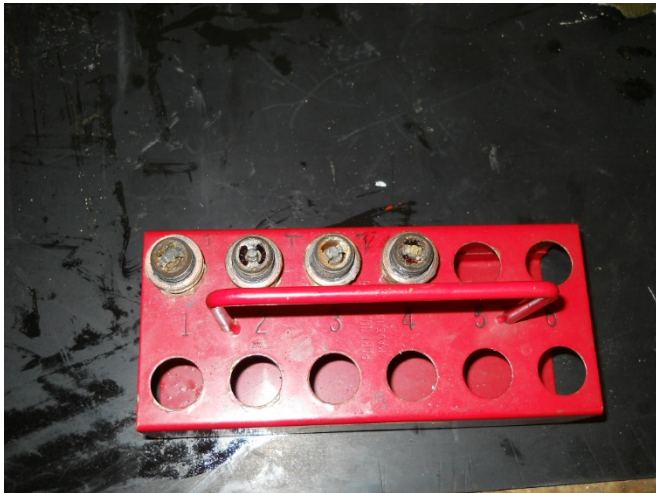
All spark plugs were removed from the engine and their electrodes were intact with corrosion observed.

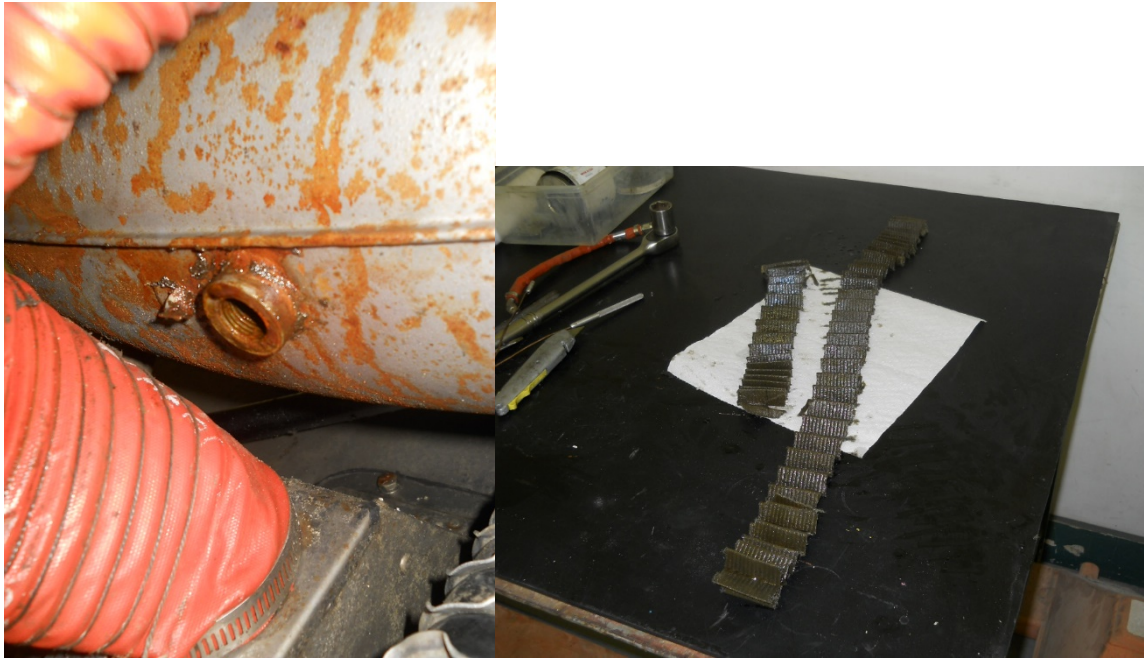
No metallic debris was observed in the oil sump or oil filter element.
