**NATIONAL TRANSPORTATION SAFETY BOARD**  
Office of Aviation Safety

**WRECKAGE EXAMINATION**  
Anglin Air Recovery, Clayton Delaware  
September 29, 2021

**A. ACCIDENT      ERA21LA267**

Location:            Easton, MD  
Date:                June 24, 2021  
Time:                1145 Eastern Daylight Time (EDT)  
Operator:           Trident Aircraft Inc.  
Aircraft:            Piper PA-28-161  
Registration:       N2143G

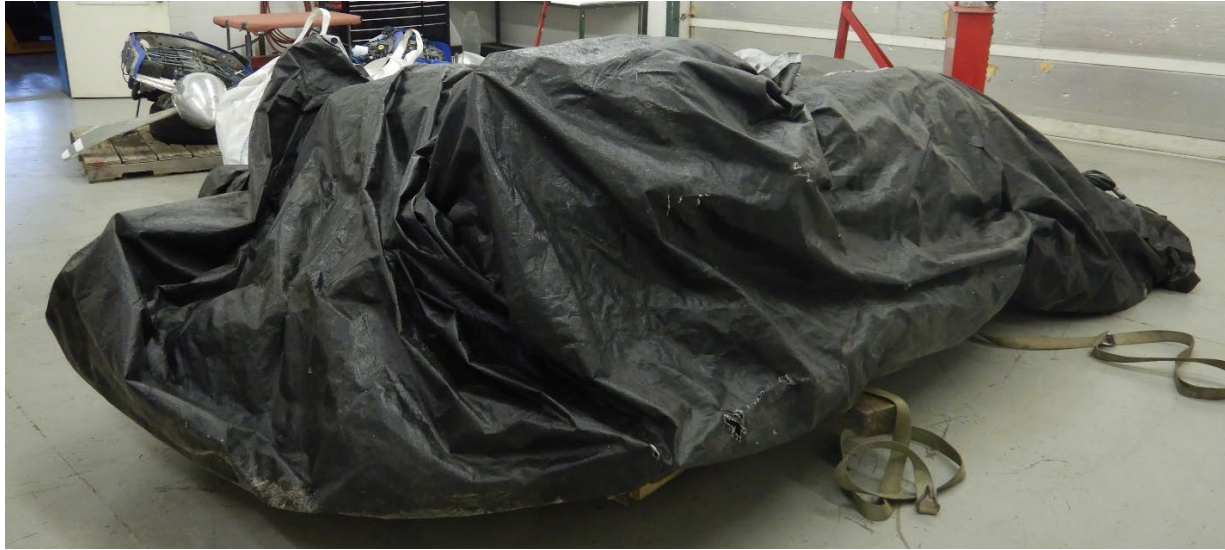
**Photograph #1 - Airframe covered.**

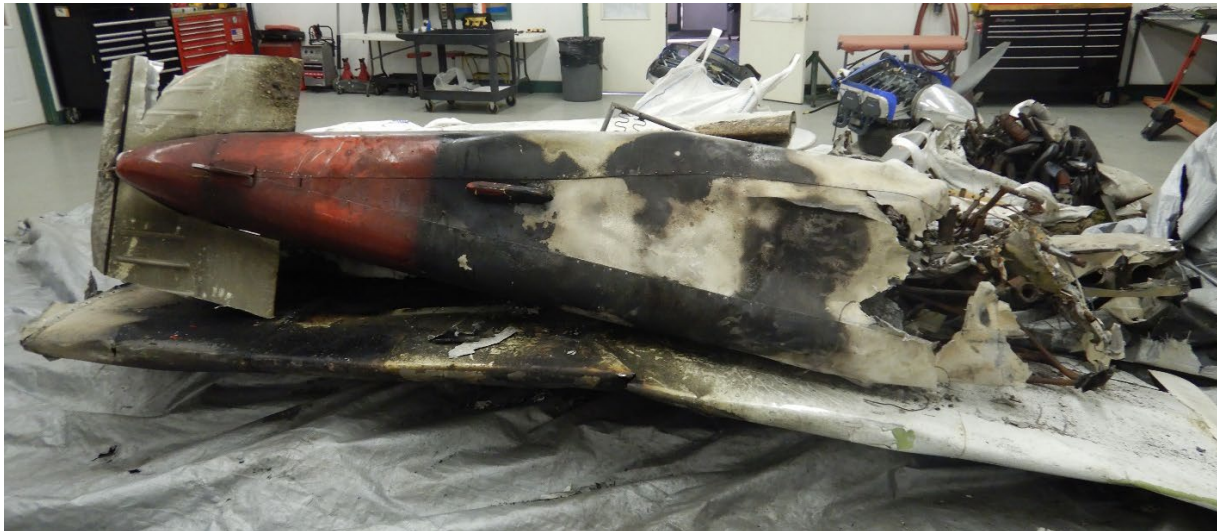
**Photograph #2 - Airframe uncovered.**

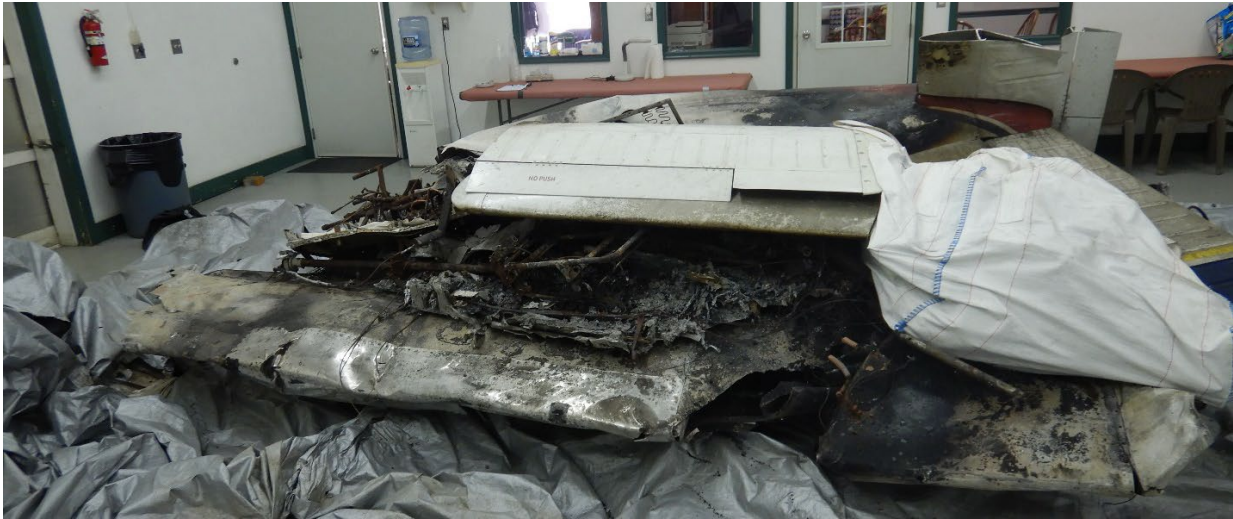
**Photograph #3 - Airframe wreckage.**

The fuselage above the lower fuselage skin and structure below the floorboards was consumed by fire. Seat #1 & #2 remained located in their respective locations in the fuselage, however all of the cushion and upholstery material was consumed. The rear bench seat frame was separated from the fuselage and all the cushion and upholstery material was consumed. The main cabin door handles and latch mechanism were observed in the debris; however the door was consumed. The instrument panel was consumed. Most of the instruments, avionics, gauges, and switches were fire damaged and unreadable.

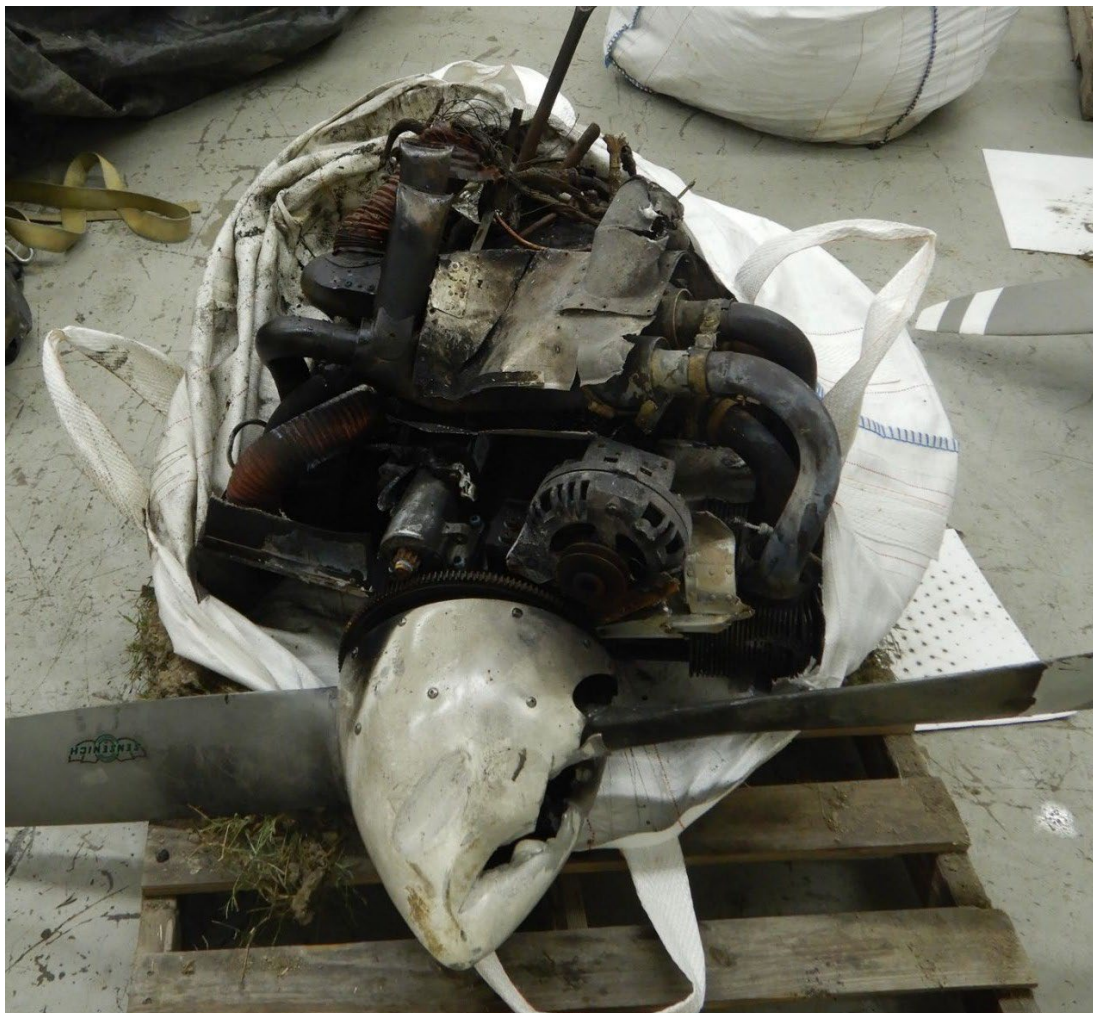
**Photograph #4 – Engine.**

As first viewed, the engine was detached from the airframe by the recovery team and was sitting in a bag on a wooden pallet. The engine was laying upside down on the pallet. The engine was hoisted and positioned upright for the examination. Thermal damage was evident on the exhaust and intake pipes, the accessories, and the accessory housing, and on the engine rocker box covers. The propeller remained attached to the crankshaft flange, but the crankshaft flange was bent from the impact forces.
