# National Transportation Safety Board

ERA21LA275

## WRECKAGE EXAMINATION

Airplane: Bell 206B, Registration N134VG

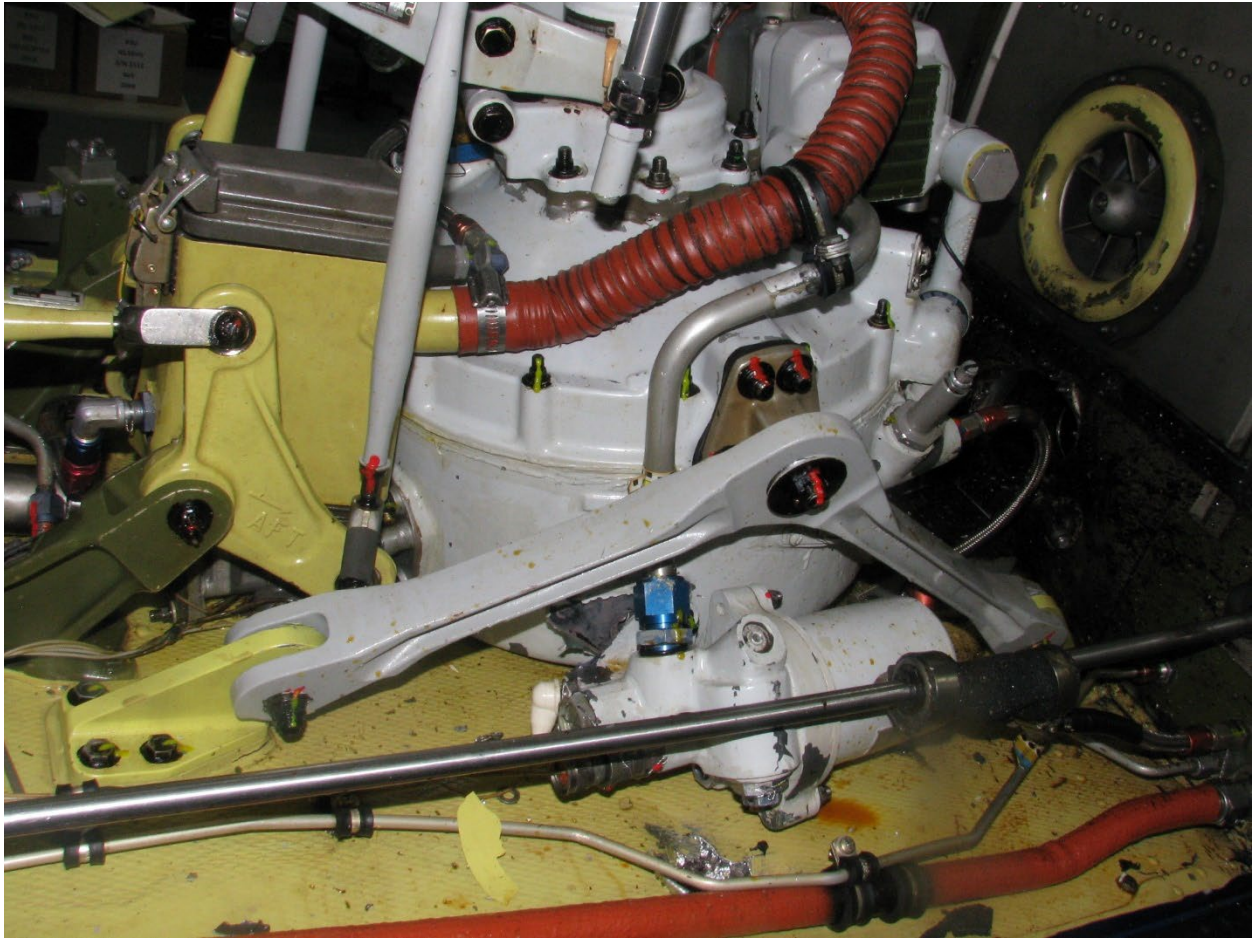
Drive continuity was demonstrated within the main transmission. Drive system mounts were intact and secure.

**Figure 1 -Transmission and Mounts - Left Side (Courtesy Bell)**

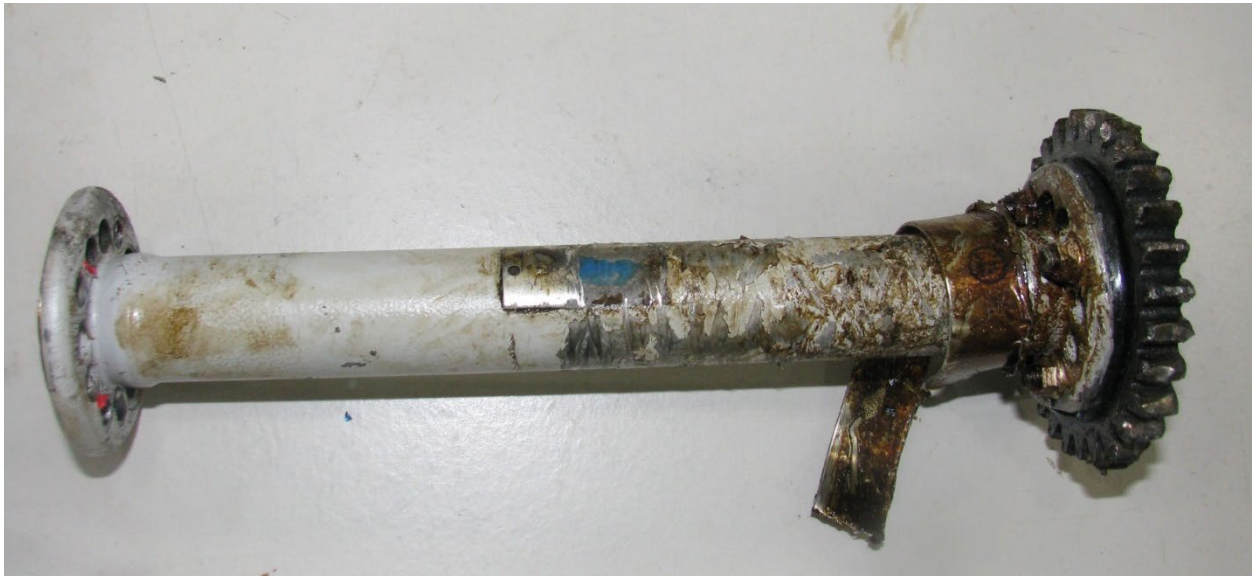
The main driveshaft exhibited disconnects at both ends with grease remnants observed from both forward and aft couplings.

**Figure 2 - Main Driveshaft (courtesy Bell)**

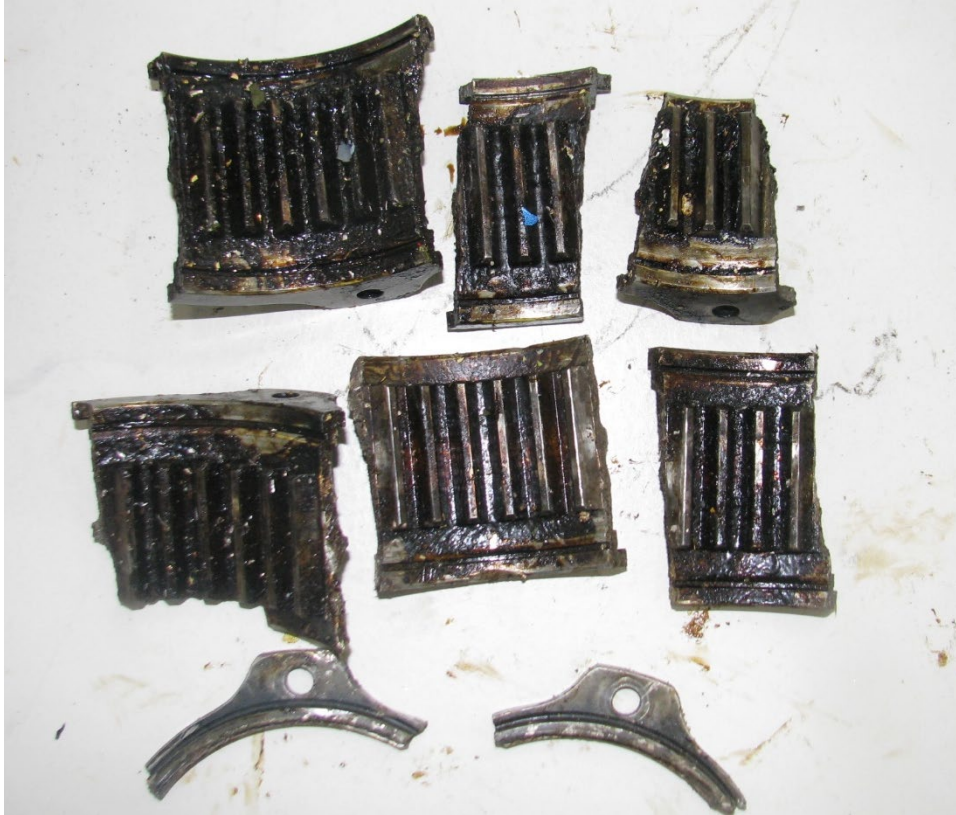
The forward transmission end exhibited axial fractures of the outer coupling consistent with misalignment during the impact sequence.

**Figure 3 - Transmission side main driveshaft outer coupling (courtesy Bell)**

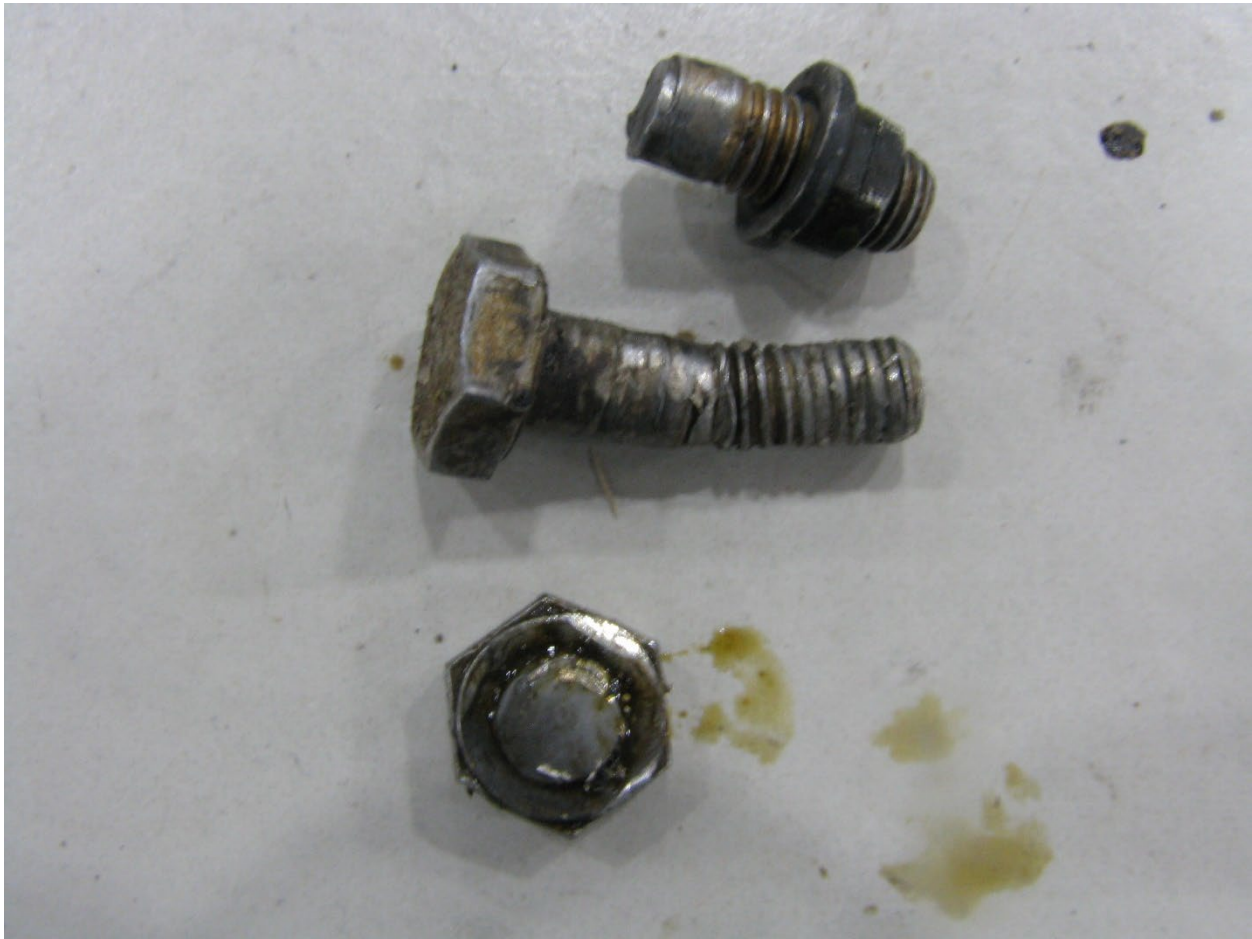
Three bolt fragments for the main driveshaft outer coupling attachment to the transmission input shaft were found fractured or bent.

**Figure 4 - Bolt remnants for main driveshaft outer coupling attachment to transmission input flange (courtesy Bell)**

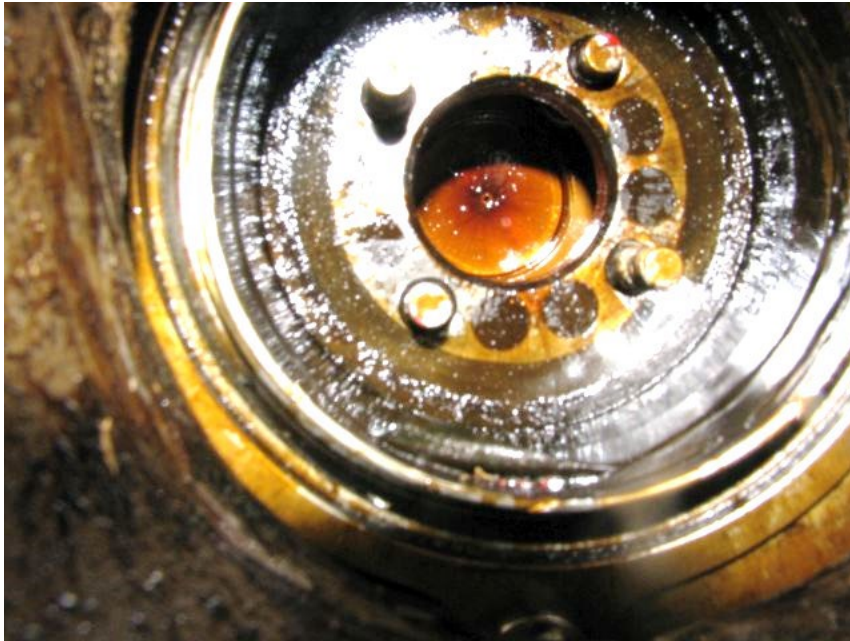
The aft main driveshaft end exhibited a separation of the driveshaft tube from the inner coupling which remained within the aft outer coupling that was still attached to the engine.

**Figure 5 - Main driveshaft inner coupling remained in engine end (courtesy Bell)**

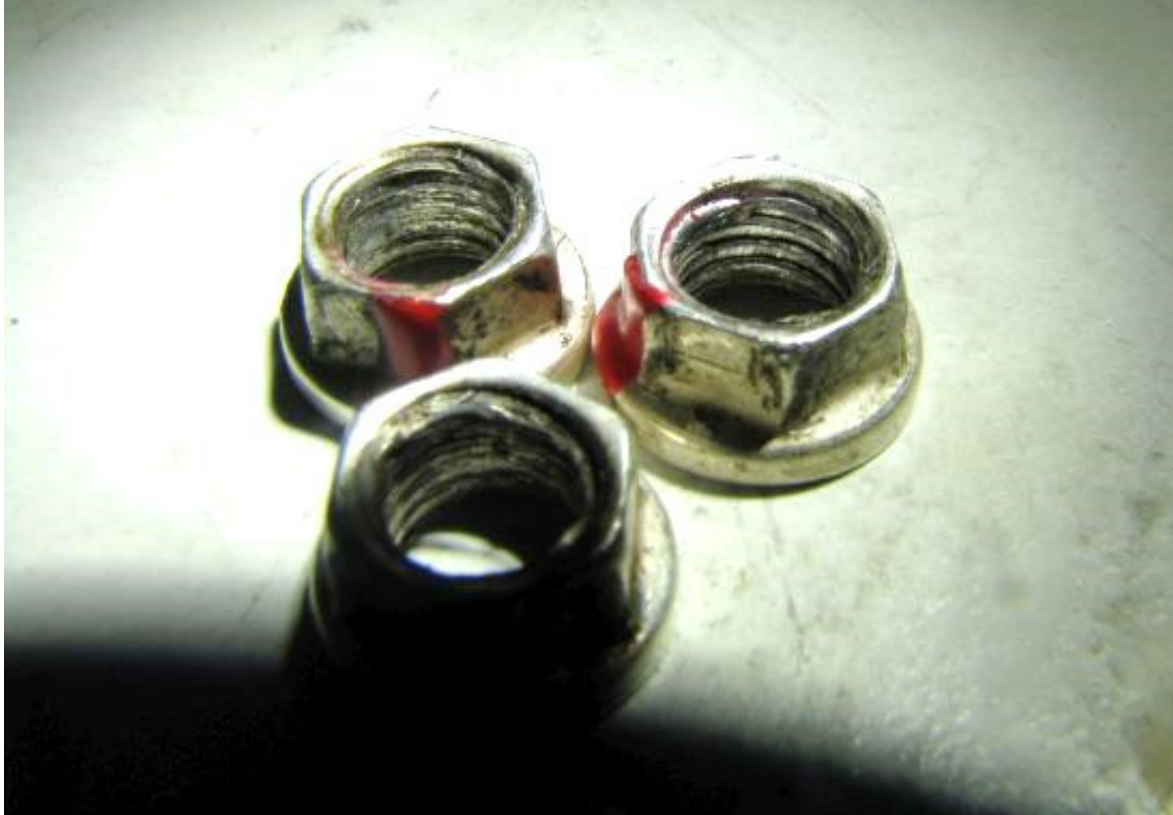
Silver plated nuts (specified to be used) were found separated from the inner coupling retention bolts. Evidence of thread remnants from the bolts were observed in the nuts, consistent with an overload pull event at impact.

**Figure 6 - Stripped silver plated nuts to secure engine end main driveshaft inner coupling to driveshaft tube (courtesy Bell)**

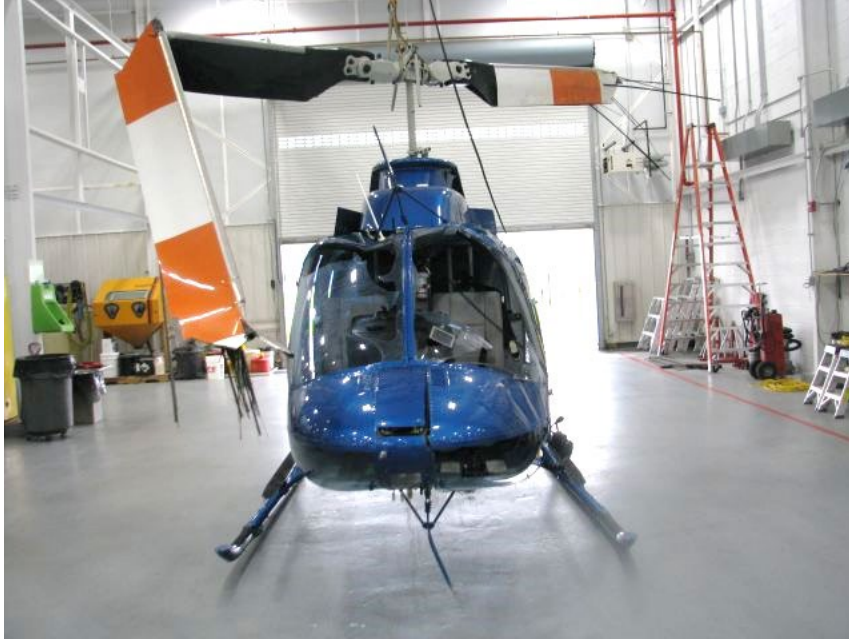
The helicopter was equipped with STC main rotor blades from Van Horn Aviation. The blades both exhibited damages consistent with rollover while rotating. Both blades exhibited detached tips, trim tab separations, chordwise fractures and fragmenting of blade skins and internal foam core.

**Figure 7 - Damage to main rotor blades (courtesy Bell)**

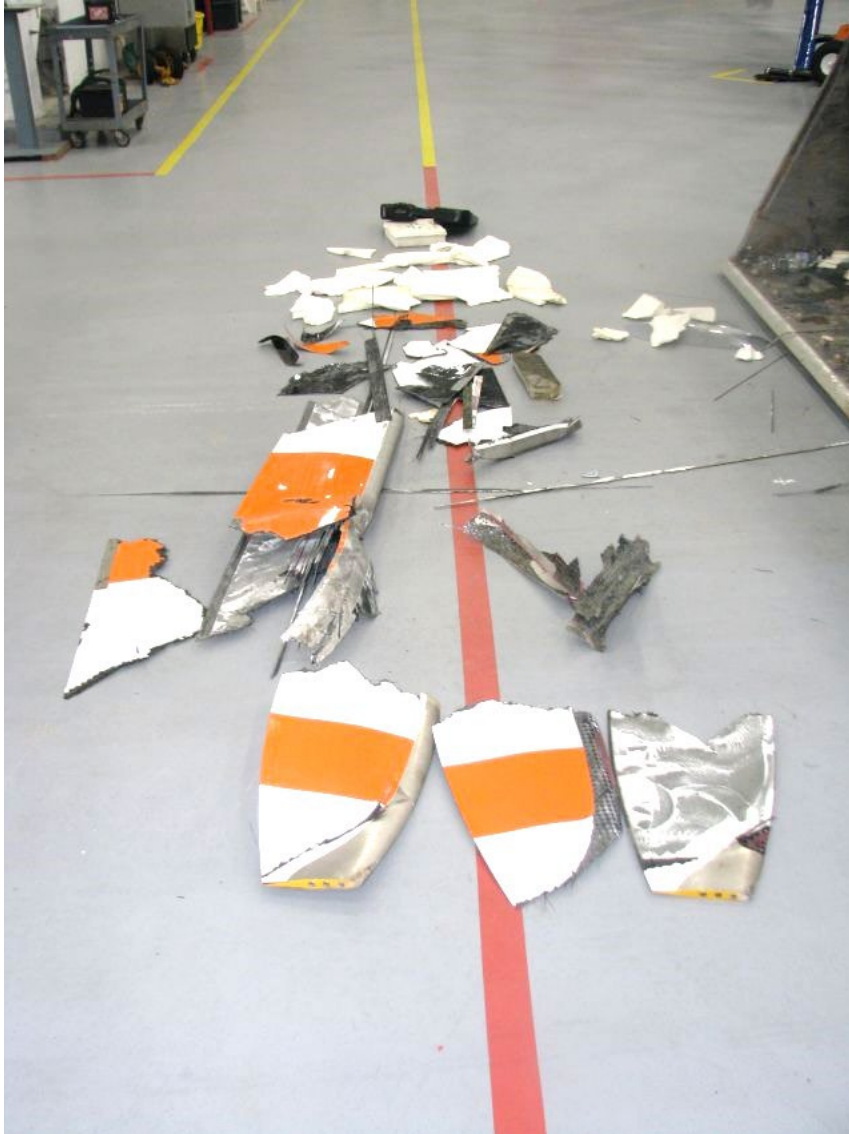
**Figure 8 - Recovered blade fragments including tips, blade sections, trim tabs, and foam core (courtesy Bell)**

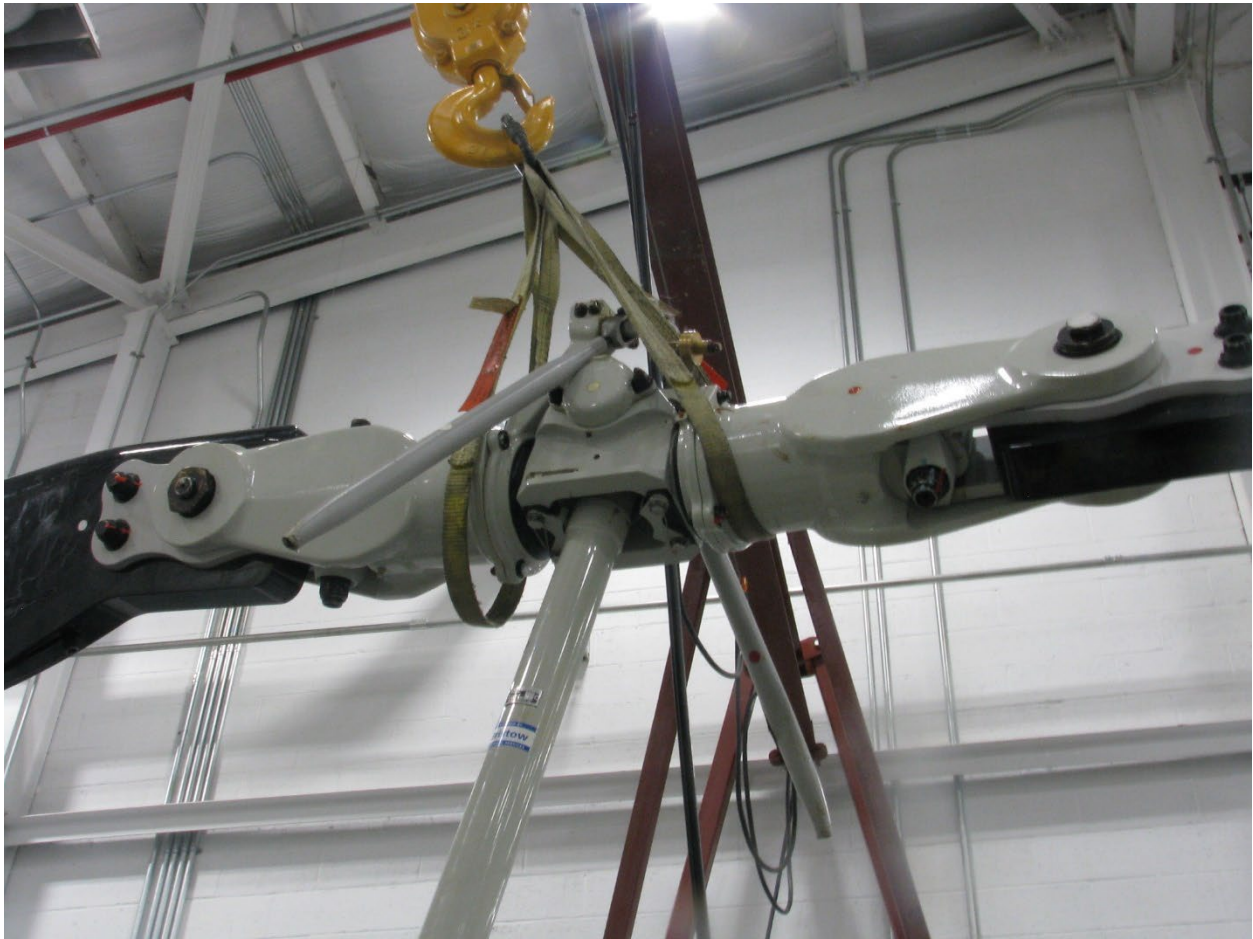
The main rotor hub was intact. Both main rotor pitch change links exhibited overload fractures.

**Figure 9 - Intact main rotor hub. Both pitch change links fractured at bottom swaged surfaces consistent with overload (courtesy Bell)**

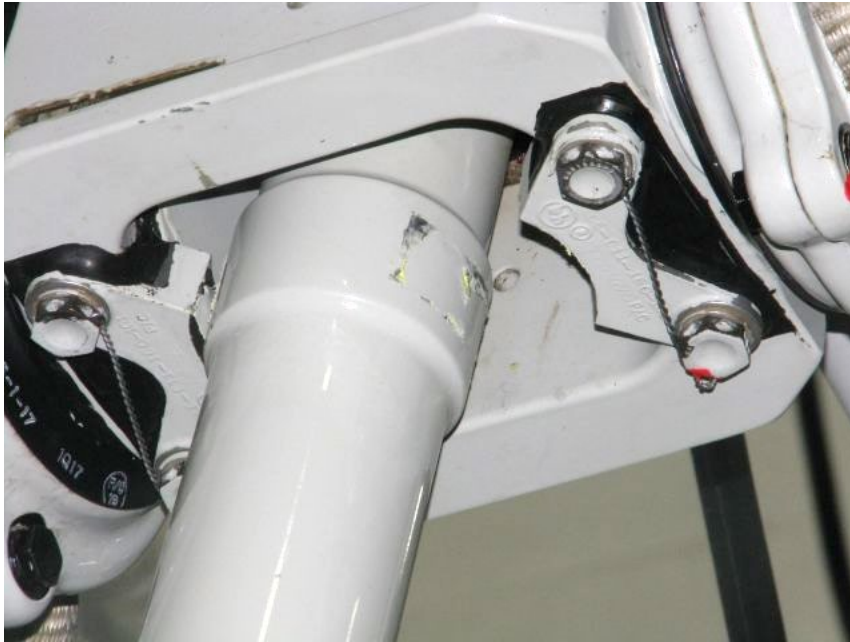
Hub to mast contact marks were present.

**Figure 10 - Main rotor hub static stop contact from excessive hub flapping (courtesy Bell)**

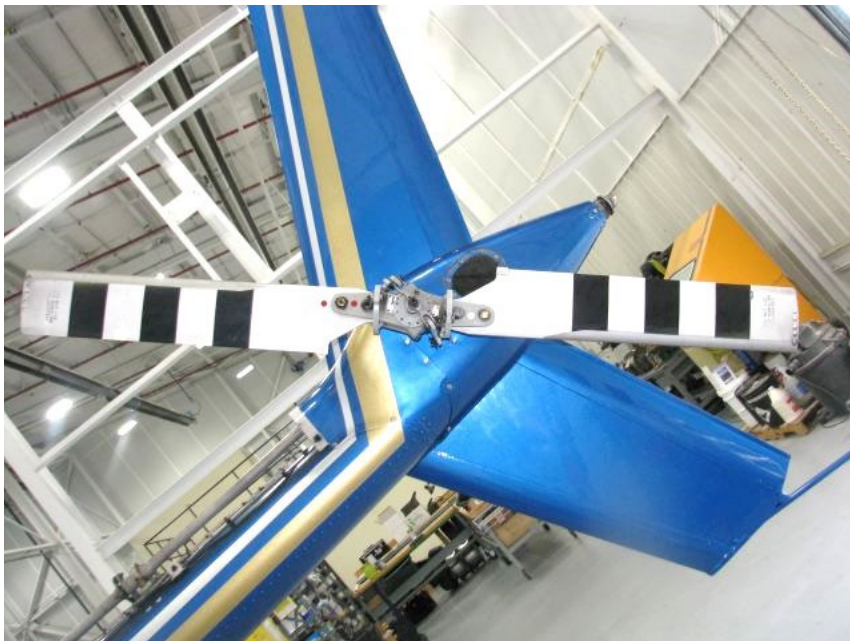
The tail rotor hub and blades were intact.

**Figure 11 - Intact tail rotor hub and blades (courtesy Bell)**

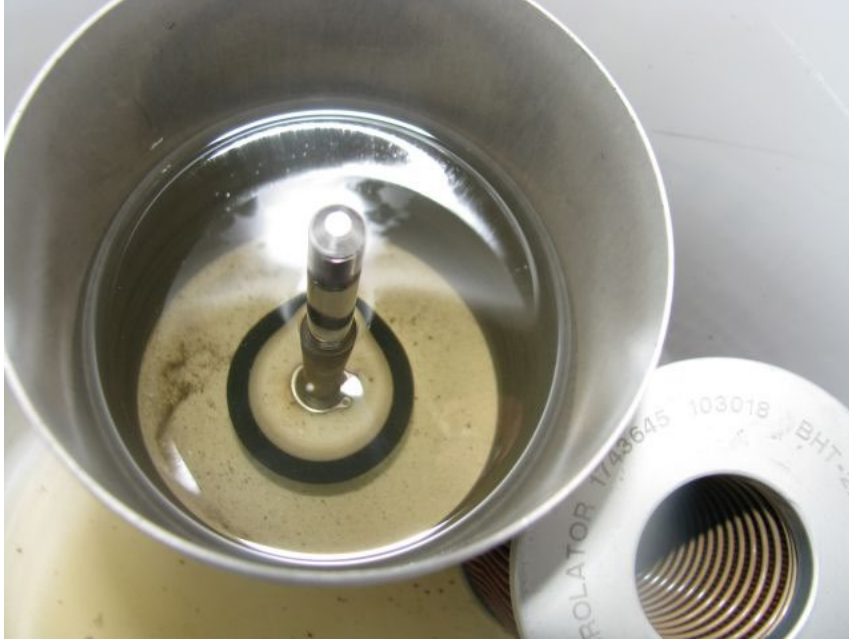
**Figure 12 - Airframe fuel filter canister with clear/slight yellow fuel and small amount of particulate (courtesy Bell)**

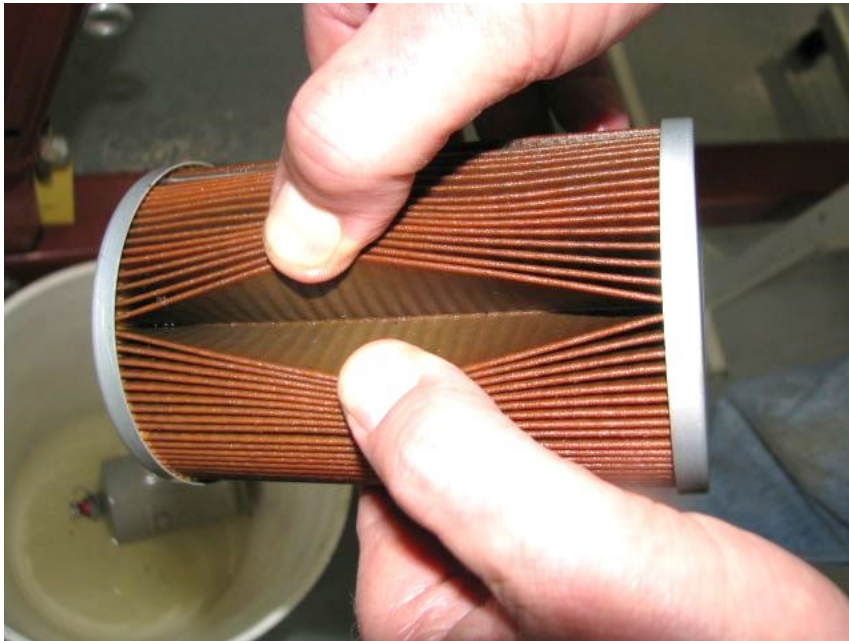
**Figure 13 - Fuel filter with little particulate observed (courtesy Bell)**

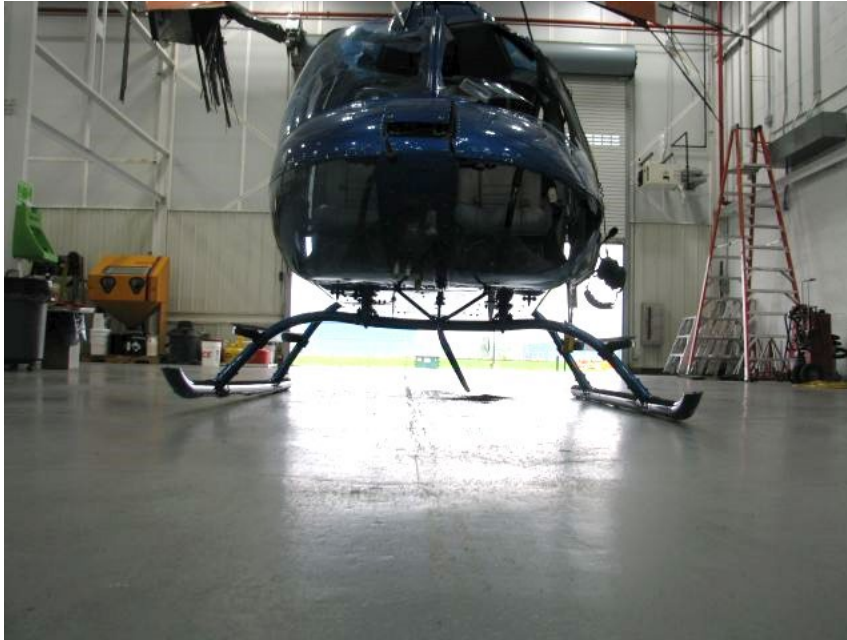
All seat belts were intact and the cockpit shoulder harnesses operated properly. The skids spread from the impact. The left and right windscreens were broken. The cockpit roof was cracked near the right forward transmission mount consistent with forces applied during the impact sequence. The left side horizontal stabilizer was bent consistent with a left rollover.

**Figure 14 - Skids slightly spread (courtesy Bell)**

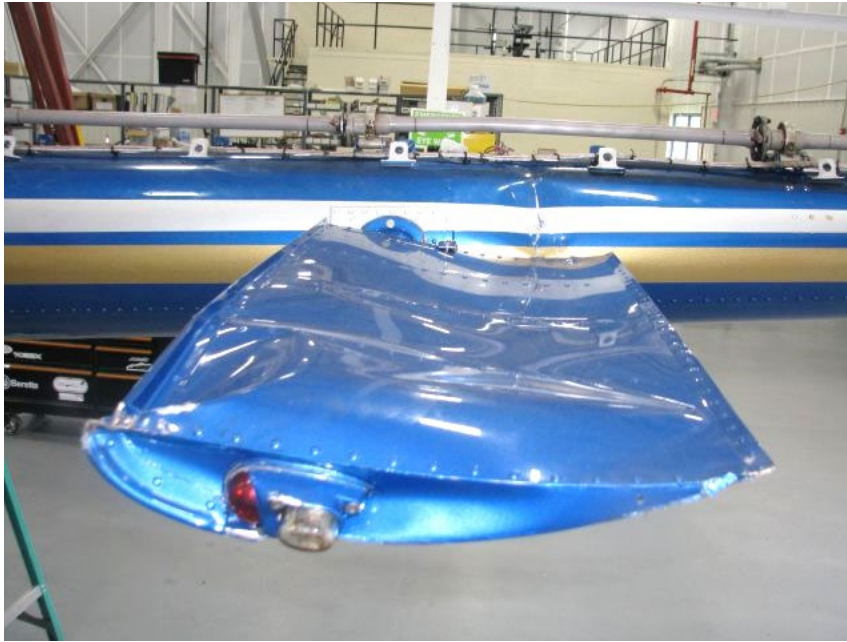
**Figure 15 - Left horizontal stabilizer (courtesy Bell)**
