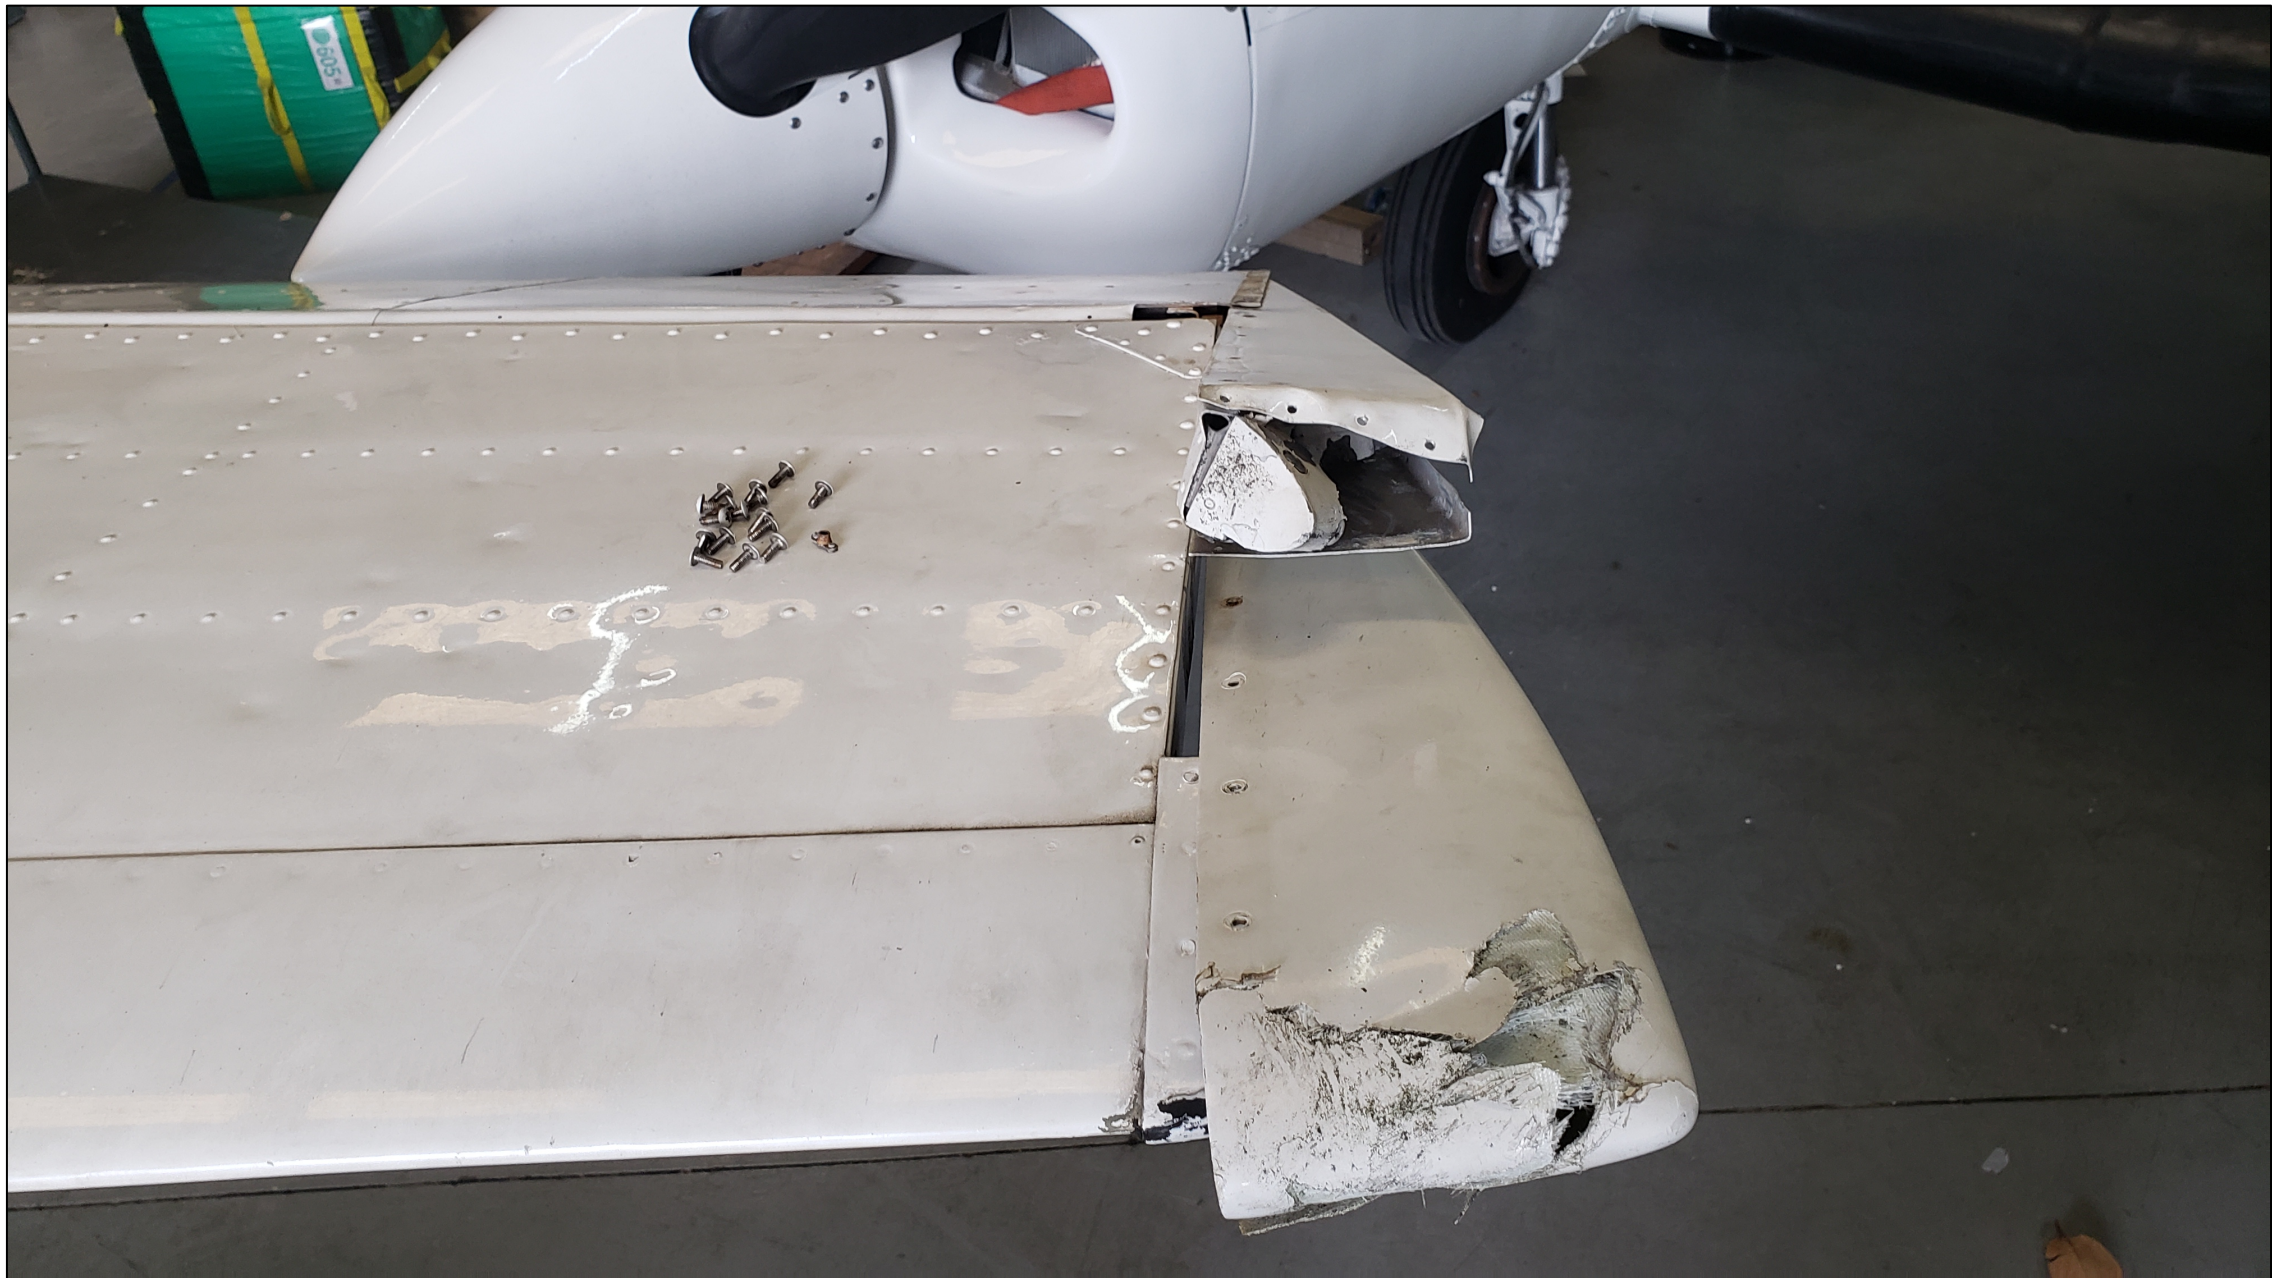
Photo 1 – View of the substantially damaged left elevator (Photo Courtesy of FAA)

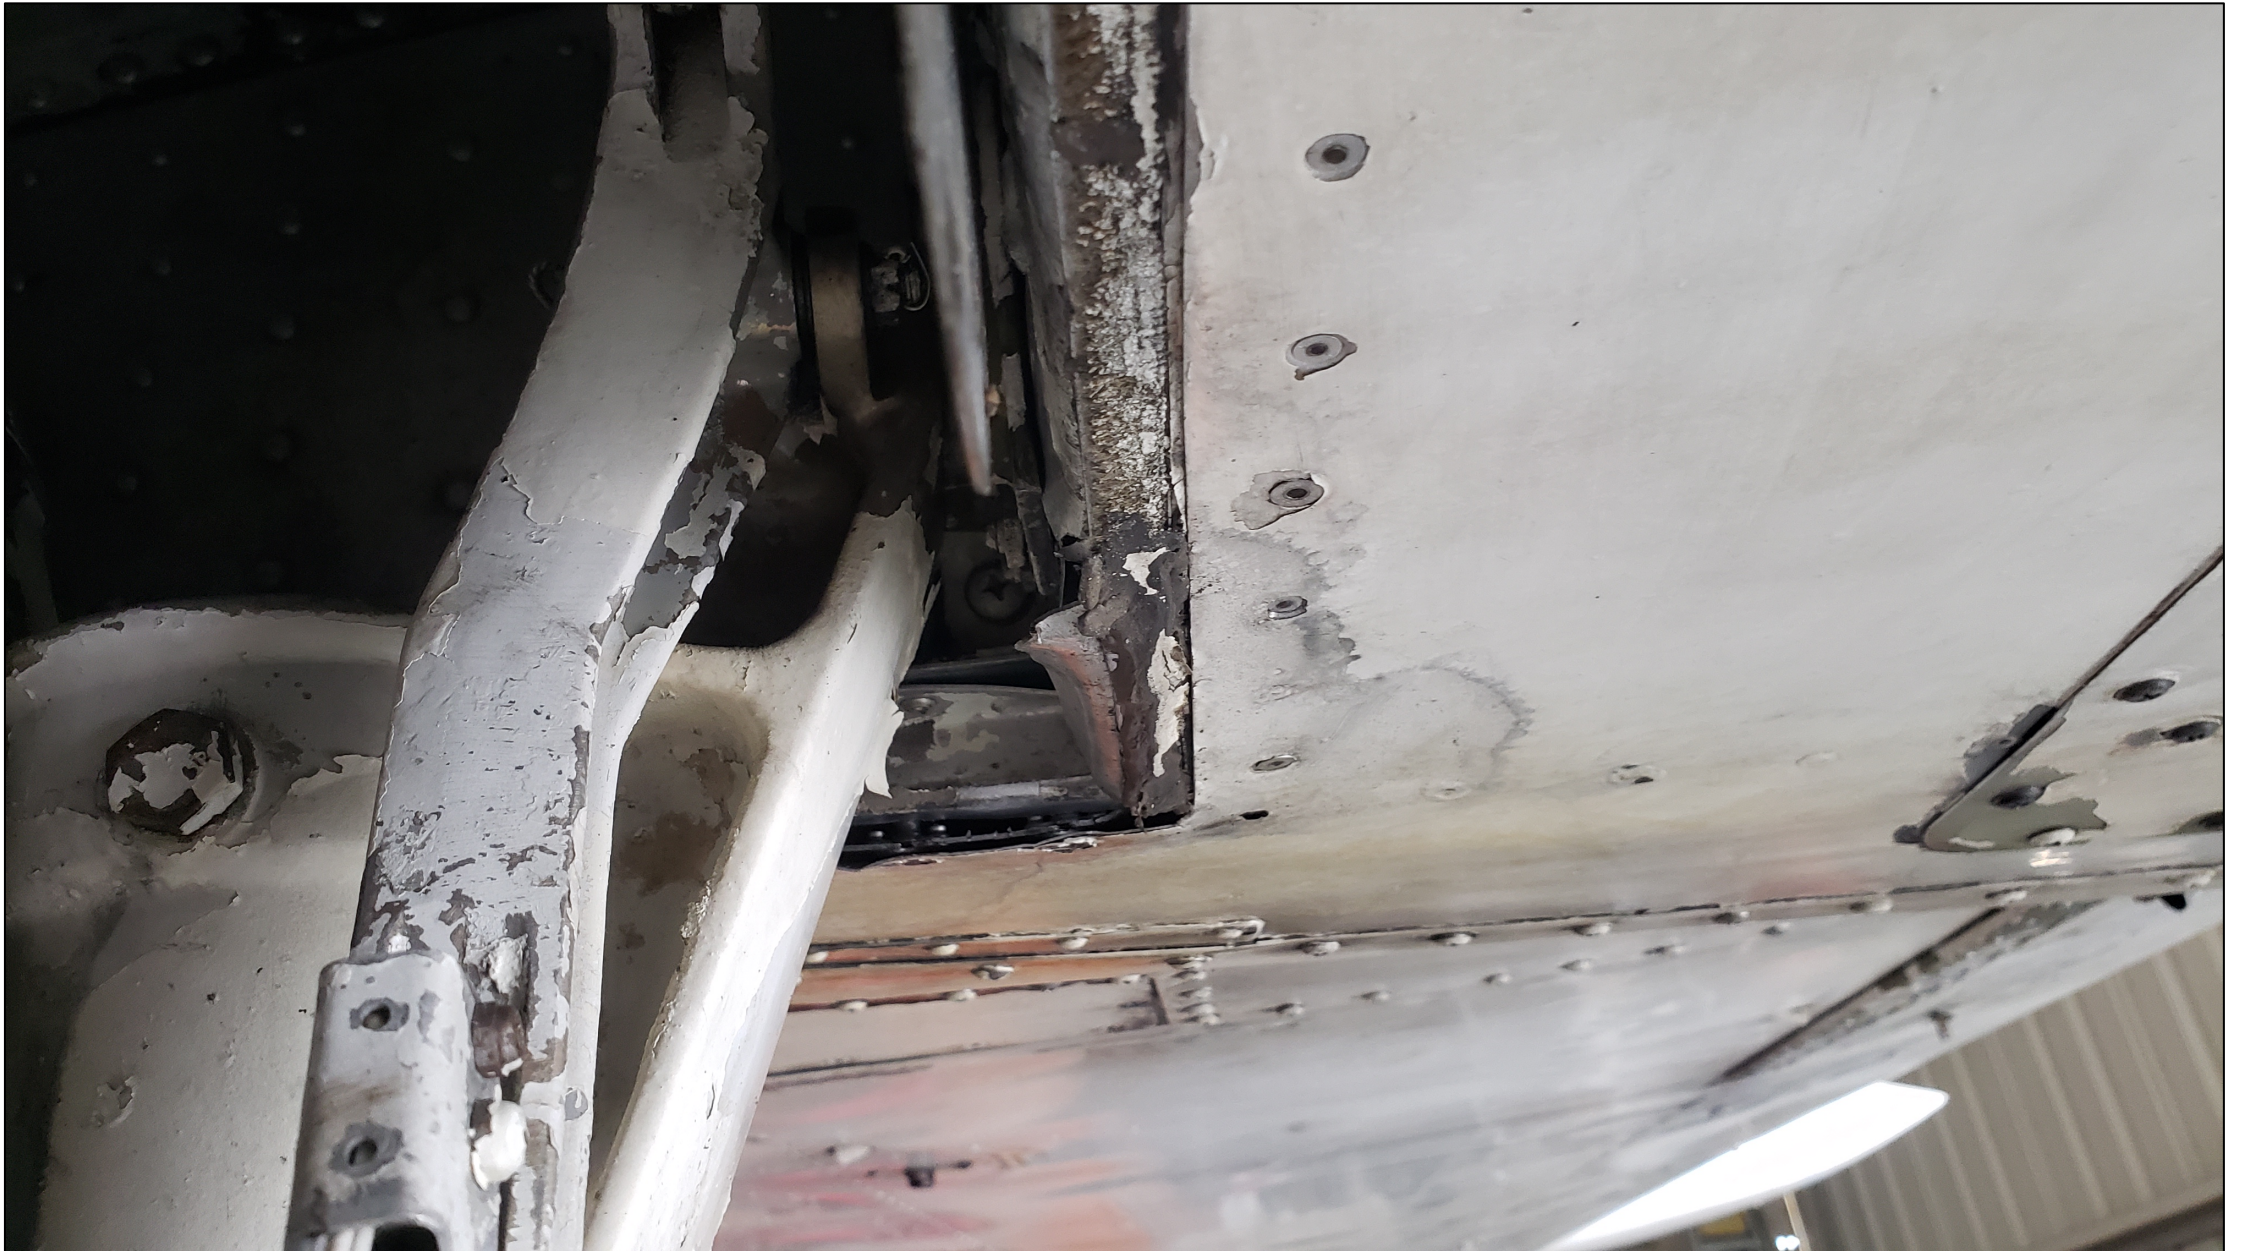
Photo 2 – View of the damaged left main landing gear assembly (Photo Courtesy of FAA)

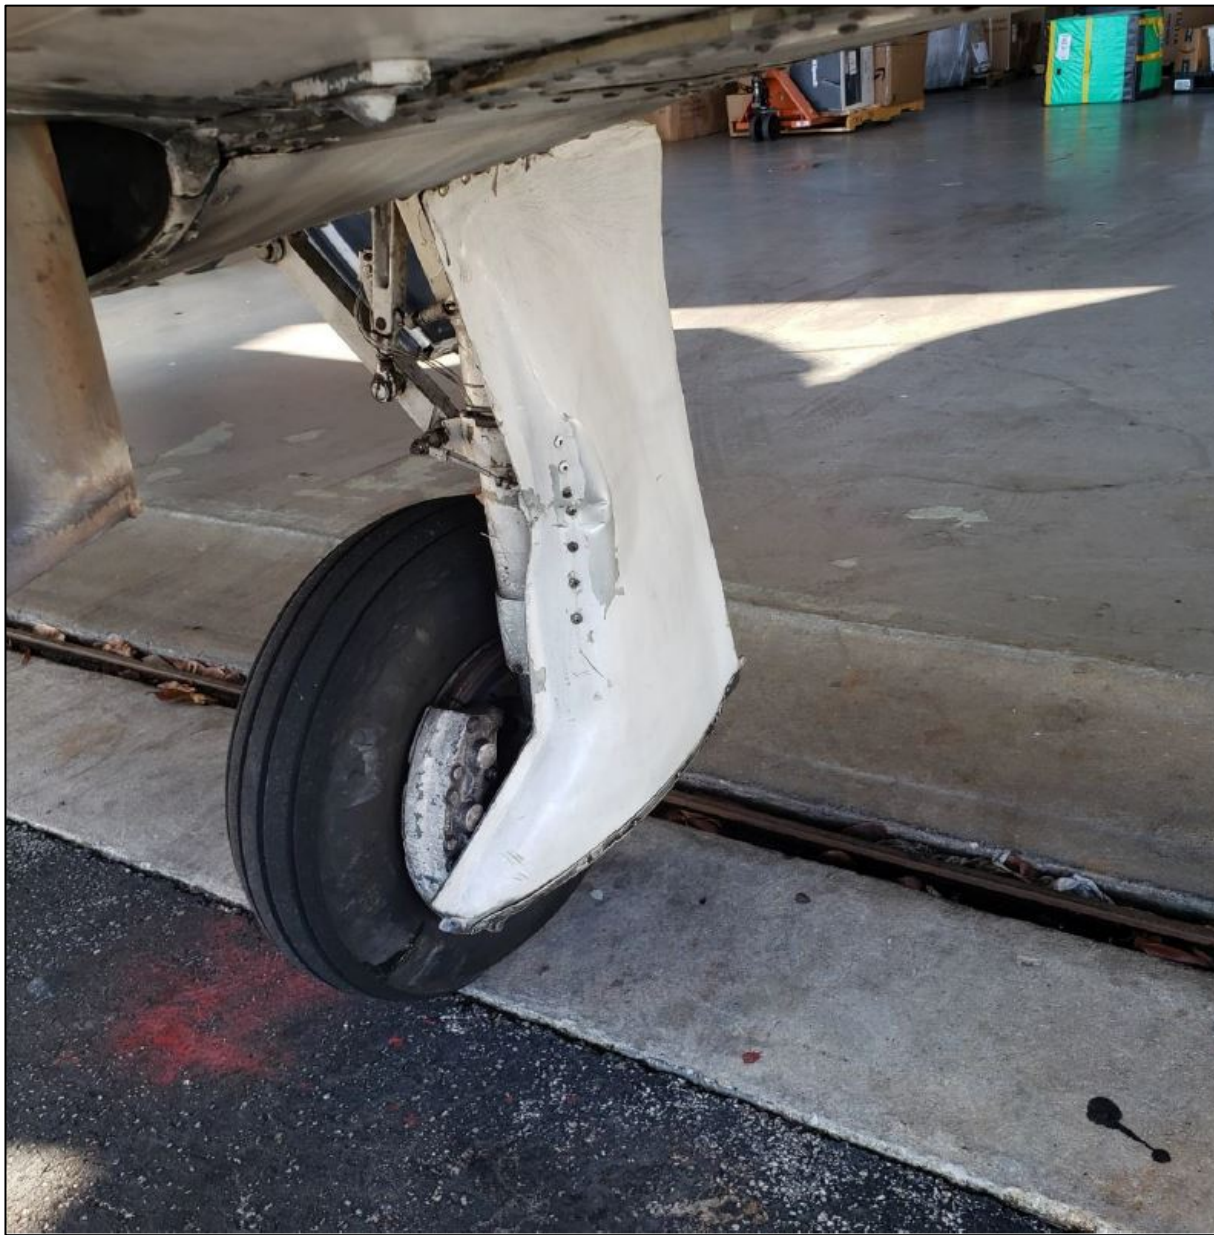
Photo 3 – Additional view of the left main landing gear damage (Photo Courtesy of FAA)

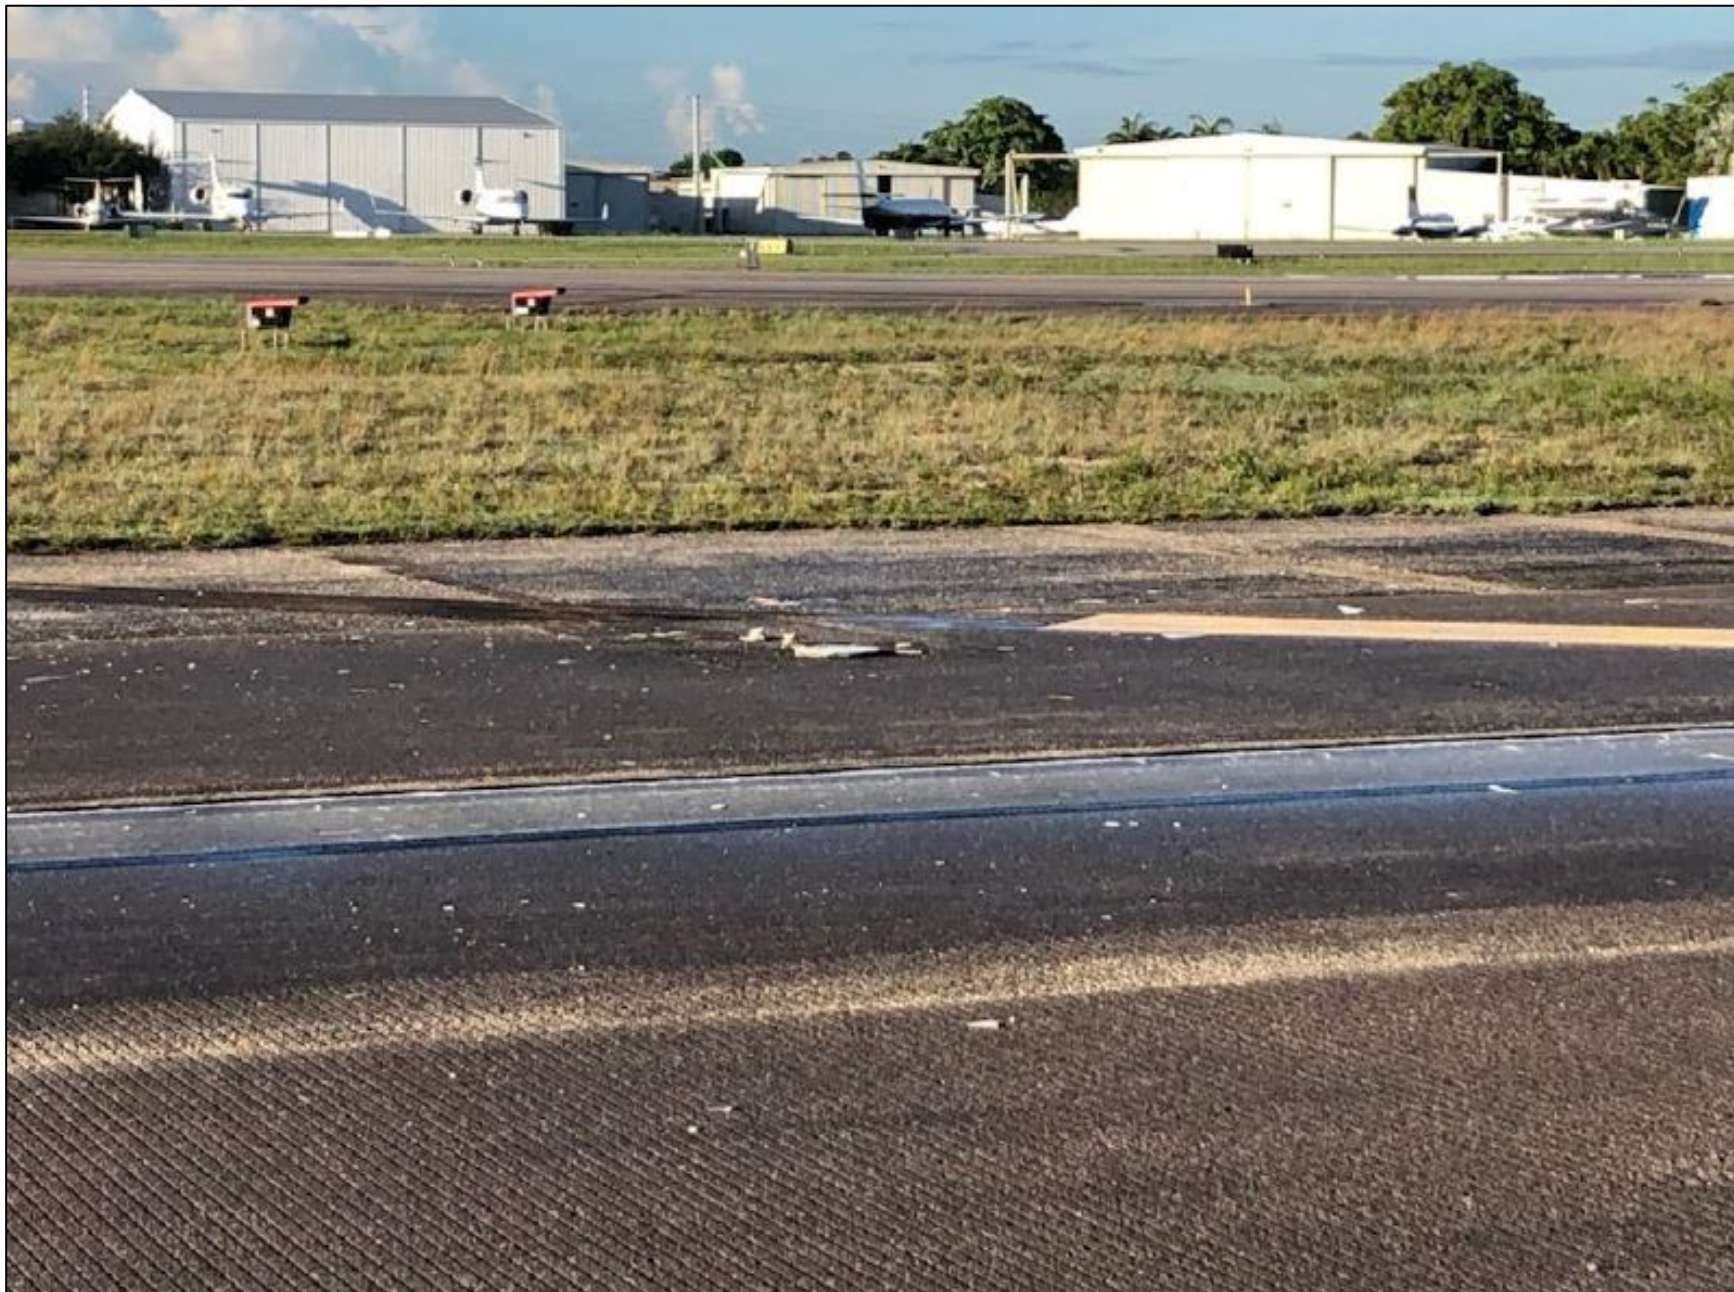
Photo 4 – View of the debris found on the runway after taxiway sign impact (Photo Courtesy of Airport Authority)
