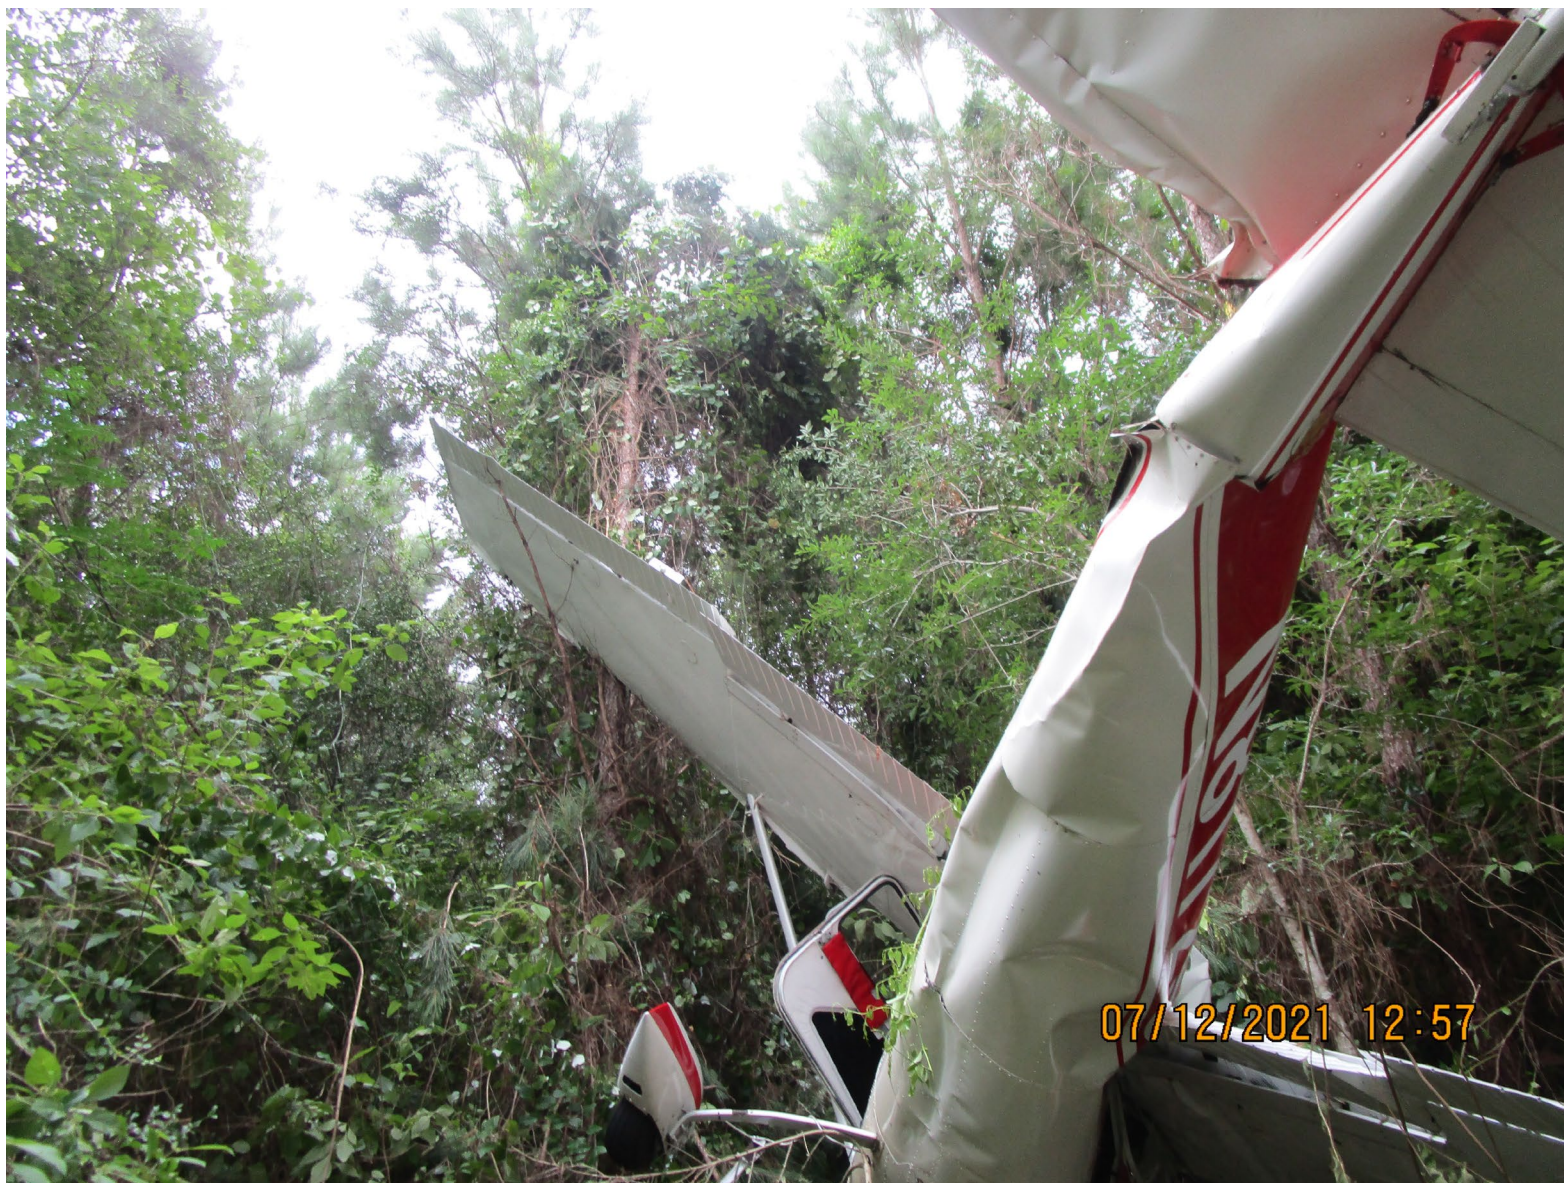
**Photo 1 – View of empennage damage. (Courtesy of FAA)**

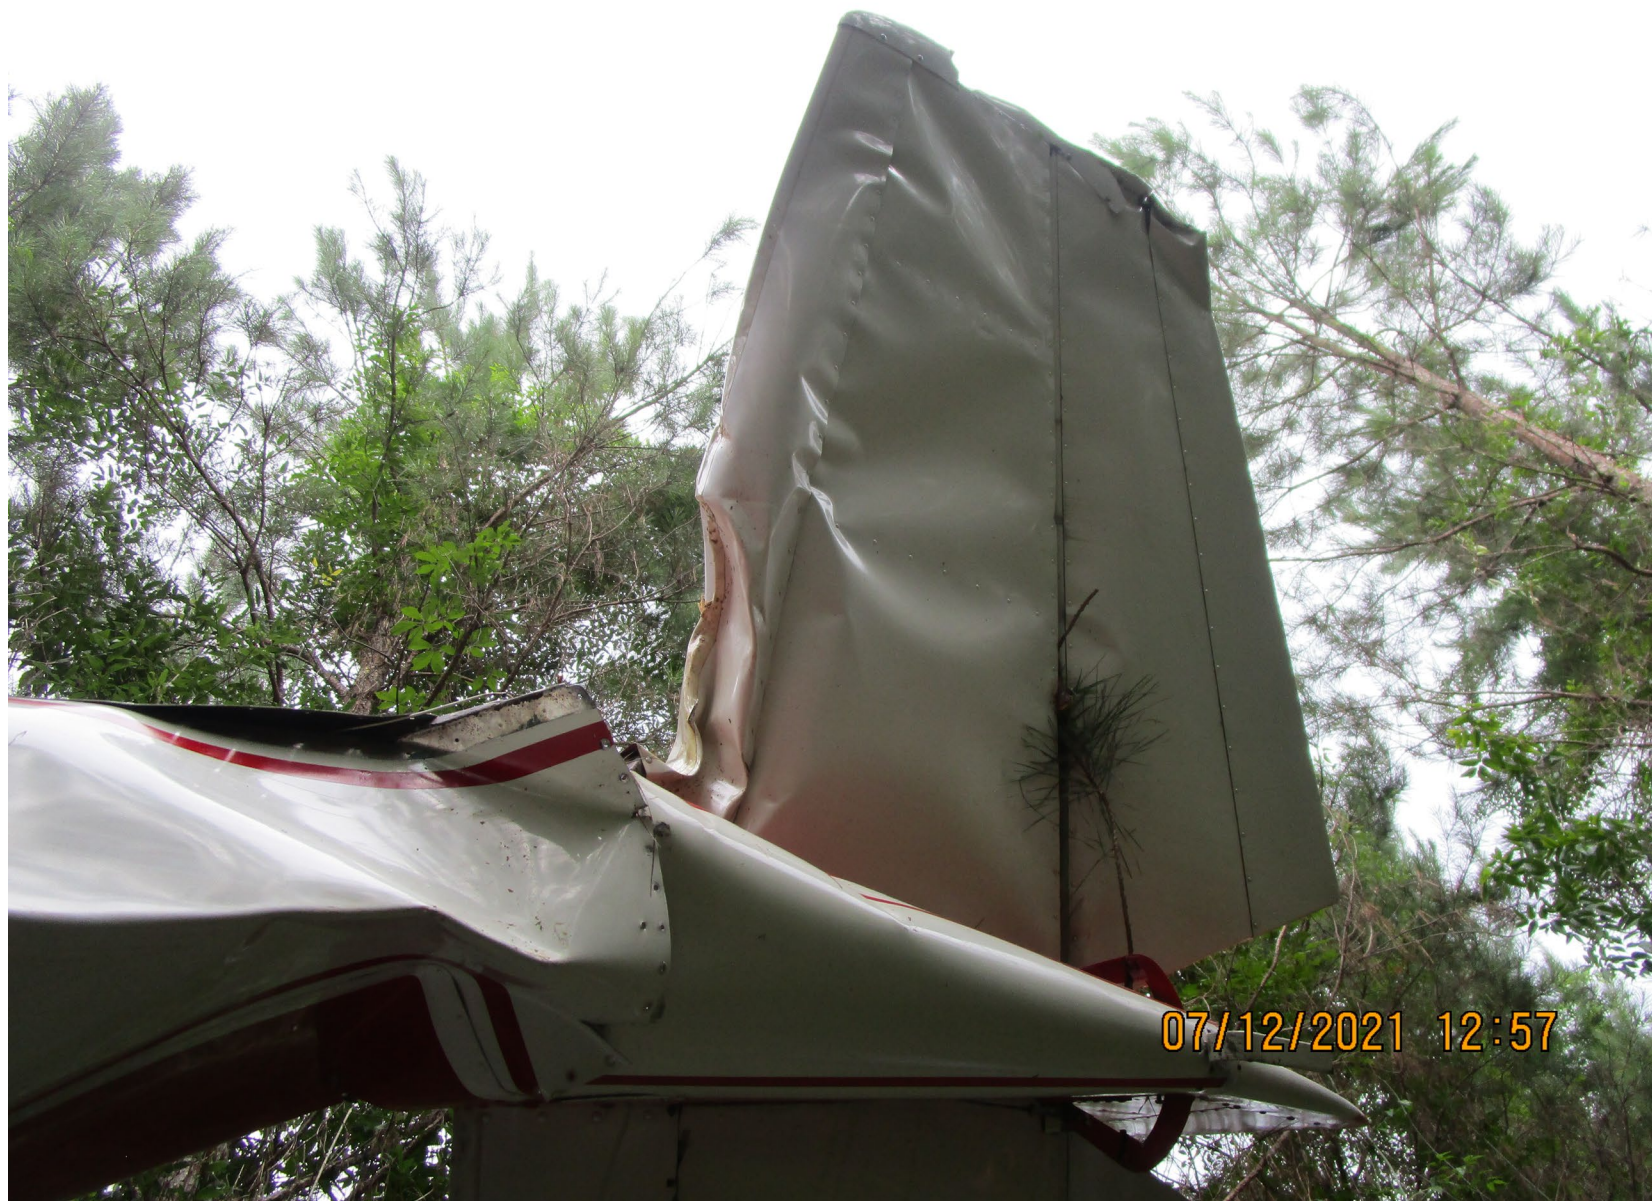
**Photo 2 – View of elevator and tail damage. (Courtesy of FAA)**

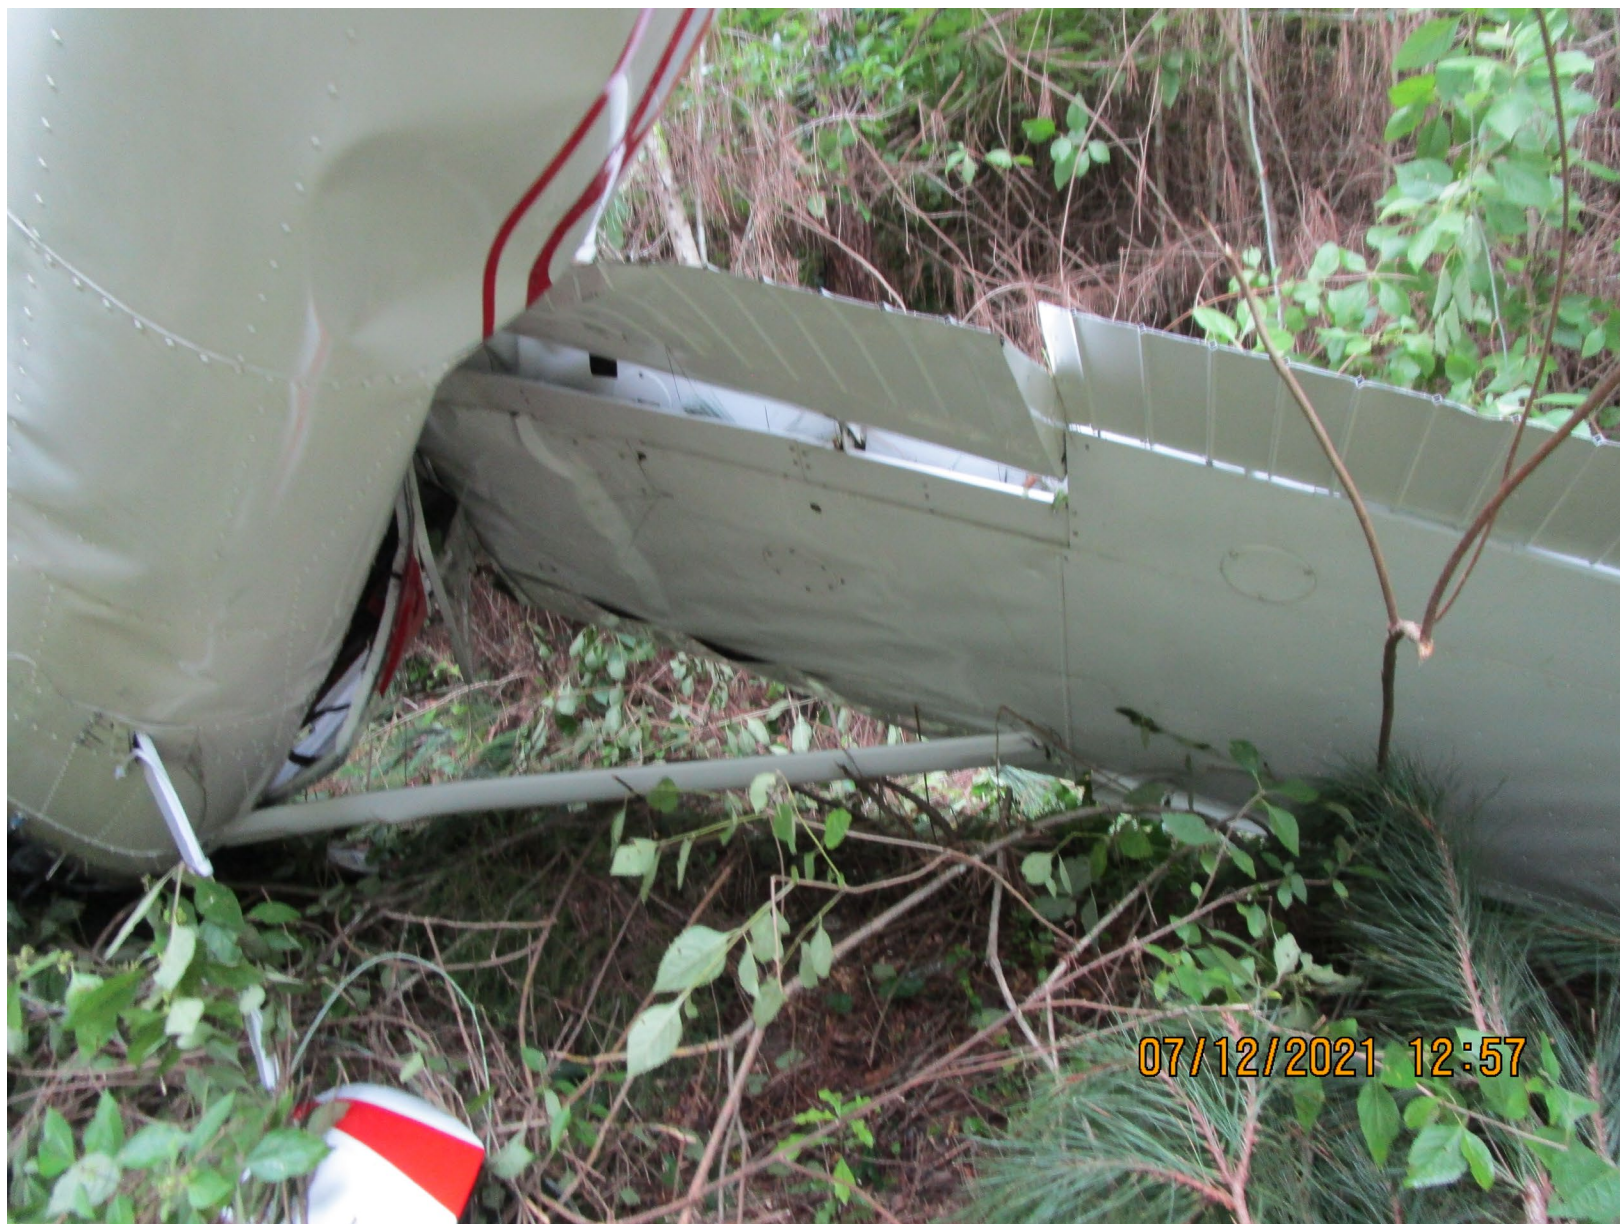
**Photo 3 – View of right inboard wing damage. (Courtesy of FAA)**
