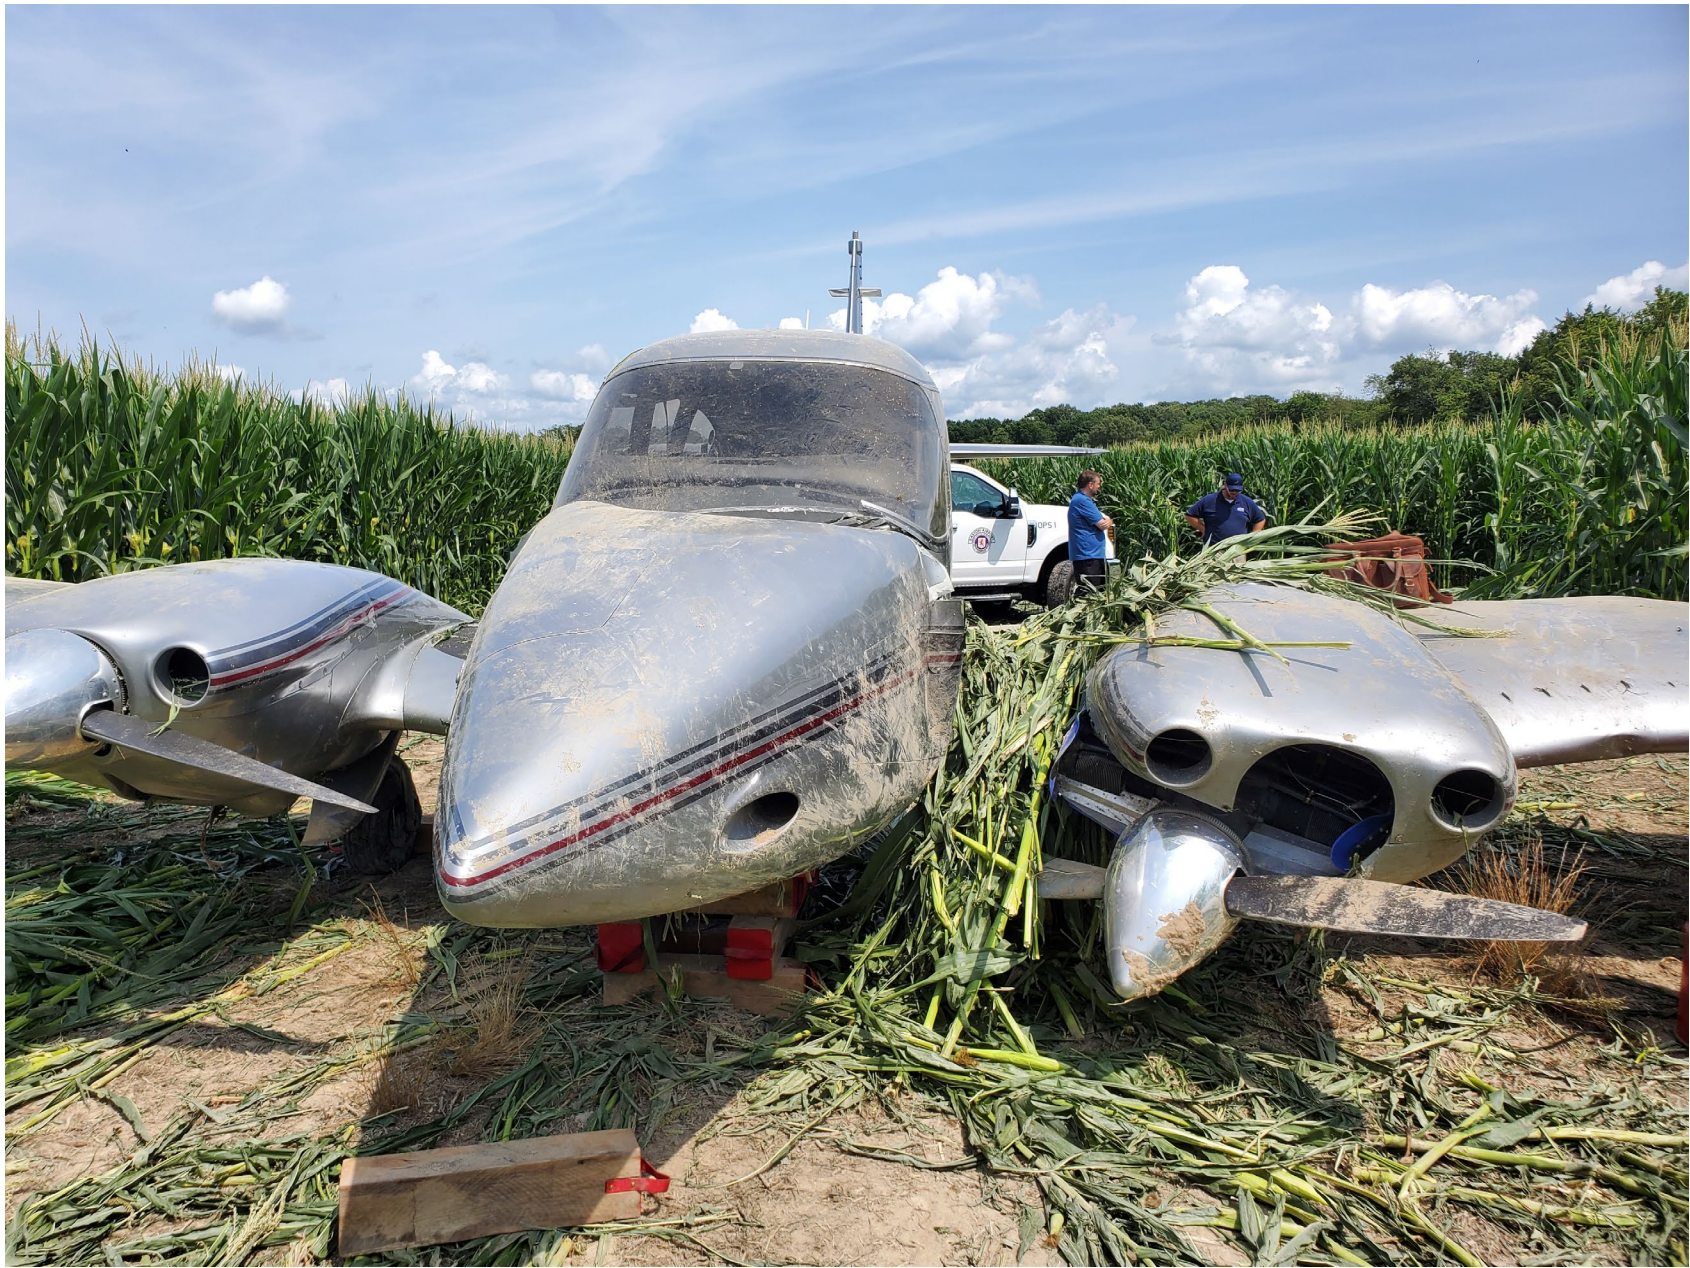
**Photo 1 – FAA Digital Photograph. Frontal View of the Airplane at the Accident Site Depicting Inboard Portions of Both Wings. Note the Feathered Left and Right Propellers and Displaced Left Engine.**

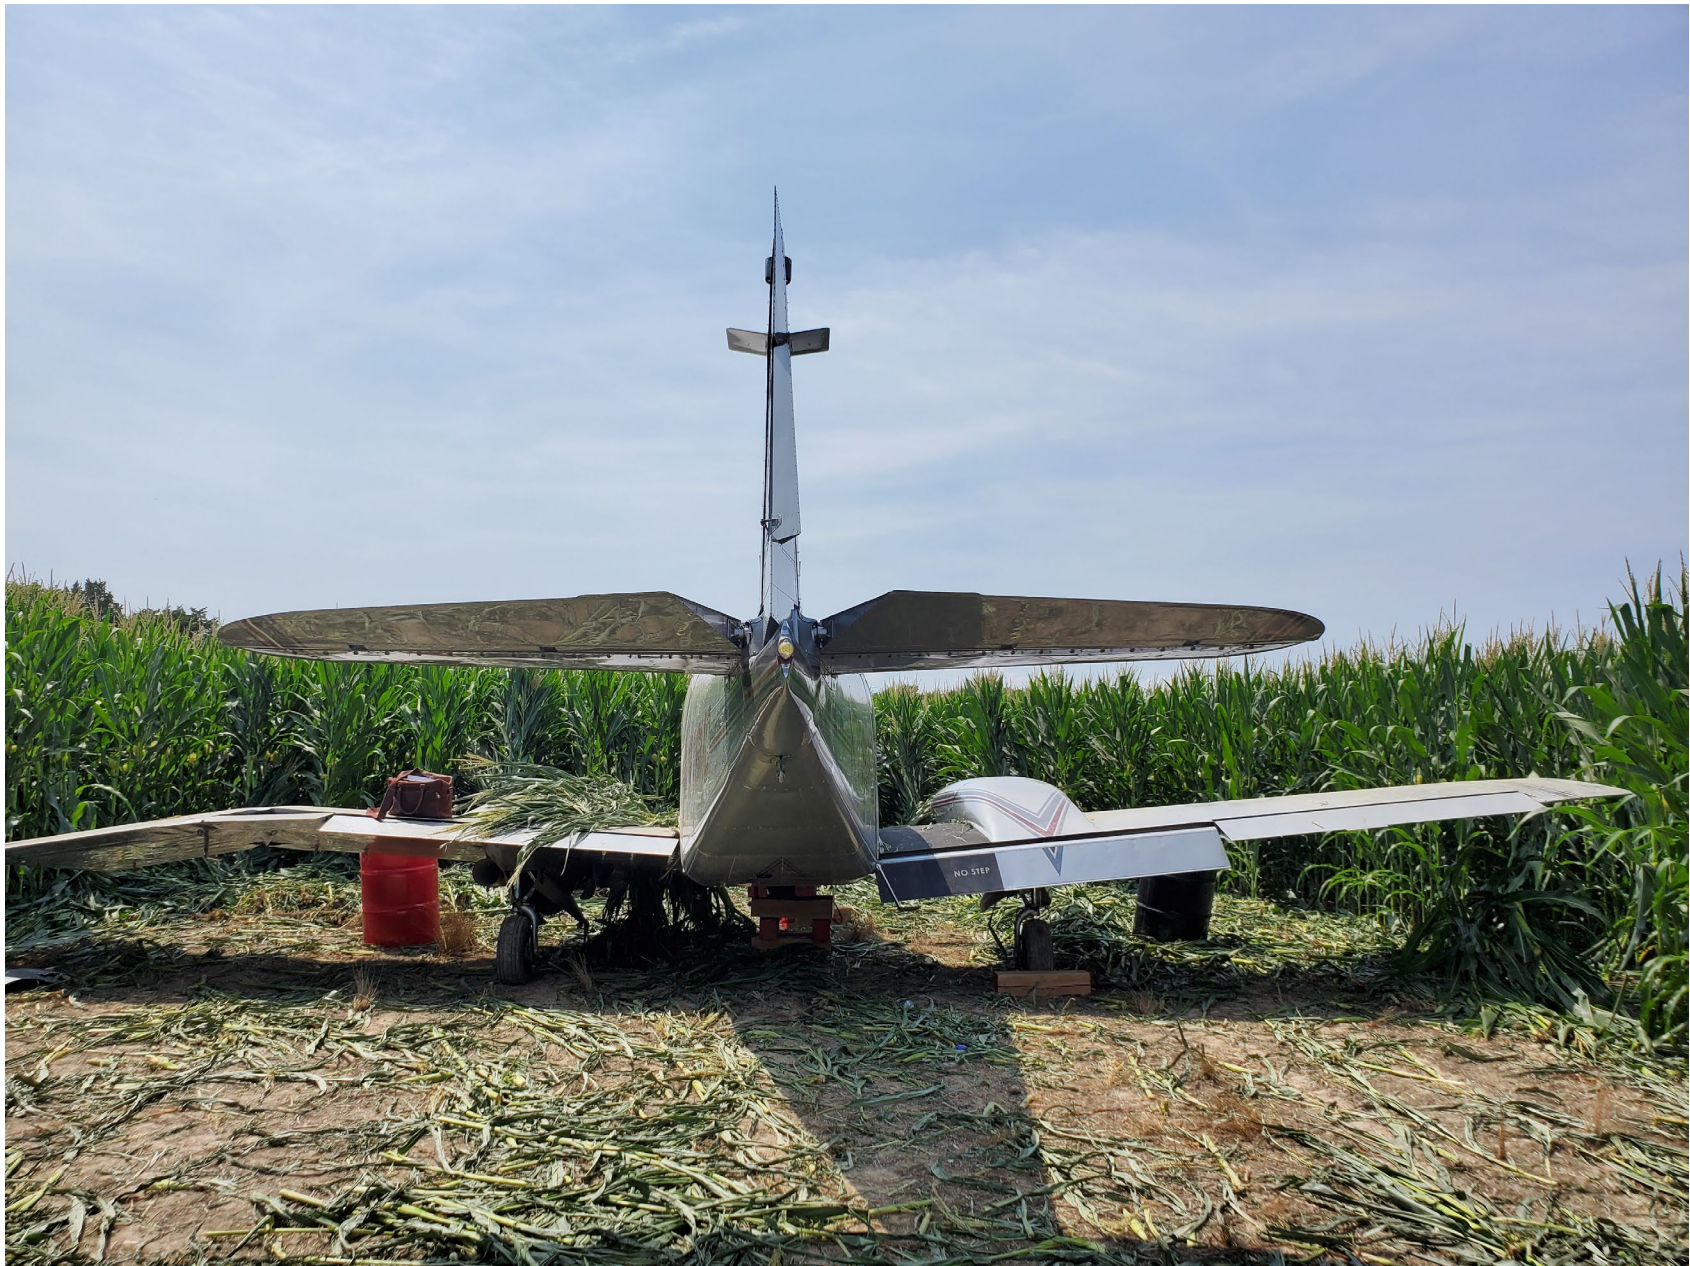
**Photo 2 - FAA Digital Photograph. Rear View of the Airplane at the Accident Site. Note the Structural Damage to the Left Wing.**

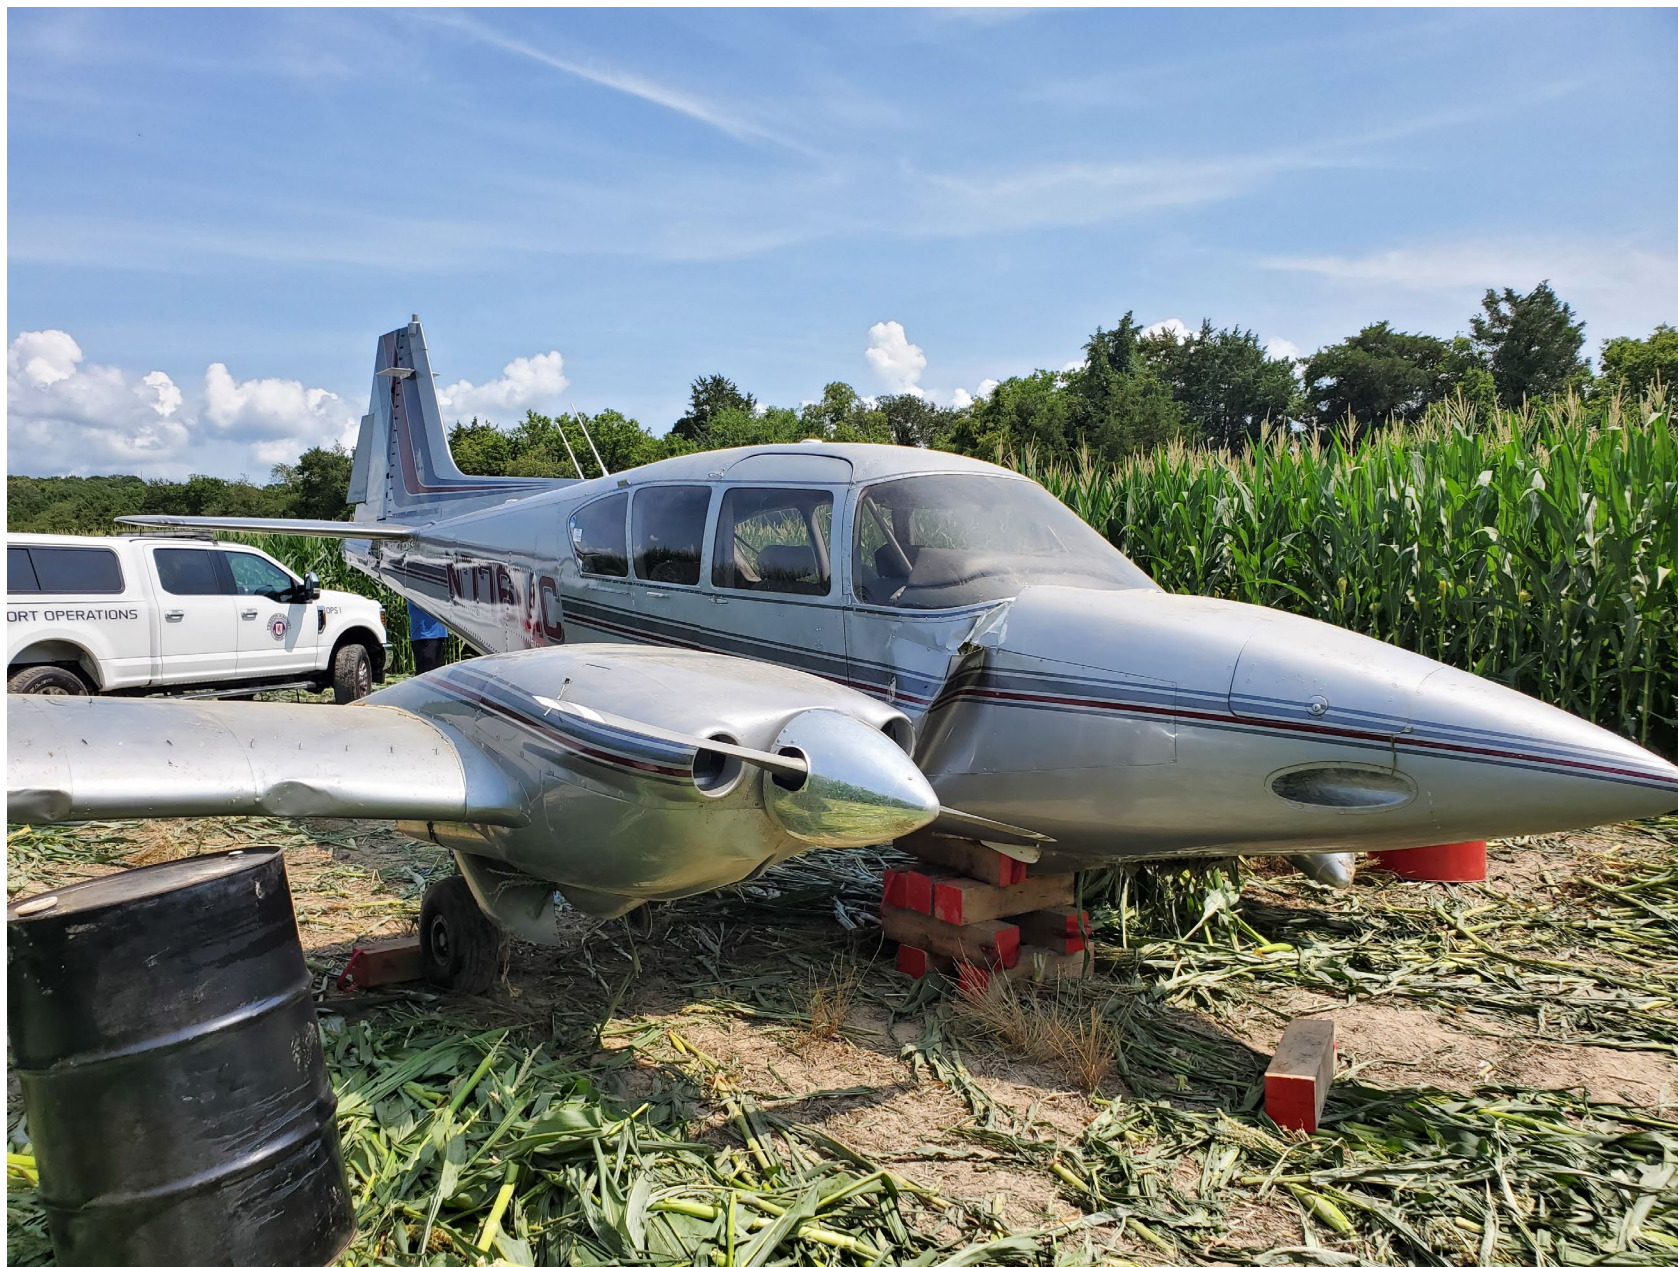
**Photo 3 - FAA Digital Photograph. Right Front Quartering View of the Airplane at the Accident Site. Note the Right Fuselage Damage, and Feathered Right Propeller.**

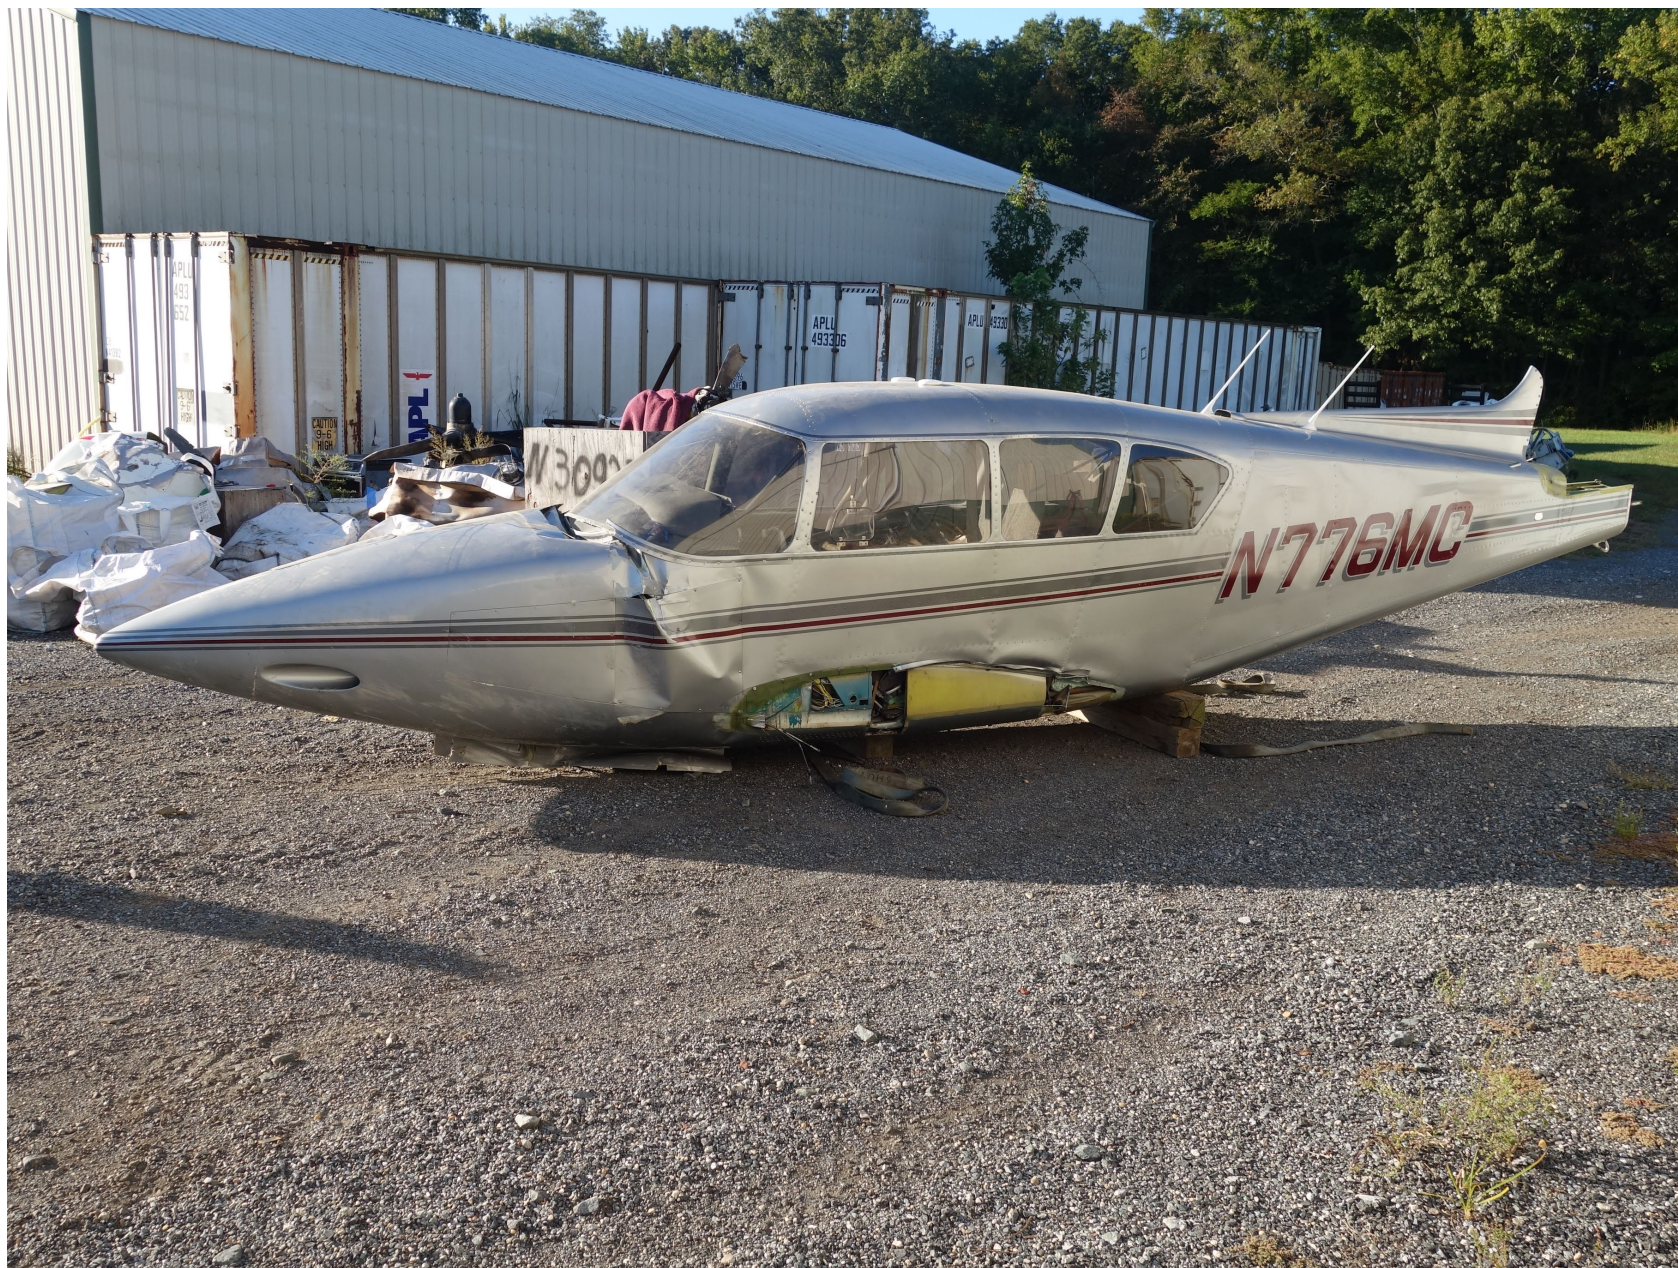
**Photo 4 – Piper Digital Photograph. Left Side View of the Fuselage Following Recovery. Note the Structural Damage.**

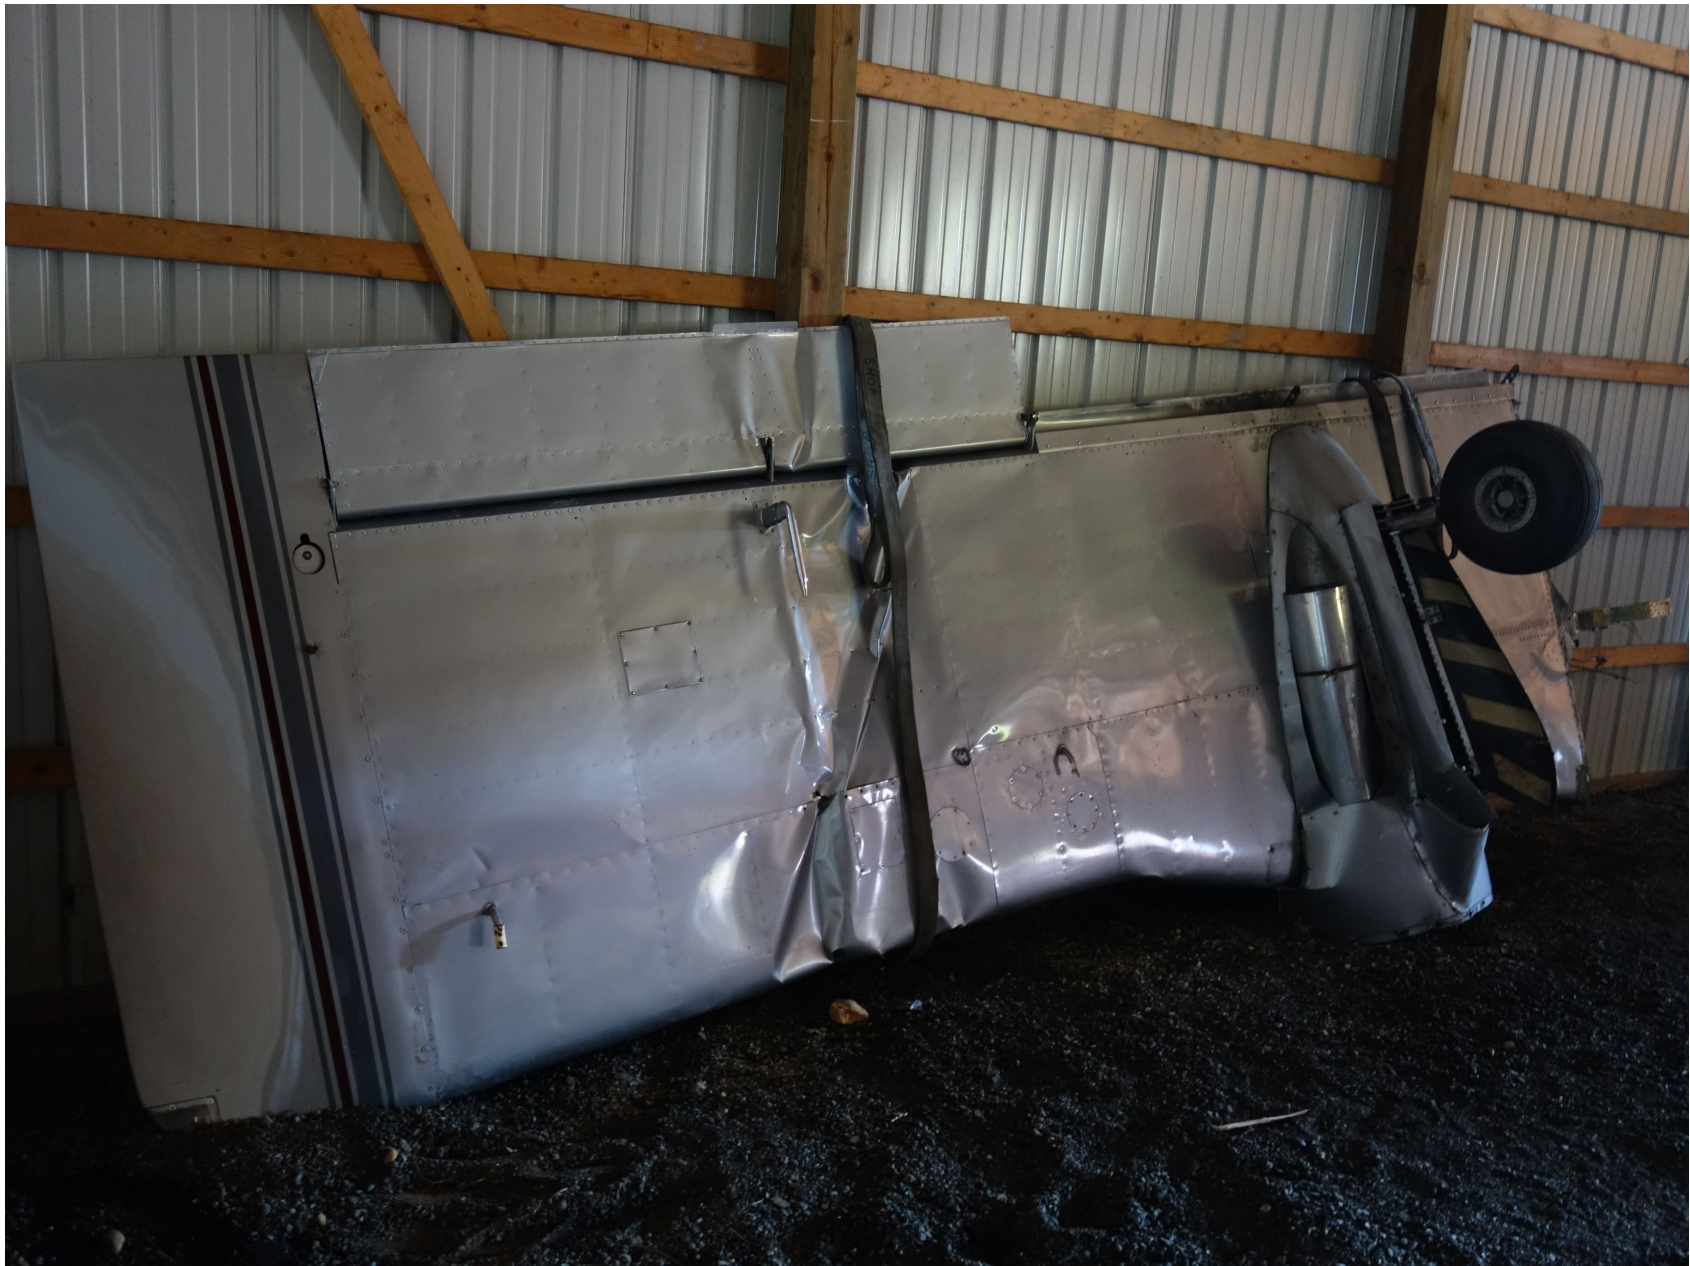
**Photo 5 - Piper Digital Photograph. View of the Bottom Side of the Left Wing. Note the Structural Damage.**

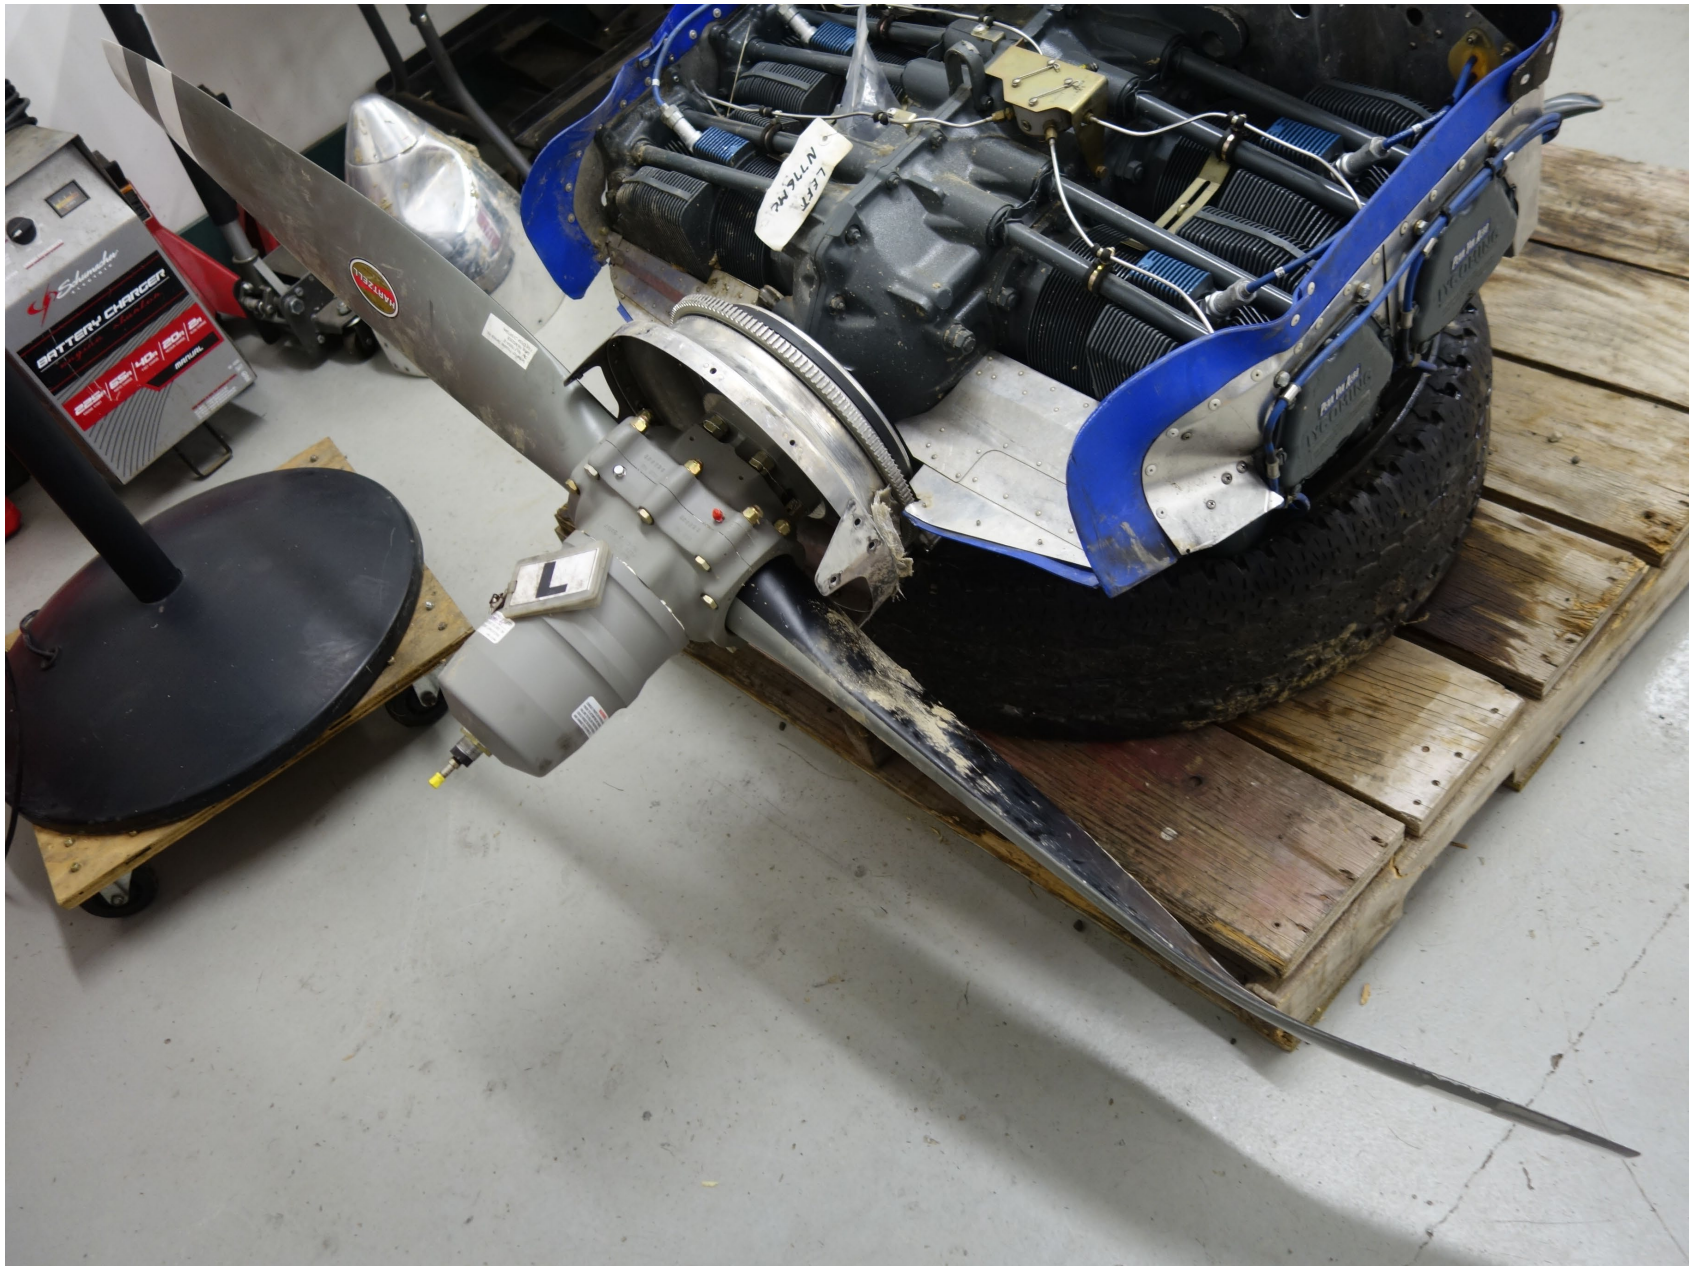
**Photo 6 - Piper Digital Photograph. View of the Separated Left Engine And Propeller Assembly. Note the Slight Aft Bend of 1 Propeller Blade.**

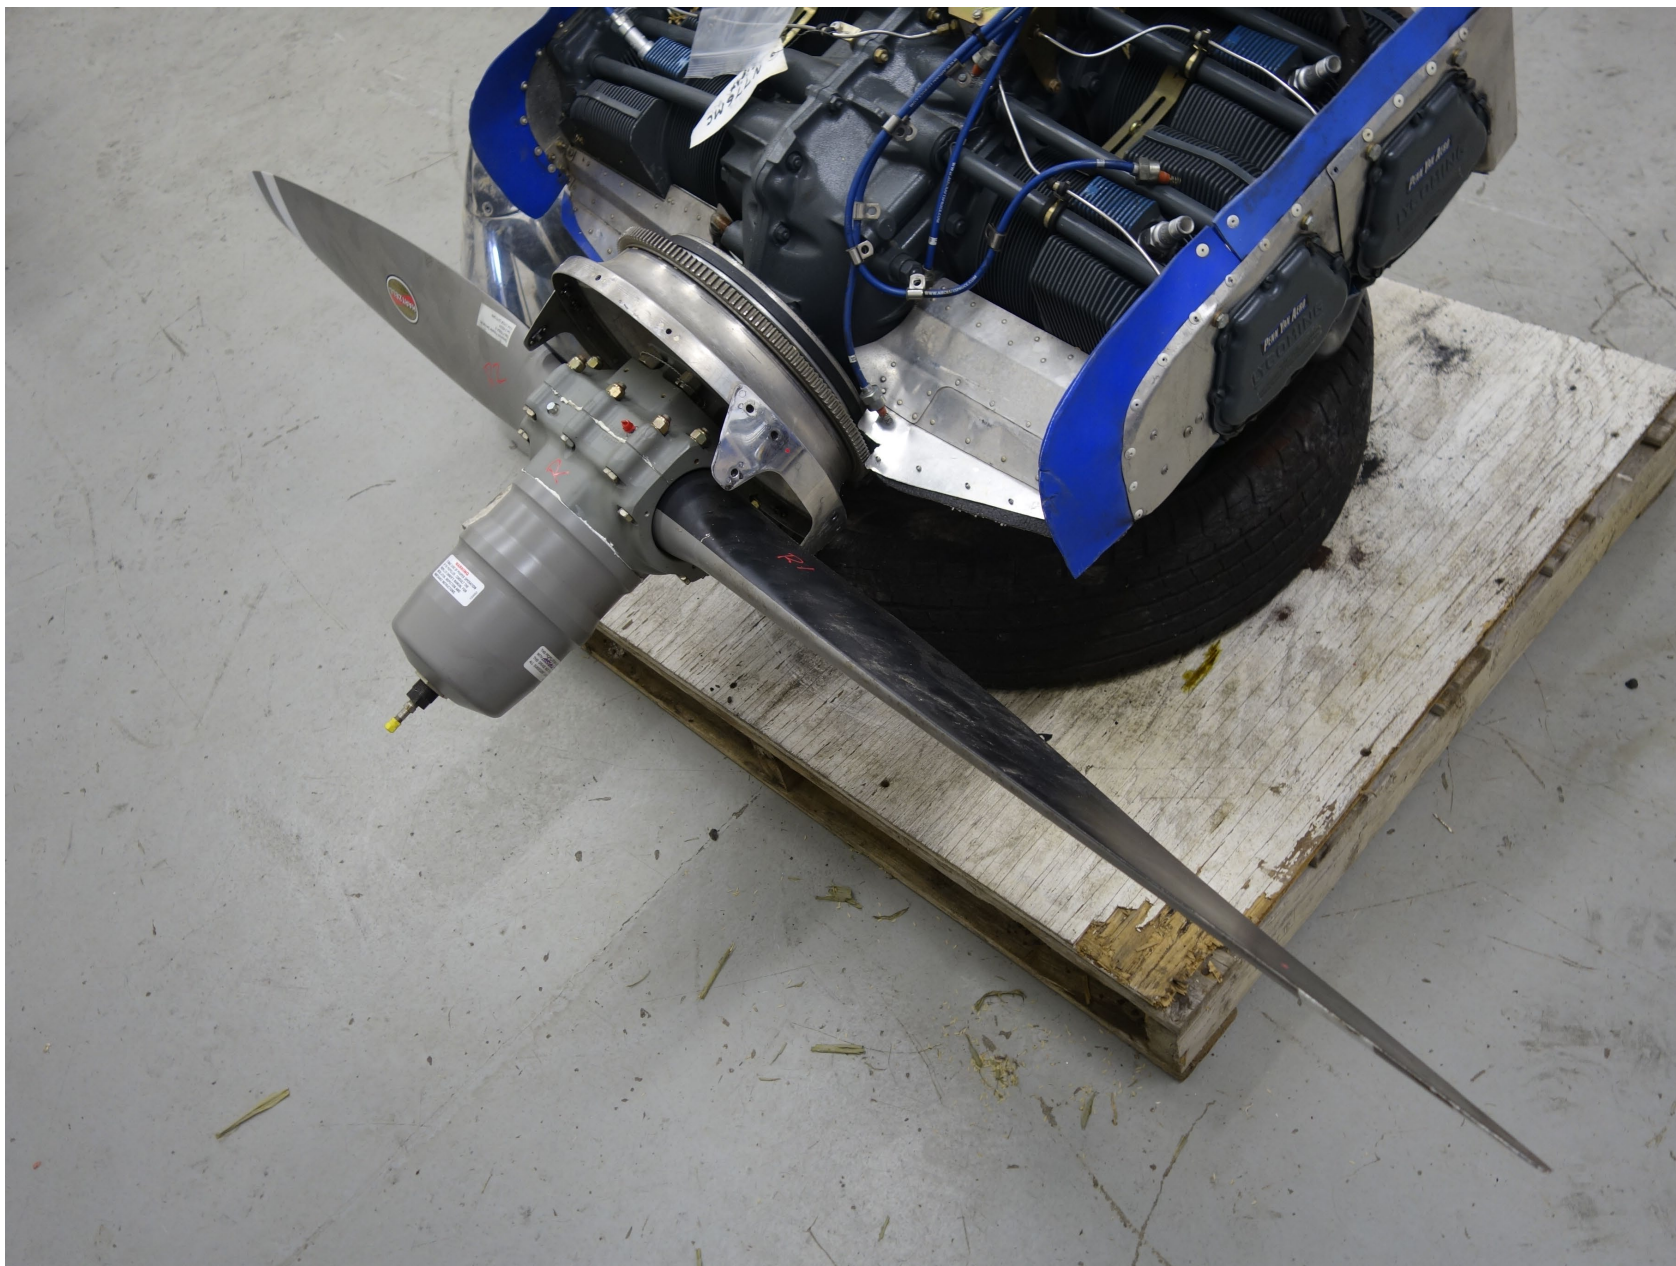
**Photo 7 - Piper Digital Photograph. View of the Separated Right Engine And Propeller Assembly.**

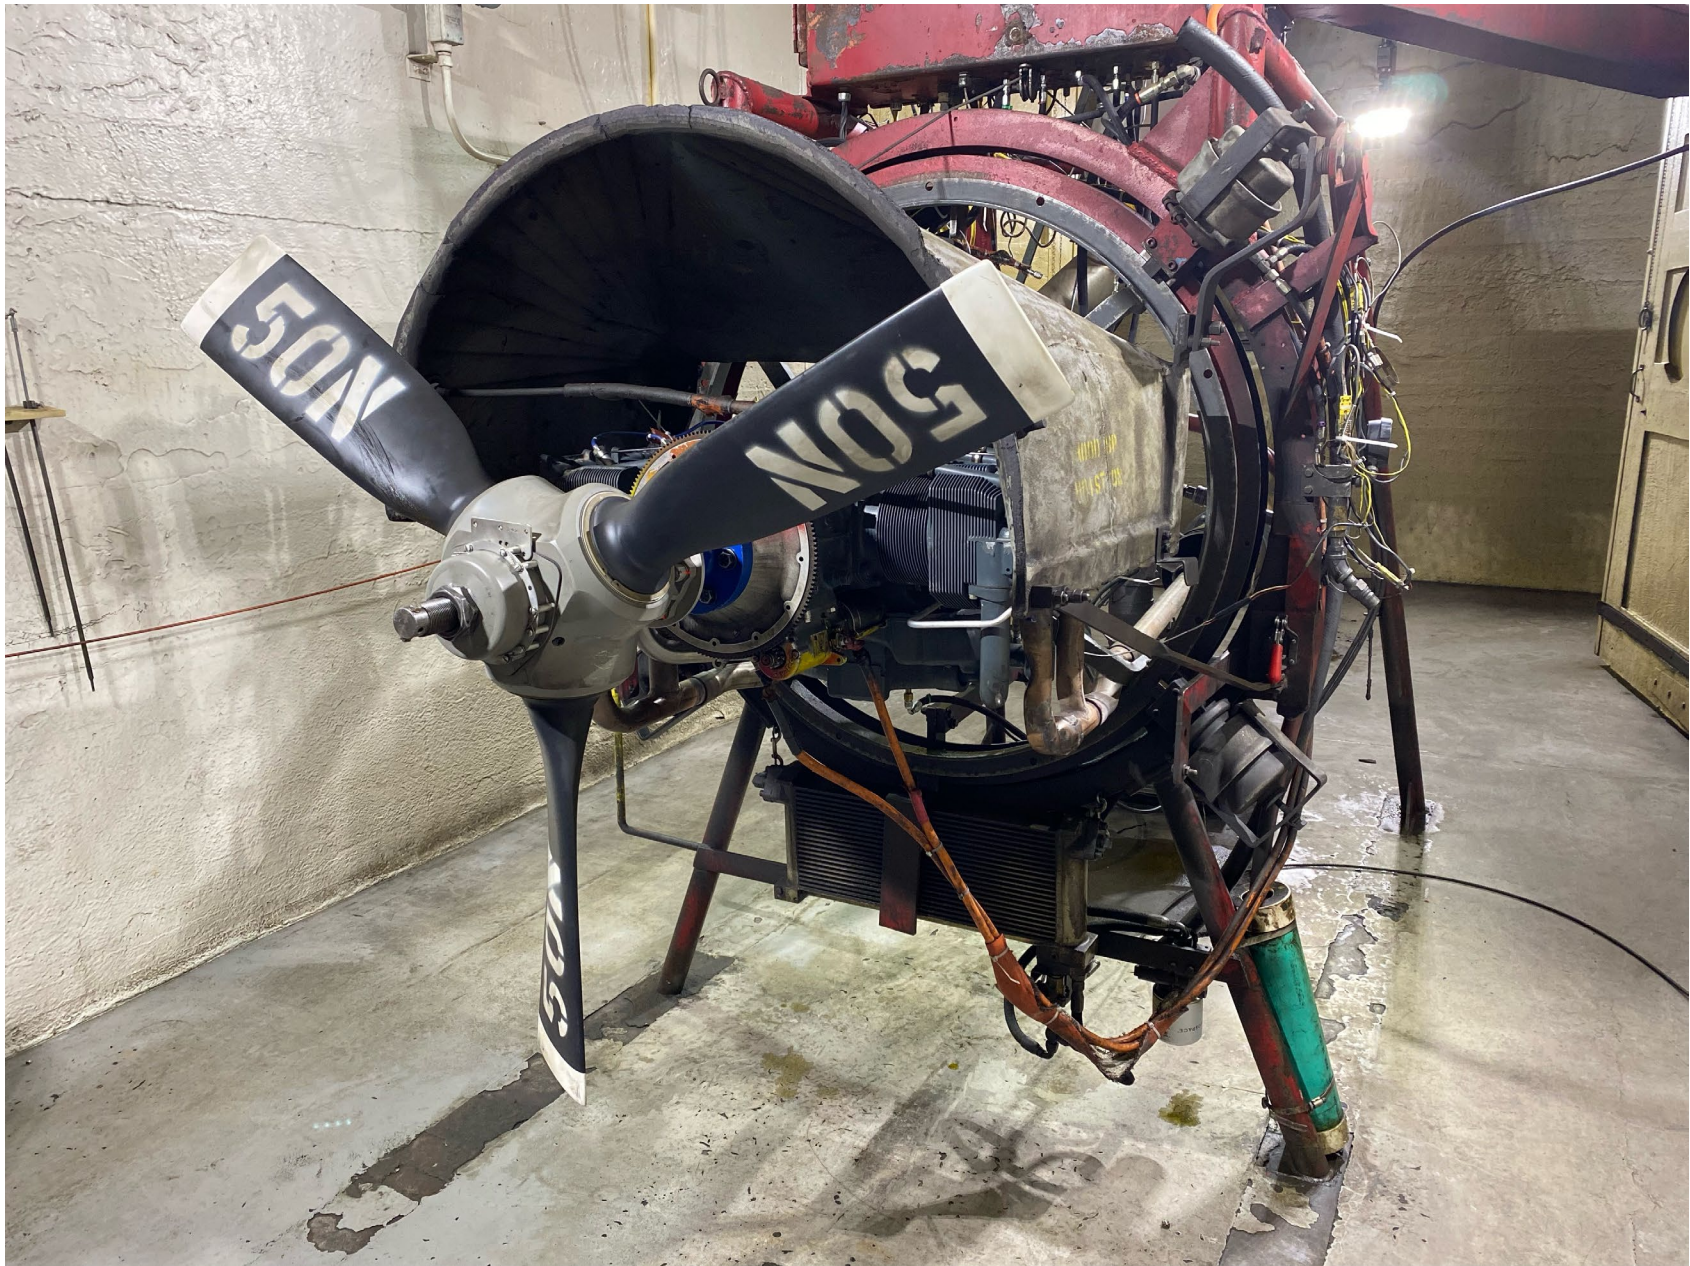
**Photo 8 - Piper Digital Photograph. View of the Left Engine with Test Club Propeller Installed Prior to Engine Run.**

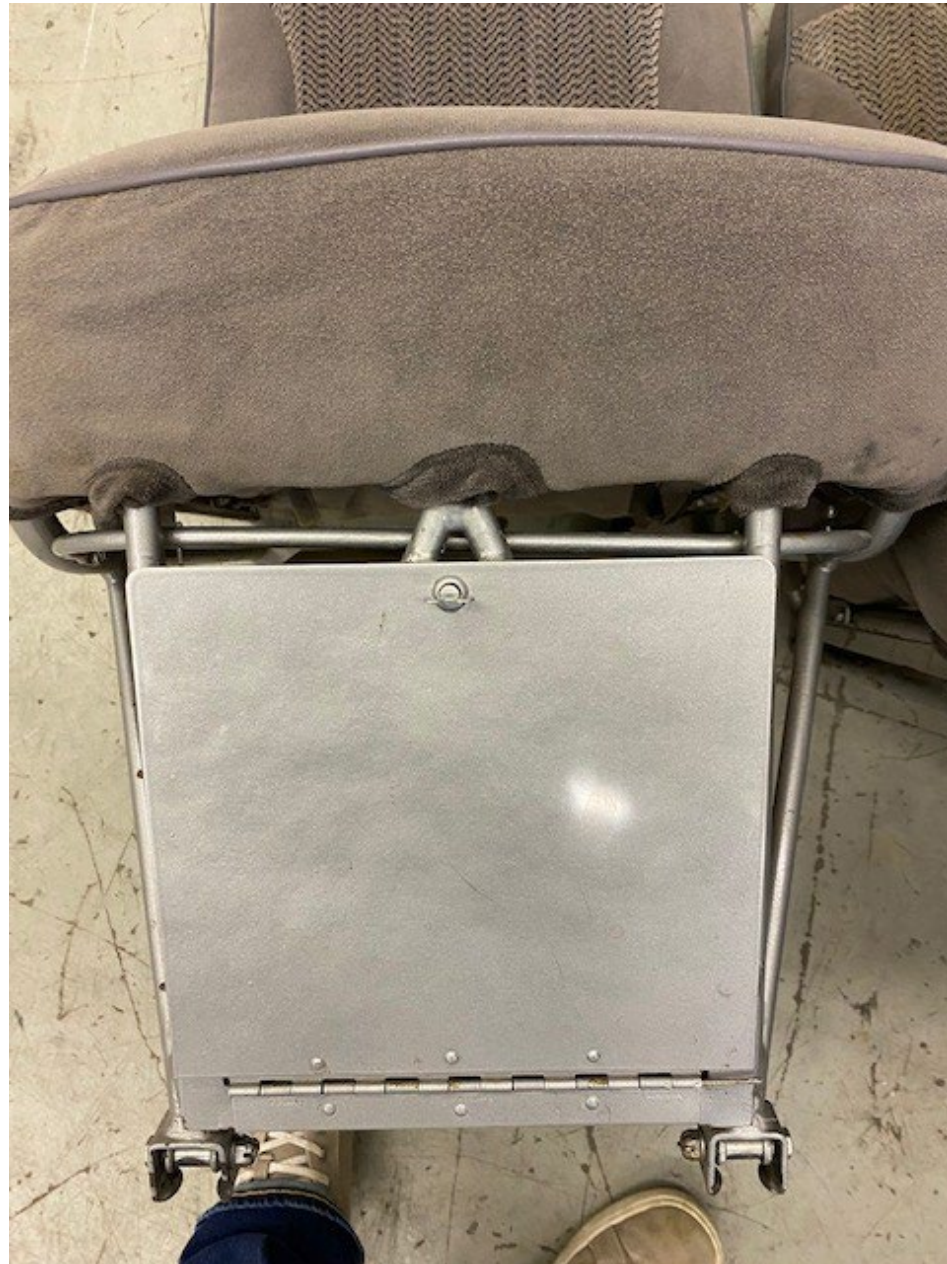
**Photo 9 – FAA Digital Photograph. Frontal View of the Co-Pilot's Seat Showing the Tube-Seat Catch Release Just Below the Bottom Seat Cushion.**

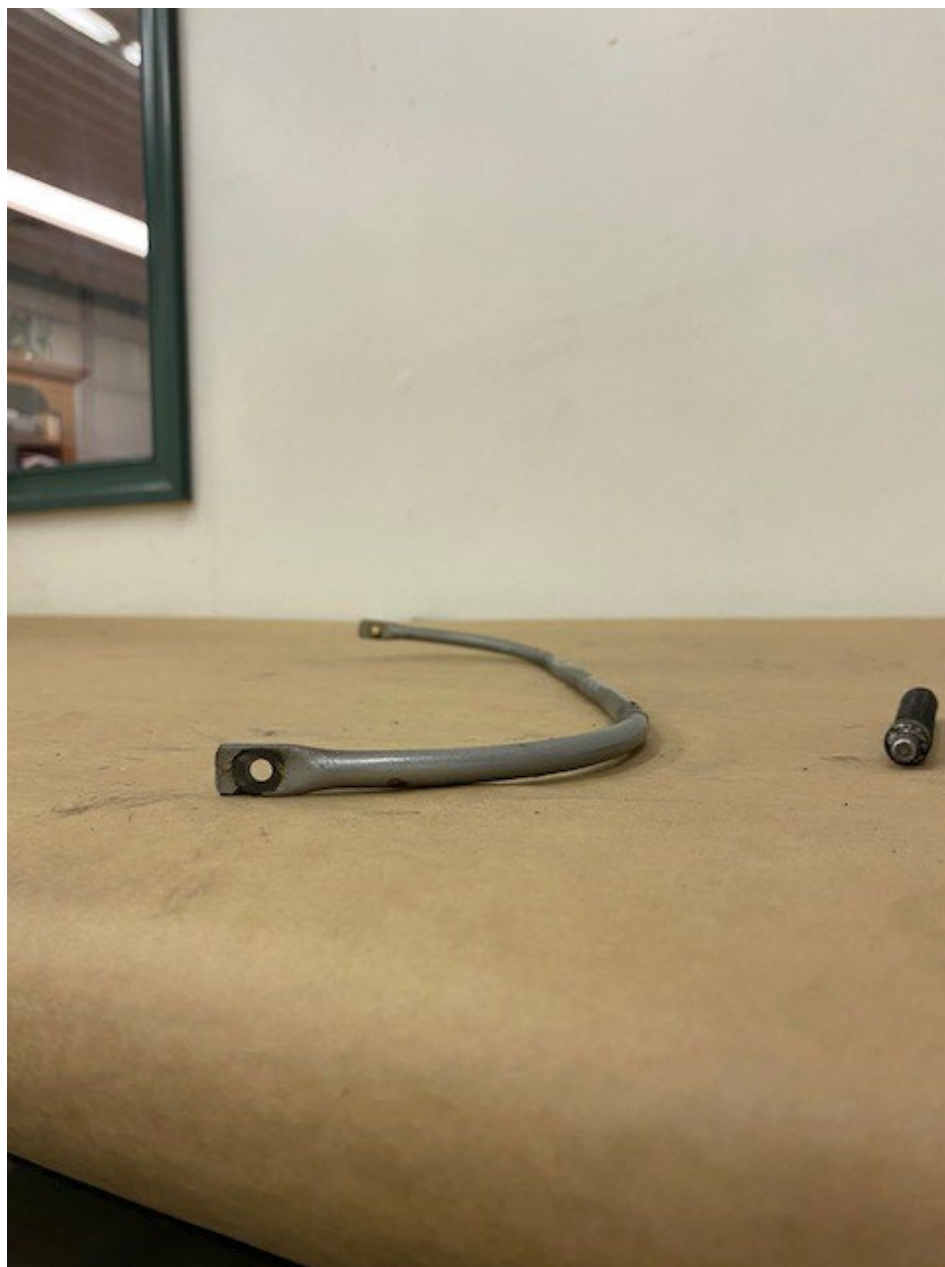
**Photo 10 – FAA Digital Photograph. View of the Right Front Seat Tube-Seat Catch Release.**

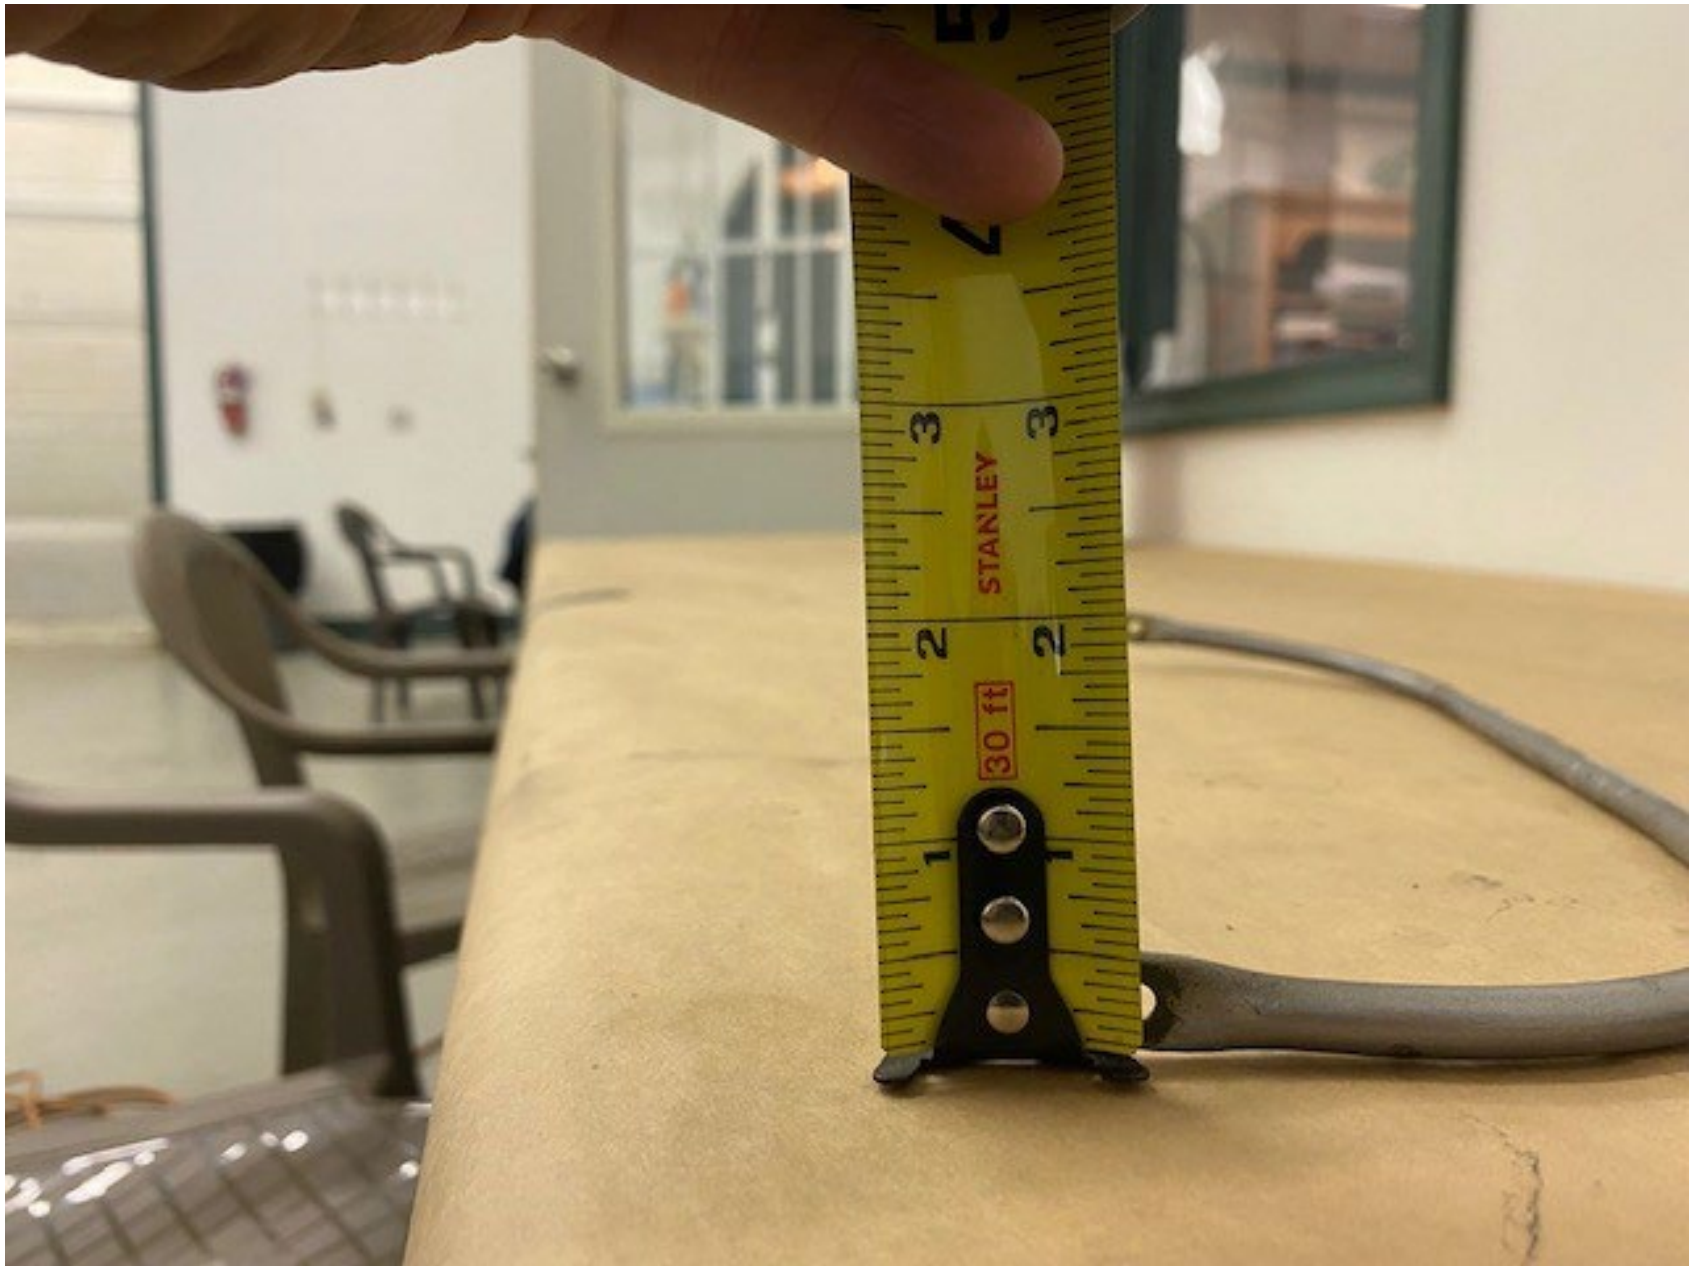
**Photo 11 - FAA Digital Photograph. View of One End of the Right Front Seat Tube-Seat Catch Release. Note the Deformed Distance Above the Table About 0.125 Inch.**
