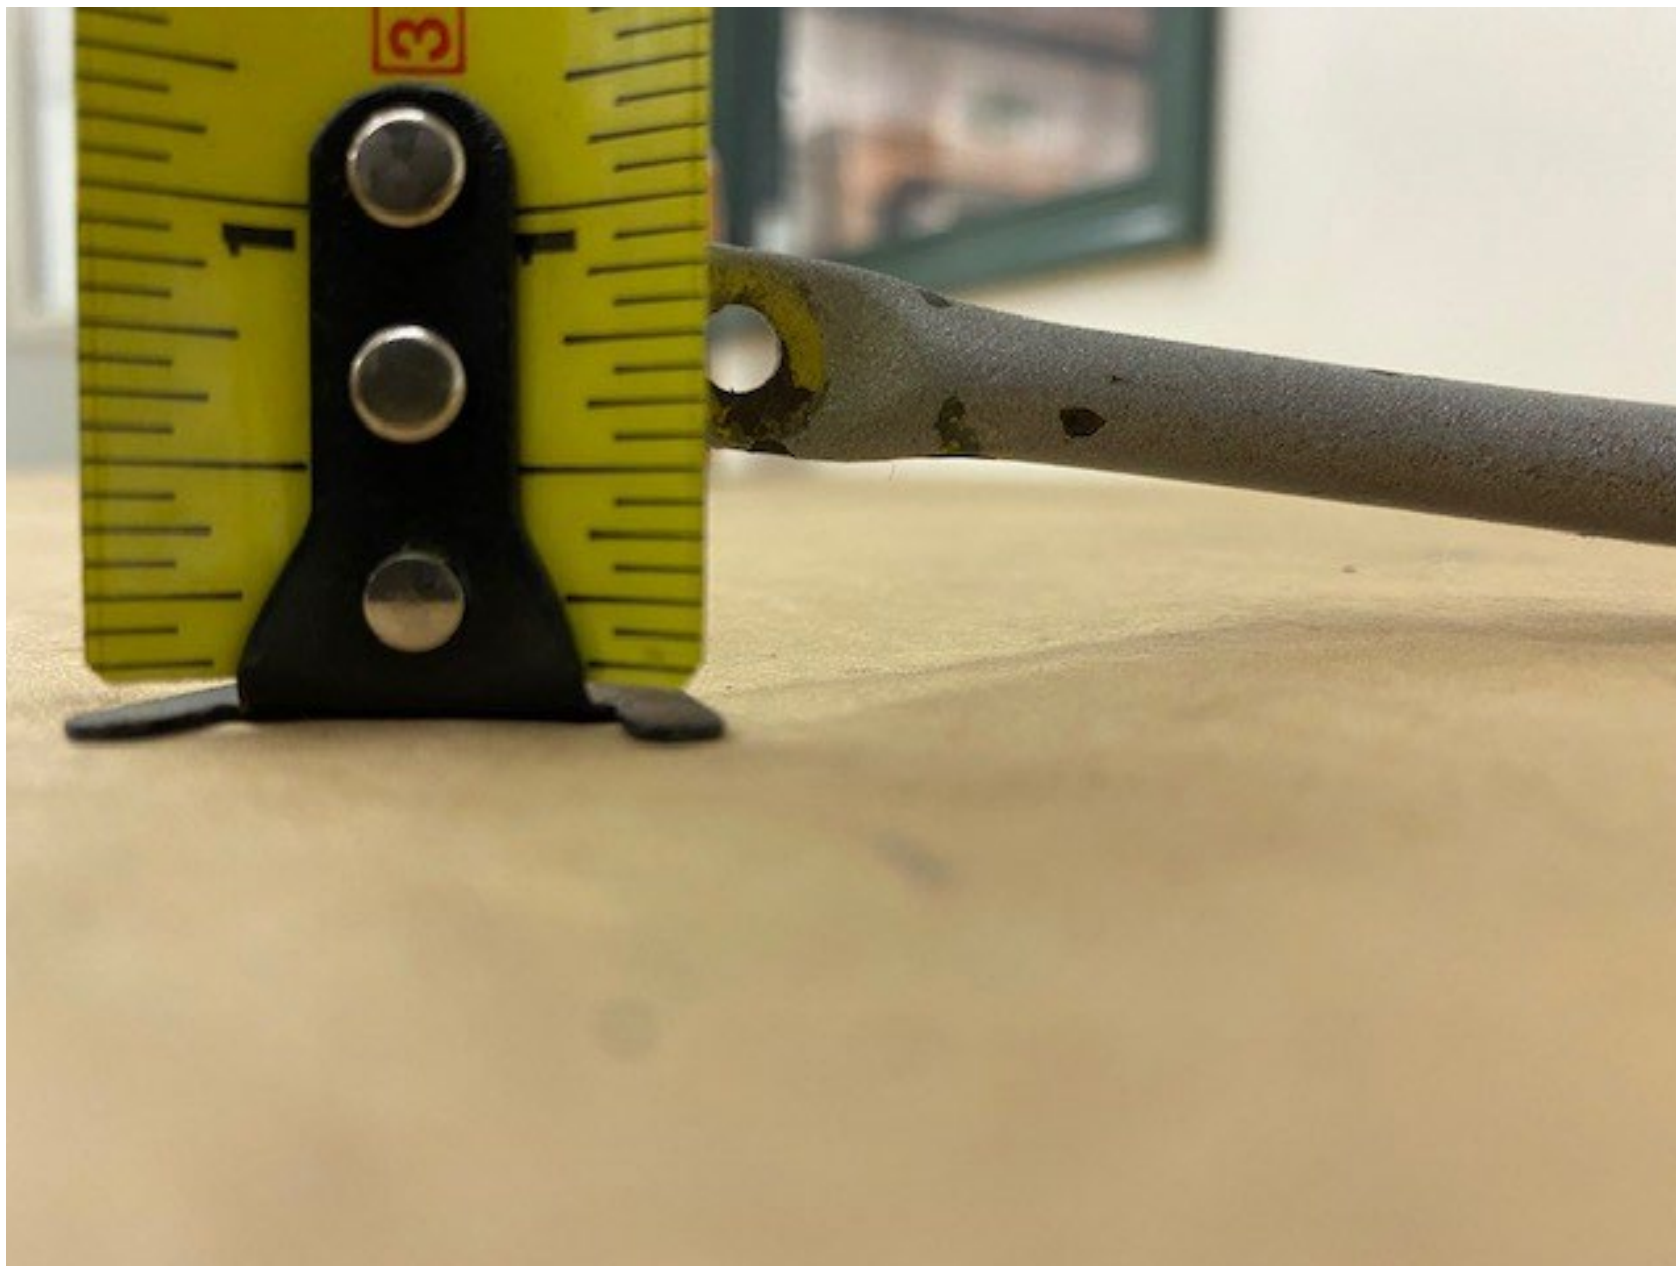
**Photo 12 - FAA Digital Photograph. View of One End of the Right Front Seat Tube-Seat Catch Release. Note the Deformed Distance Above the Table About 0.5625 Inch.**

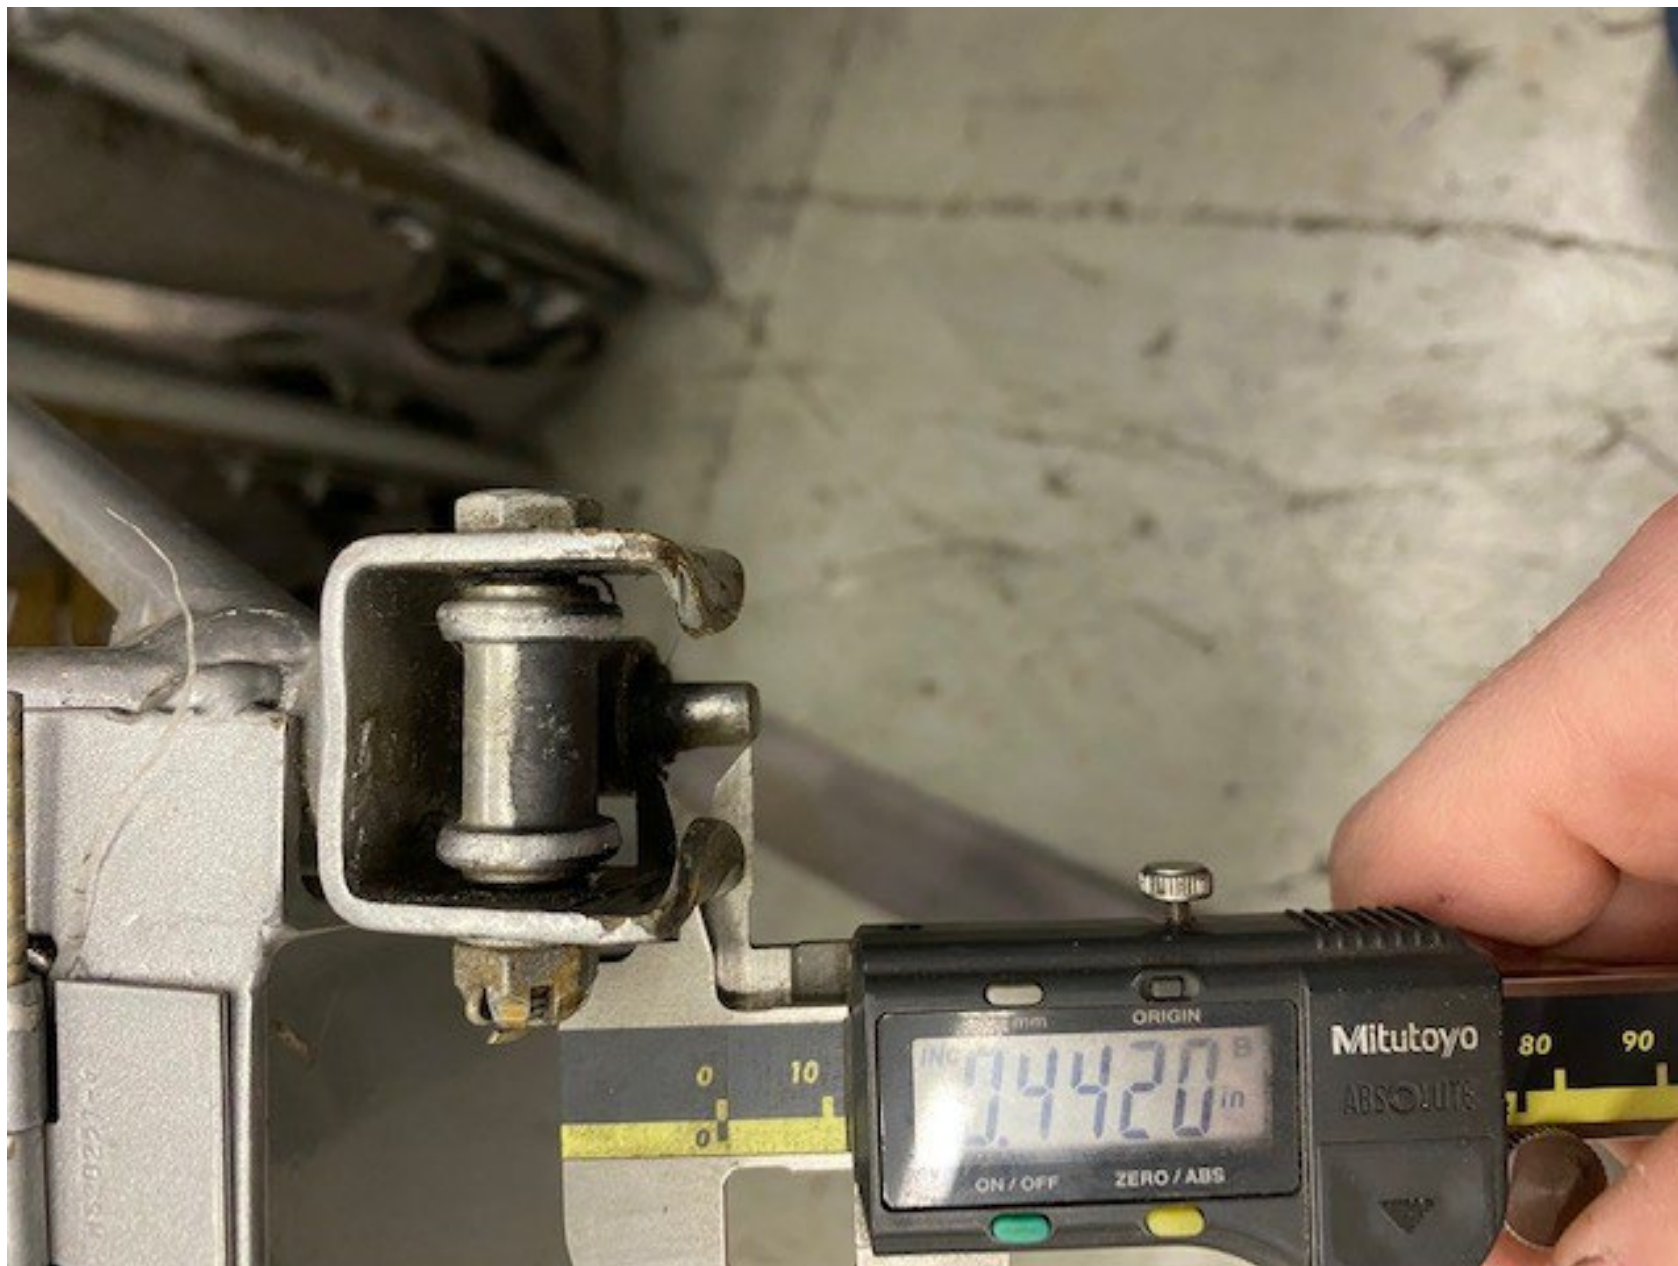
**Photo 13 - FAA Digital Photograph. View of the Left Plunger-Seat Catch Extension of the Right Front Seat. Note the Extension of 0.4420 Inch From the Housing.**

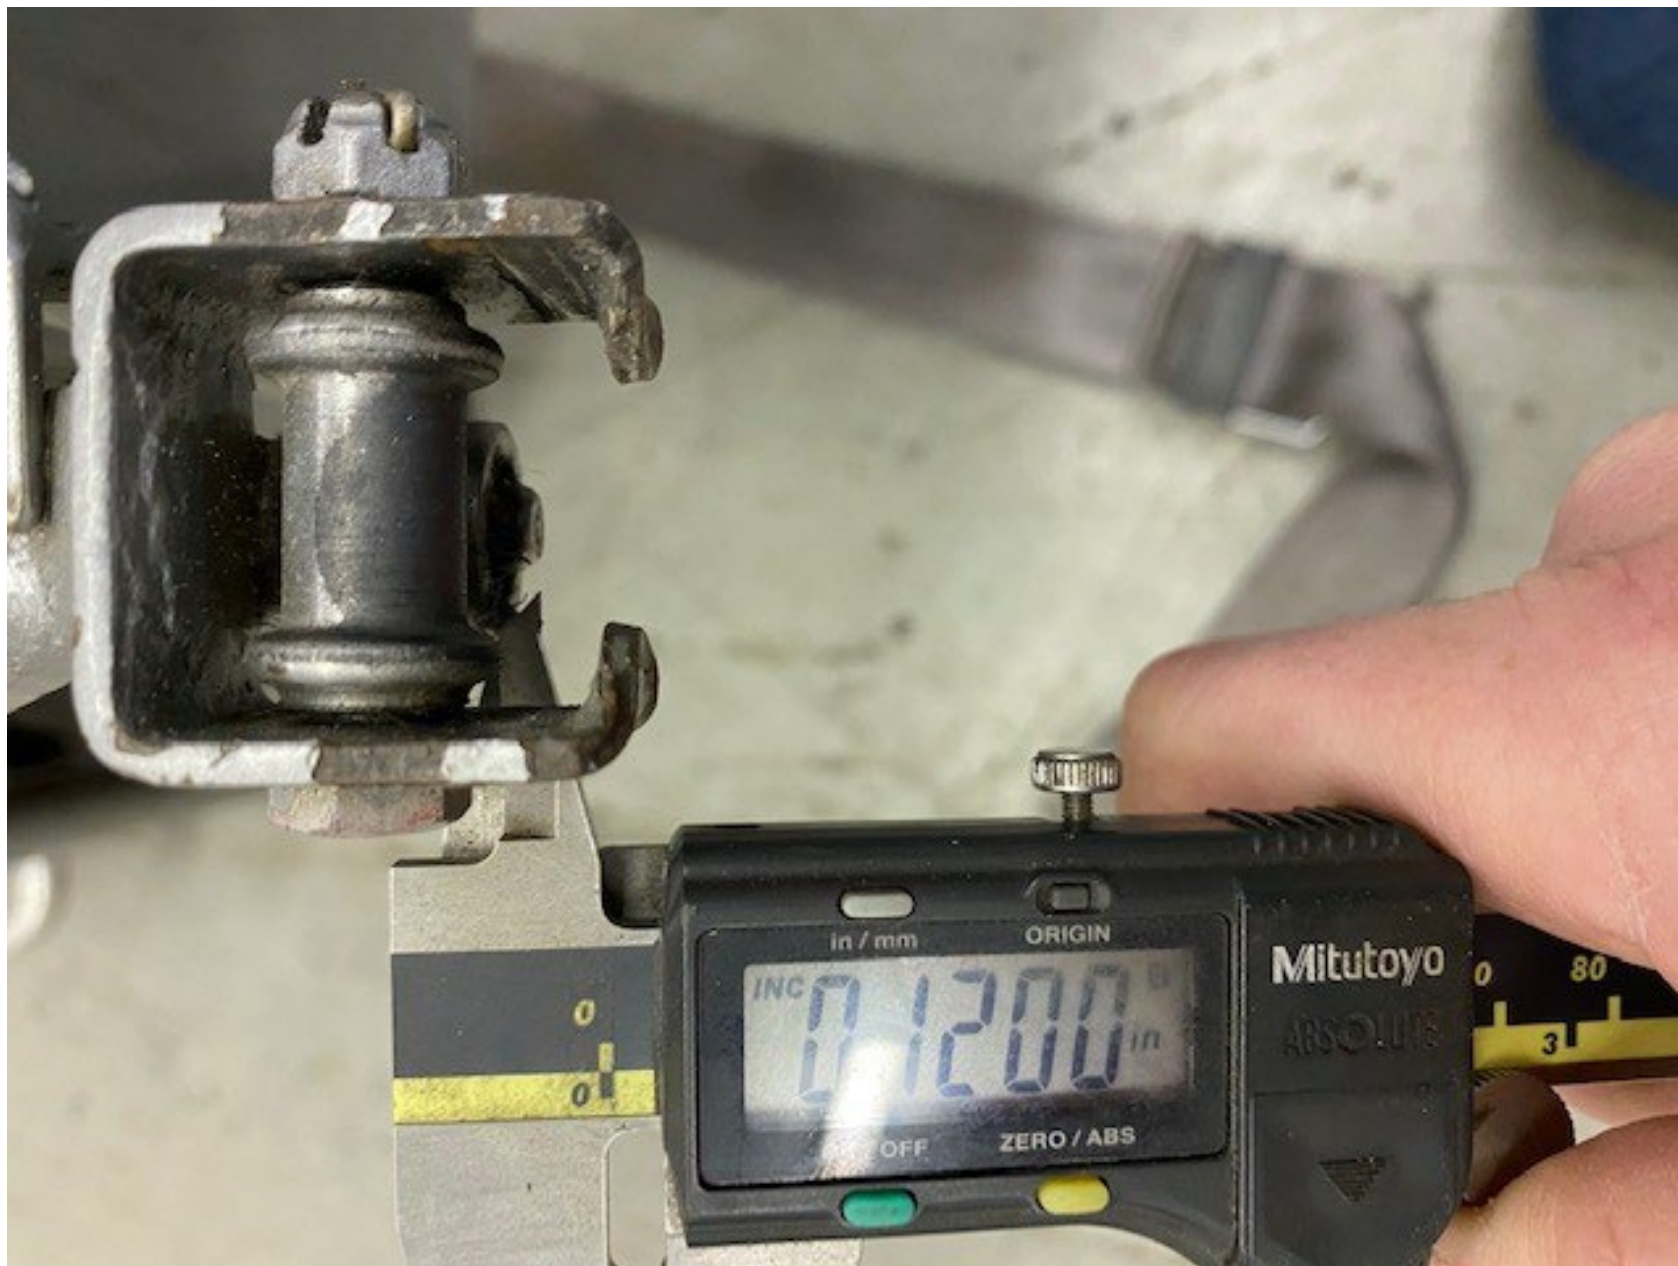
**Photo 14 - FAA Digital Photograph. View of the Right Plunger-Seat Catch Extension of the Right Front Seat. Note the Extension of 0.1200 Inch From the Housing.**
