## NATIONAL TRANSPORTATION SAFETY BOARD

### Wreckage Examination

#### A. ACCIDENT      ERA21LA290

Location: Piermont, New Hampshire  
Date: July 16, 2021  
Time: 1945 Eastern Daylight Time (EDT)  
Operator: Boland Balloon  
Aircraft: Experimental Balloon  
Registration: N2925L

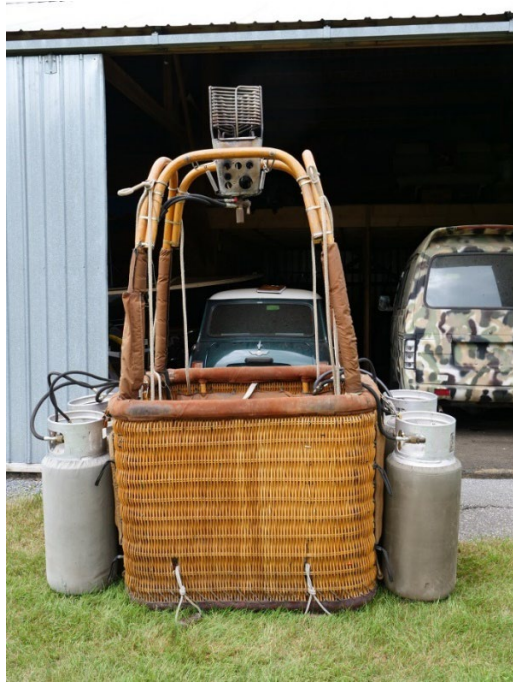
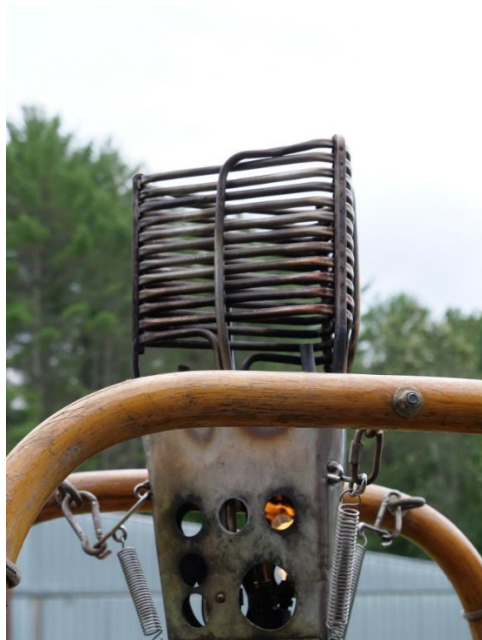
The balloon was examined at the pilot's hangar at 2B9 on July 21, 2021. The balloon was not manufactured by Cameron Balloon US. The basket and burner were manufactured by Galaxy Balloons, the propane gas tanks were manufactured by Worthington and the envelope was an experimental envelope built by the pilot. The basket, propane tanks, and burner operated normally. The burner's pilot light was lit without difficulty.

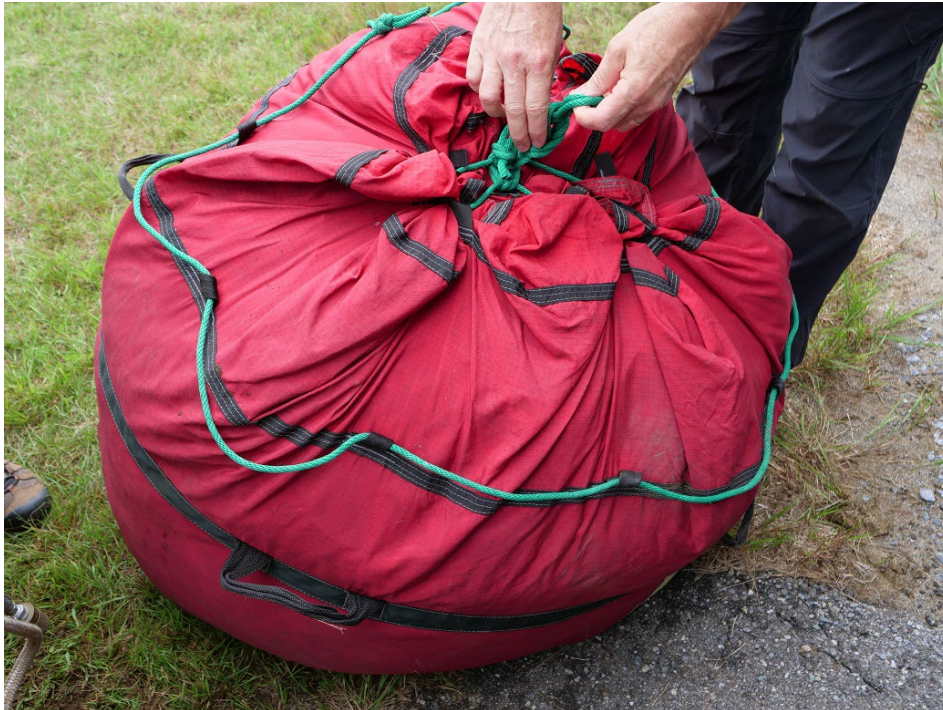
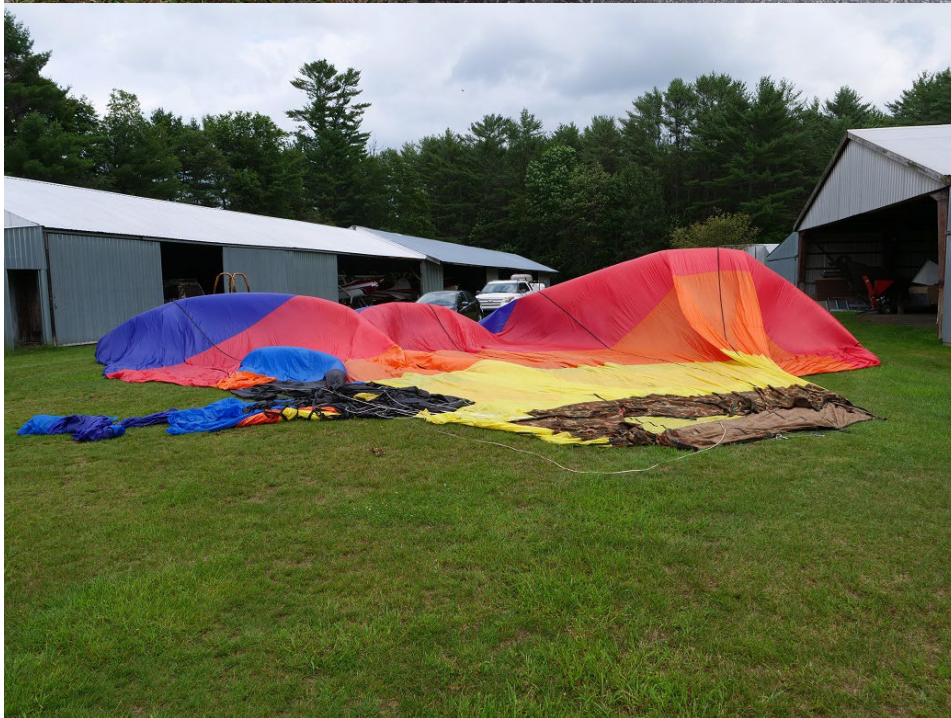
The envelope was removed from its storage bag and laid out for examination. No anomalies were noted with the basket or envelope that would have precluded normal operation.
