## **NATIONAL TRANSPORTATION SAFETY BOARD**

Office of Aviation Safety  
Eastern Region

**Photo Array**

**ERA21LA291**

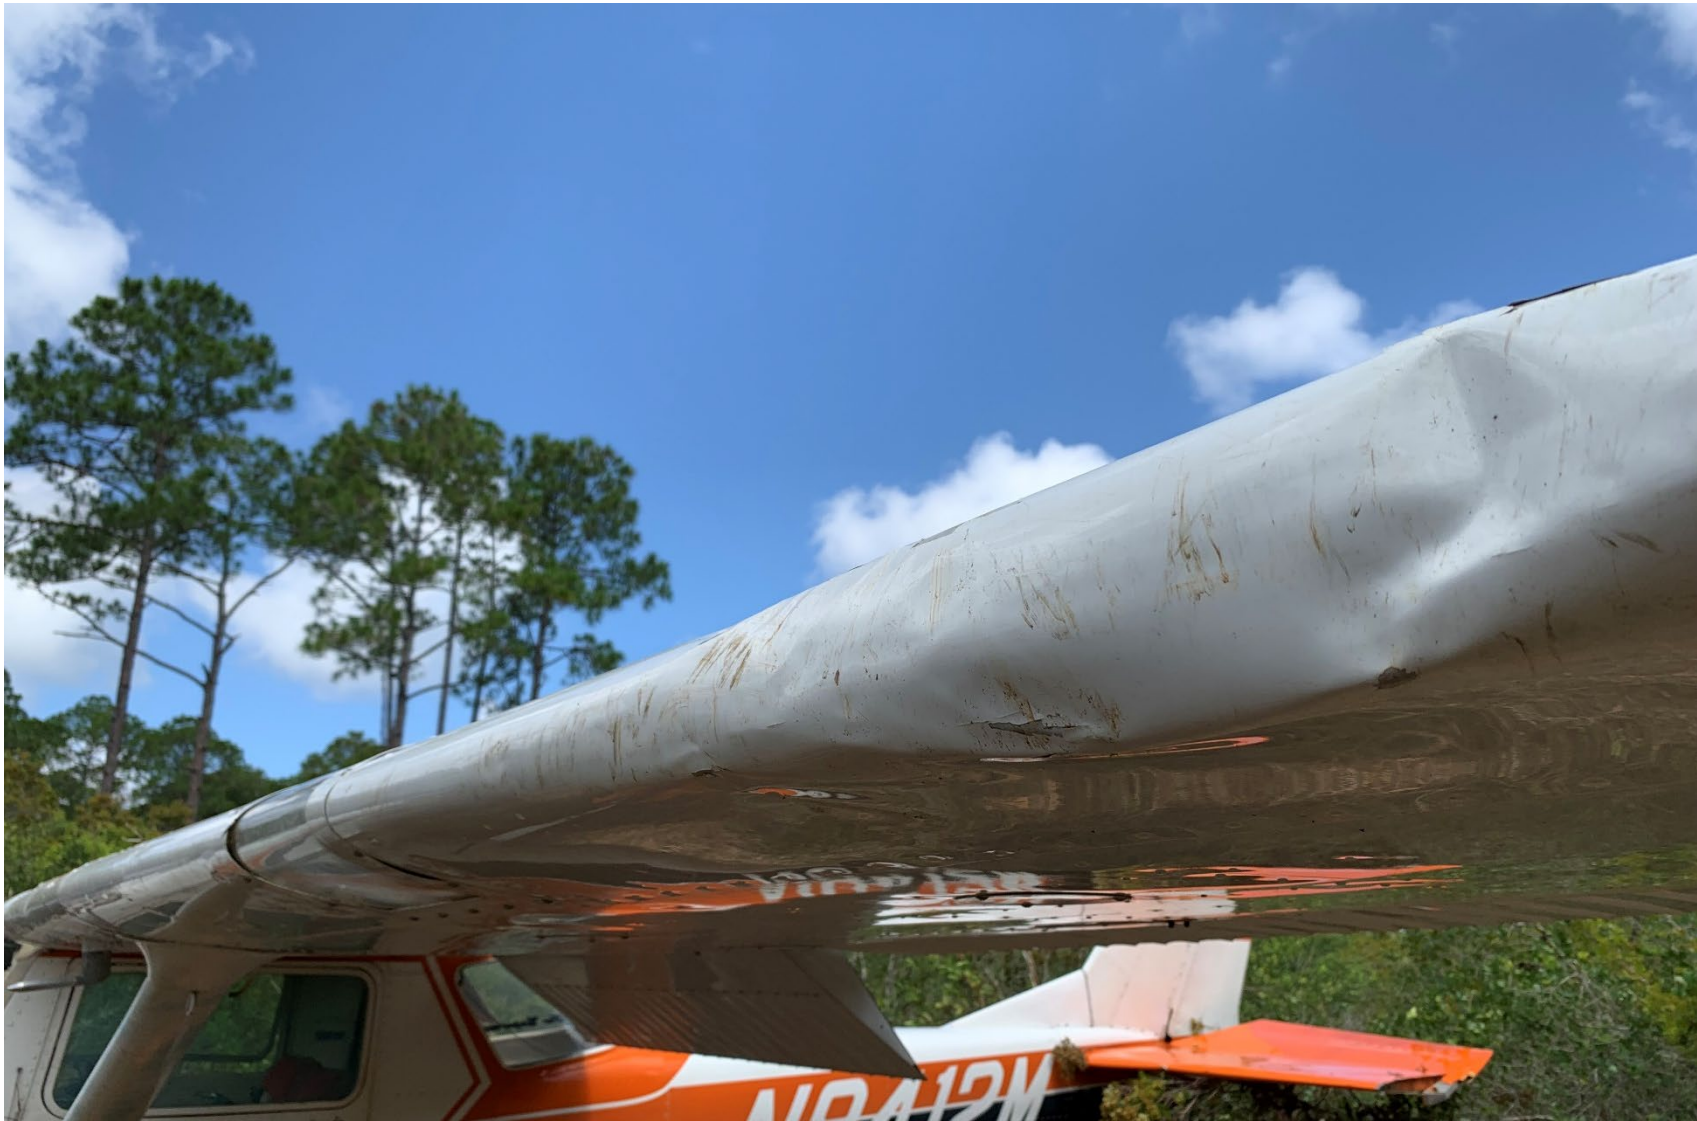
**Photo 1 – View of the damage to the leading edge. (Photo Courtesy of FAA)**

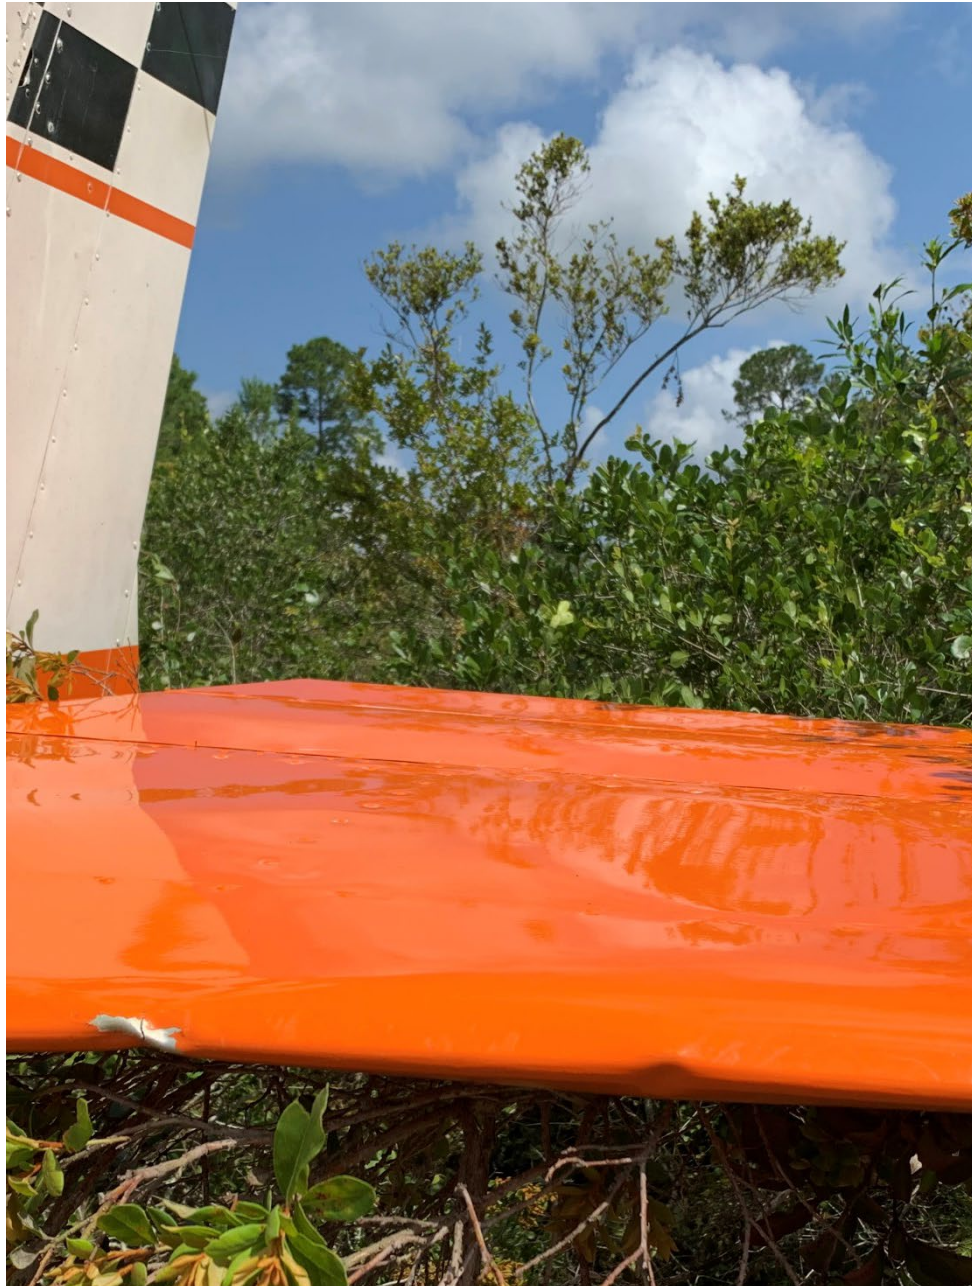
**Photo 2 – View of the damage to the horizontal stabilizer. (Photo Courtesy of FAA)**
