## **NATIONAL TRANSPORTATION SAFETY BOARD**

### **Specialist's Factual Report**

# **METEOROLOGY**

ERA21LA295

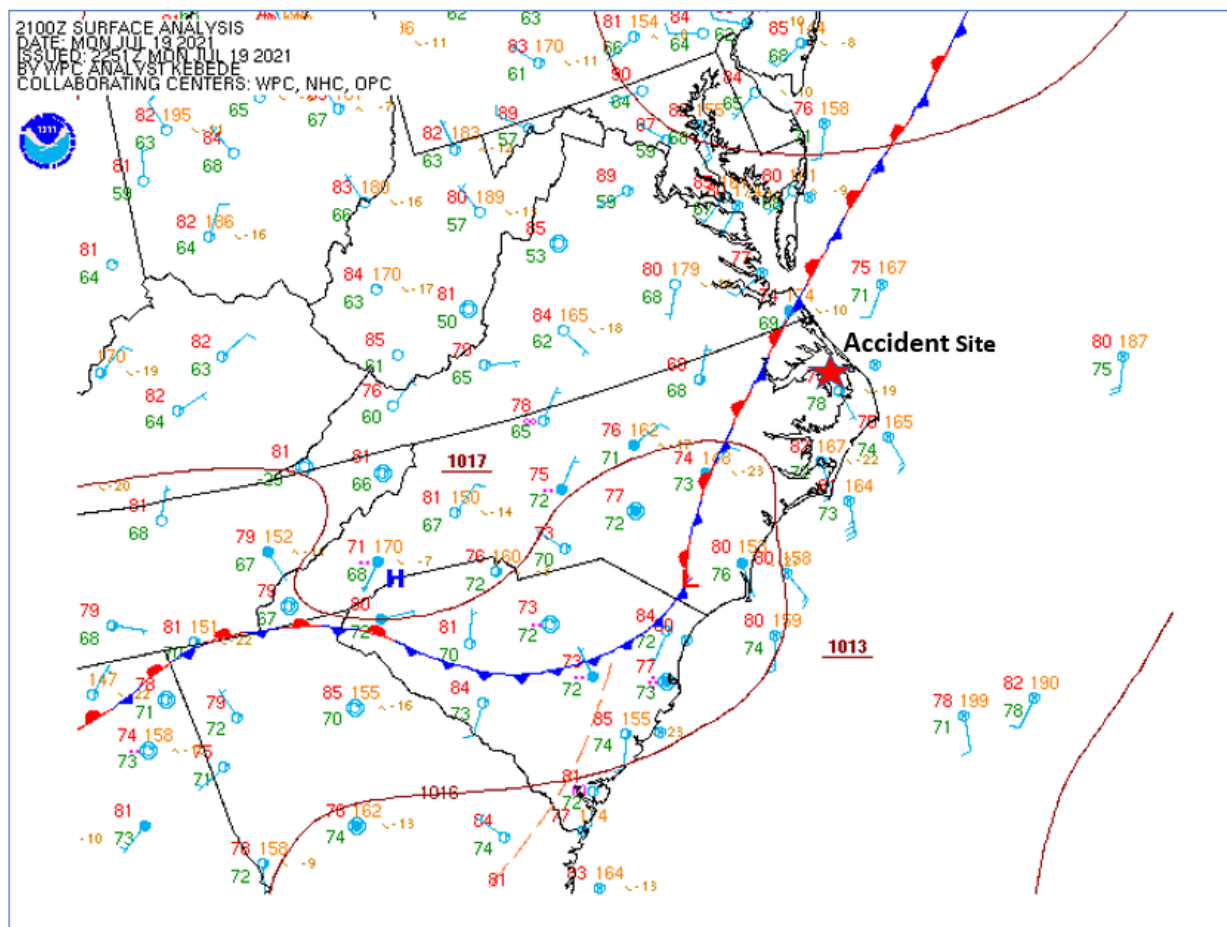
The National Weather Service (NWS) east central section of the Surface Analysis Chart for 1700 EDT is included as figure 1. The chart depicted a low-pressure system at 1013 hectopascals (hPa) over southeast North Carolina along a stationary front which extended northeast from North Carolina into extreme southeastern Virginia and into the Atlantic Ocean. The accident site was located immediately east of the stationary front. The station models in the vicinity of the accident site on the warm air side of the stationary front depicted southerly winds magnitudes from calm to 15 knots.

**Figure 1** - NWS east-central Surface Analysis Chart for 1700 EDT.

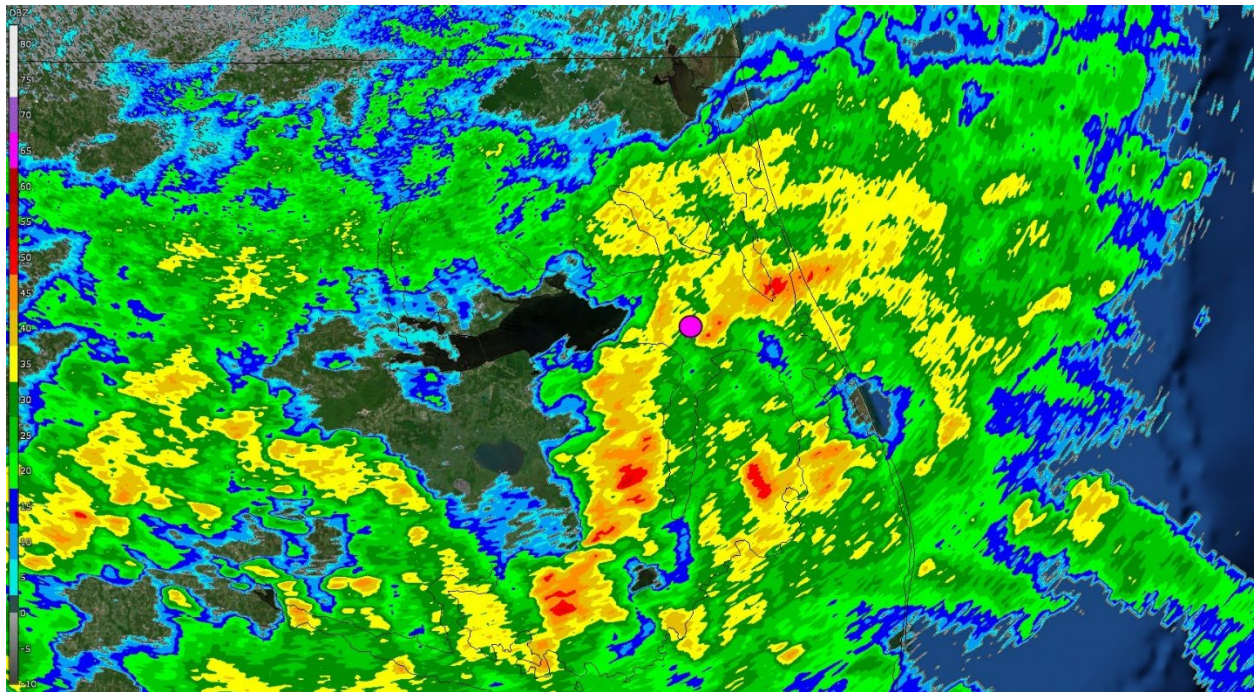
WSR-88D<sup>2</sup> Level-II base reflectivity weather radar imagery from the Wakefield, Virginia, site (KAKQ) is presented in figure 2. KAKQ was located approximately 75 miles northwest of the accident location at an elevation of about 250 feet. Assuming standard refraction and considering the 0.95° beam width<sup>3</sup> for the WSR-88D radar beam, the KAKQ 0.529° tilt would have “seen” altitudes above the accident location of between about 4,400 and 12,000 feet above msl. The imagery revealed light to extreme values of reflectivity<sup>4</sup> in the immediate vicinity of the accident location at the accident time.

**Figure 2** – KAKQ 0.529° Level-II base reflectivity product from a sweep initiated at 1848 EDT. Accident location marked by the purple circle. Reflectivity has been “smoothed” out.

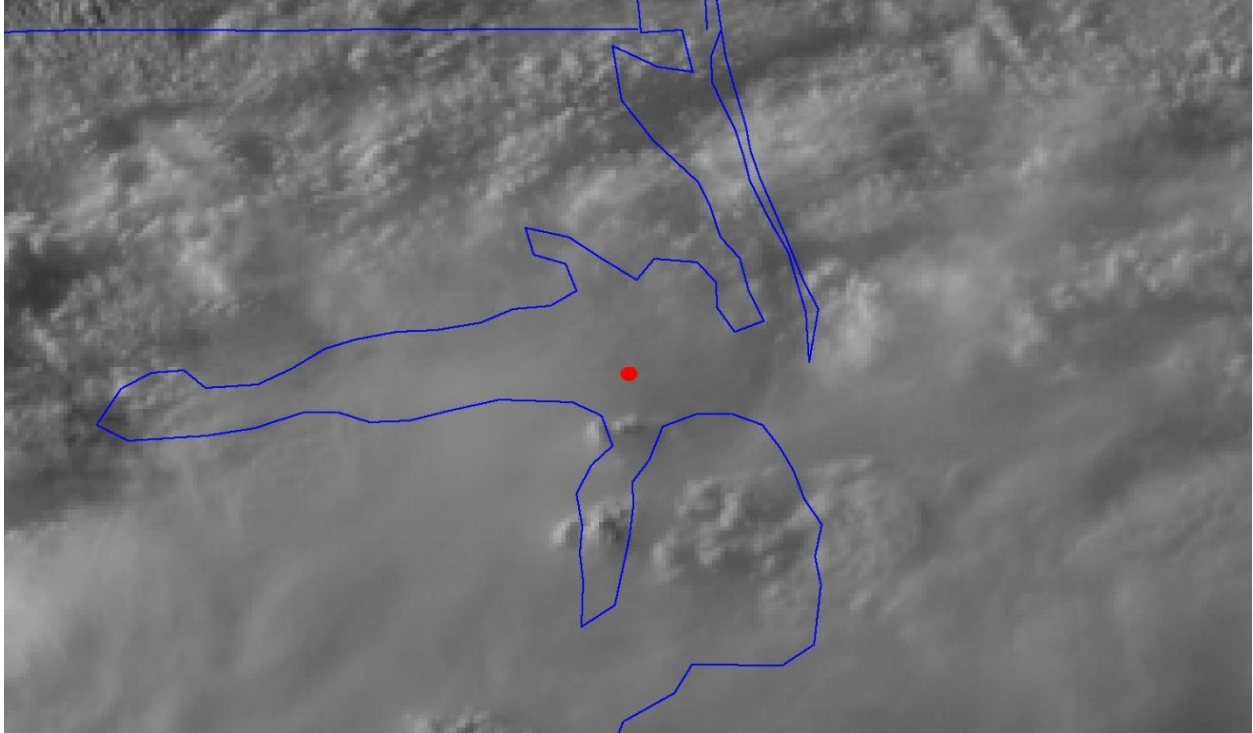
Geostationary Operational Environmental Satellite (GOES)-16 visible (0.64 $\mu\text{m}$ ) and infrared (10.3 $\mu\text{m}$ ) data were obtained from an archive at the Space Science Engineering Center at the University of Wisconsin-Madison. Images from 1846 EDT are presented in figures 4 and 5. The GOES-16 visible imagery depicted cloudy conditions over the accident region. Infrared cloud-top temperatures over the accident site were about -33°C, which, when considering the 1900 EDT HRRR sounding, corresponded to cloud top heights greater than 30,000 feet.

**Figure 4** – GOES-16 visible imagery from 1846 EDT. Accident location denoted by red dot. Image is not corrected for parallax error.

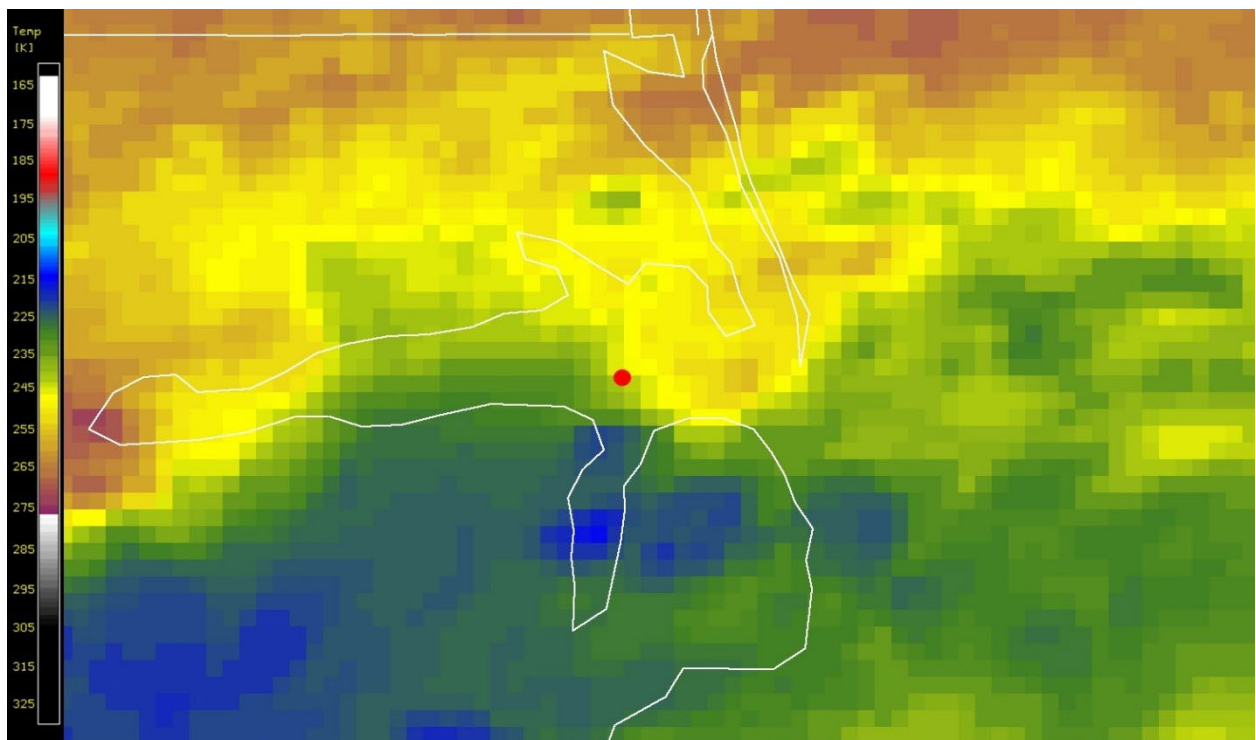
**Figure 5** – GOES-16 infrared imagery from 1846 EDT. Accident location denoted by red dot. Image is not corrected for parallax error.
