# NTSB Investigation: ERA21LA295

N4529J | Robinson R44 II

Photo Array

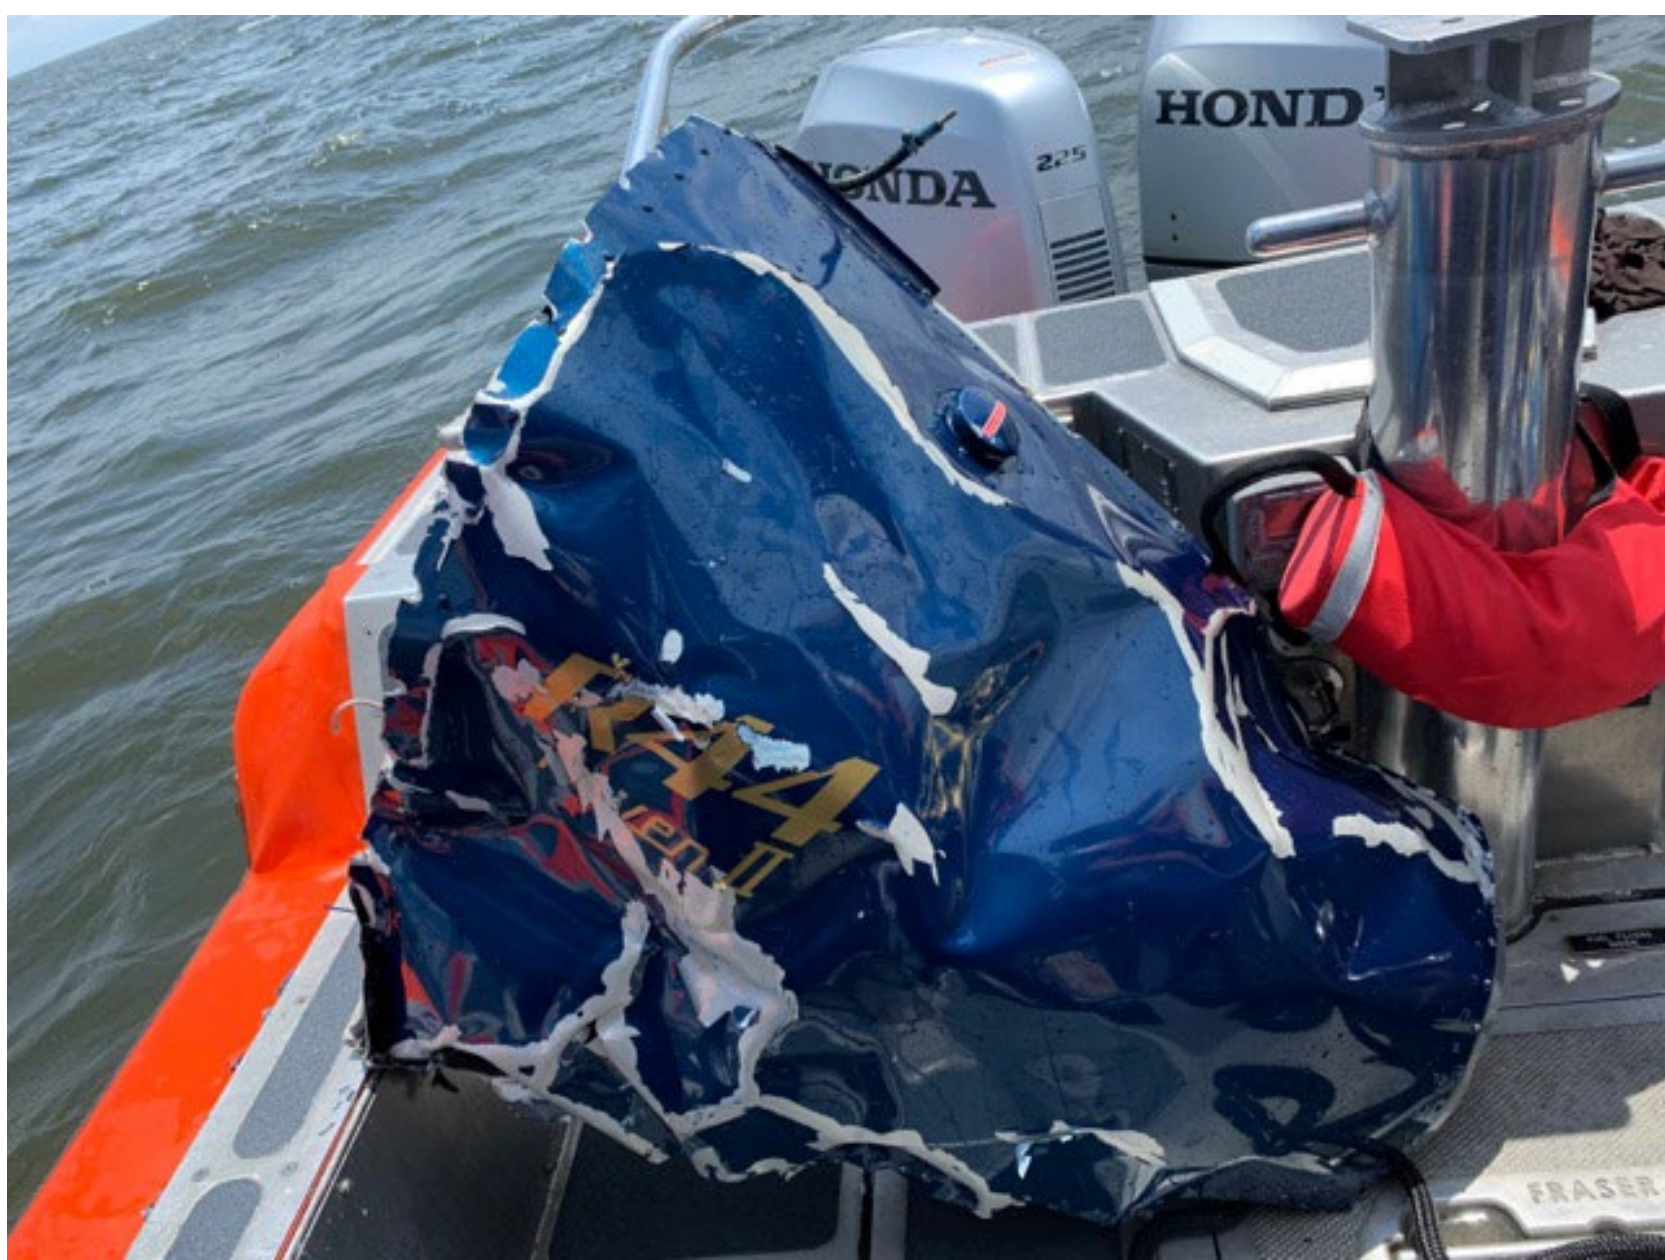
Photo 1 – View of a portion of the helicopter's airframe and fuel tank cap as recovered by the United States Coast Guard (Photo Courtesy of USCG)

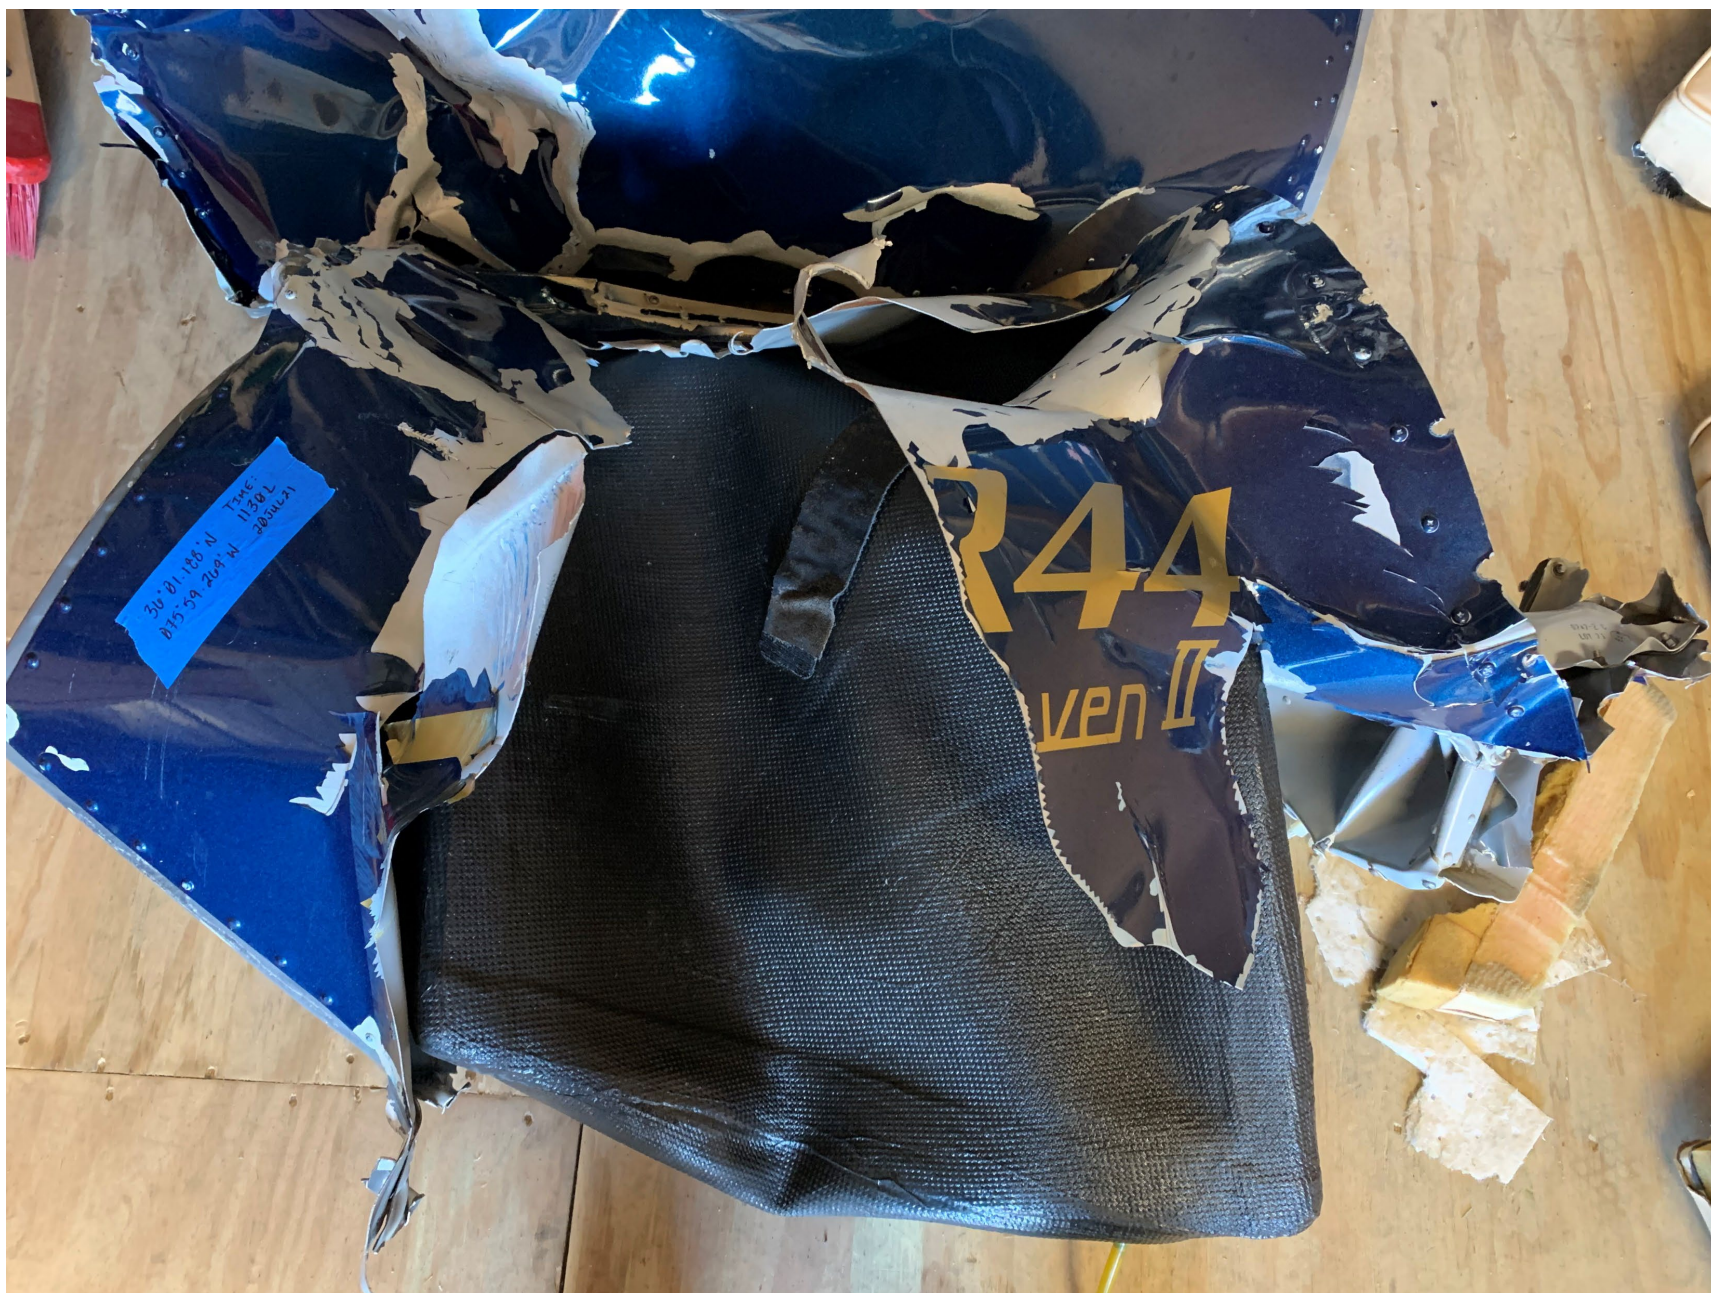
Photo 2 – Additional view of the helicopter's airframe displaying the model type, as recovered by the United States Coast Guard (Photo Courtesy of USCG)

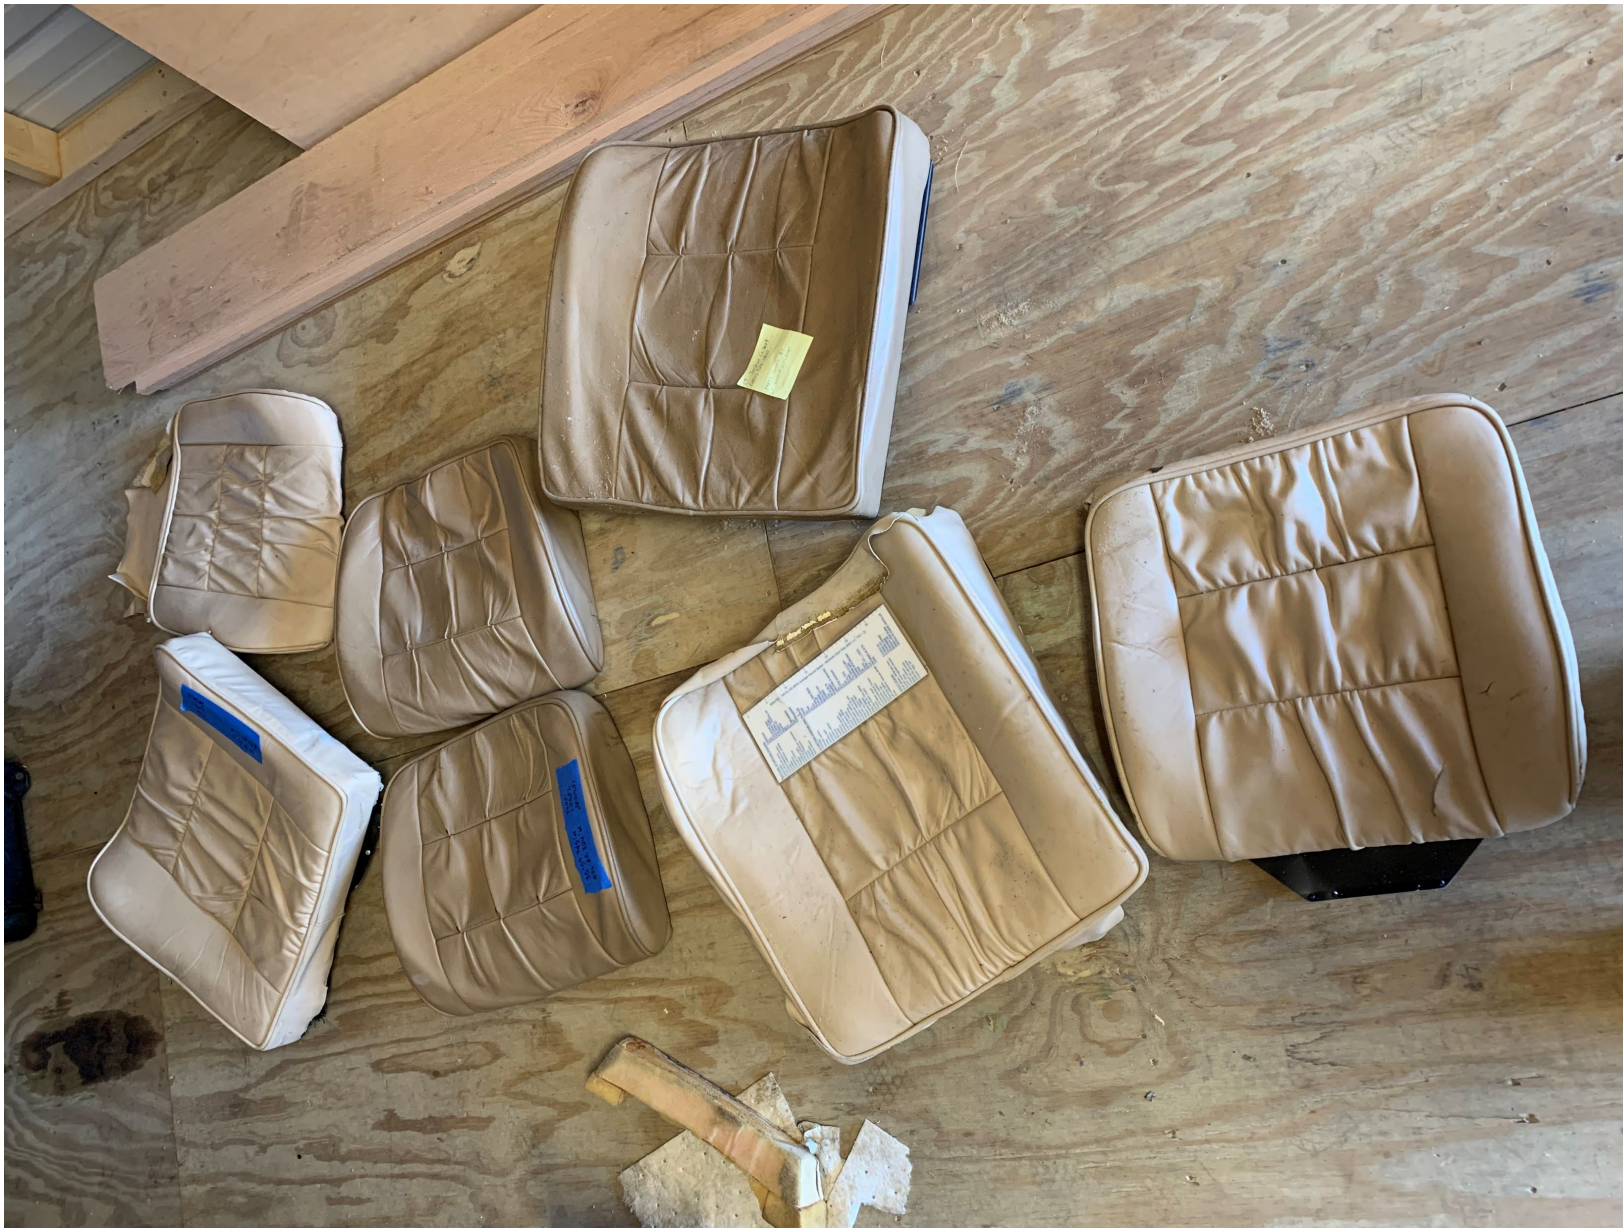
Photo 3 – Seat cushions and checklist recovered by the United States Coast Guard (Photo Courtesy of USCG)
