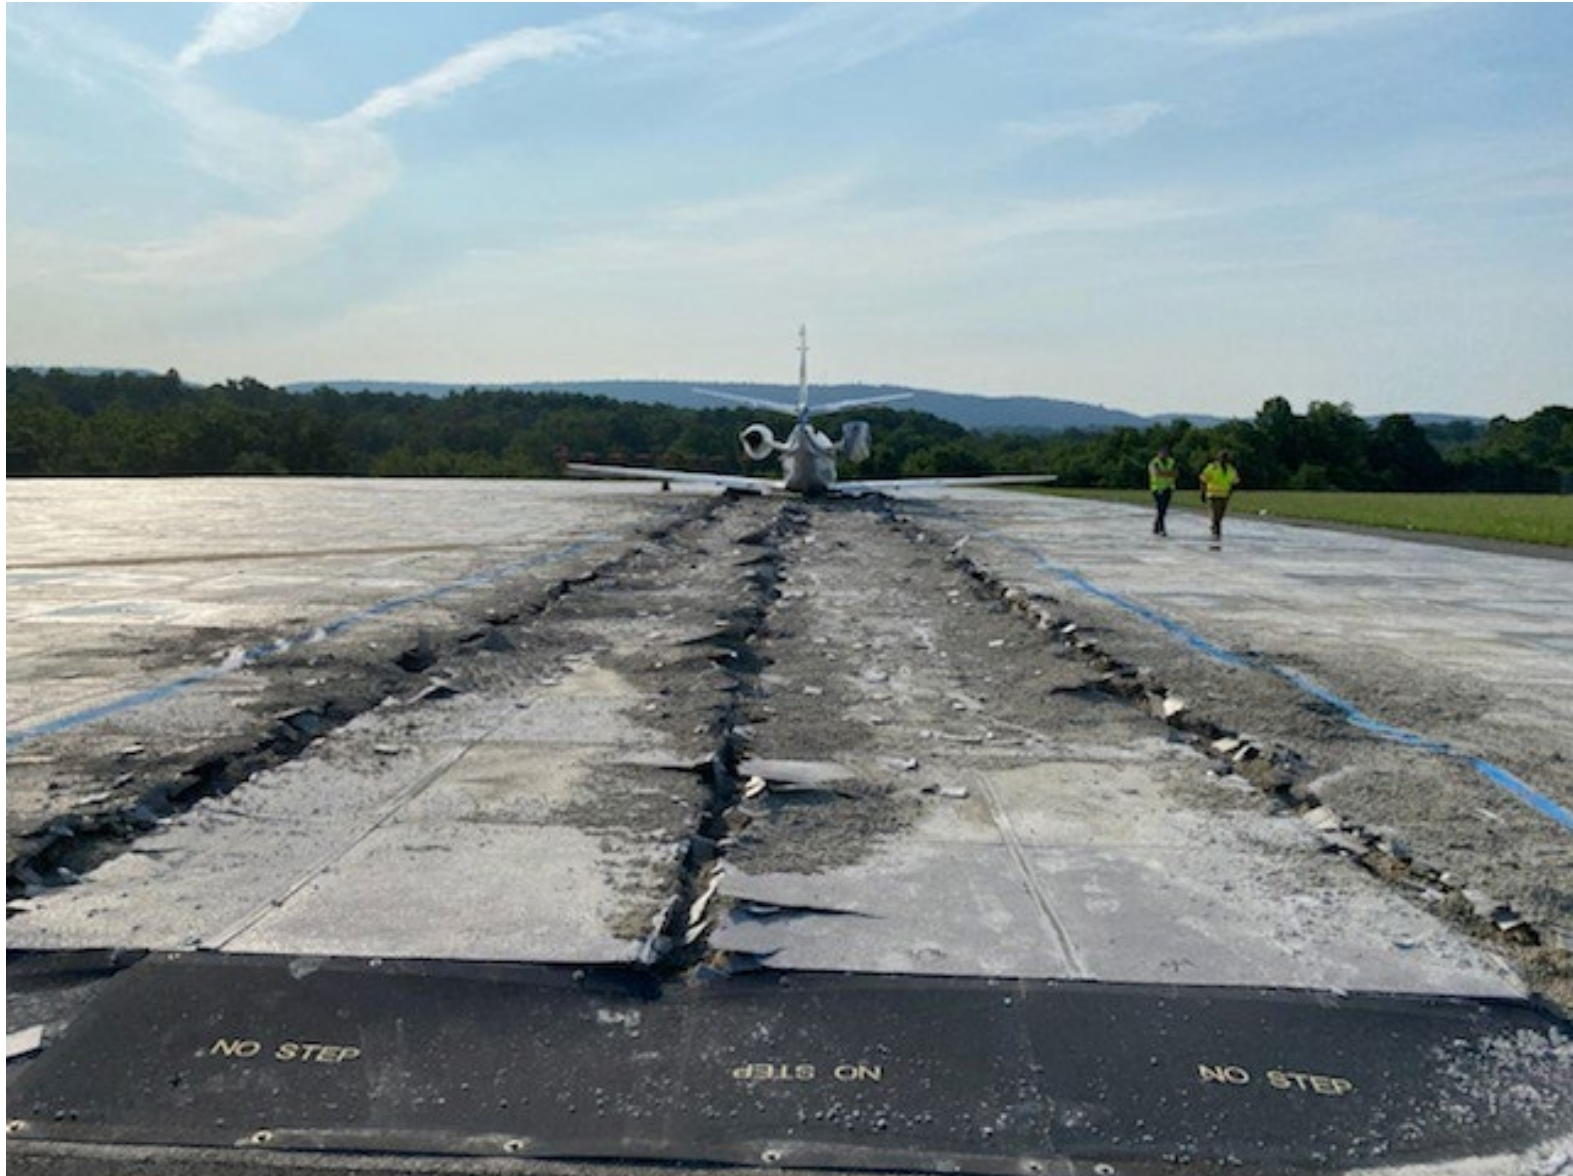
**Photo 1 – View of airplane resting in EMAS system. (Courtesy of AIG)**

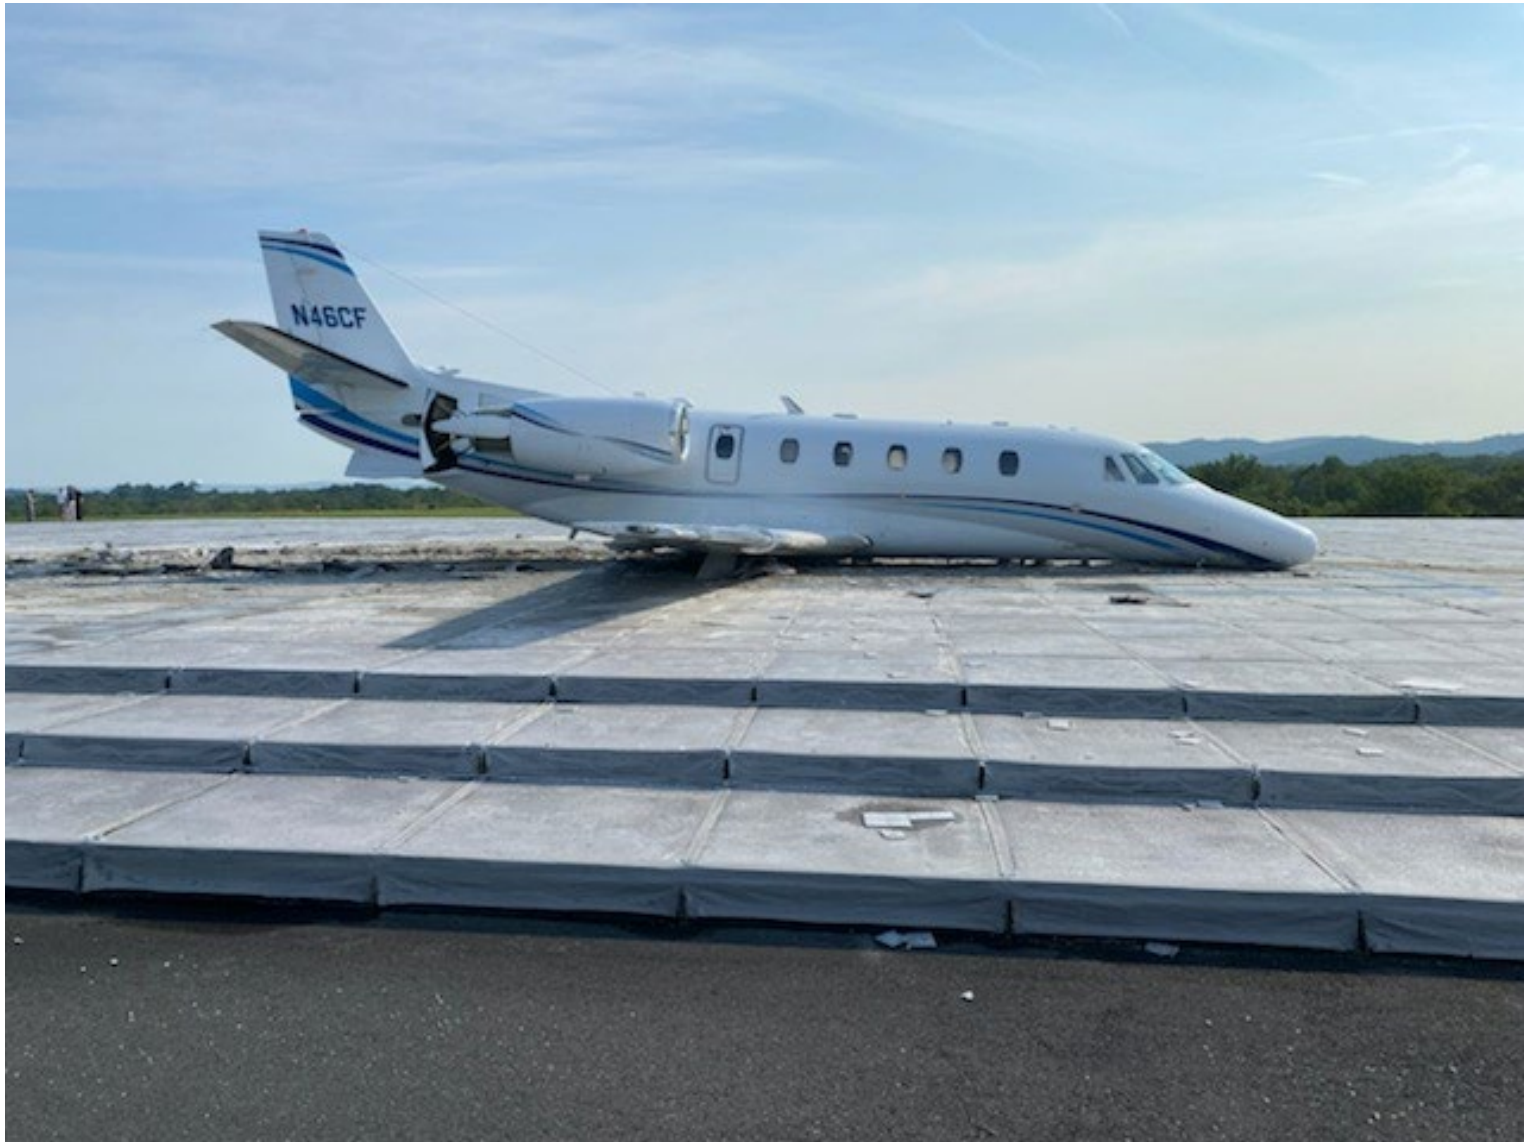
**Photo 2 – Right profile view of airplane resting in EMAS system. (Courtesy of AIG)**

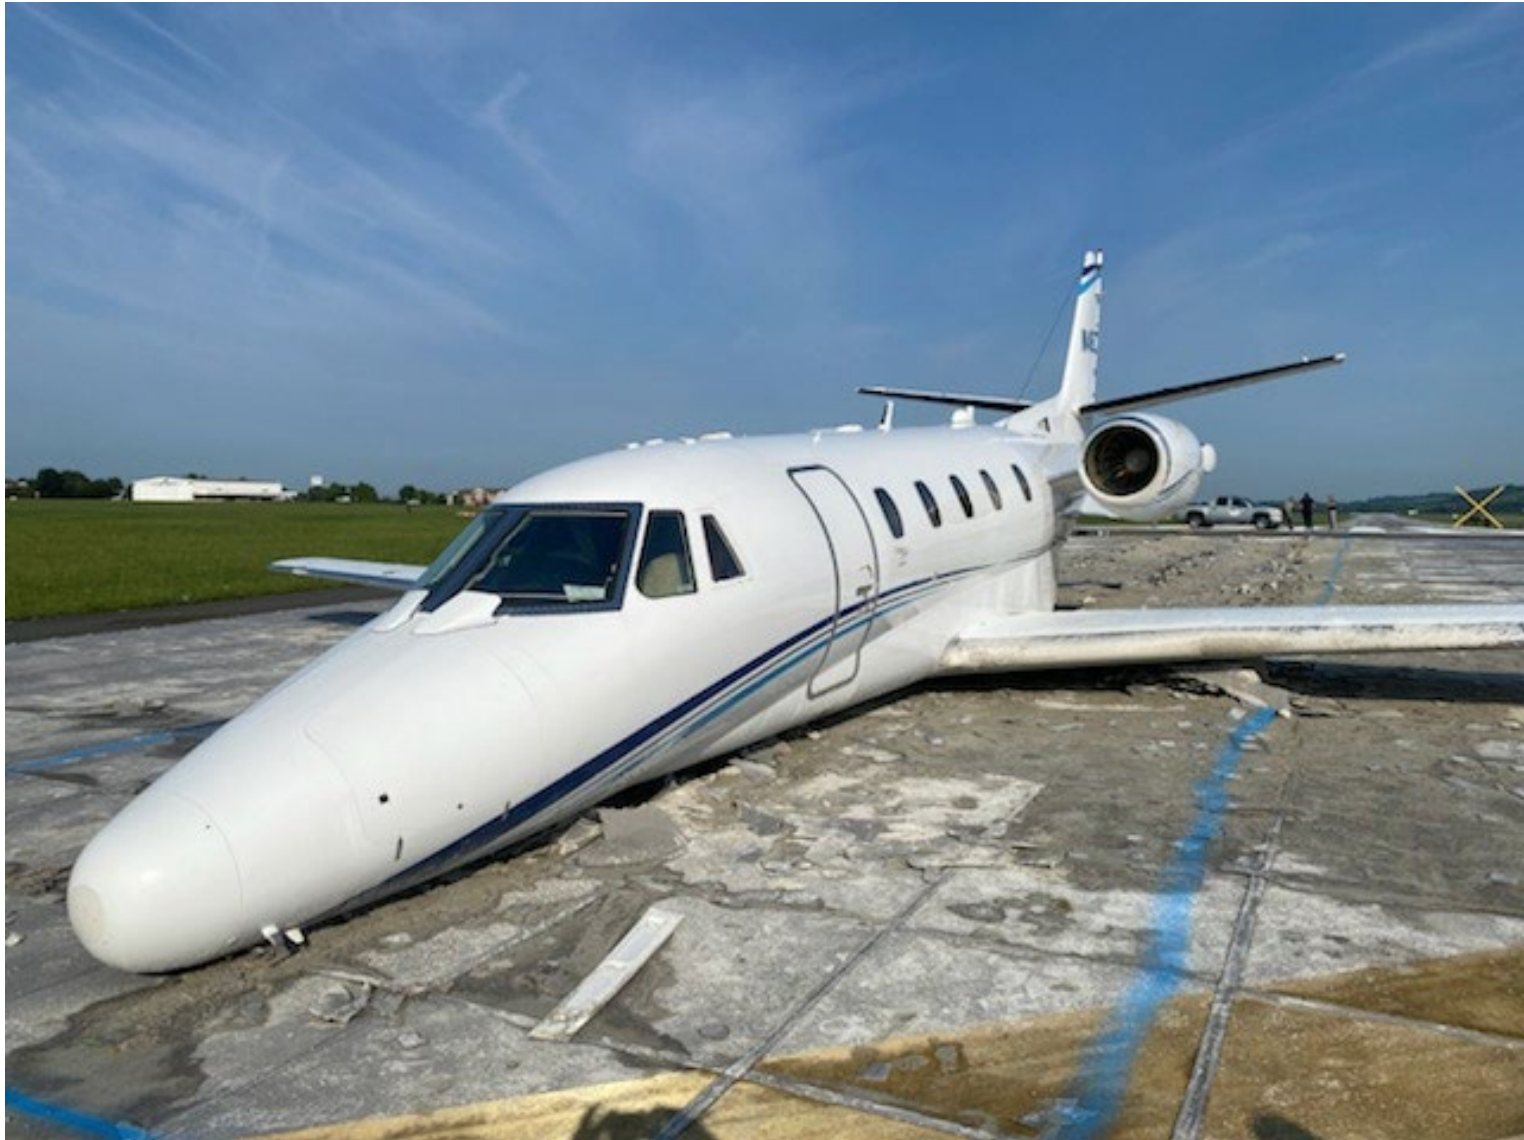
**Photo 3 – Left quarter view of airplane resting in EMAS system. (Courtesy of AIG)**

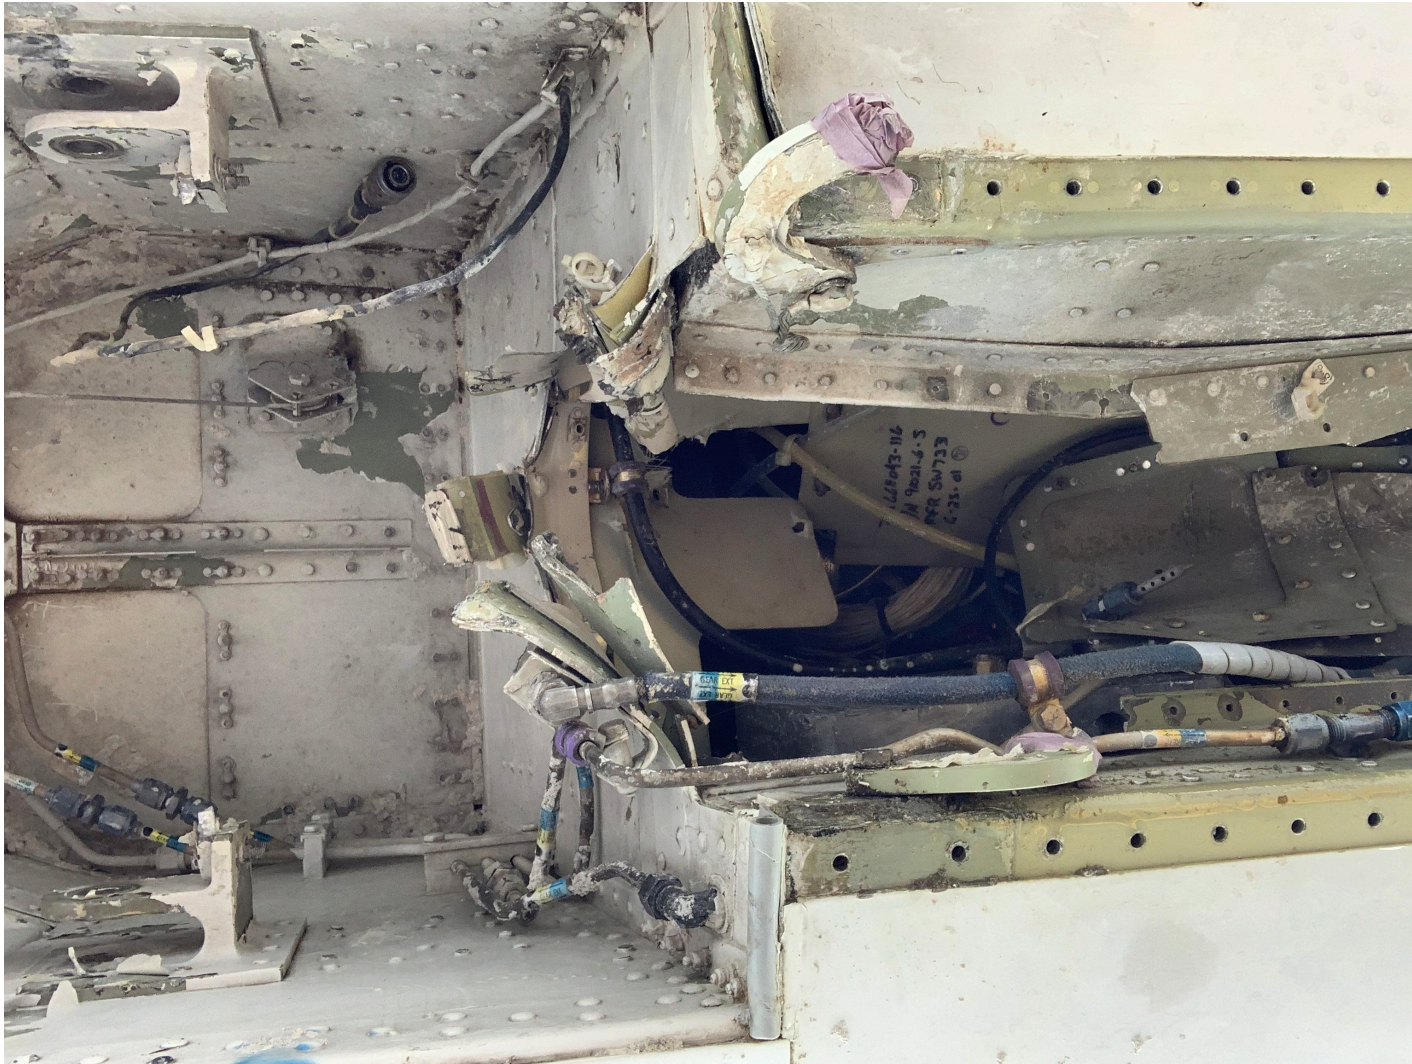
**Photo 4 – View of nose landing gear well damage looking up. Note: pressure vessel was compromised (Courtesy of FAA)**
