## **Memorandum For Record**

**Date: August 12, 2021**  
**NTSB Accident Number: ERA21LA297**

Following the accident involving N3059X, a Cessna 150F, serial number (SN) 15064459 on July 23, 2021, in Arden, North Carolina, the airplane was transported to Atlanta Air Salvage in Griffin, Georgia and remained secured pending NTSB investigation.

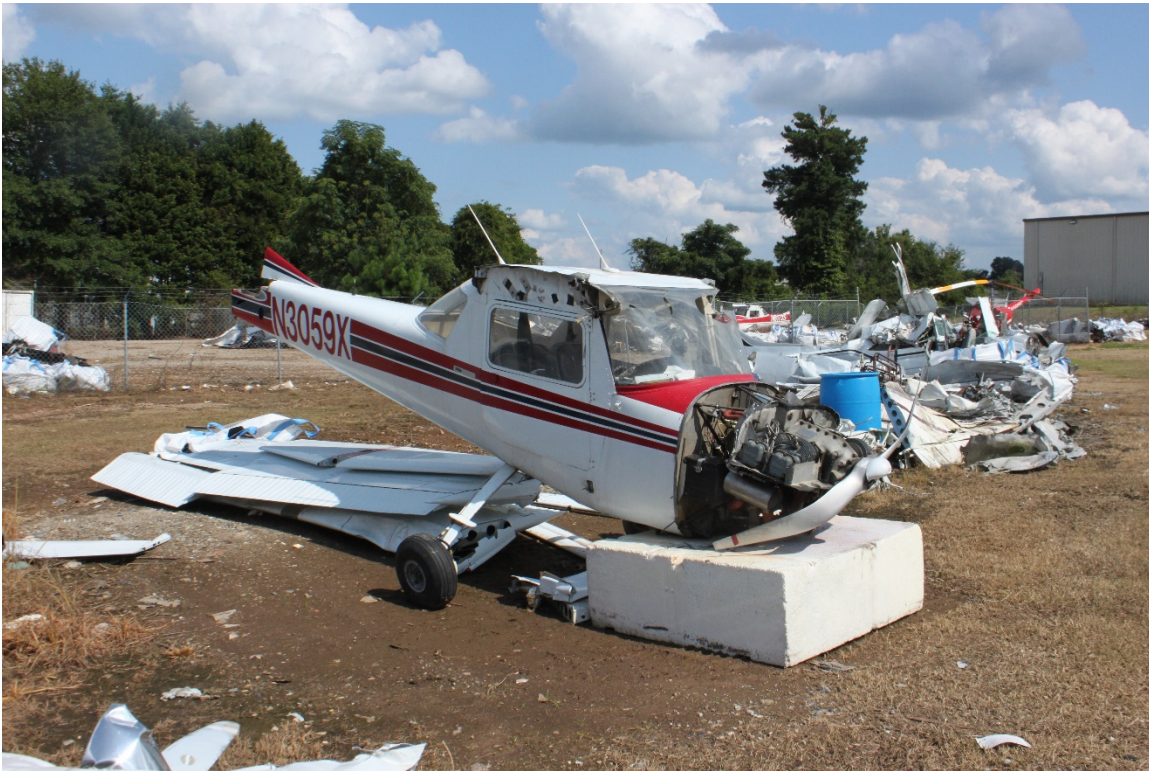
Cursory examination of the airframe and engine was performed of N3059X on August 11, 2021. As first viewed the wings, vertical stabilizer and rudder, horizontal stabilizer and elevators, and engine cowlings were removed and resting on the ground beneath the aft empennage. The airplane was in a nose low/tail high attitude with the lower portion of the engine resting on a thick portion of Styrofoam (Figure 1).

Figure 1: NTSB Digital Photograph. Left Forward Quartering View of the Airplane at the Salvage Facility.

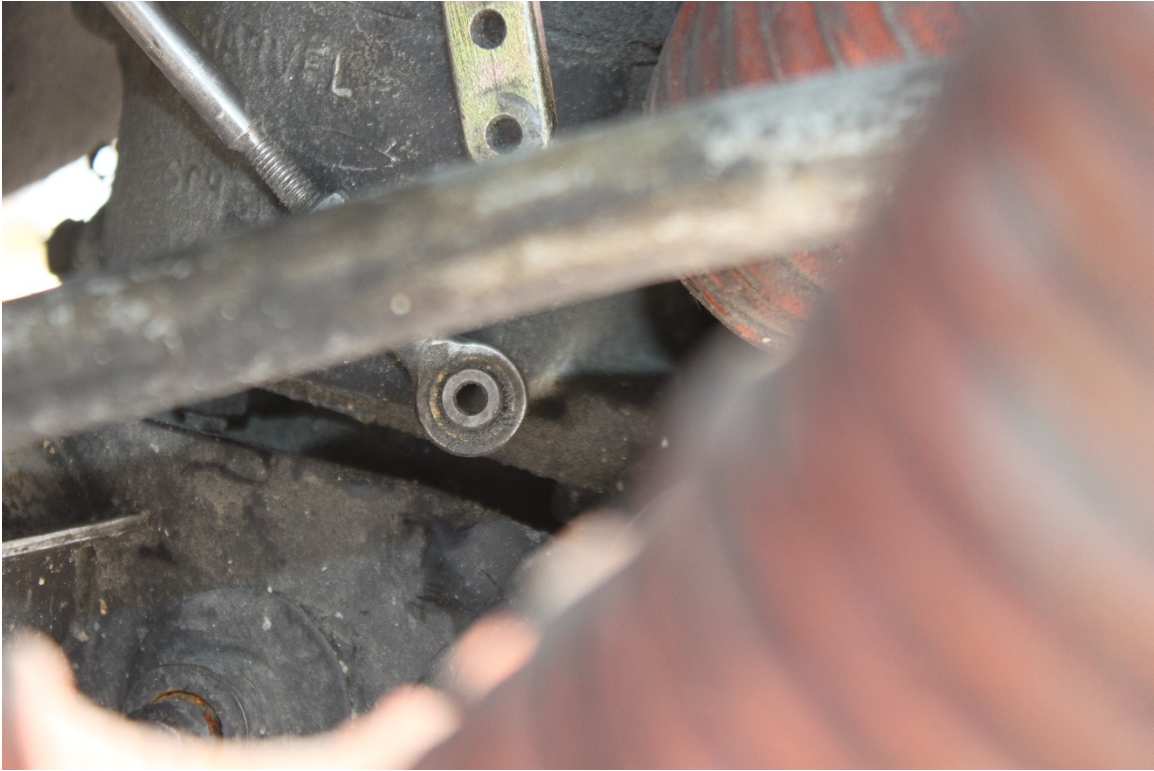
Examination of the carburetor revealed the throttle control lever was in the full forward (or wide-open) position which matched the position of the cockpit control. The throttle control cable was separated from the intact throttle control lever and the rod end attached to the end of the throttle control cable was also intact (Figure 2). Further examination of the throttle control lever revealed there was no spring installed. All ignition leads at the spark plugs were tight and both magnetos were tightly secured to the accessory case with no evidence of slippage. Examination of the Brackett Aero Filters, Inc., part number BA-4106 Rev. A revealed the filter element was in-place with a wire screen aft of the element.

Figure 2: NTSB Digital Photograph. Close-Up View of the carburetor, intact throttle control lever, and separated but intact Throttle Control Cable.
