## **NTSB AIRFRAME AND ENGINE EXAMINATION**

**NTSB Investigation: ERA21LA309  
N36DK, Enstrom 280FX  
Lycoming HIO-360-F1AD (S/N L-32665-51A)  
Operated by BETA AIR LLC**

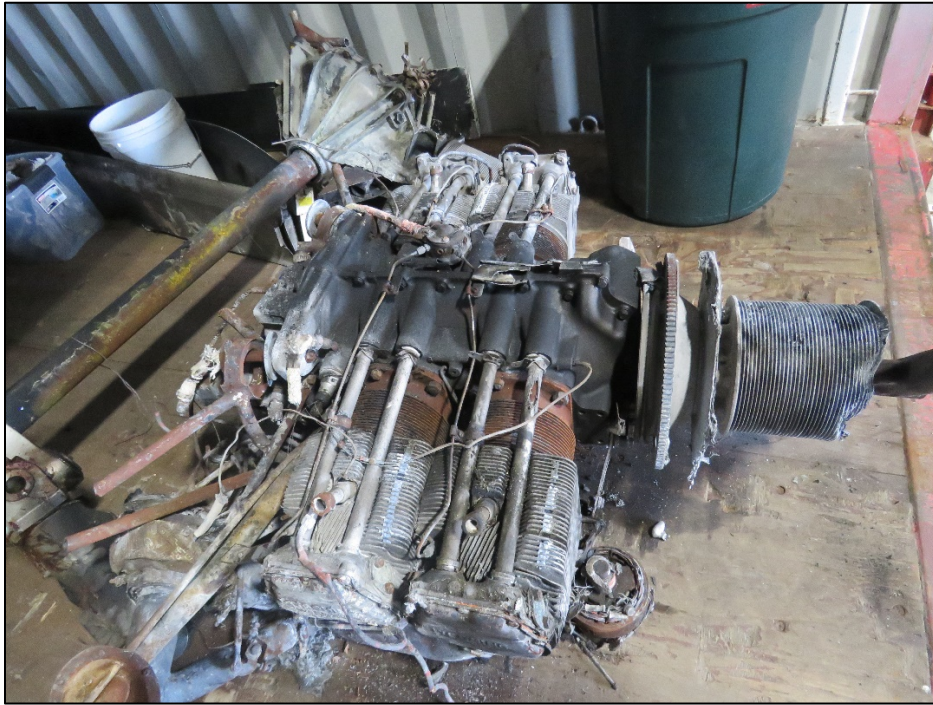
The entire engine displayed significant thermal damage. The top of the engine was sooted black. The greatest thermal damage was located around the No. 3 cylinder, which was the forward left portion of the engine, near the turbocharger location.

*Photo 1: Overview of the engine*

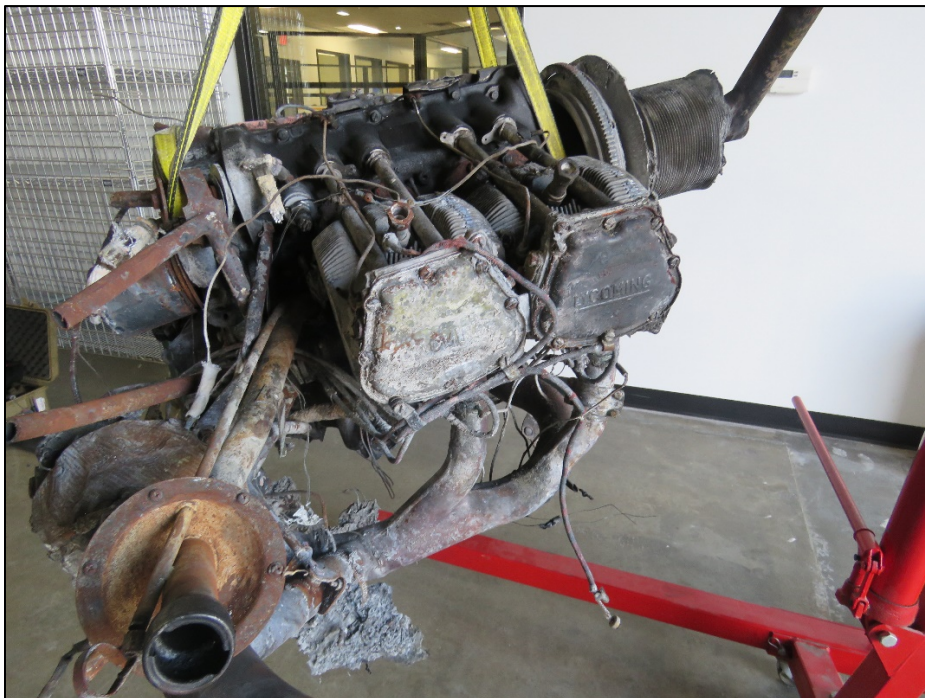
*Photo 2: Overview of the turbocharger side of the engine*

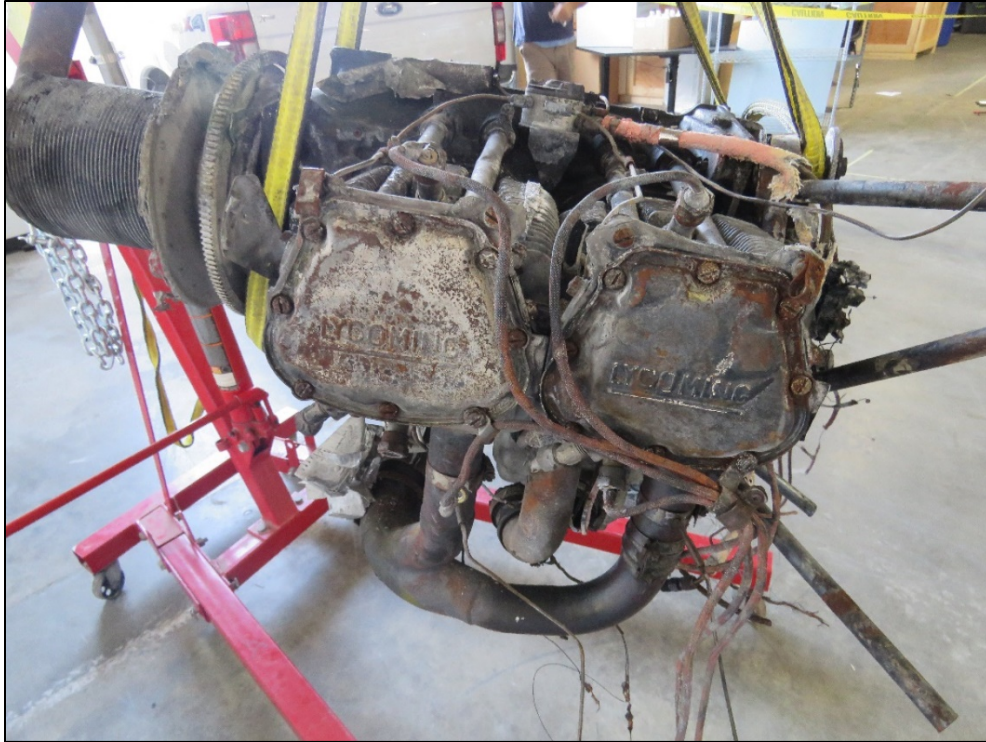
The rocker box covers were removed and visually examined. The exhaust rocker bosses of the No. 3 cylinder were broken, however, no pushrod tubes were bent. All cylinders were borescoped and cylinders 1 and 3 showed carbon material flaked off and laying in the bottoms of the cylinders.

*Photo 3: Overview of the engine cylinders*

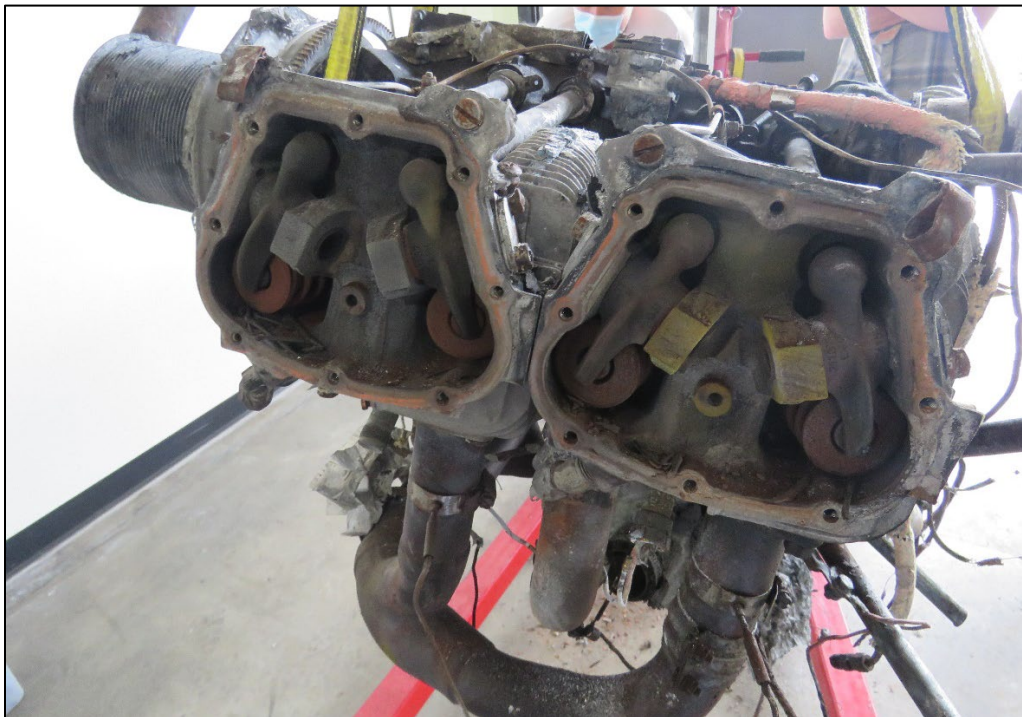
*Photo 4: View of the cylinder valves*

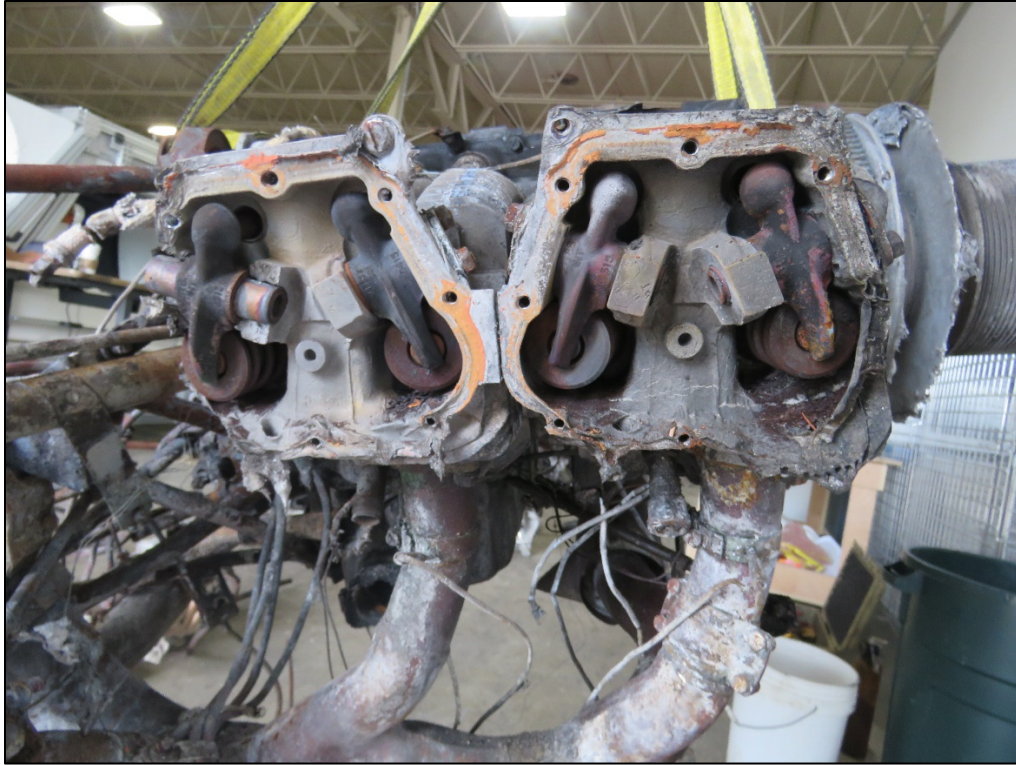
*Photo 5: View of the engine cylinders*

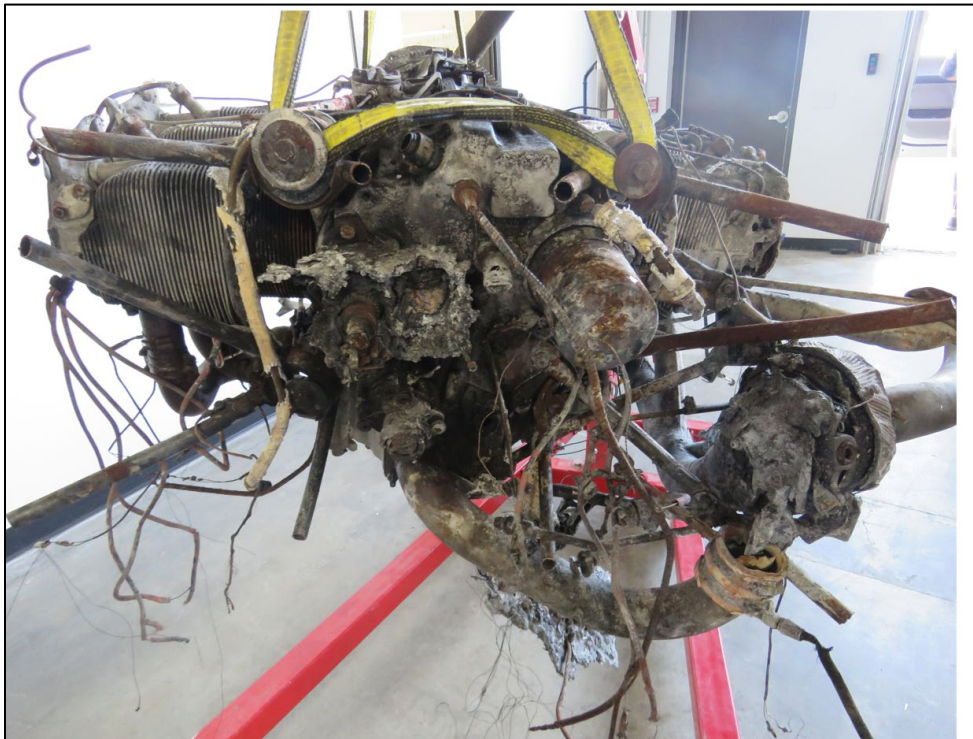
The flexible fuel and oil lines all displayed significant thermal damage, and some were destroyed by fire. The metal fuel lines connecting to their respective attach points were found secure.

*Photo 6: Accessory section of engine and view of damaged oil and fuel hose lines*

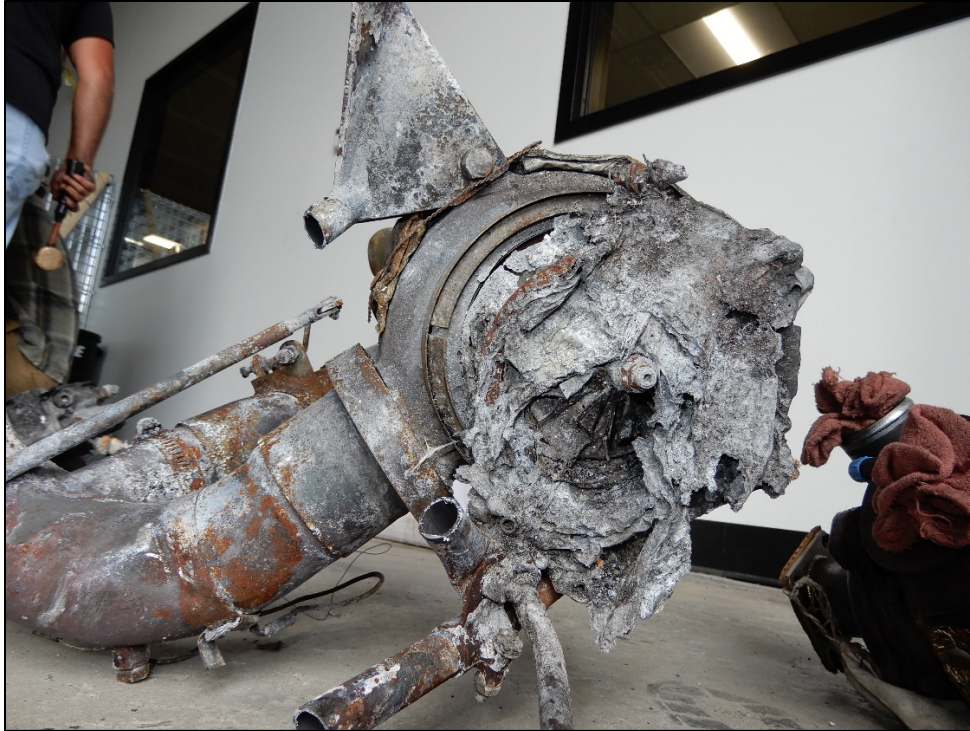
The turbo system added by Enstrom helicopters remained mostly attached to the right aft portion of the engine. The outer portion of the turbocharger displayed significant thermal damage. The turbocharger exhaust and inlet clamps remained installed, their safety wire was present, and the clamps remained tight. The turbocharger was partially disassembled, and its core appeared unremarkable.

*Photo 7: View of the turbo charger*

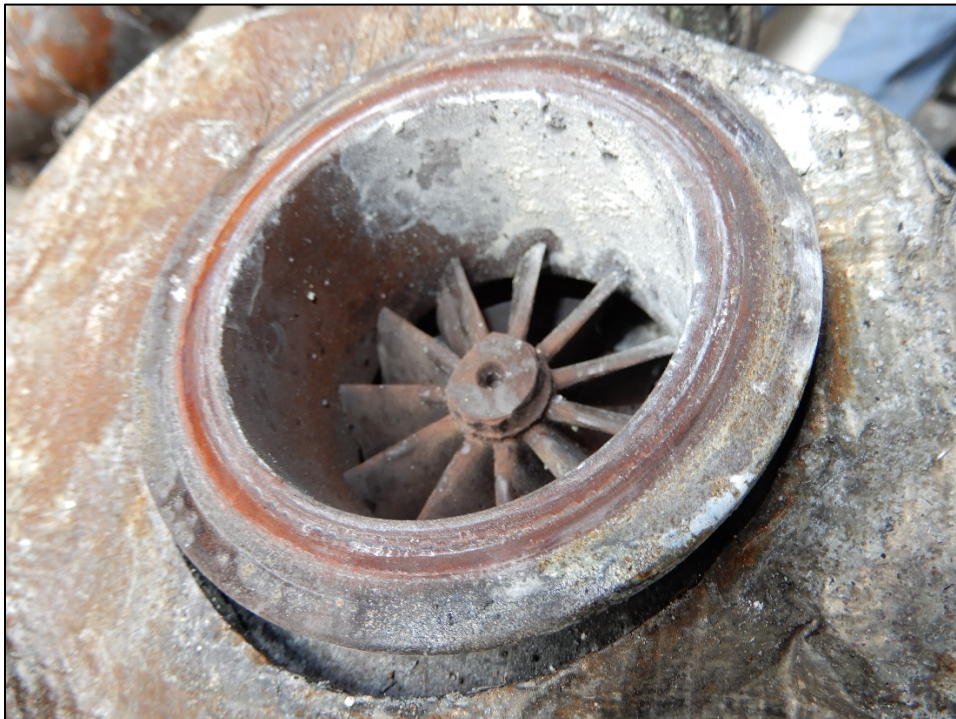
*Photo 8: View of the turbo charger with fire debris removed from its outer area*

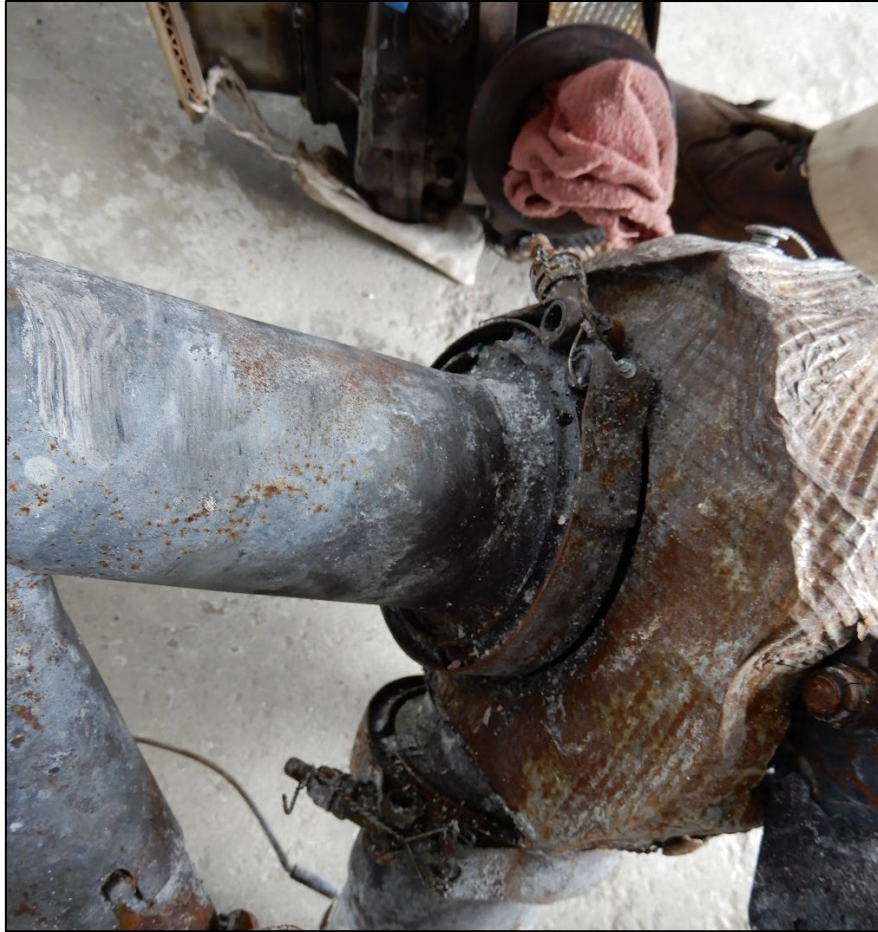
*Photo 9: View of the exhaust clamps at the turbocharger*
