## **NATIONAL TRANSPORTATION SAFETY BOARD**

**Photo Array**

**ERA21LA316**

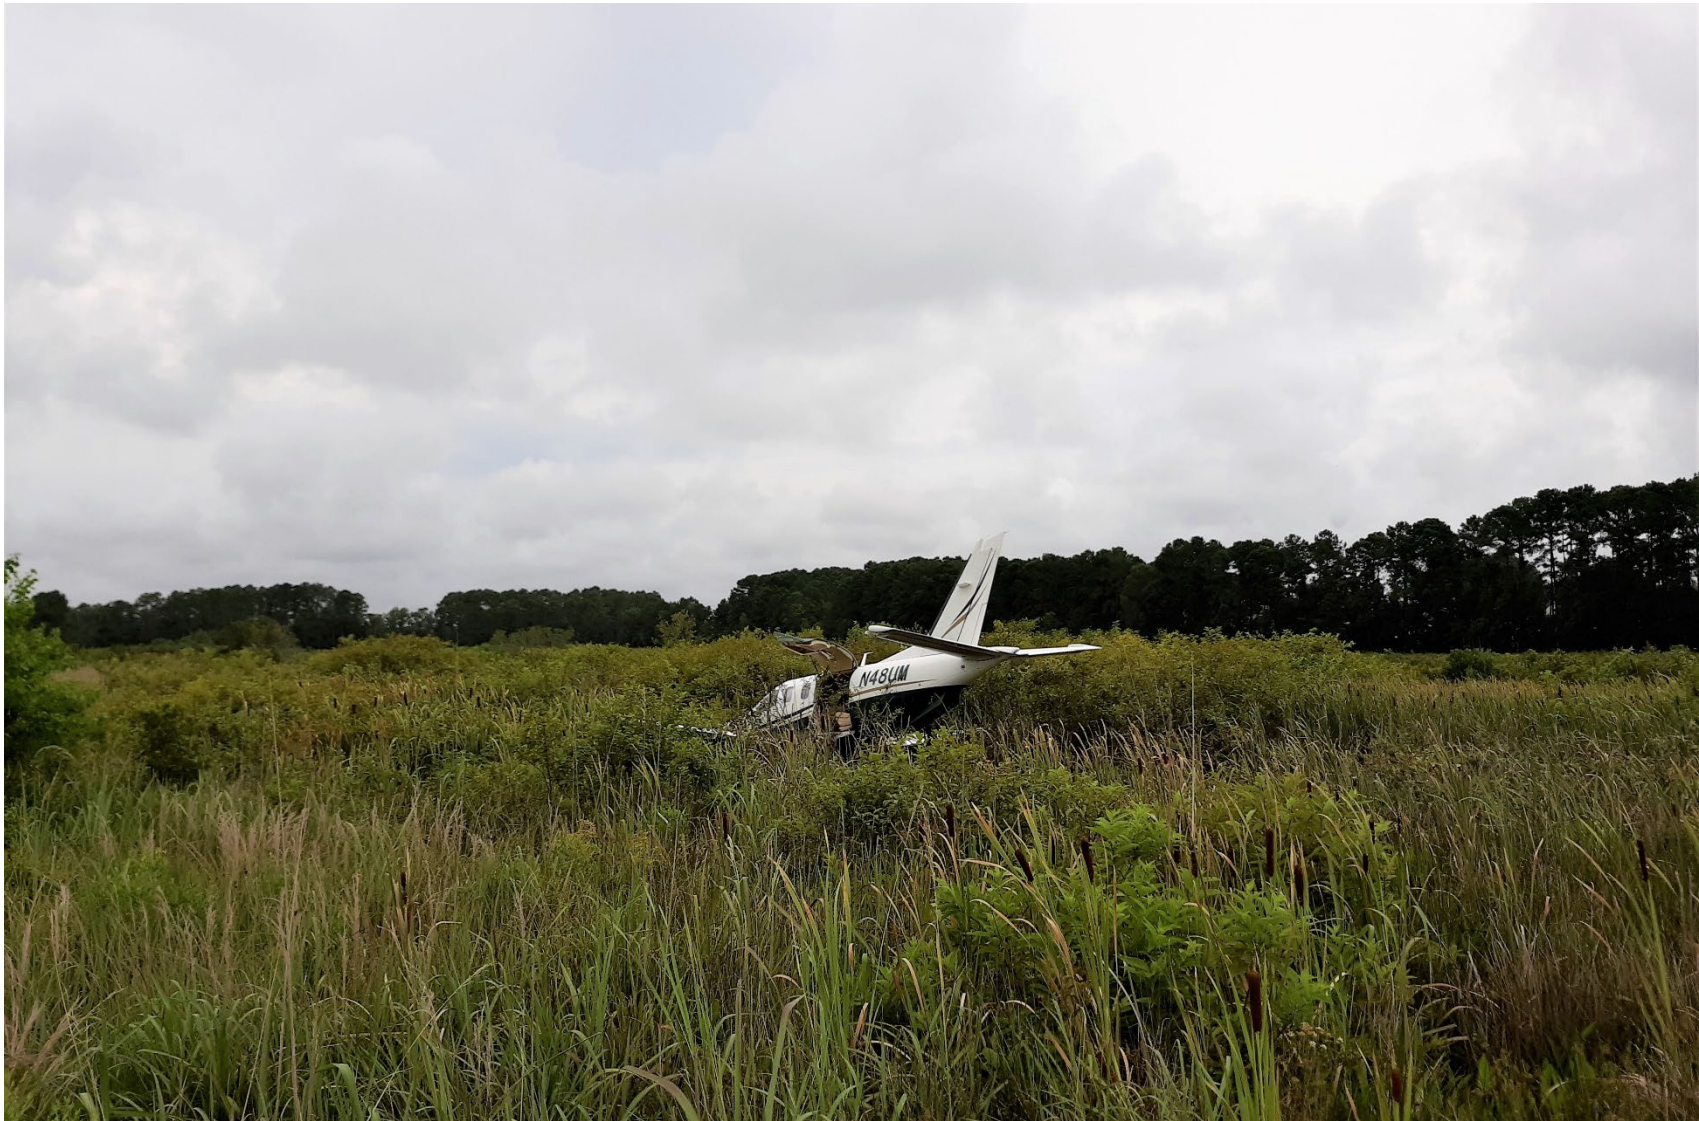
**Photo 1 – View of the airplane where it came to rest. (Photo Courtesy of FAA)**

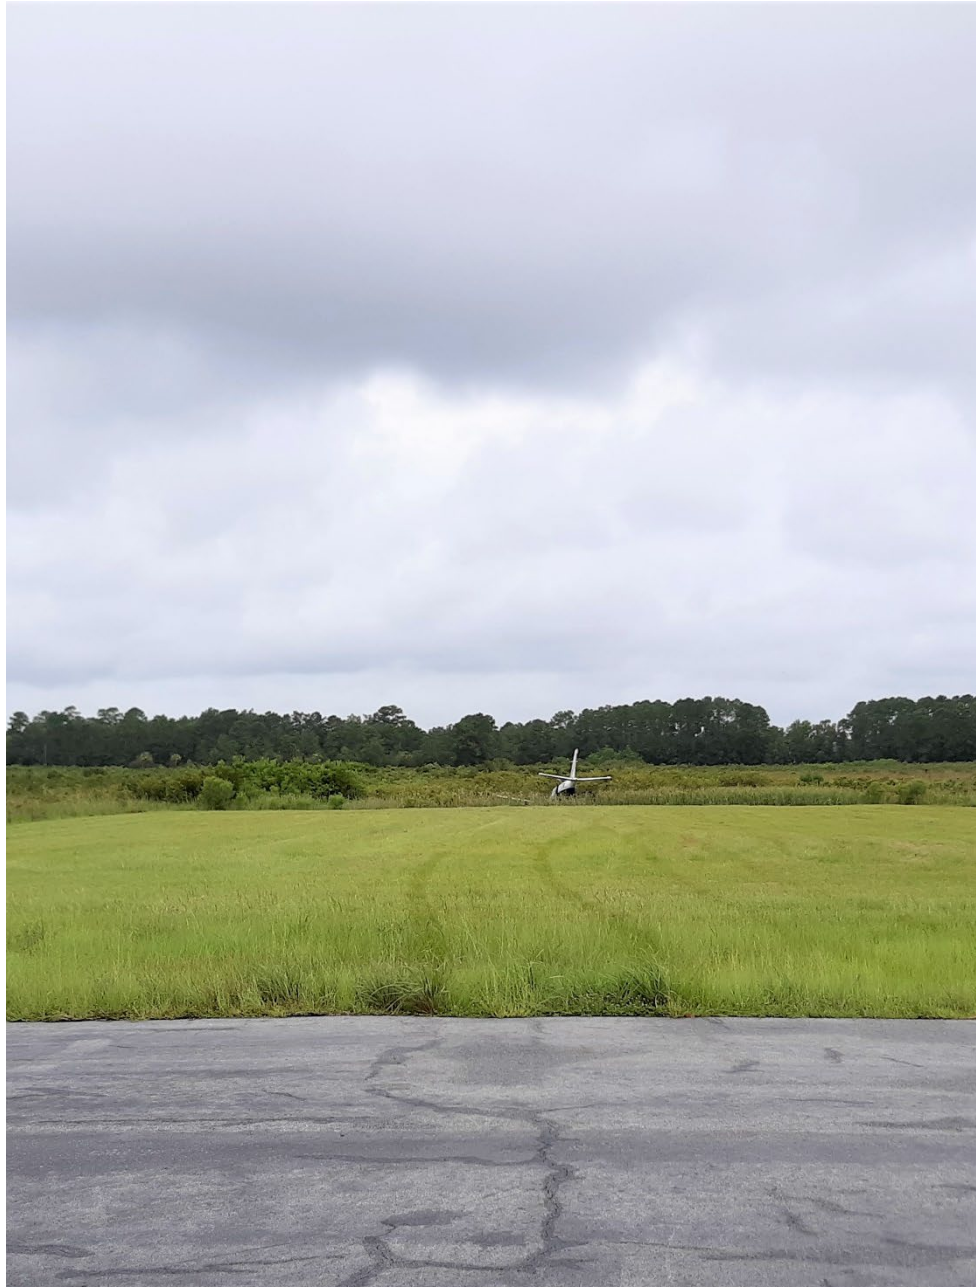
**Photo 2 – View of airplane from the end of the runway. (Photo Courtesy of FAA)**

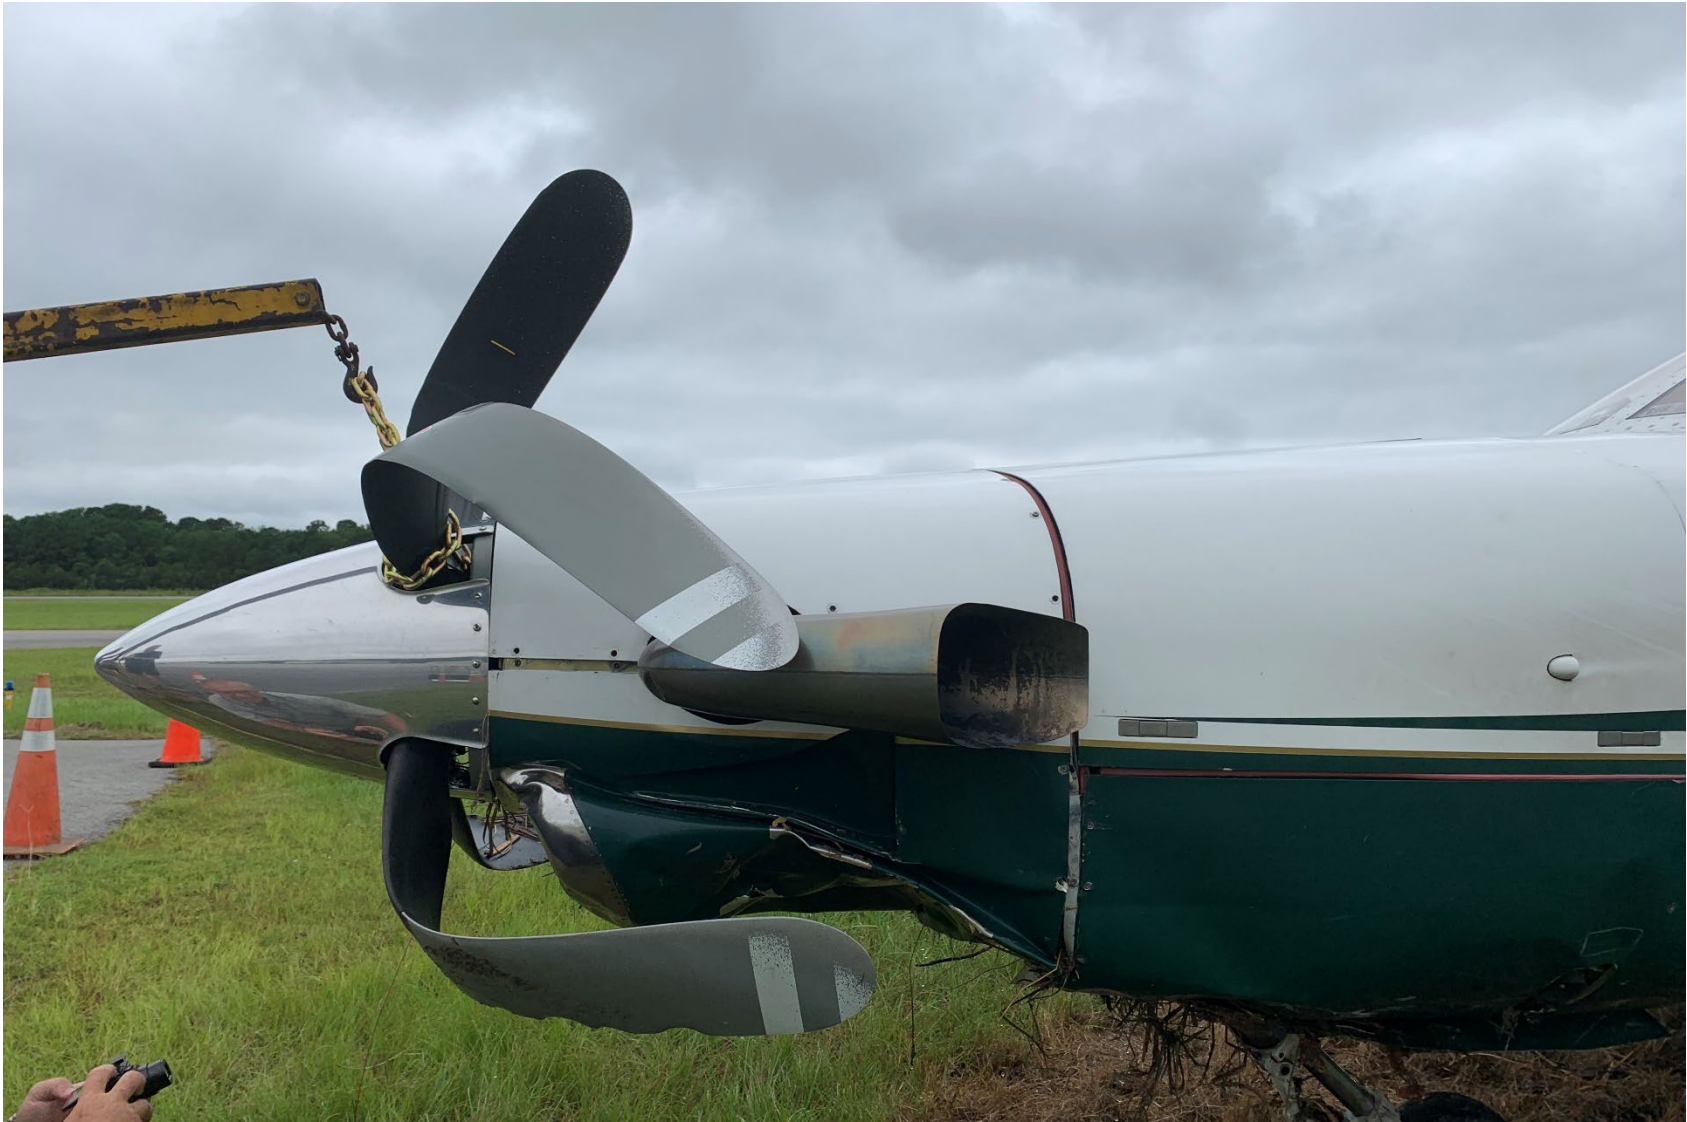
**Photo 3 – View of the damage to the propellor and lower fuselage. (Photo Courtesy of FAA)**
