## **Memorandum For Record**

**Timothy W. Monville**  
**Sr. Air Safety Investigator**  
**Eastern Region**

**Date: November 3, 2021**  
**NTSB Accident Number: ERA21LA320**

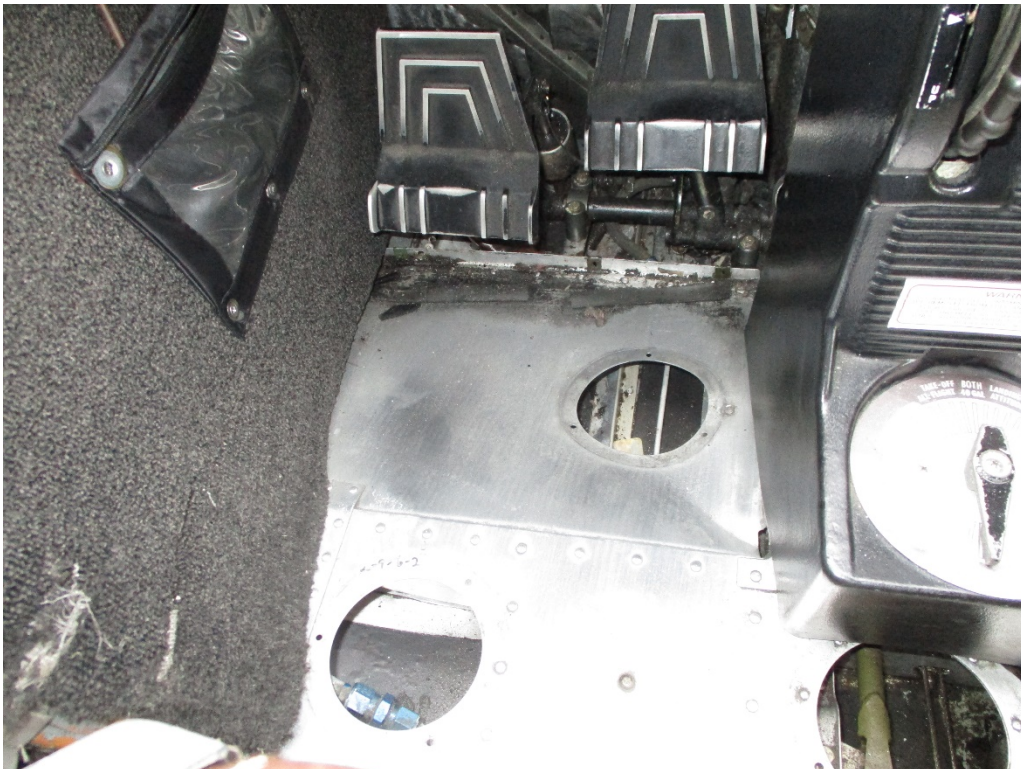
Pictures of the damaged areas taken by the FAA inspector on September 3, 2021, were provided to NTSB using Kiteworks on September 9, 2021. A review of the provided pictures revealed a compression wrinkle was noted in the floor on the pilot’s side of the airplane (Figure 1), and a compression wrinkle was also noted in the floor on the co-pilot’s side of the airplane (Figure 2).

Figure 1: FAA Digital Photograph. View of the Pilot side Interior of the Aircraft Depicting A compression Wrinkle in the floor.

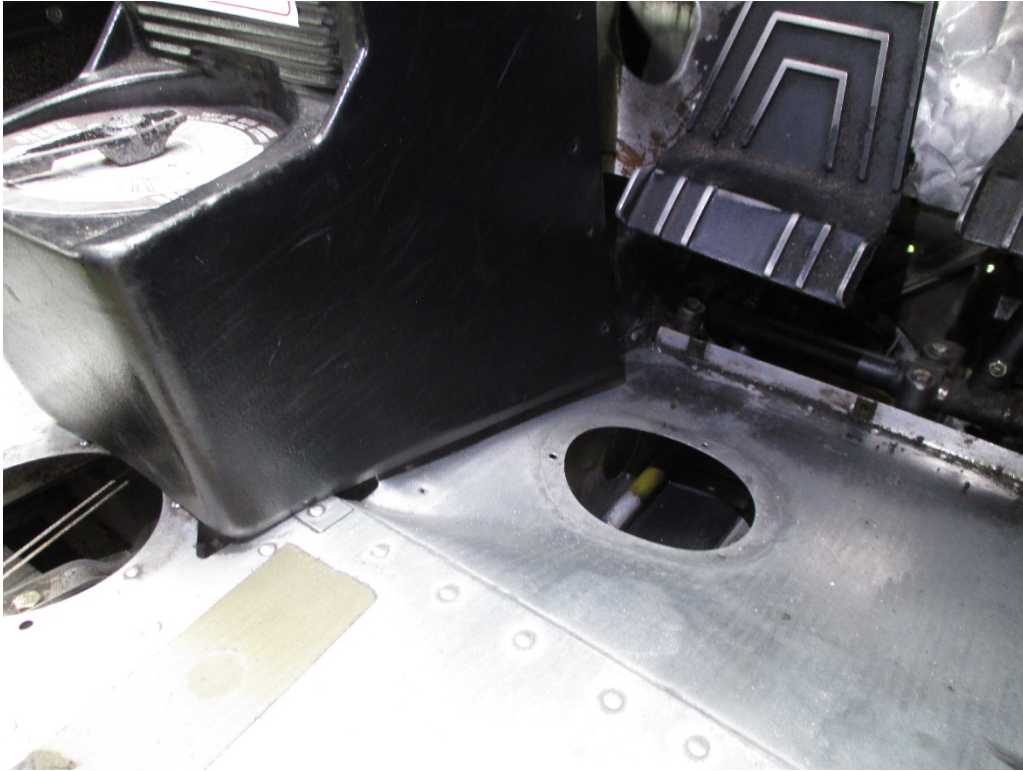
Figure 2: FAA Digital Photograph. View of the Co- Pilot side of the Interior Aircraft Depicting A compression Wrinkle in the floor.
