**National Transportation Safety Board**  
Office of Research and Engineering  
Washington, D.C. 20594

## Airplane Performance Study

**Location:** Hiddenite, North Carolina  
**Date:** August 9, 2021  
**Time:** 1735 GMT (1335 EDT)  
**Airplane:** Diamond DA-42-L360, N906ER  
**NTSB Number:** ERA21LA322

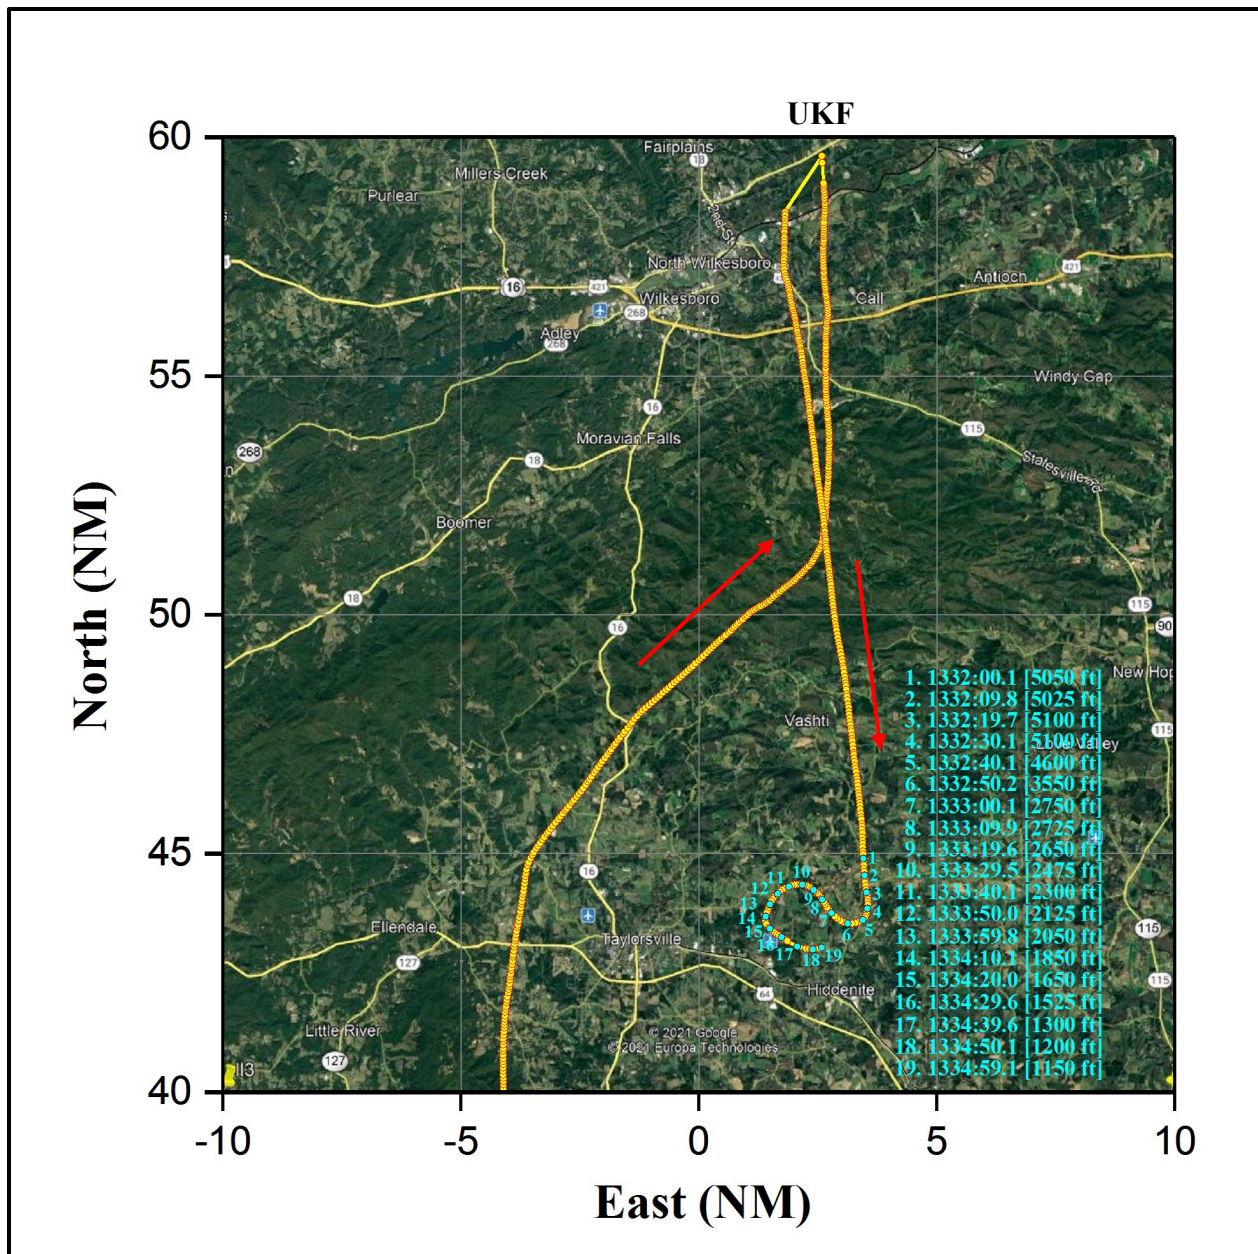
Figure 6: ADS-B Ground Track from Wilkes County Airport to Accident Site  
(ADS-B Geometric Altitude for Final Three Minutes in Cyan)

Figure 6 captures the ground track after departing UKF along with the ADS-B geometric altitude during the final three minutes. The return flight includes a 6,000 fpm descent<sup>4</sup> and the final circling left turn to the accident site.

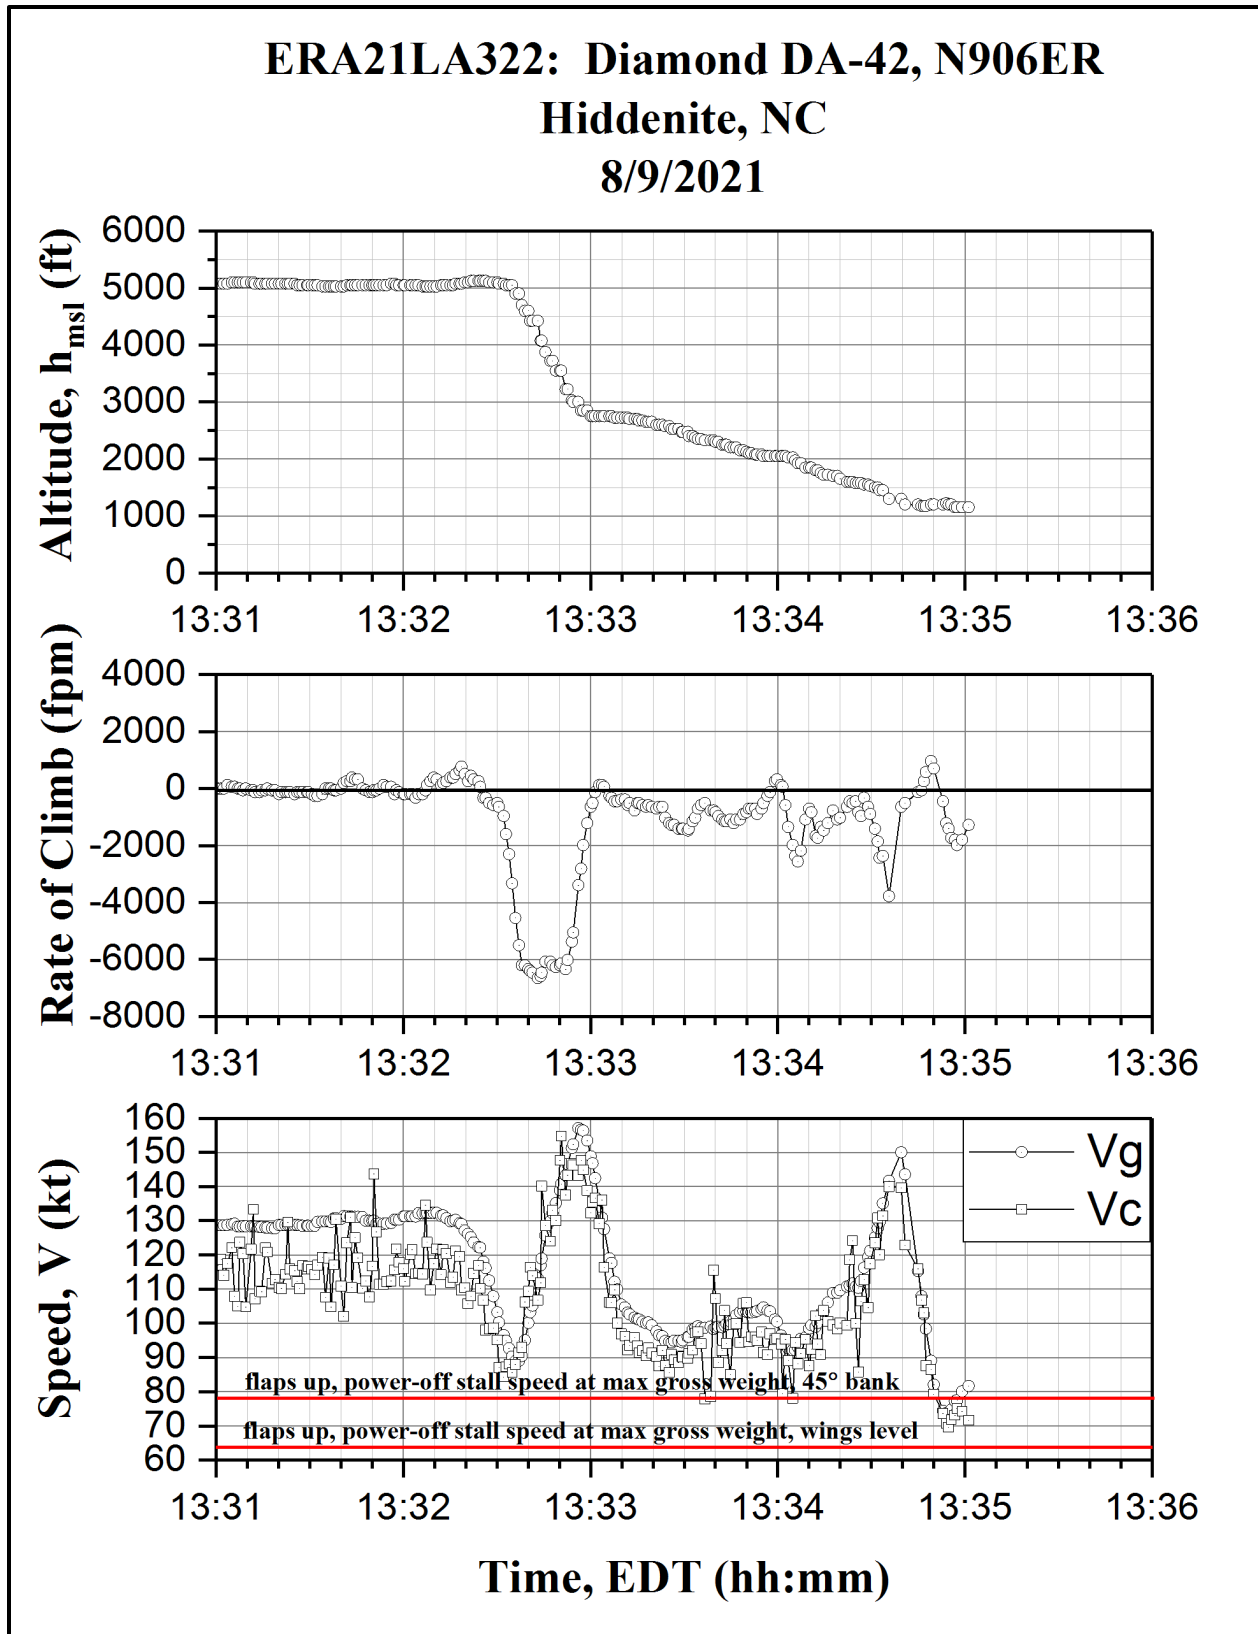
Figure 7: ADS-B Ground Speed ( $V_g$ ) and Estimated Airspeed ( $V_c$ ) Prior to Impact

Figures 7 through 9 include additional flight parameters for the final four minutes either recorded directly in the ADS-B data or estimated from recorded parameters. Figure 7 highlights the stall speeds published in the Pilot's Operating Handbook. Diamond provides level flight, power off<sup>5</sup> stall speeds at various weights and bank angles in calibrated airspeed. However, the ADS-B only records ground speed.

To compare ADS-B ground speed to the published stall speeds, wind, temperature, and pressure at altitude must all be considered. Preliminary weather data from a High-Resolution Rapid Refresh (HRRR) numerical model were obtained for the accident site from the NTSB Meteorologist Group Chairman. The HRRR data and ADS-B ground speed were used to estimate the airspeed shown in Figure 7. Using the estimated bank angles shown in Figure 8, it appears that N906ER never slowed below the published stall speed.

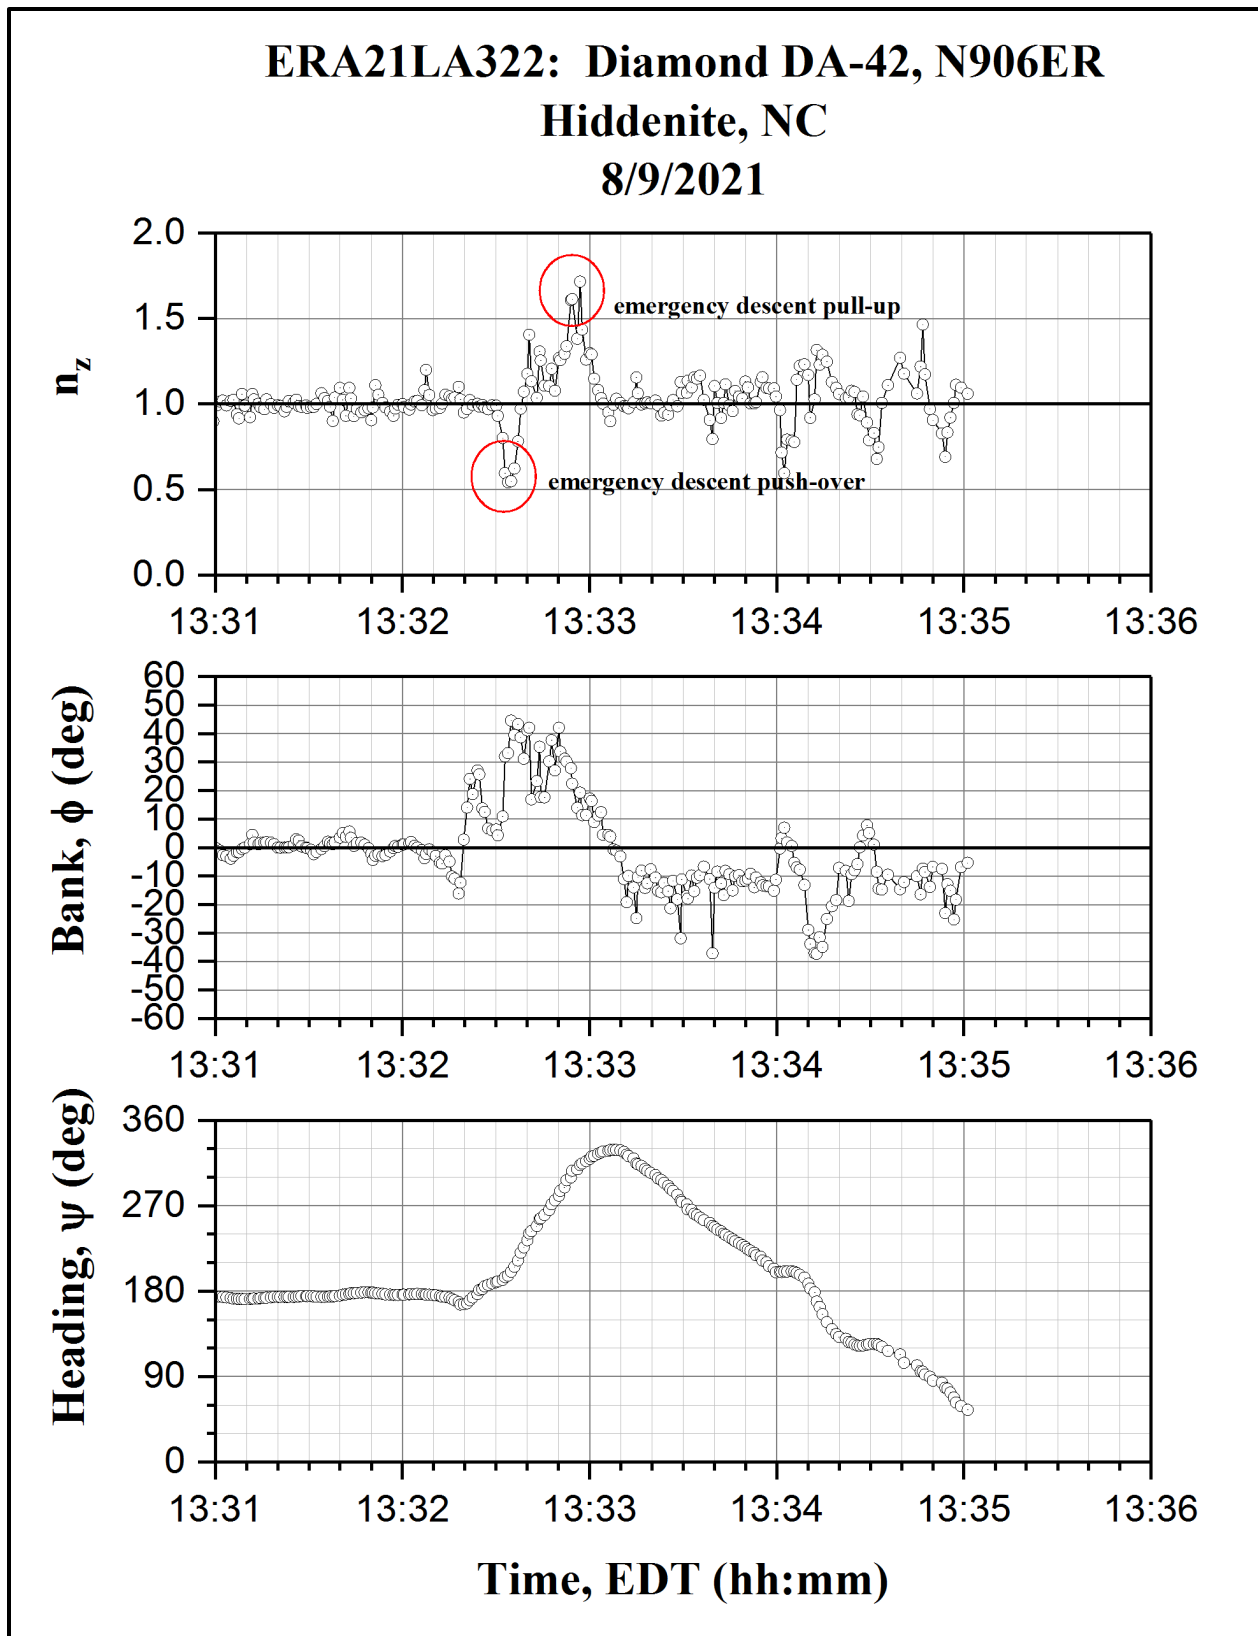
Figure 9: Estimated Vertical Load Factor Prior to Impact

In addition to the stall speed data, the ADS-B indicate that the pilot was able to slow the sink rate, raise the airplane pitch attitude by approximately five degrees, and pull in excess of 1g (Figure 9) in the final five seconds<sup>6</sup>. The airplane's bank angle decreased from about 20° left-wing-down to 10° left-wing-down in the same period. Figure 10 shows the airplane in its final position.

While both the student and the instructor indicated that they could not raise the airplane's nose, ADS-B data indicate that the sink rate decreased, and the pitch attitude increased in the final seconds of the flight.

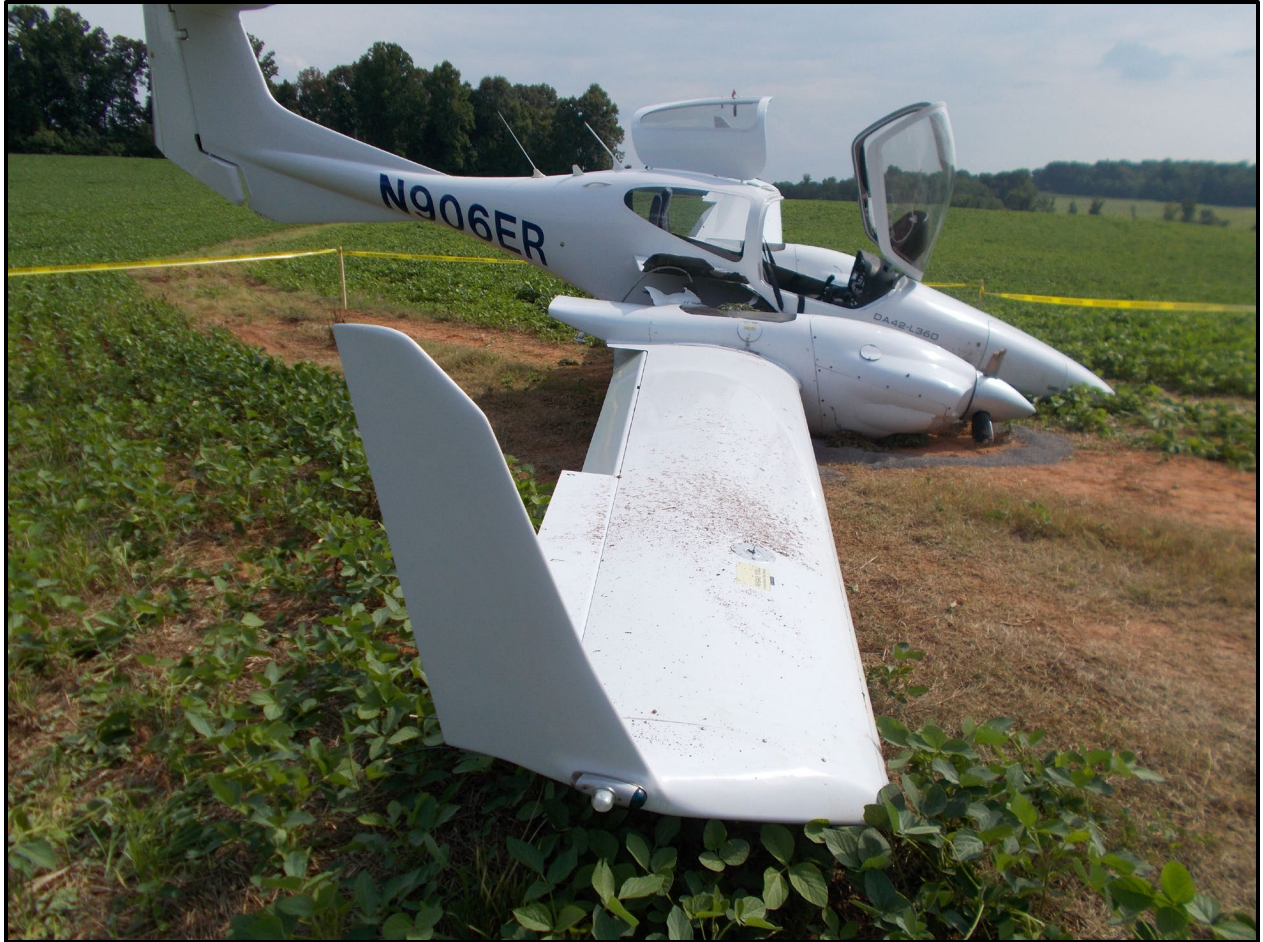
flaps for landing. The airplane subsequently touched down nose low in a soybean field, impacted a ditch, and skidded to a stop.

**Figure 10: The Airplane in its Final Resting Position**
