## RECORD OF CONVERSATION

**Date: October 4, 2021**  
**Person Contacted: Timothy W. Cook**  
**NTSB Accident Number: ERA21LA335**

**Subject:** ERA21LA335, Record of Conversation/Interview

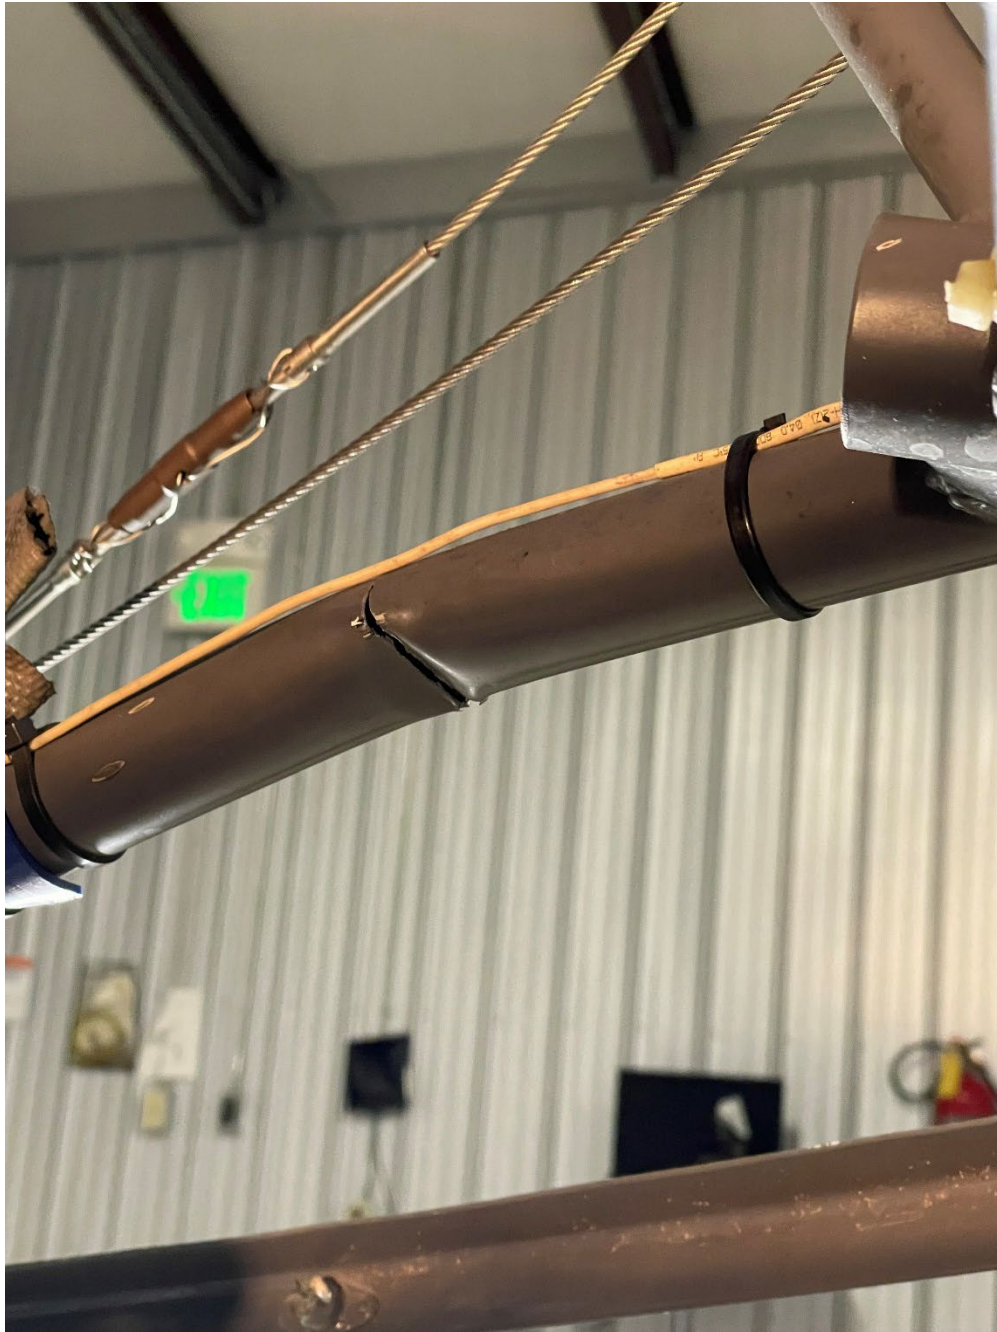
He indicated that the helicopter rolled onto its right side, resulting in ground damage to the main rotor blades. Additionally, some skin on the right side of the helicopter was damaged as well as a tailboom mounting tube that was damaged (Figure 1). The tail rotor drive shaft was stripped out where the tailboom connects.

Figure 1: Digital photograph Provided by Pilot/Owner. View Showing the Damage to one Tailboom Support Tube Which Requires Repair.
