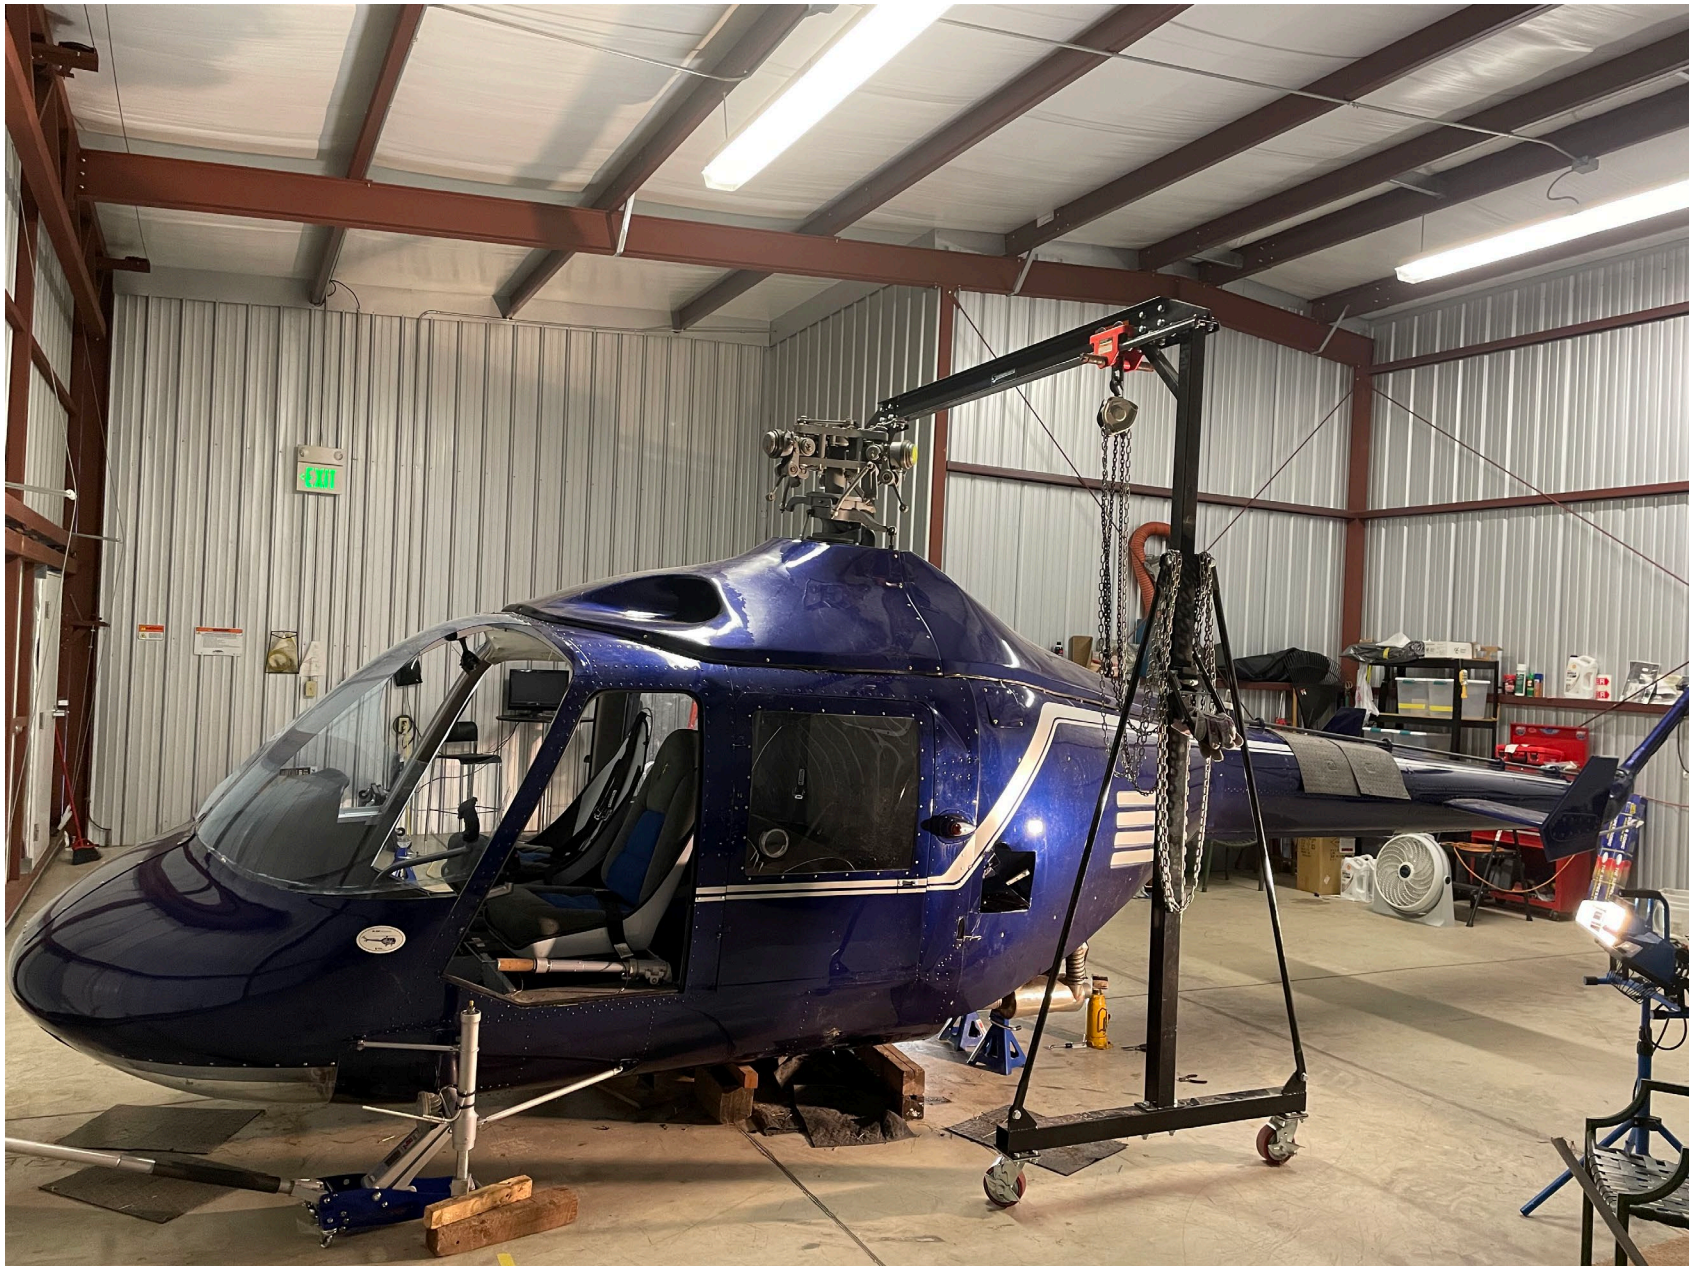
**Photo 1 – Digital Photograph From Pilot/Owner. Left Side View of the Helicopter Following Recovery.**

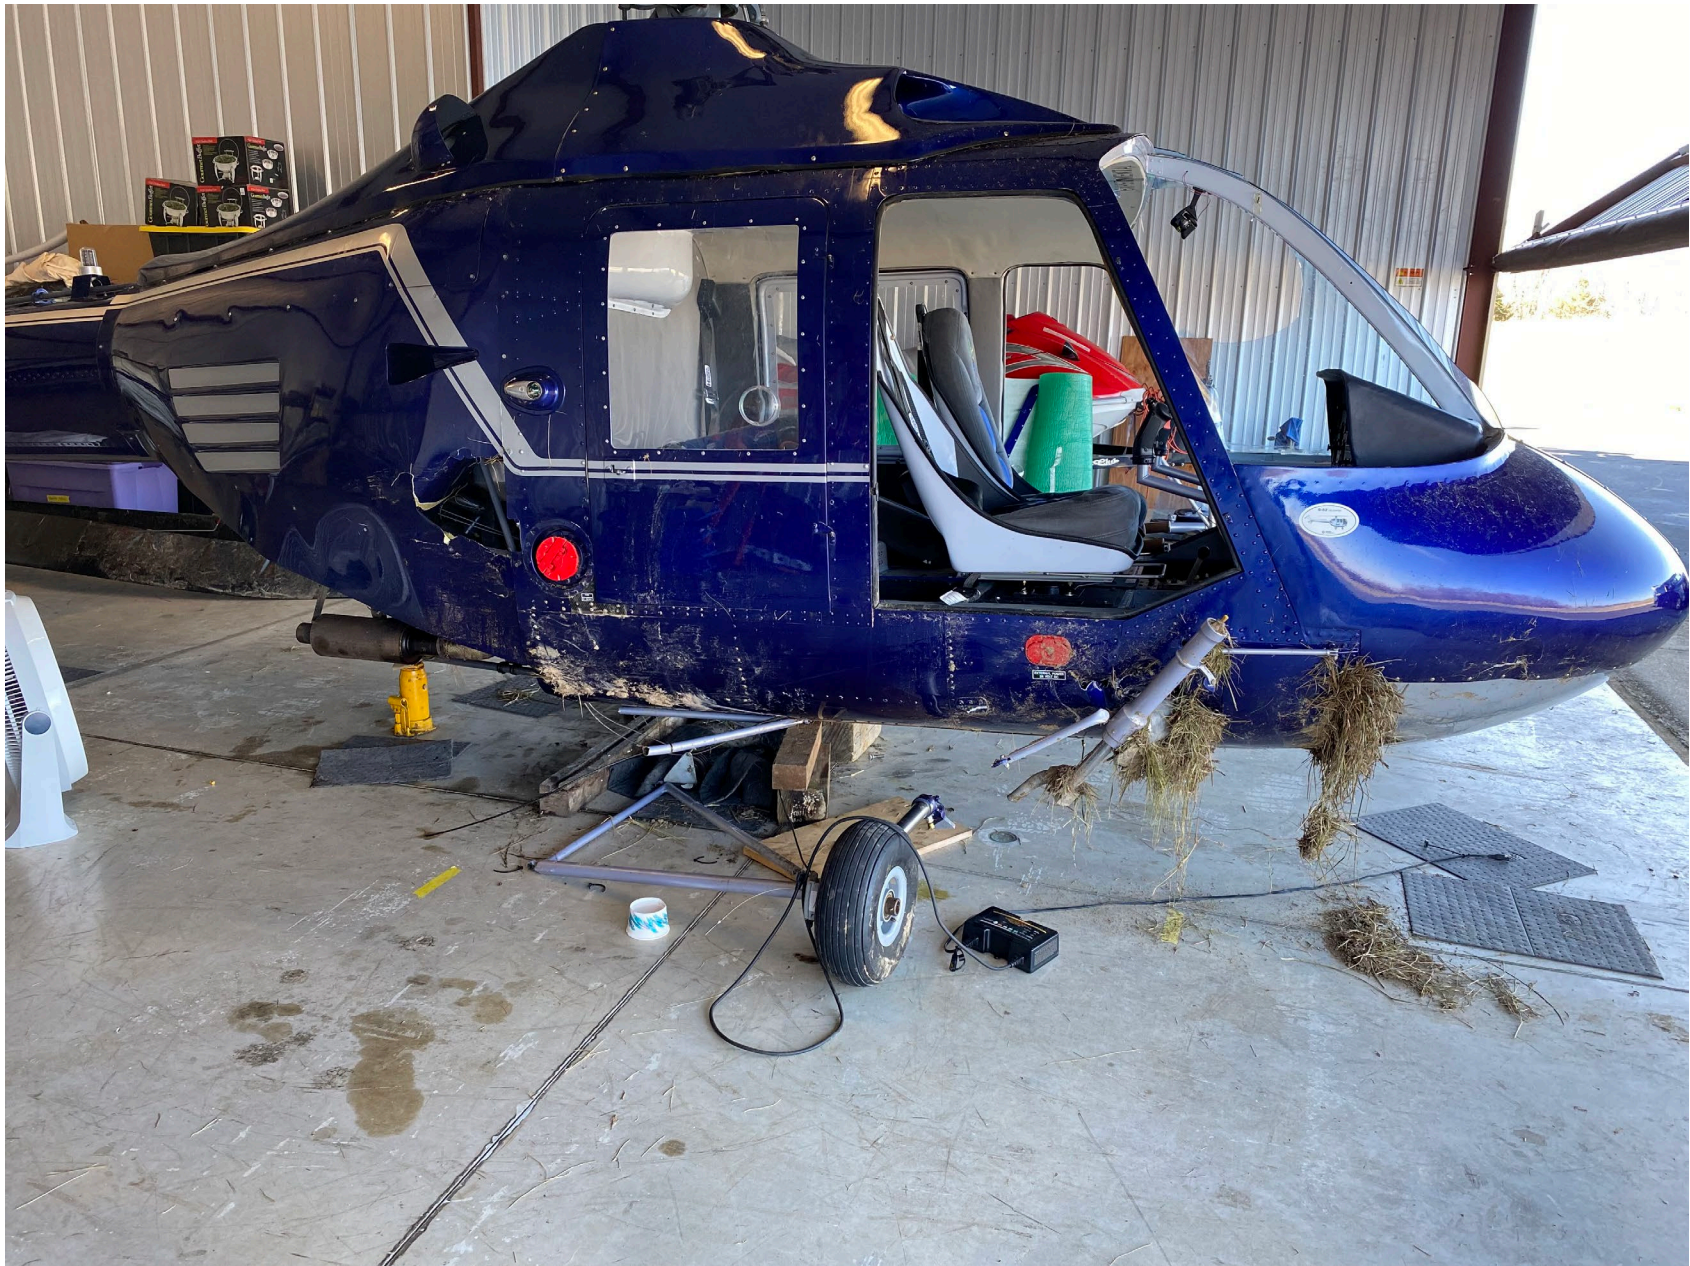
**Photo 2 – Digital Photograph From Airport Manager. Right Side View of a Portion of the Helicopter Following Recovery.**

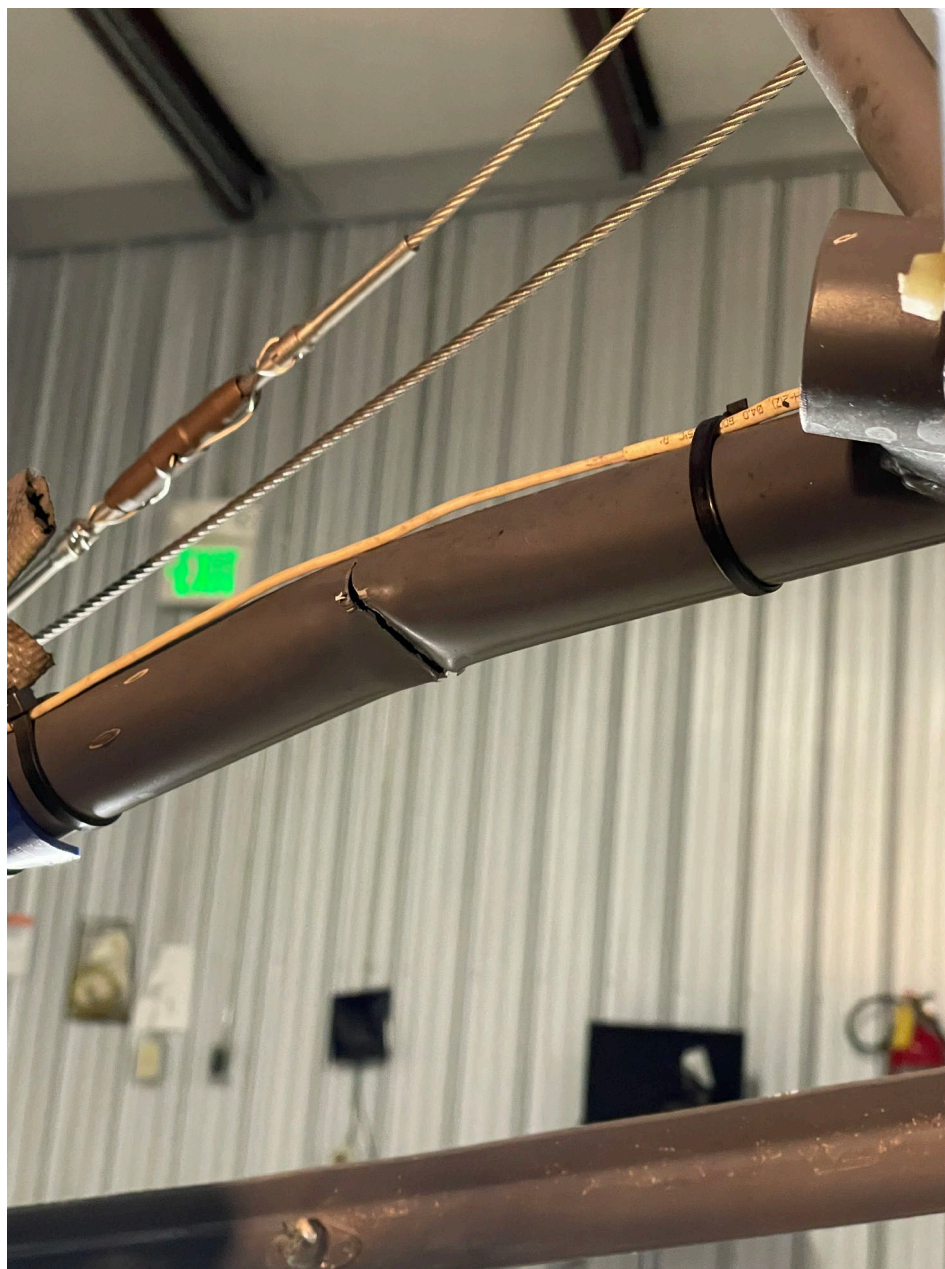
**Photo 3 - Digital Photograph From Pilot/Owner. View Depicting Crack and Deformation To One of Four Structural 4130 Steel Tubes That Connect the Tailboom.**
