# NATIONAL TRANSPORTATION SAFETY BOARD

## MATERIALS LABORATORY FACTUAL REPORT

Report No. 21-103

Place : Port Orange, Florida  
Date : 08/21/2021  
Vehicle : Enstrom Helicopter Corporation Model 280C  
NTSB No. : ERA21LA339  
Investigator : Daniel Boggs

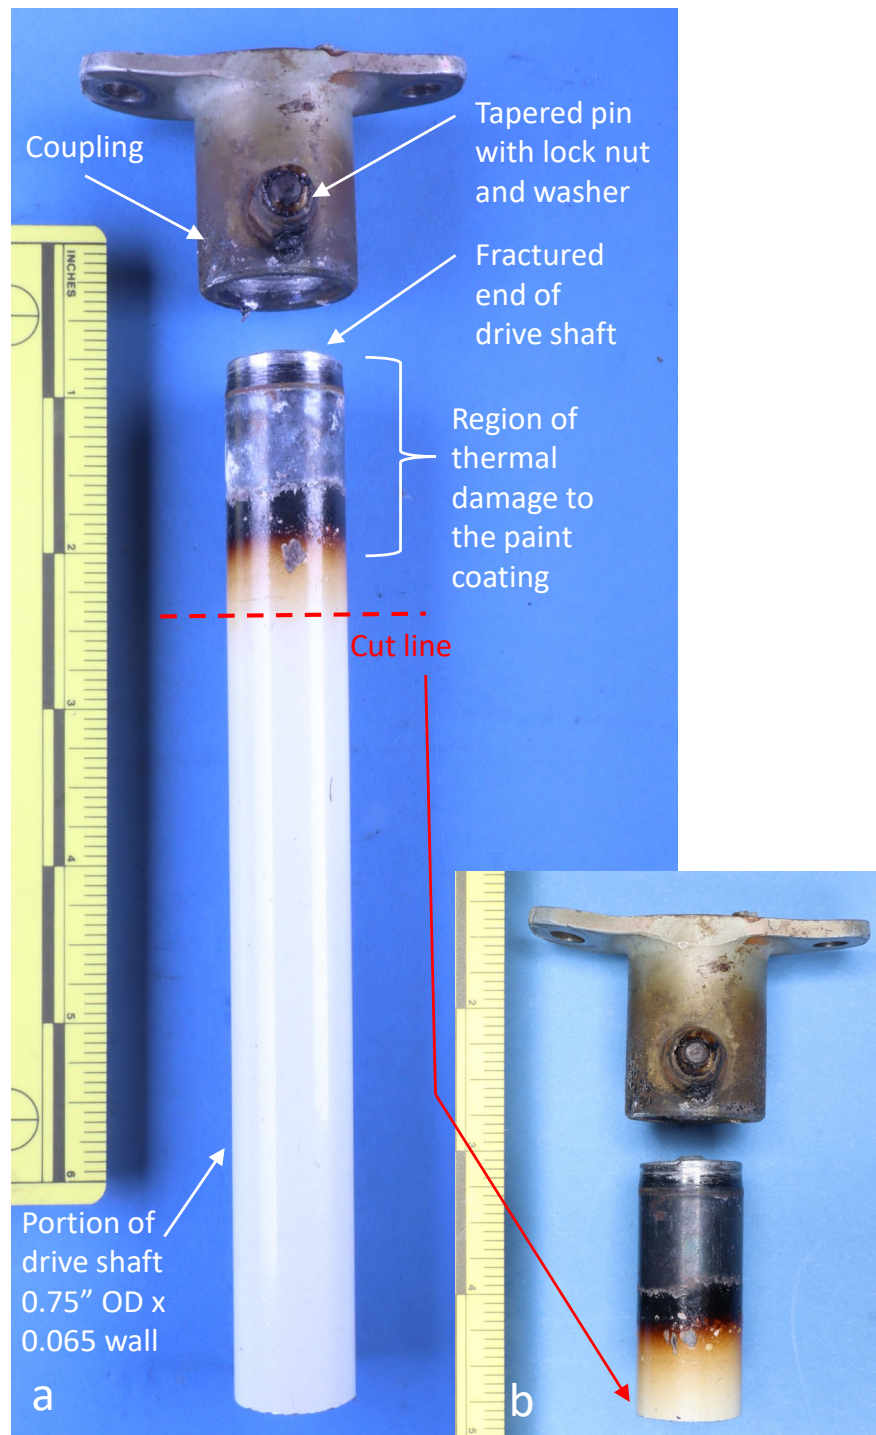
The as-received portion of a tail rotor drive shaft and a tail rotor drive flange are shown in Figure 1. To facilitate microscopy, x-ray CT imaging, and photodocumentation, the drive shaft piece was cut at the line indicated in the figure. A sketch showing an exploded view of the drive coupling and drive shaft assembly, referenced from the Enstrom F-28F/280F Series Maintenance Manual, is shown in Figure 2 with key components annotated.

Figure 1 The as-received portion of a tail rotor drive shaft and a tail rotor drive coupling. The drive shaft tube was cut along the red dashed line to facilitate imaging.

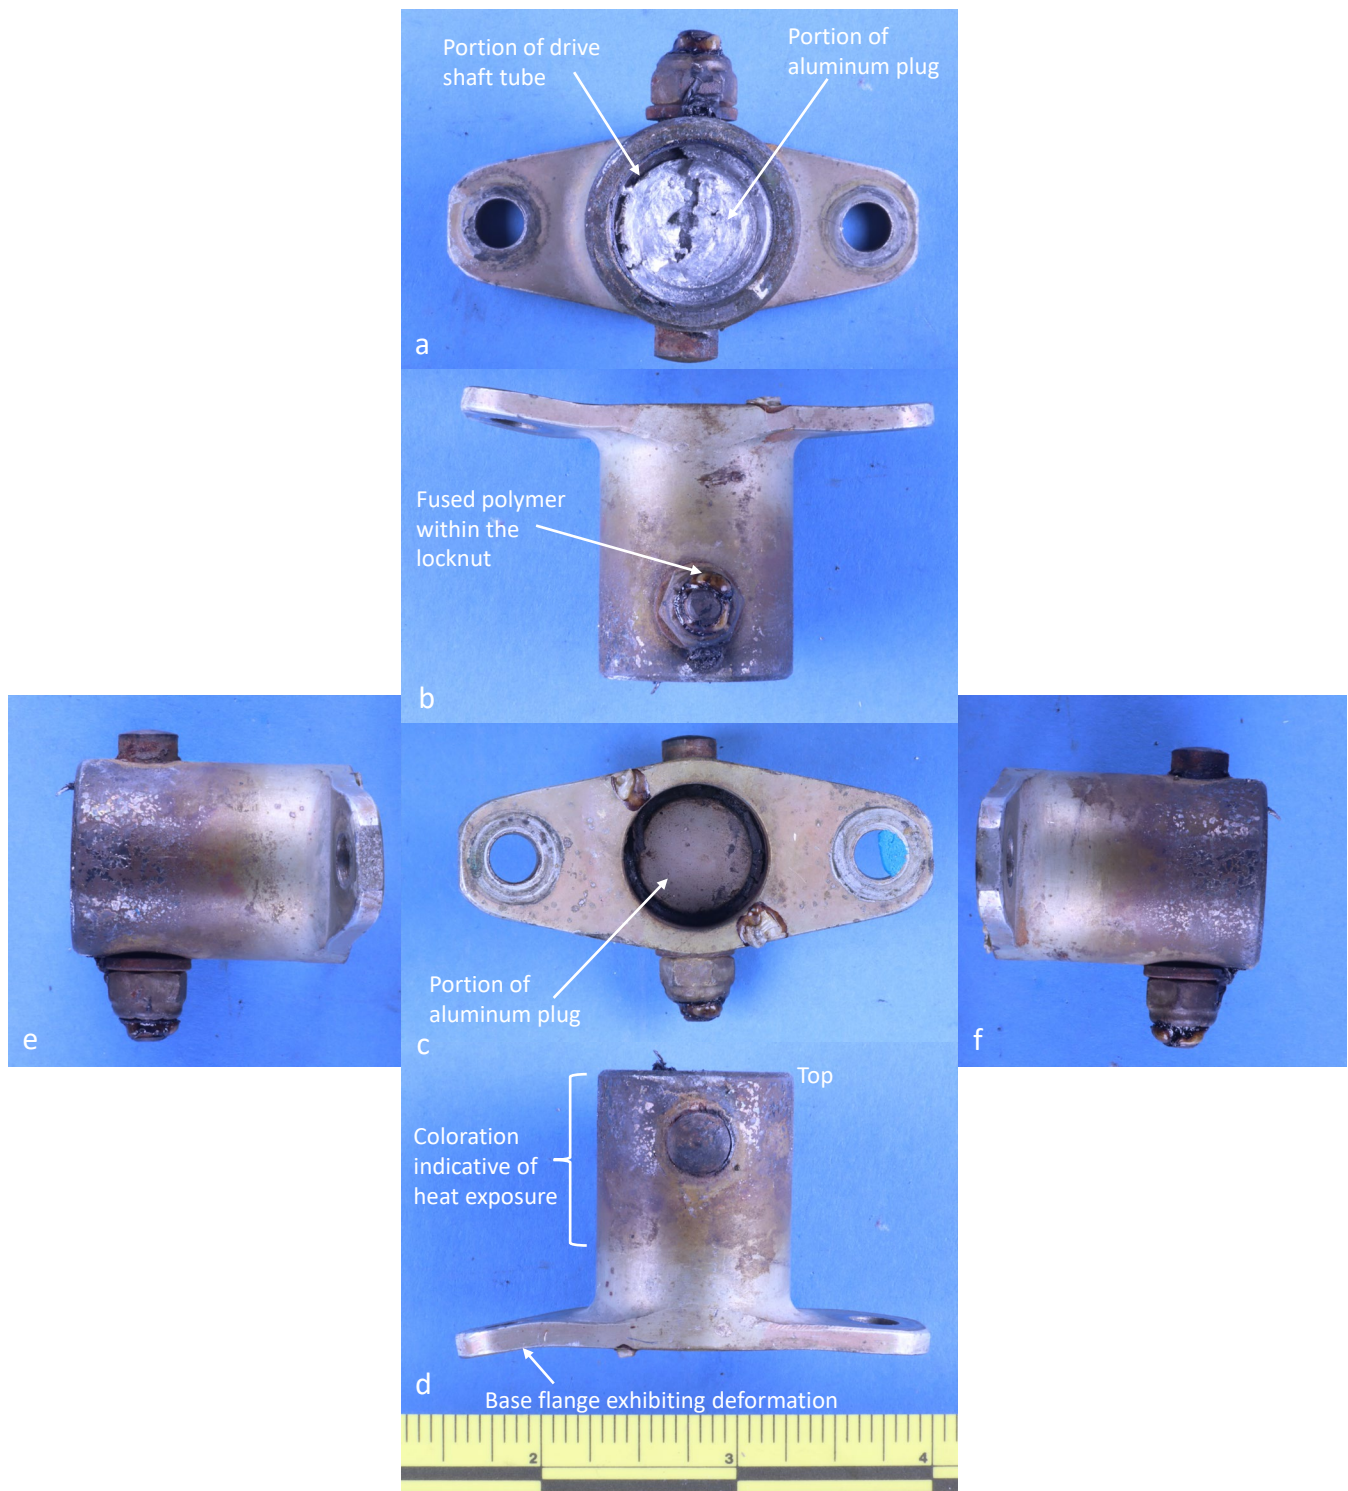
Projection views of each side of the drive coupling piece are shown in Figure 3. As revealed in the images in Figure 3a and 3c, a portion of an aluminum plug (part number 28-13619) and a portion of the steel drive shaft tube are present within the bore of the drive coupling. In Figure 3b, the polymer locking feature in the locknut has fused and extruded from the locknut. The image in Figure 3d reveals coloration on the outside of the steel drive coupling, consistent with heat exposure. A pronounced concave bend is observed in the flange portion of the drive coupling as revealed in Figure 3d.

Figure 3 Projection views of each side of the as-received drive coupling piece.

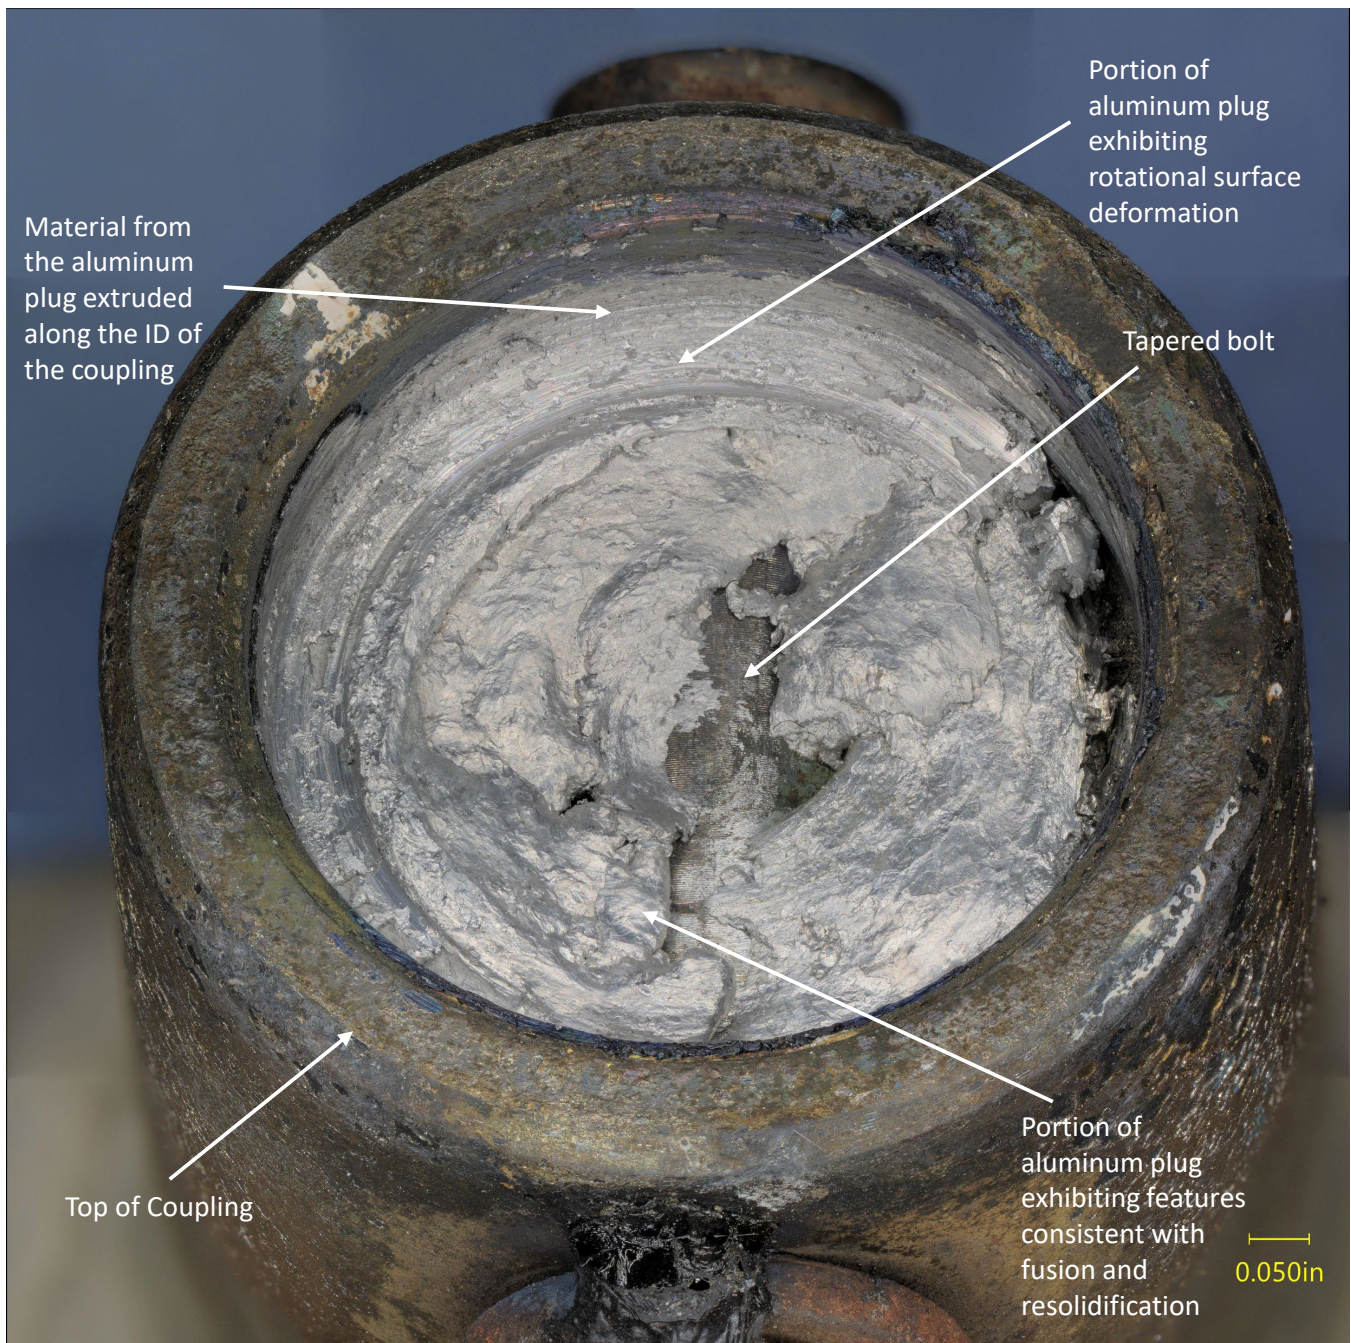
A closer internal view of the top of the drive coupling piece is shown in Figure 4. This image reveals a portion of the aluminum plug (part number 28-13619), with rotational surface deformation just top side of the tapered bolt. Some features consistent with fusion and re-solidification of the aluminum plug are also present.

Figure 4 Oblique view of the inner bore of the top of the drive coupling piece. Annotations detail the condition of the damaged aluminum plug.

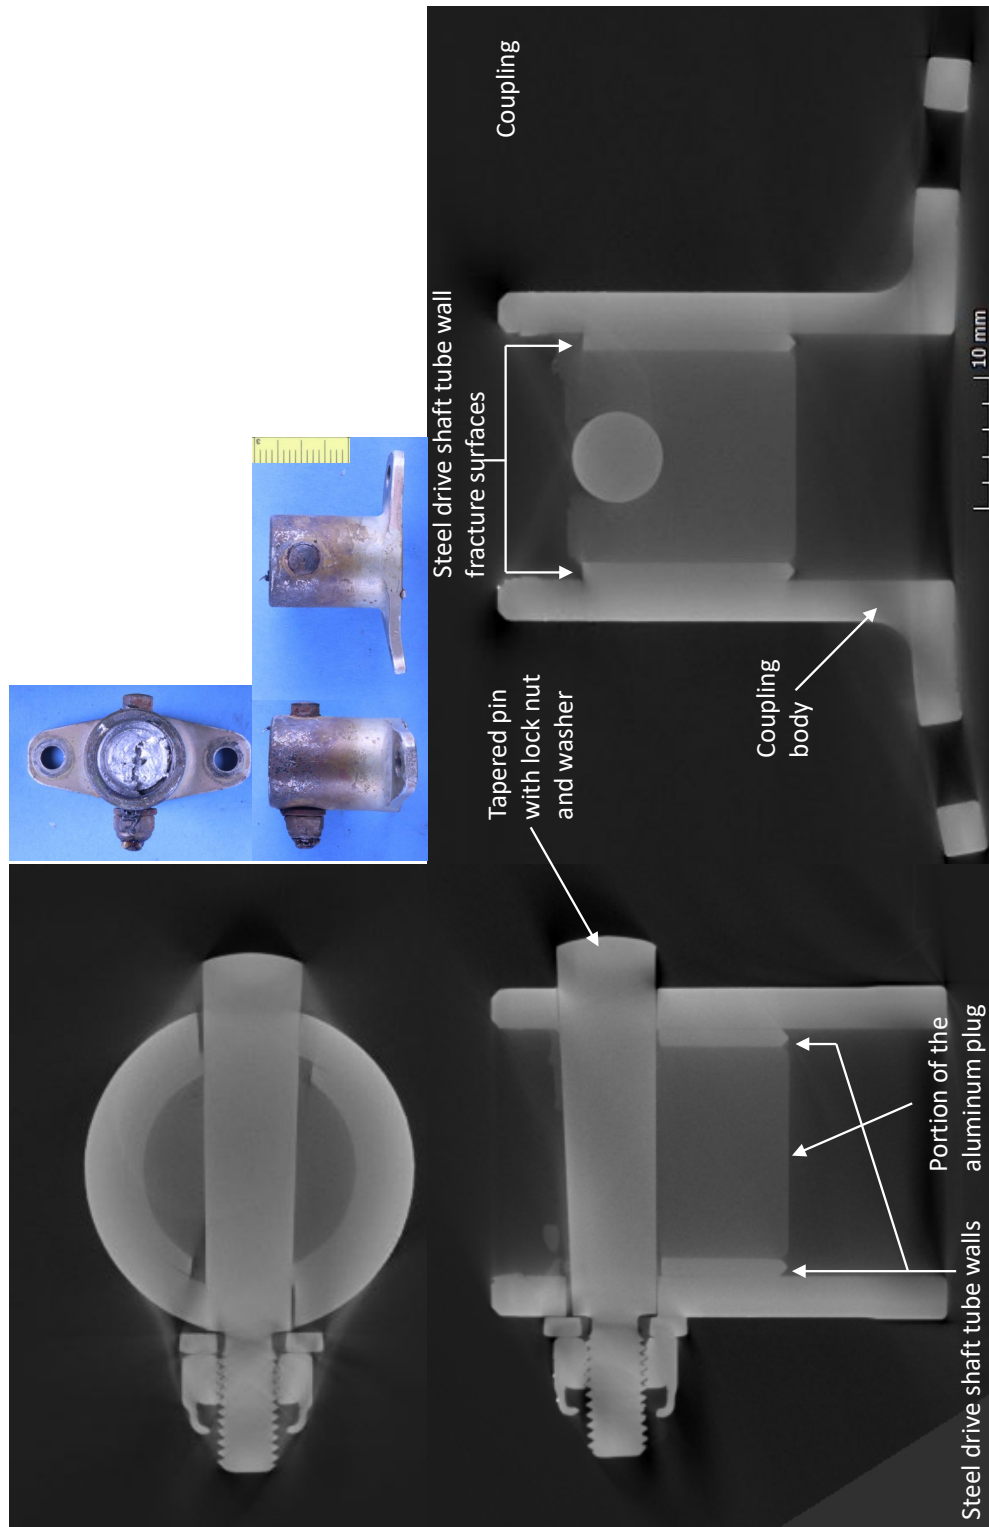
X-ray computed tomography (CT) radiographs of the drive coupling piece are shown in Figures 5 and 6. The fractured portion of the drive shaft tube is observed within the bore of the drive coupling. No necking or large-scale plastic deformation is associated with the fracture surfaces of the drive shaft tube. The fracture surface is rather planar through the thickness of the drive shaft tube wall. Figure 6 details distortion in the bolt

Figure 5 X-ray CT radiographic images of the drive coupling piece showing a portion of the fractured drive shaft tube and the location of the fracture relative to the tapered bolt.

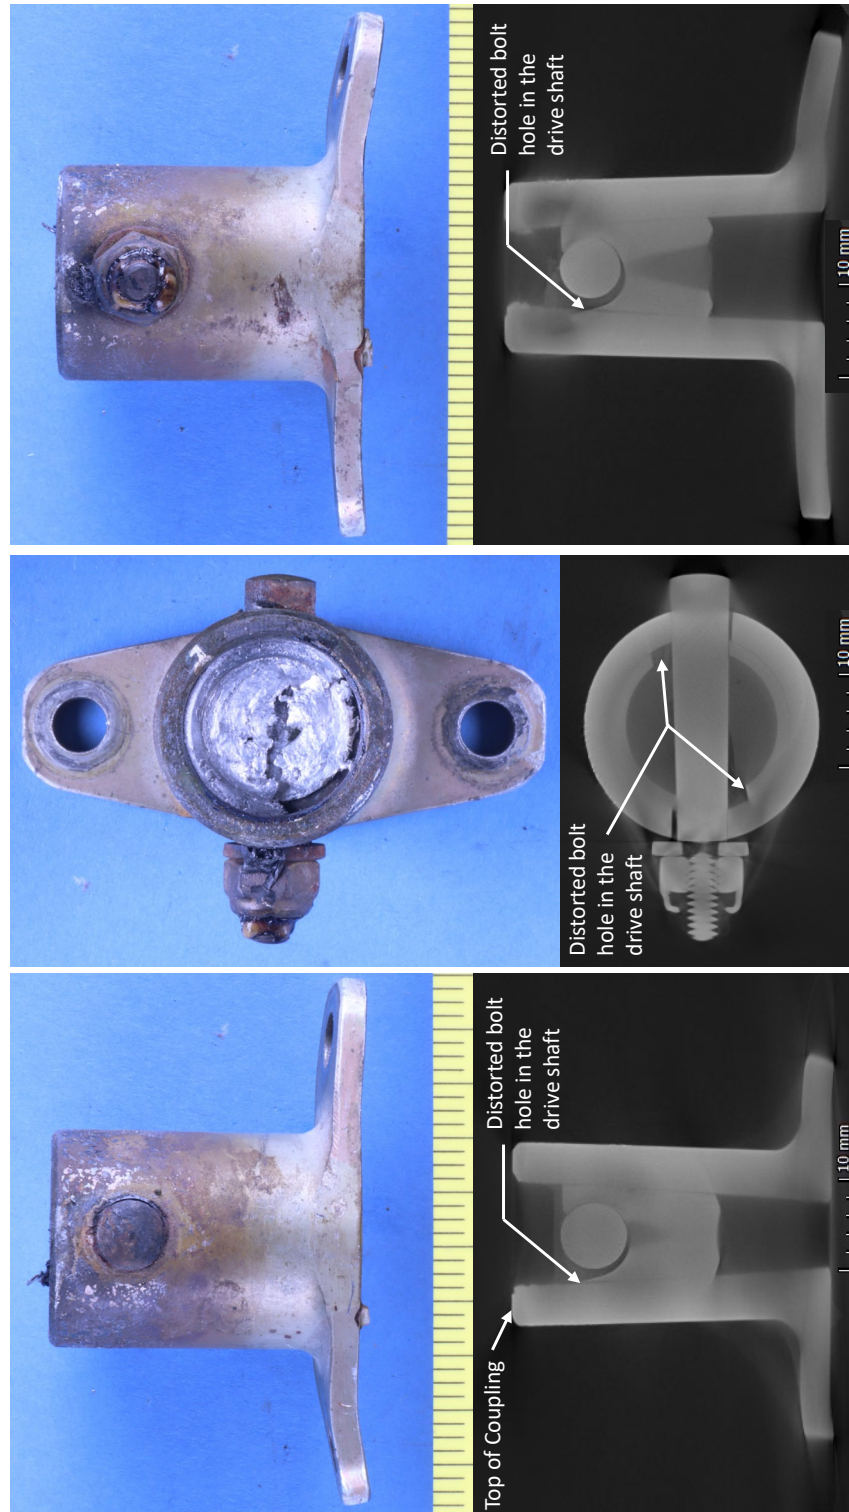
holes in the drive shaft tube wall consistent with gross mechanical shear deformation (e.g. mode II loading). A pronounced concave bend is observed in the flange portion of the drive coupling.

Figure 6 X-ray CT radiographic images of the drive coupling piece showing a portion of the fractured drive shaft tube and distortion of the cross-drilled bolt hole in the drive shaft.

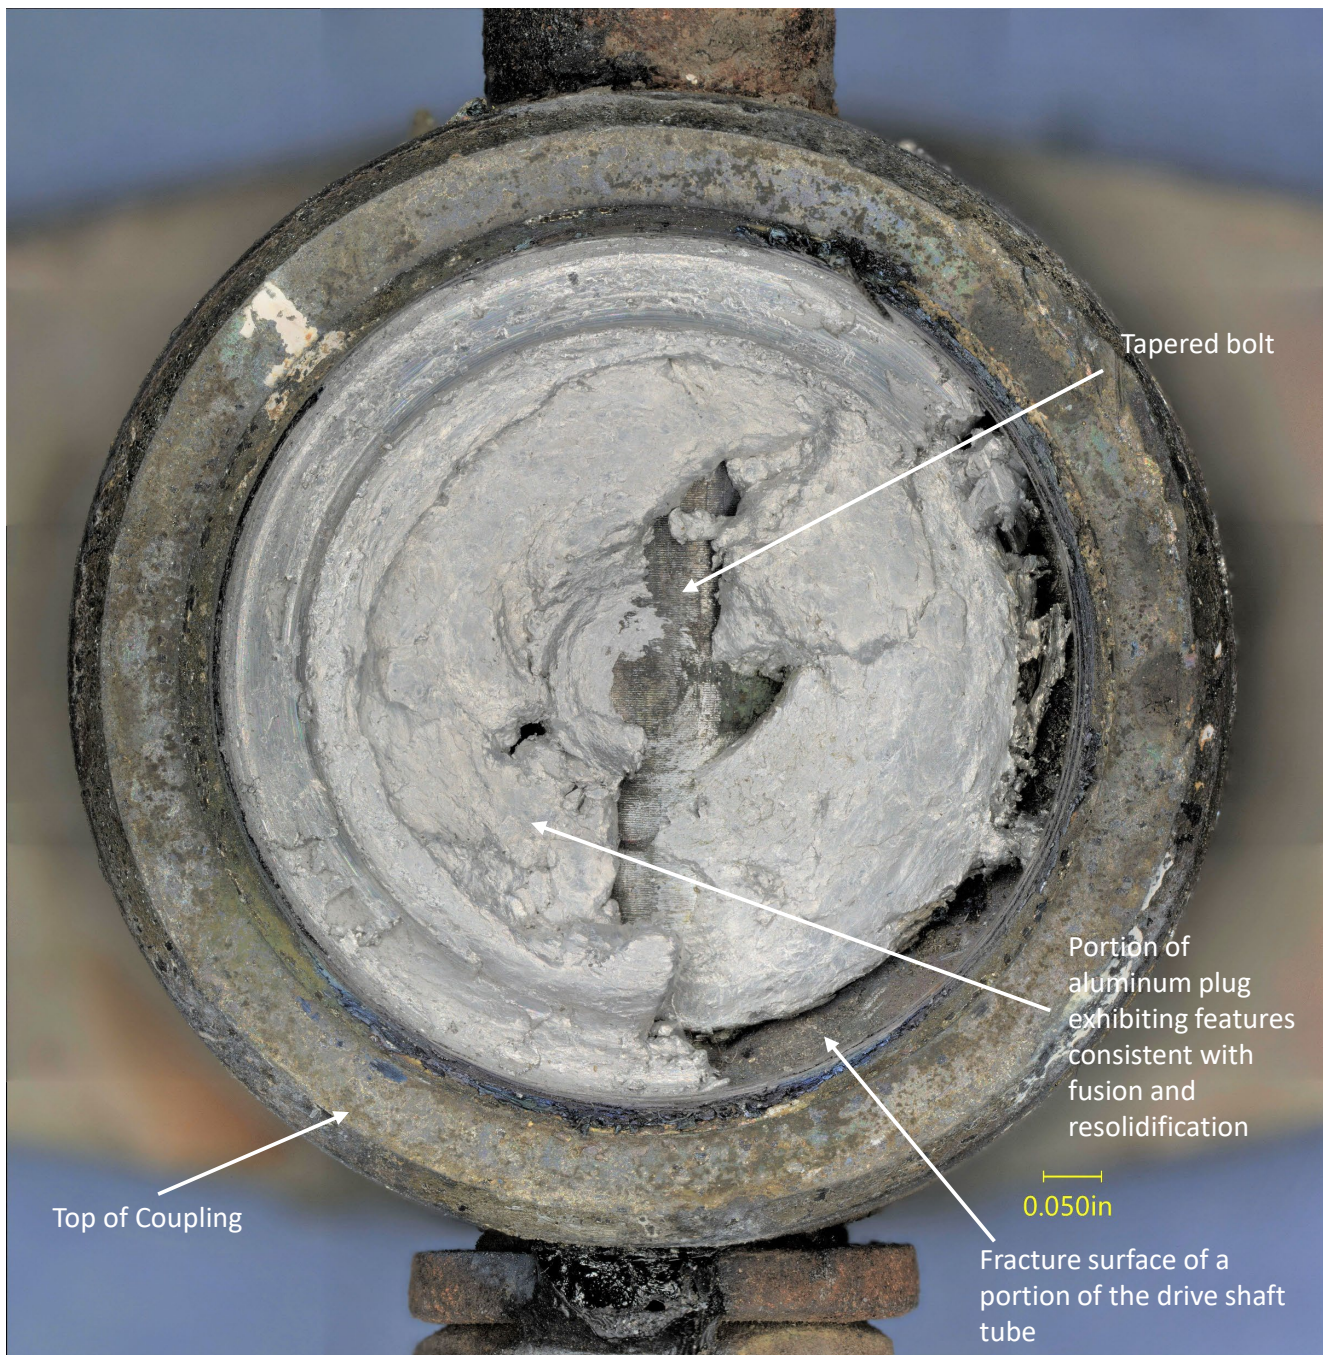
Figure 7 and 8 show close views of the internal bore at the top side of the drive coupling. In Figure 7, a portion of aluminum plug exhibiting features consistent with fusion and resolidification is observed. The fracture surface of the drive shaft tube is obscured by remnants of the aluminum plug. To reveal the fracture surface of the drive shaft tube, the drive coupling was placed in concentrated sodium hydroxide to partially dissolve the aluminum plug remnants, while the steel drive coupling and bolt remain intact. In Figure 8, a close view of the drive coupling bore from the top side is shown with the aluminum plug remnants partially dissolved to reveal the tapered bolt and the drive shaft fracture surface. As shown in the image, the bolt holes in the drive shaft tube are mechanically distorted consistent with the presence of an axially applied torsional shear-stress in the drive shaft tube in the clockwise direction. Macroscopically, the fracture surface in the drive shaft tube is consistent with overstress due to torsionally-applied shear stress (e.g. mode II loading).

Figure 7 Close view of the internal bore at the top side of the drive coupling. A portion of aluminum plug exhibiting features consistent with fusion and resolidification is observed. The fracture surface of the drive shaft tube is obscured by remnants of the aluminum plug.

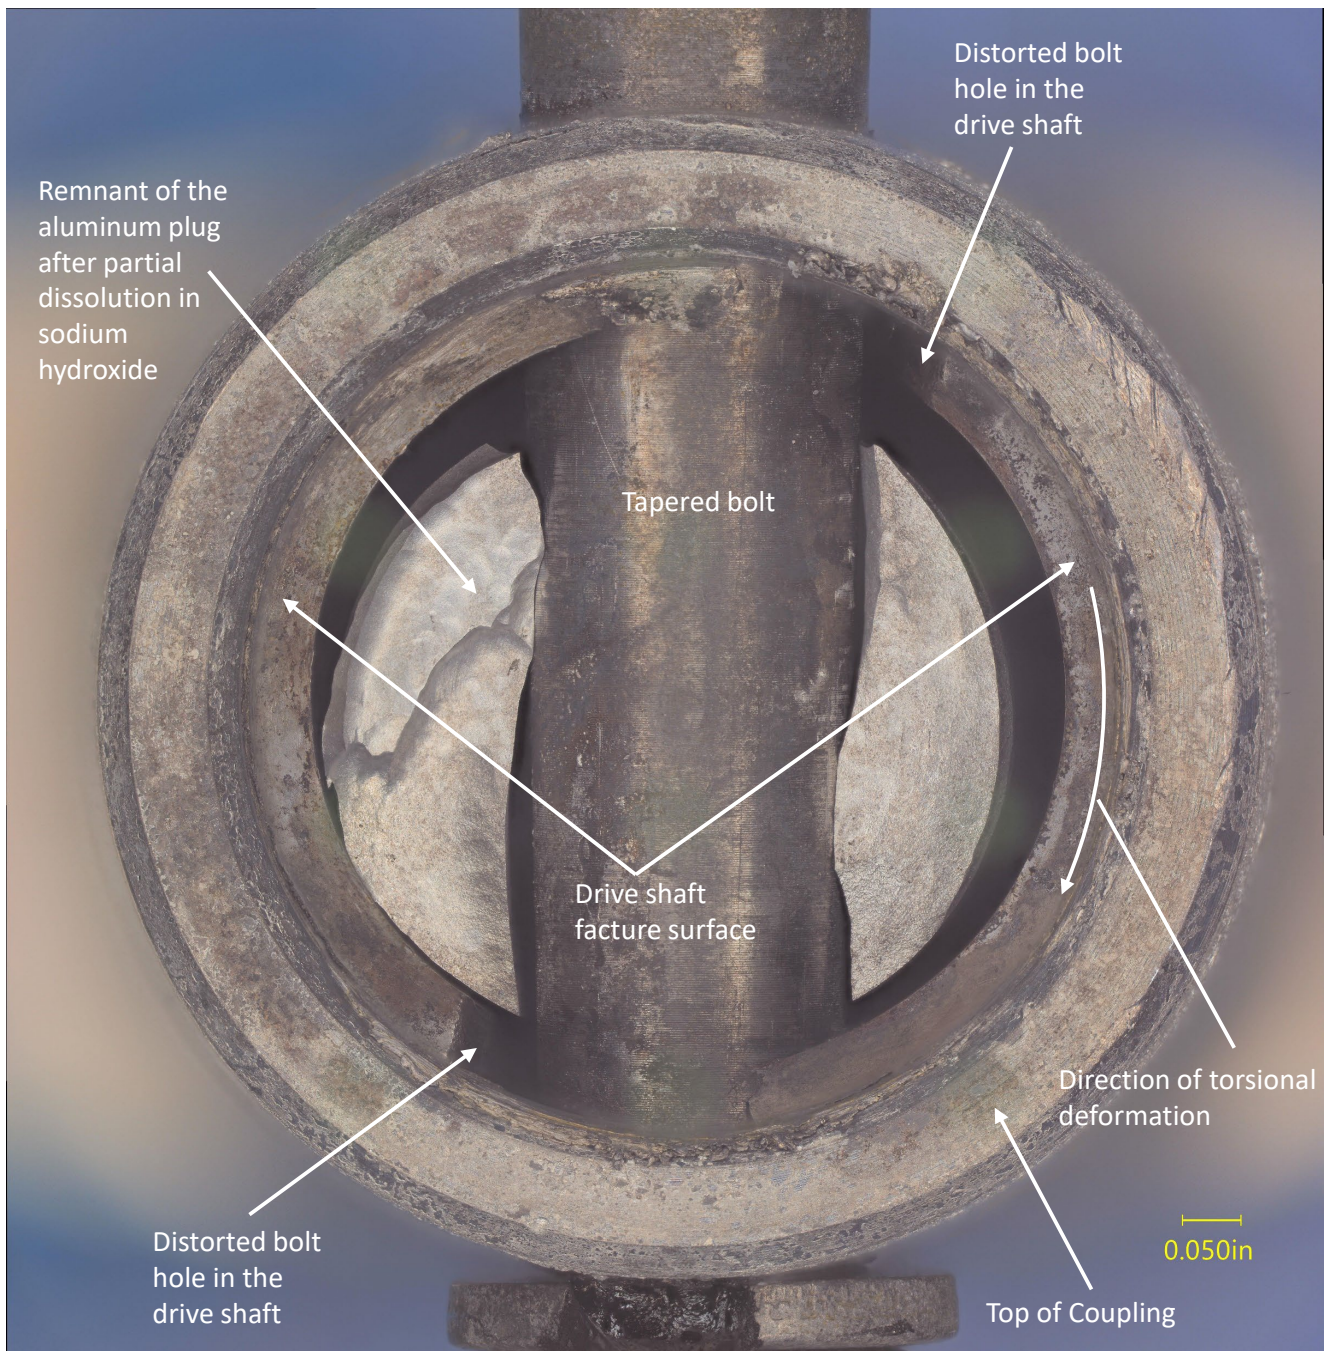
Figure 8 Close view of the drive coupling bore from the top side, shown with the aluminum plug remnants partially dissolved to reveal the tapered bolt and the drive shaft fracture surface. The bolt holes in the drive shaft tube are mechanically distorted consistent with the presence of an axially applied torsional shear-stress in the drive shaft tube in the clockwise direction.

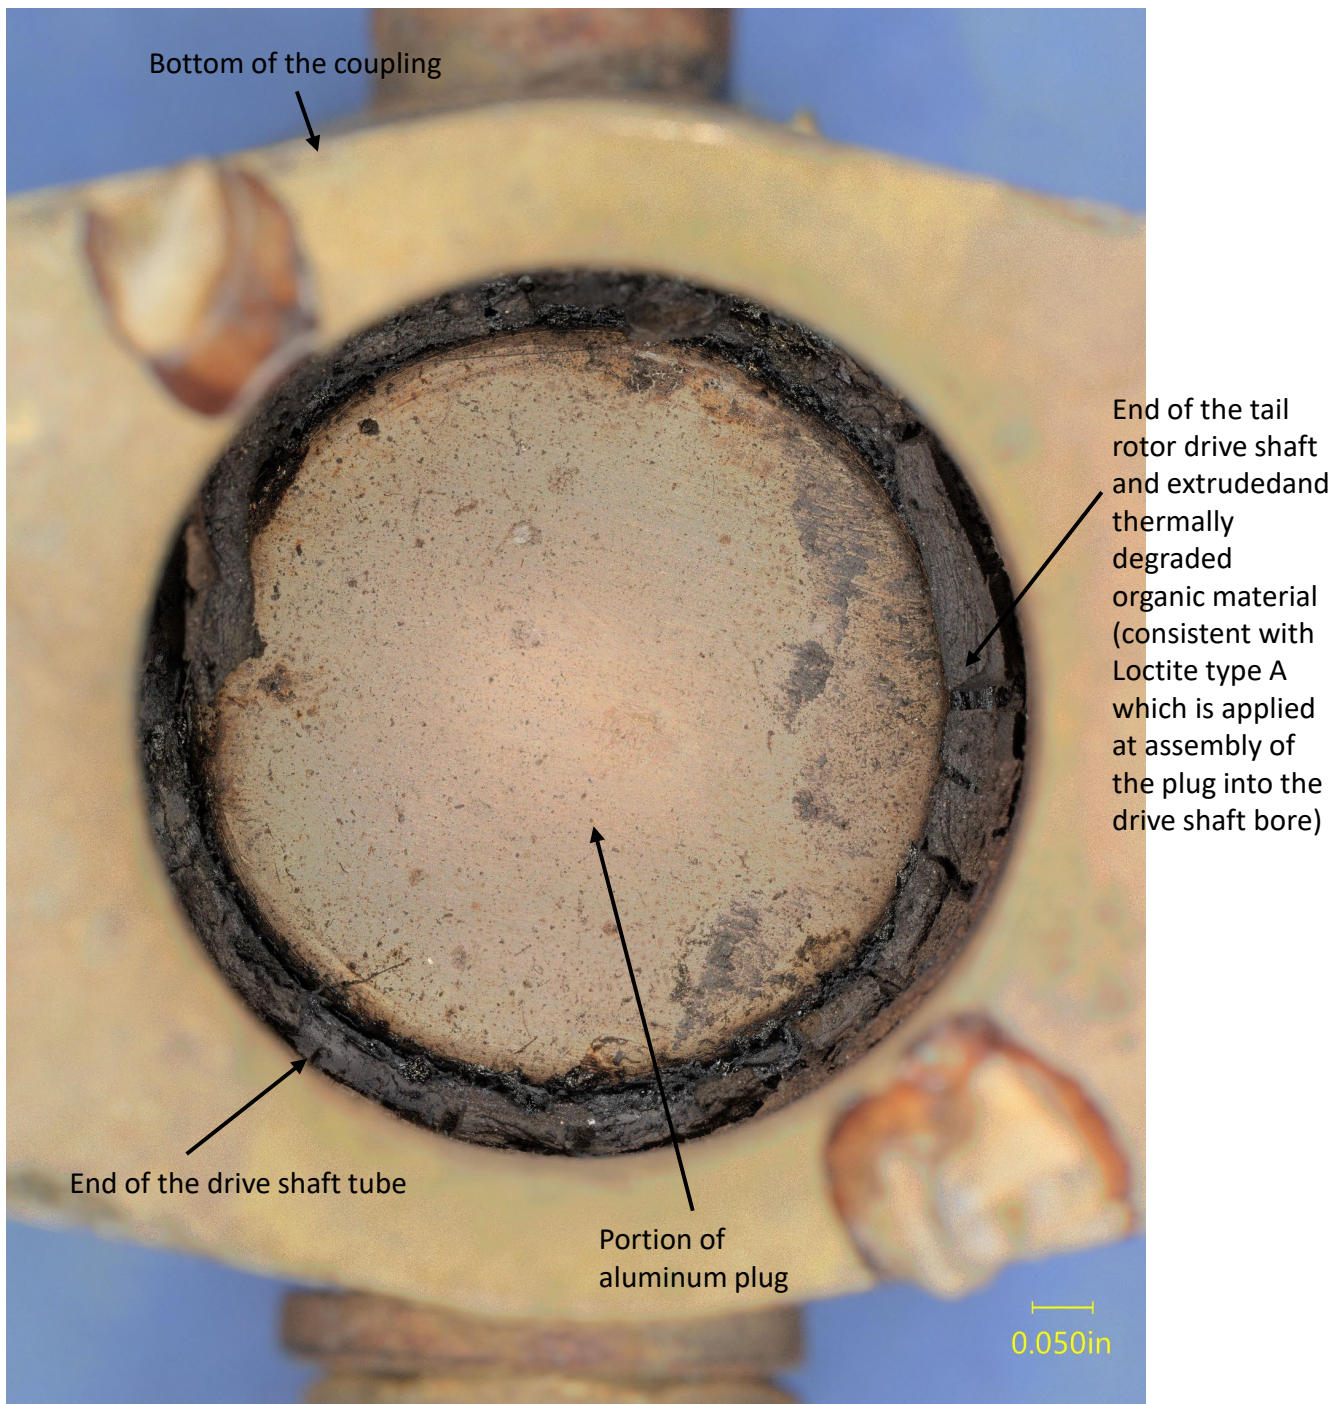
Figure 9 shows a close view of the internal bore at the bottom or flange side of the drive coupling. This image reveals a portion of the aluminum plug, the chamfered end of the drive shaft tube, and extruded and thermally degraded organic material. Based on its location, the extruded and thermally degraded organic material is consistent with an adhesive (Loctite A) which is applied to the aluminum plug before it is inserted into a reamed counterbore in the end of the drive shaft tube.

Figure 9 A close view of the internal bore at the bottom or flange side of the drive coupling. This image reveals a portion of the aluminum plug, the chamfered end of the drive shaft tube, and extruded and thermally degraded organic material.

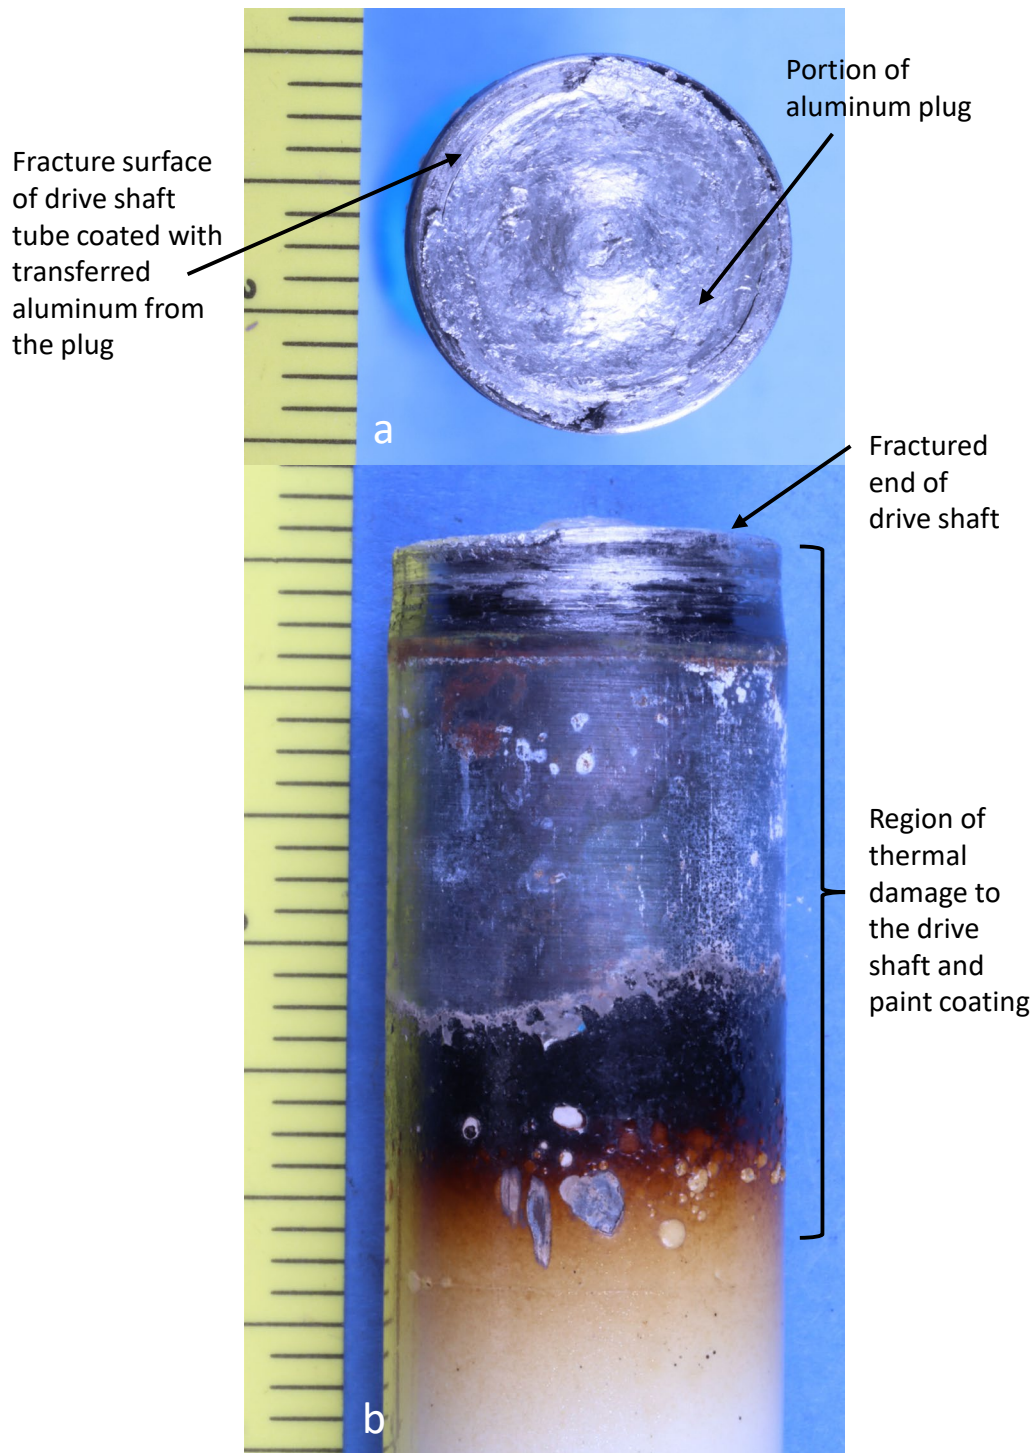
The side view of the drive shaft in Figure 10b shows a region of thermal damage approximately 1.5 inches long. Detailed in Figures 11-13, the drive shaft outside diameter (OD) at the end adjacent to the fractured end has been mechanically reduced by about 0.02 inch due to wear which occurred due to relative rotational sliding between the OD surface of the drive shaft and the ID surface of the drive coupling. The OD surface of the drive shaft also exhibited areas with transferred aluminum (Figure 12).

Figure 10 Images of the fractured end of the as-received drive shaft tube. A region of thermal damage is noted as well as the presence of a portion of the aluminum plug.

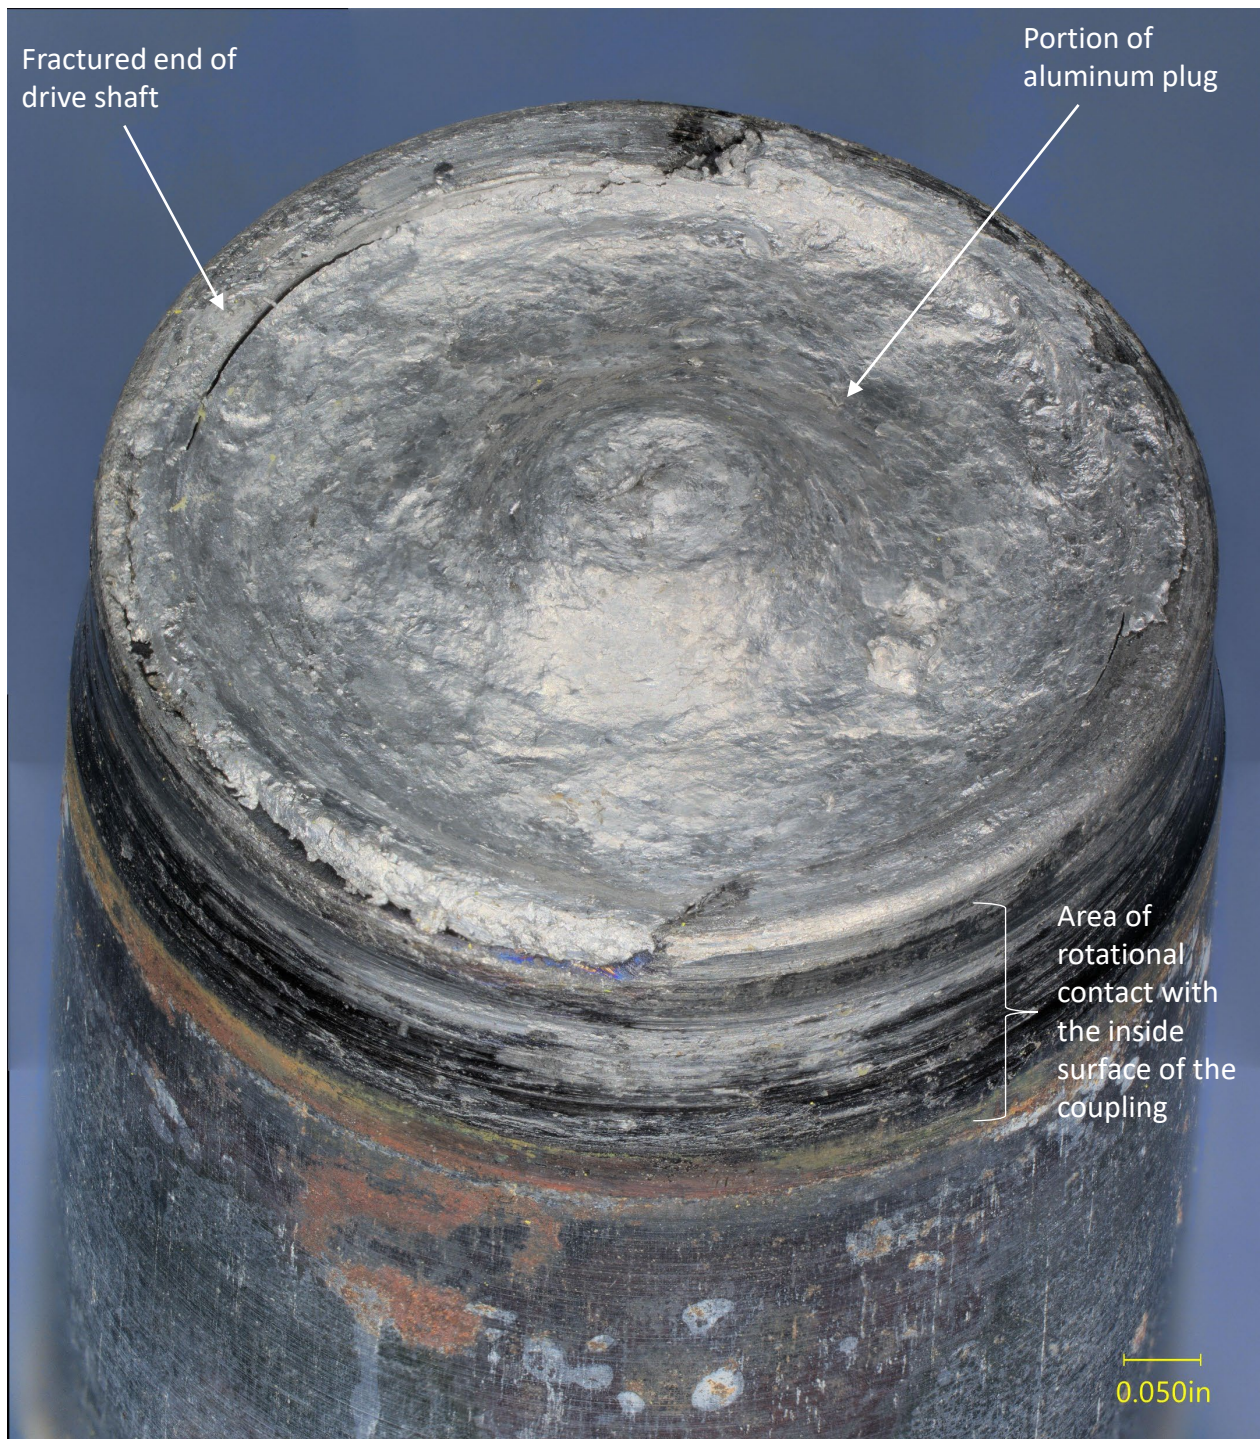
Figure 11 Oblique view of the fractured end of the as-received drive shaft tube showing rotational contact damage on the outside diameter of the drive shaft where it mates with the coupling.

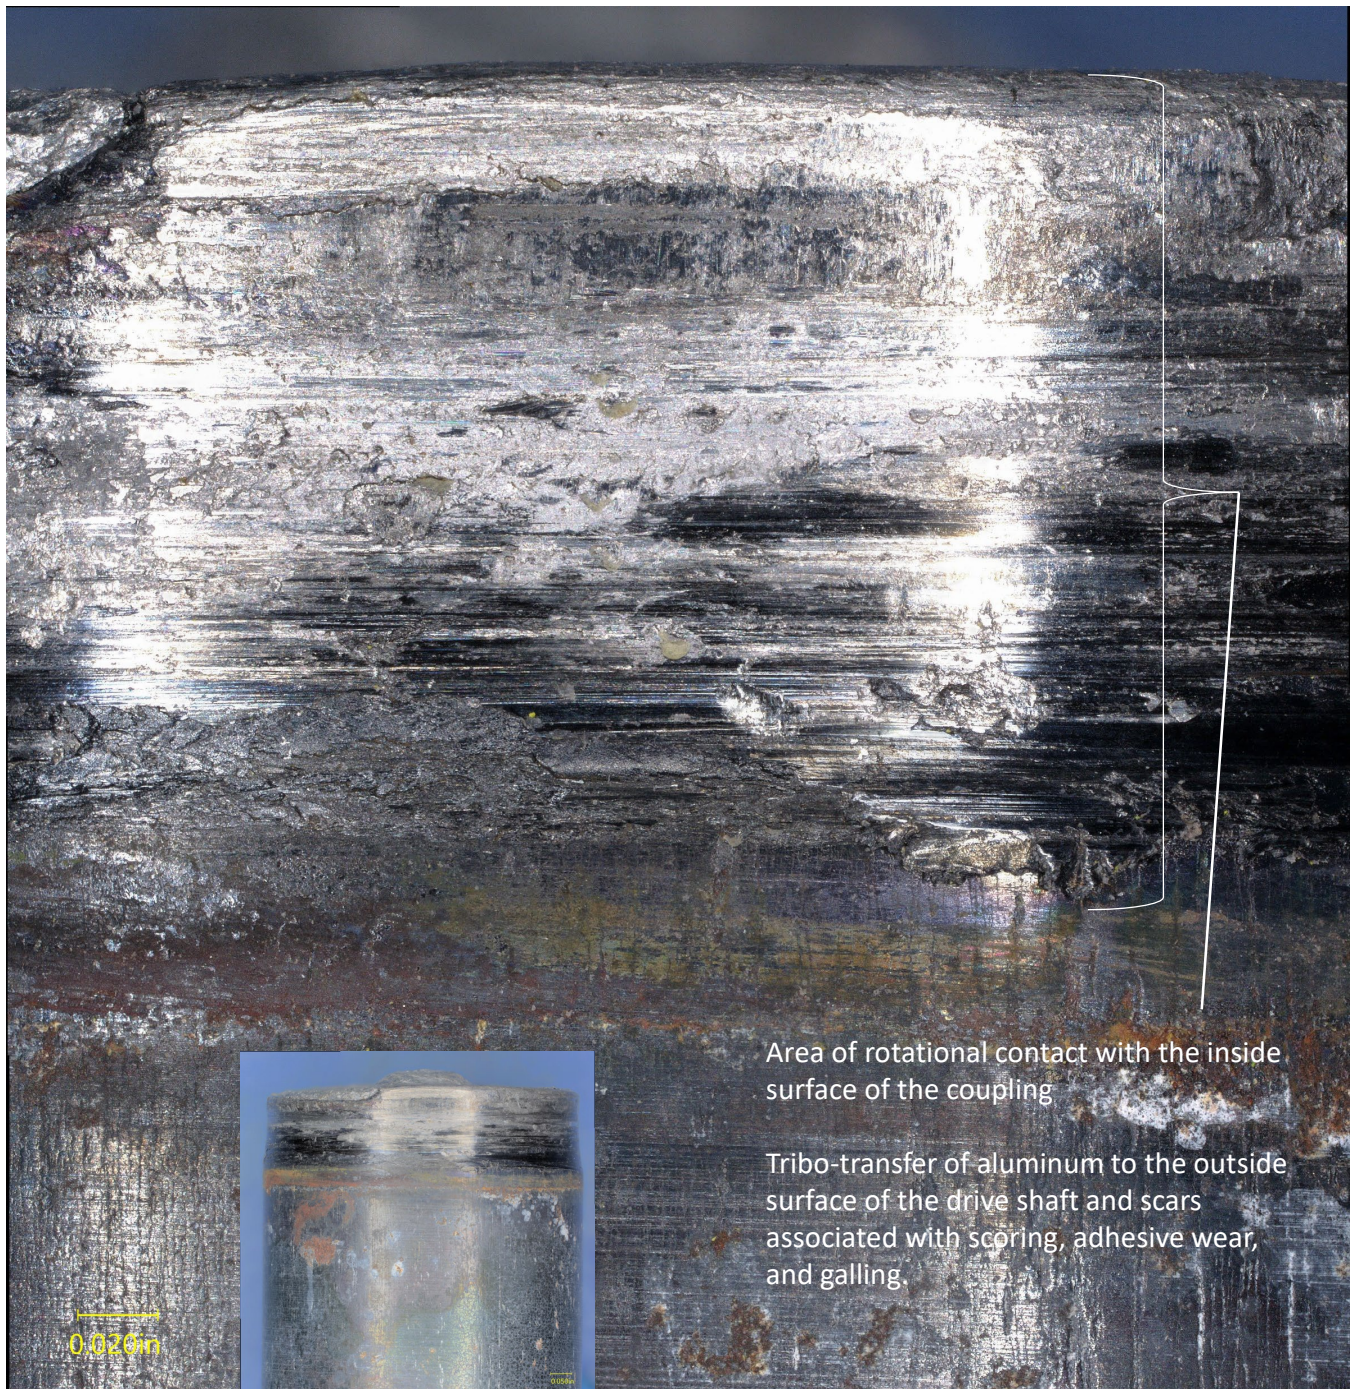
Figure 12 Closer side view of the fractured end of the as-received drive shaft tube showing rotational contact damage on the outside diameter of the drive shaft where it mates with the coupling.

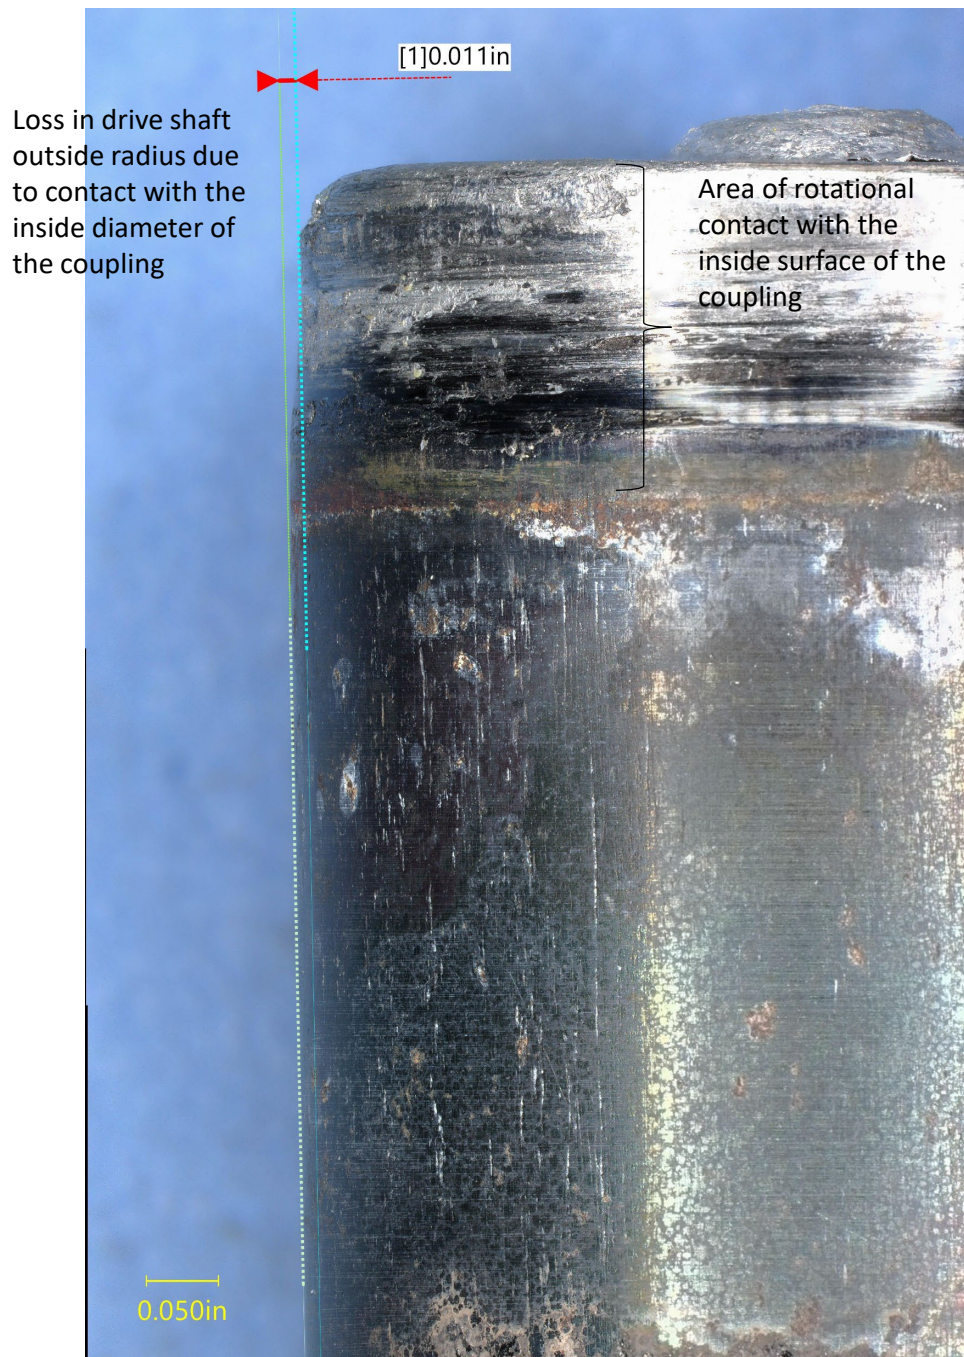
Figure 13 Image of the fractured end of the as-received drive shaft tube showing the reduction in outside diameter due to rotational contact of the outside diameter of the drive shaft where it mates with the coupling.
