# NATIONAL TRANSPORTATION SAFETY BOARD

## MATERIALS LABORATORY FACTUAL REPORT

Report No. 21-103

Place : Port Orange, Florida  
Date : 08/21/2021  
Vehicle : Enstrom Helicopter Corporation Model 280C  
NTSB No. : ERA21LA339  
Investigator : Daniel Boggs

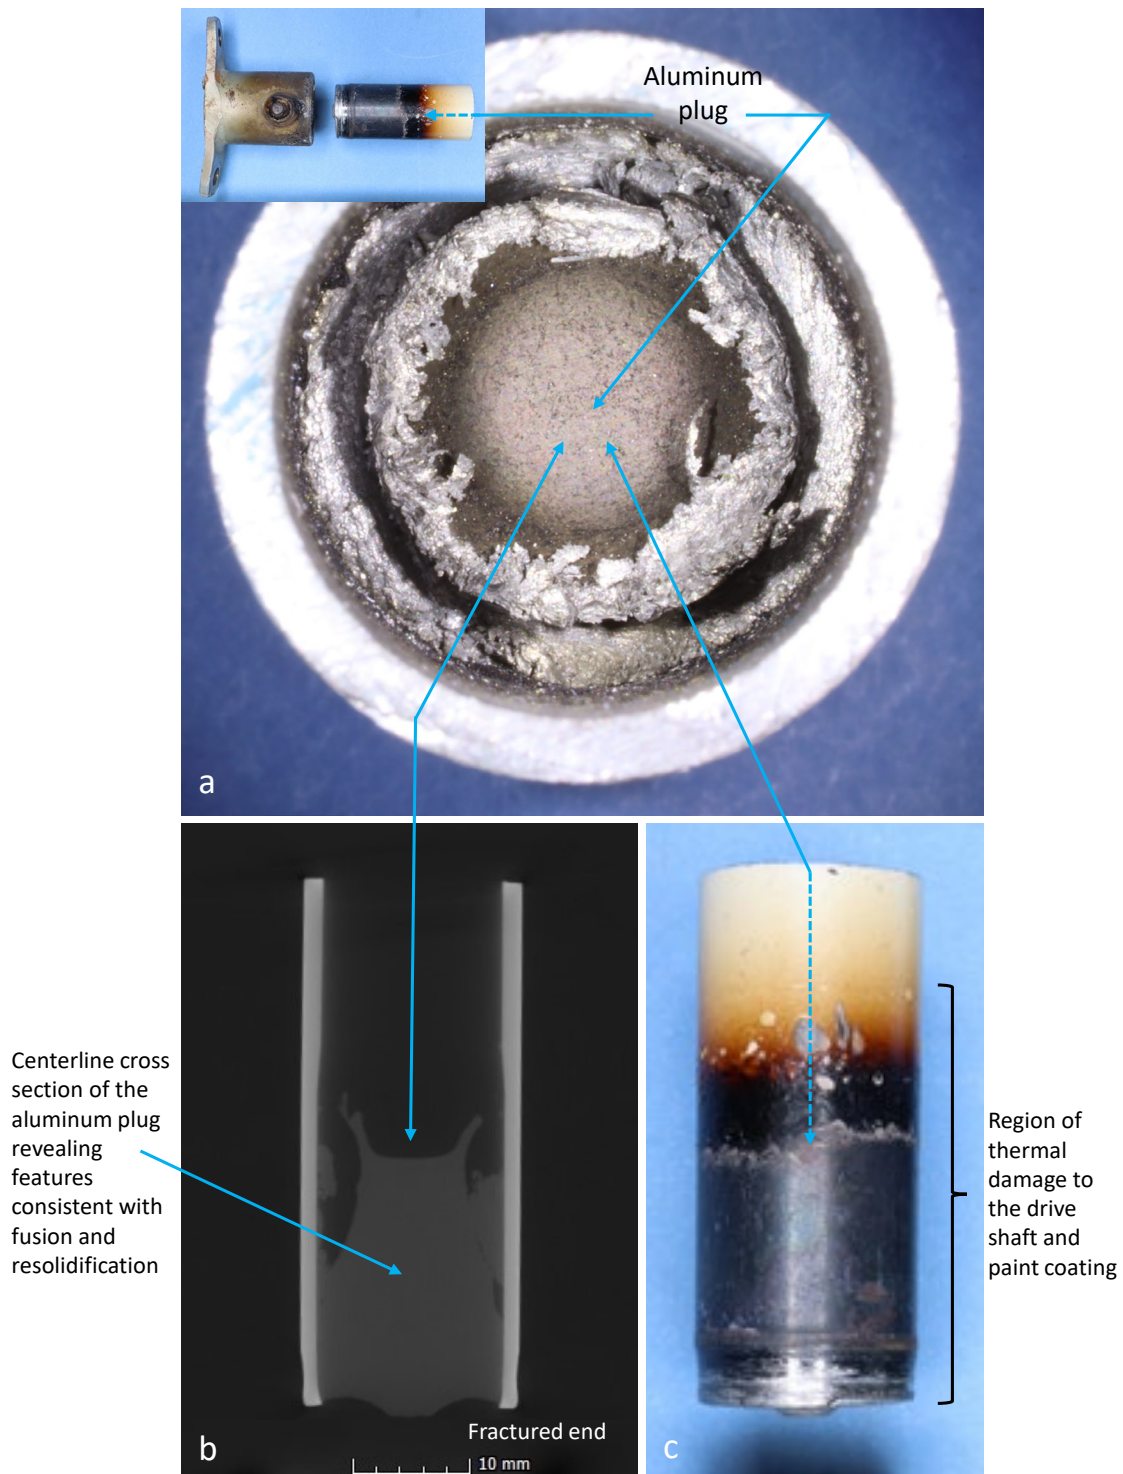
Figure 14a shows the inner bore of the drive shaft at the end facing away from the drive coupling. The image shows the end of the aluminum plug remnant and aluminum that has been fused, extruded, and resolidified. An x-ray CT cross section of the drive shaft is shown in Figure 14b. The cross-sectional radiograph reveals voids and extrusion features consistent with fusion and resolidification of the OD surface of the aluminum plug.

Figure 14 The as-received fractured end of the drive shaft tube. View a shows the bore of the tube with melted, resolidified, and extruded aluminum from the plug. View b shows a longitudinal cross-sectional x-ray CT radiograph of the damaged plug piece inside the bore.

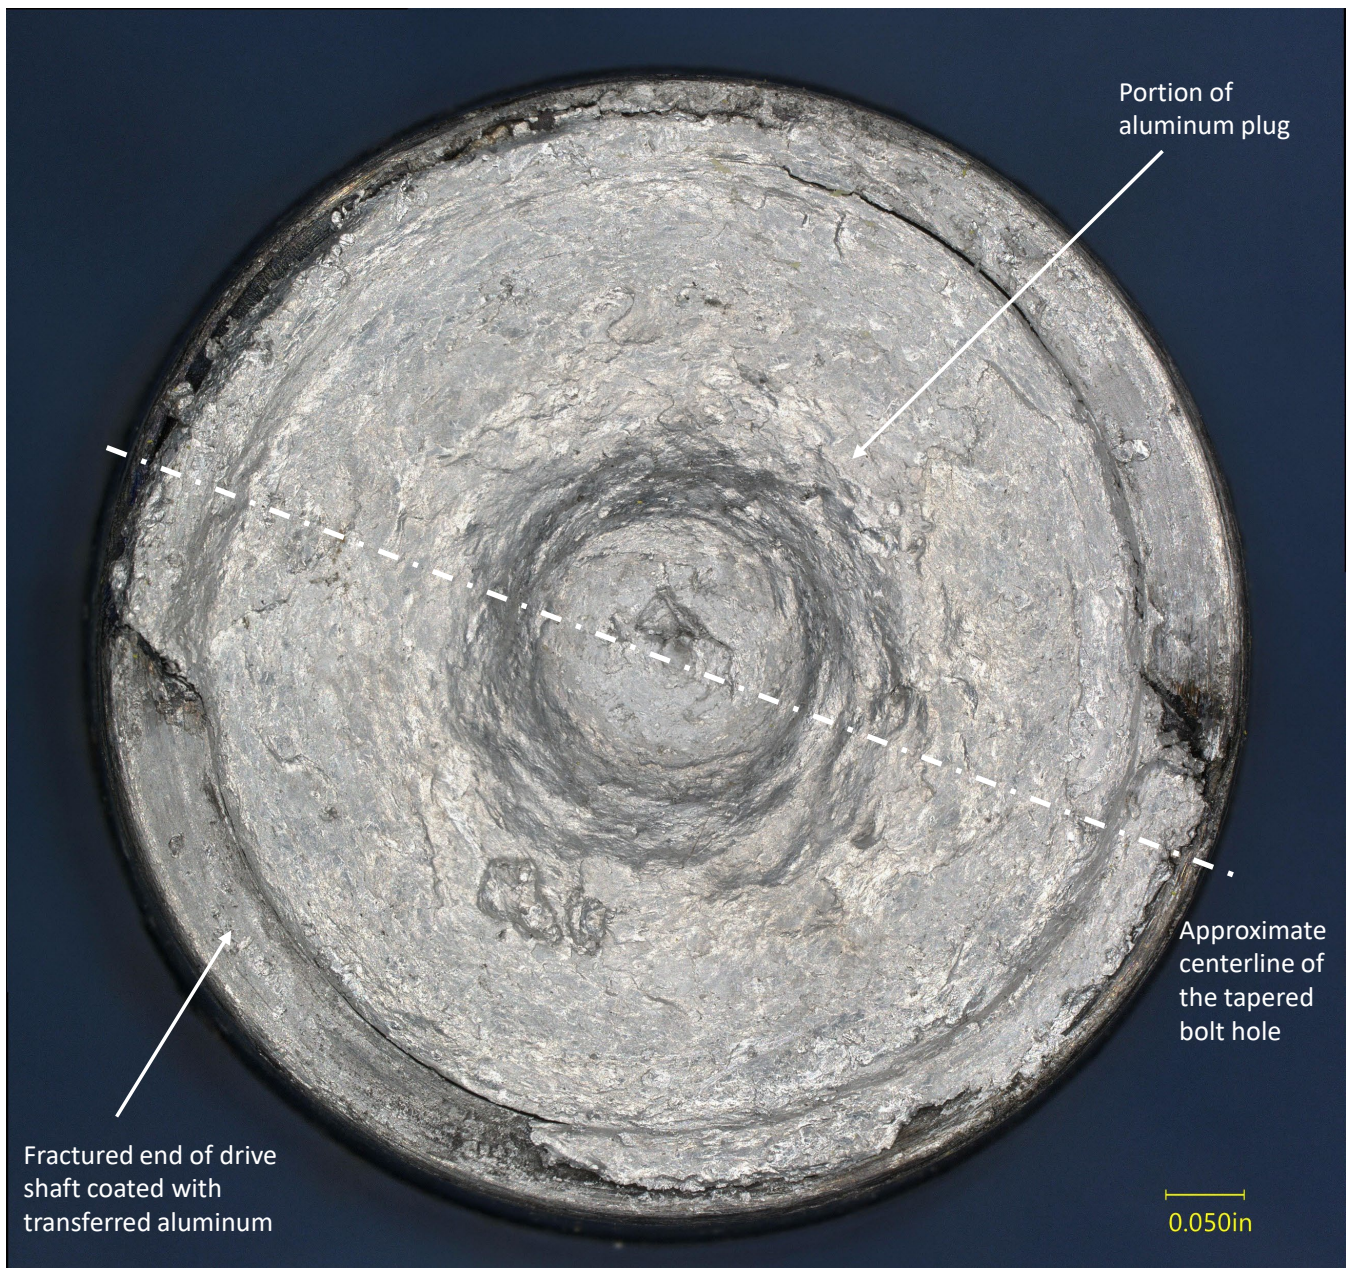
The as received fracture surface of the drive shaft tube is shown in Figure 15. A portion of the aluminum plug fills to inner void space of the tube. The fracture surface of the steel drive shaft tube was also coated with aluminum from the plug. To expose the fracture surface of the drive shaft, the assembly was immersed in concentrated sodium hydroxide to partially dissolve the aluminum while leaving the drive shaft steel intact. The exposed drive shaft tube fracture surface is shown in Figure 16. Much of the fracture

Figure 15 Image of the fractured end of the as-received drive shaft tube showing the presence of aluminum from the damage plug.

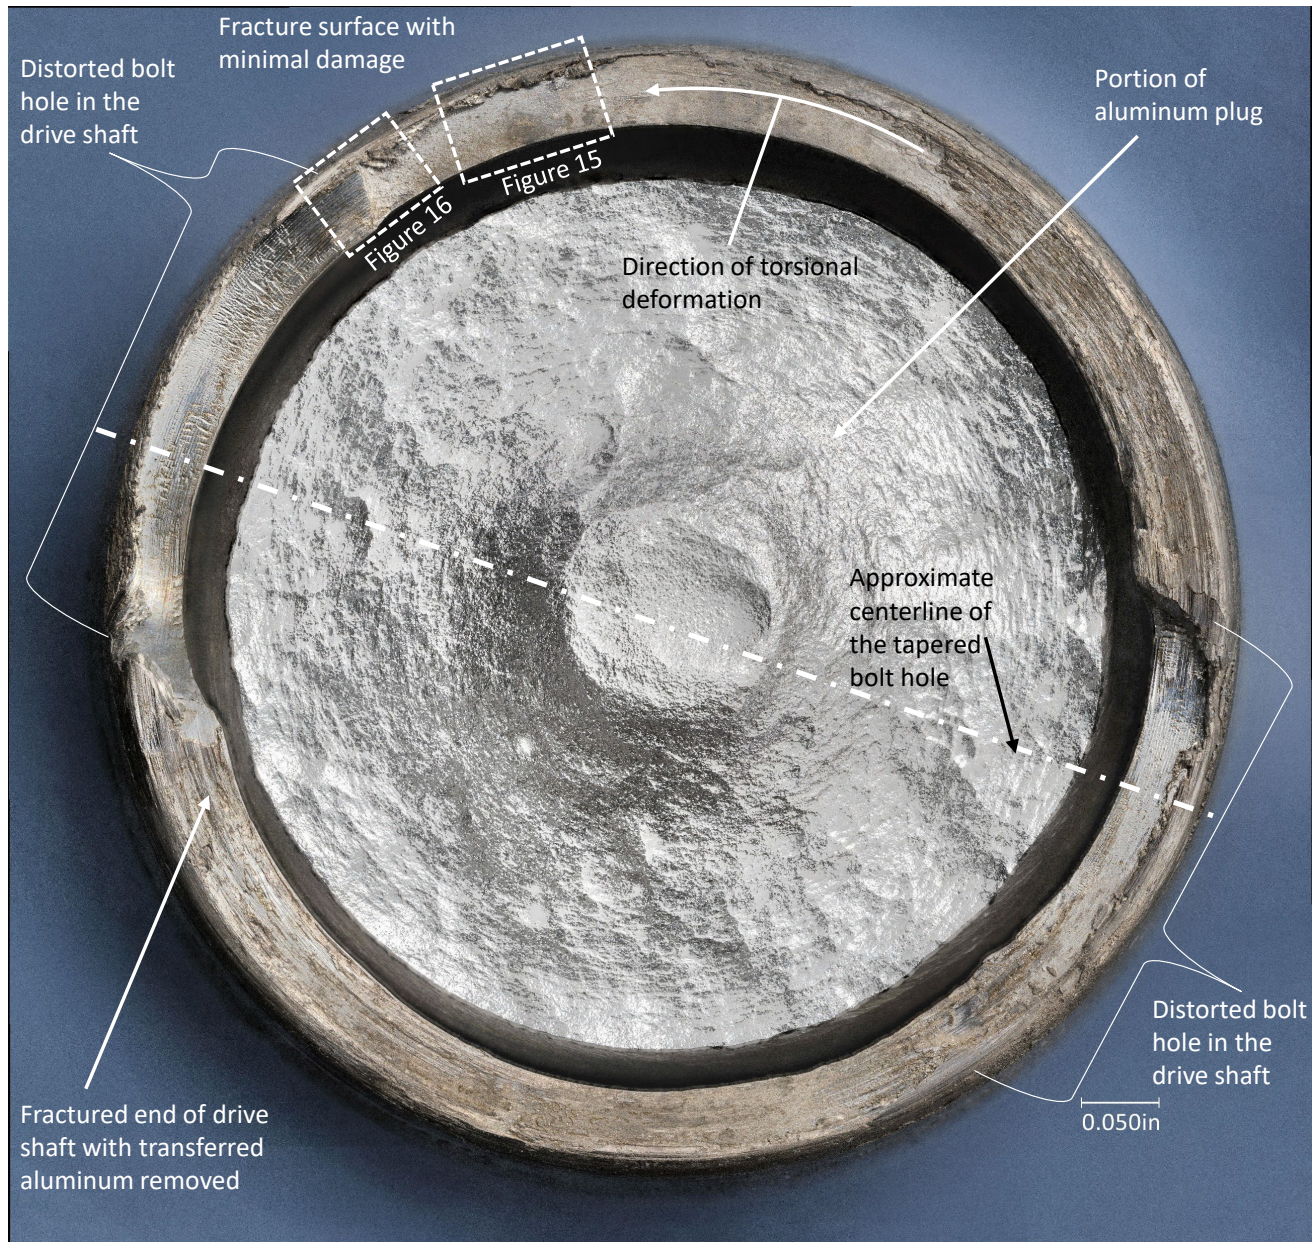
surface was damaged by mechanical contact—obliterating most fracture surface macro and micro-features. Portions of both bolt holes are present on this fracture surface (see annotations in the figure for locations) and their elongated shape are consistent with shear deformation from axial torsional loads (e.g. mode II loading). The figure also shows a location on the fracture surface where the fracture micro-features were minimally damaged. A scanning electron microscope was used to image the fracture micro-features in this region. The images are shown in Figures 16 and 17. In all instances elongated microvoids were observed consistent with mode II microvoid coalescence (overstress fracture in shear).

Figure 16 The drive shaft fracture surface after immersing in concentrated sodium hydroxide to partially dissolve the aluminum while leaving the drive shaft steel intact. Much of the fracture surface was damaged by mechanical contact—obscuring most fracture surface macro and micro-features. Portions of both bolt holes are present on this fracture surface (see annotations in the figure for locations) and their elongated shape are consistent with shear deformation from axial torsional loads.

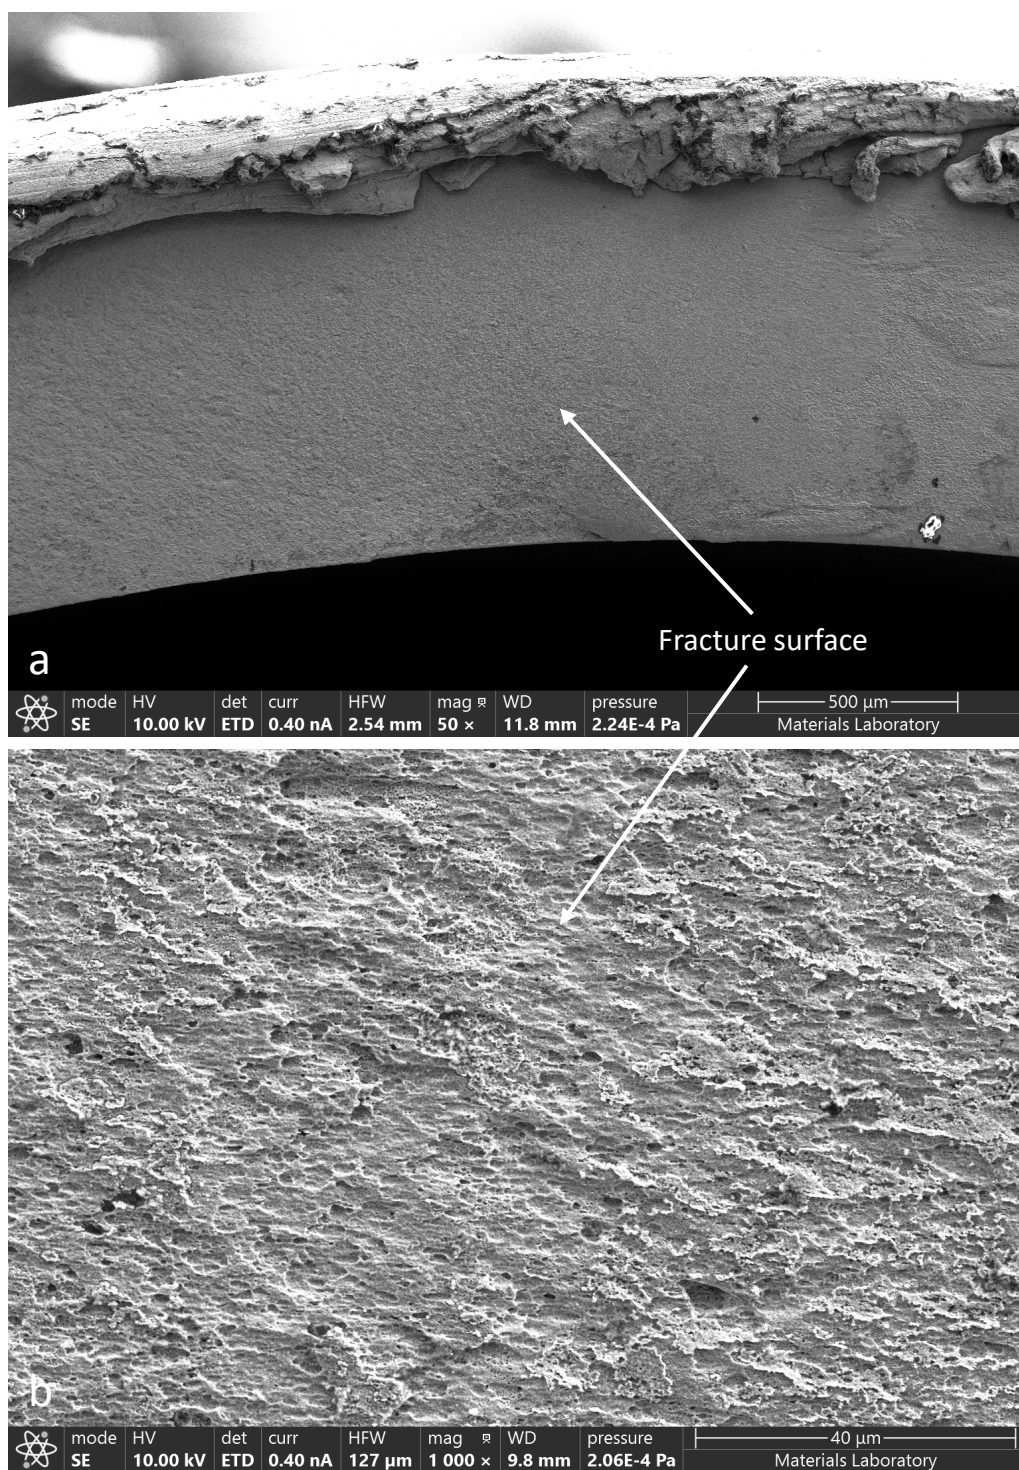
Figure 17 Scanning electron fractographs of the fracture surface region identified in Figure 16. View b shows microvoid coalescence with elongated microvoids consistent the mode II shear overstress fracture.

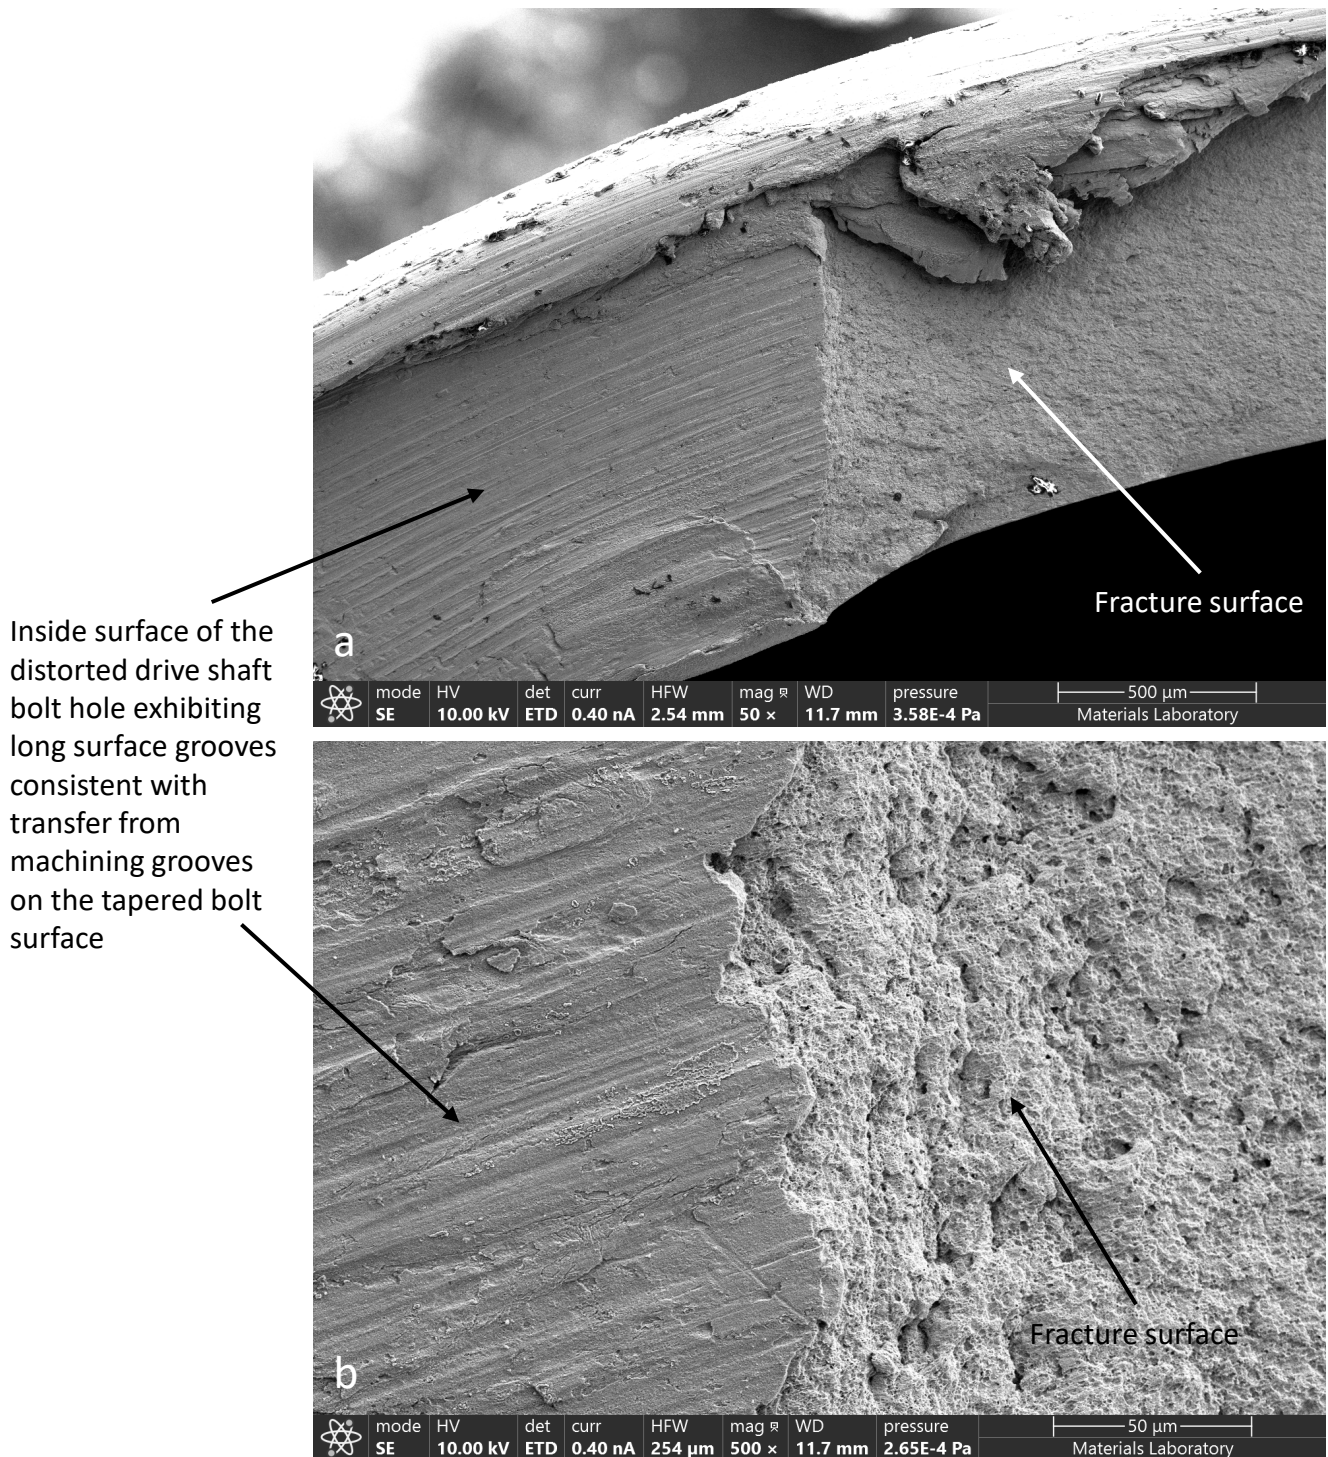
Figure 18 Scanning electron fractographs of the fracture surface region identified in Figure 16. View b shows microvoid coalescence with elongated microvoids consistent the mode II shear overstress fracture.

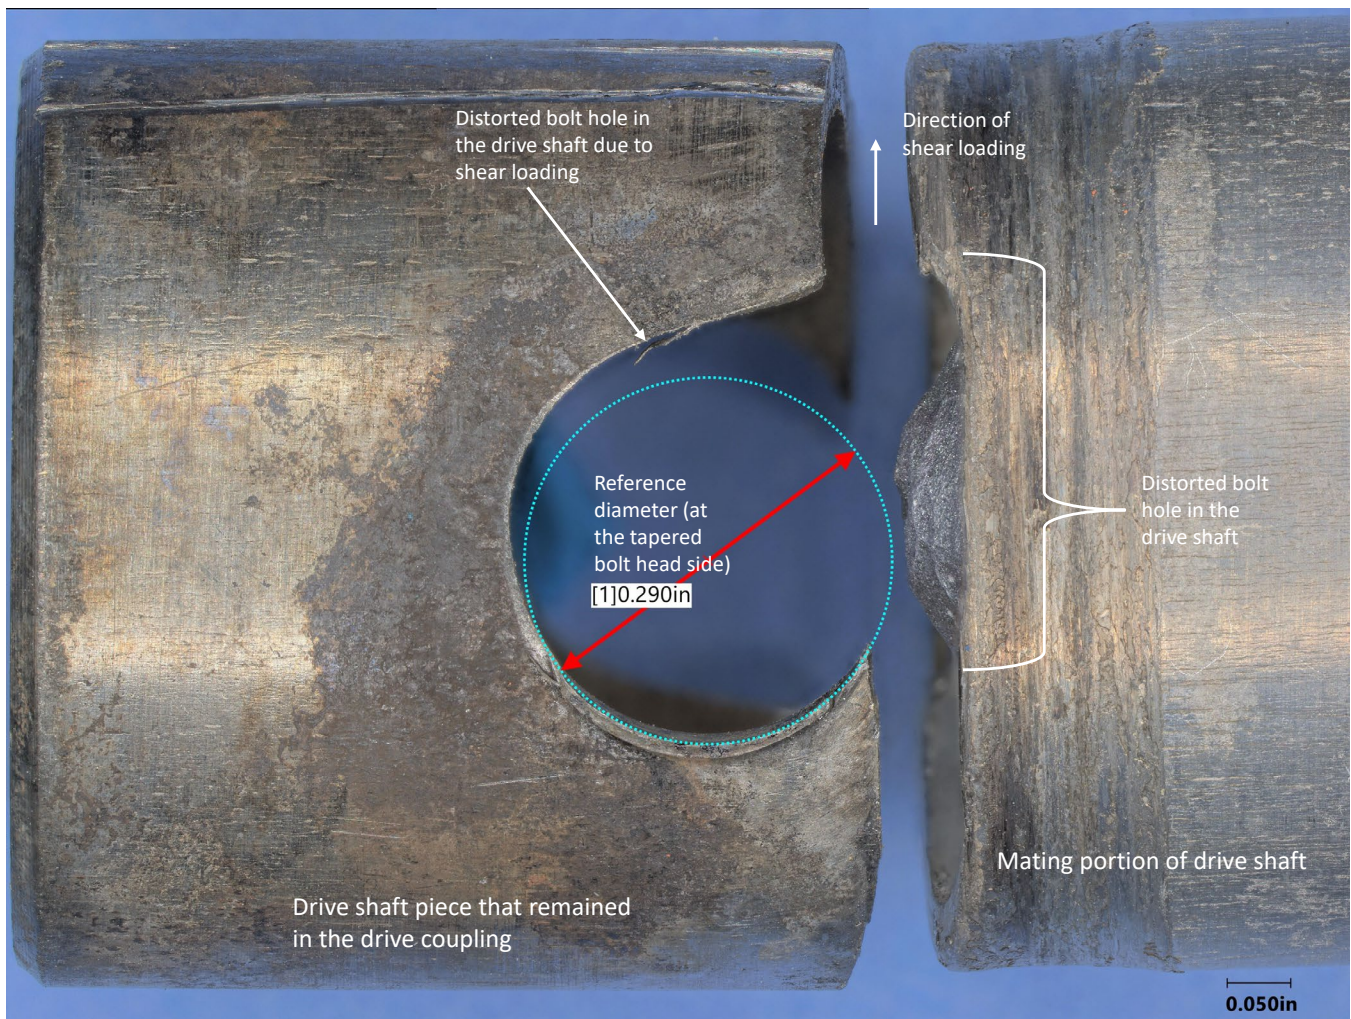
Figure 19 shows a side view of both fractured ends of the drive shaft pieces. The pieces are arranged to approximate their general positions at the time of final fracture. The distortion to the bolt hole due to the torsional shear overload is evident.

Figure 19 A side view of both fractured ends of the drive shaft piece. The pieces are arranged to approximate their general positions at the time of final fracture.
