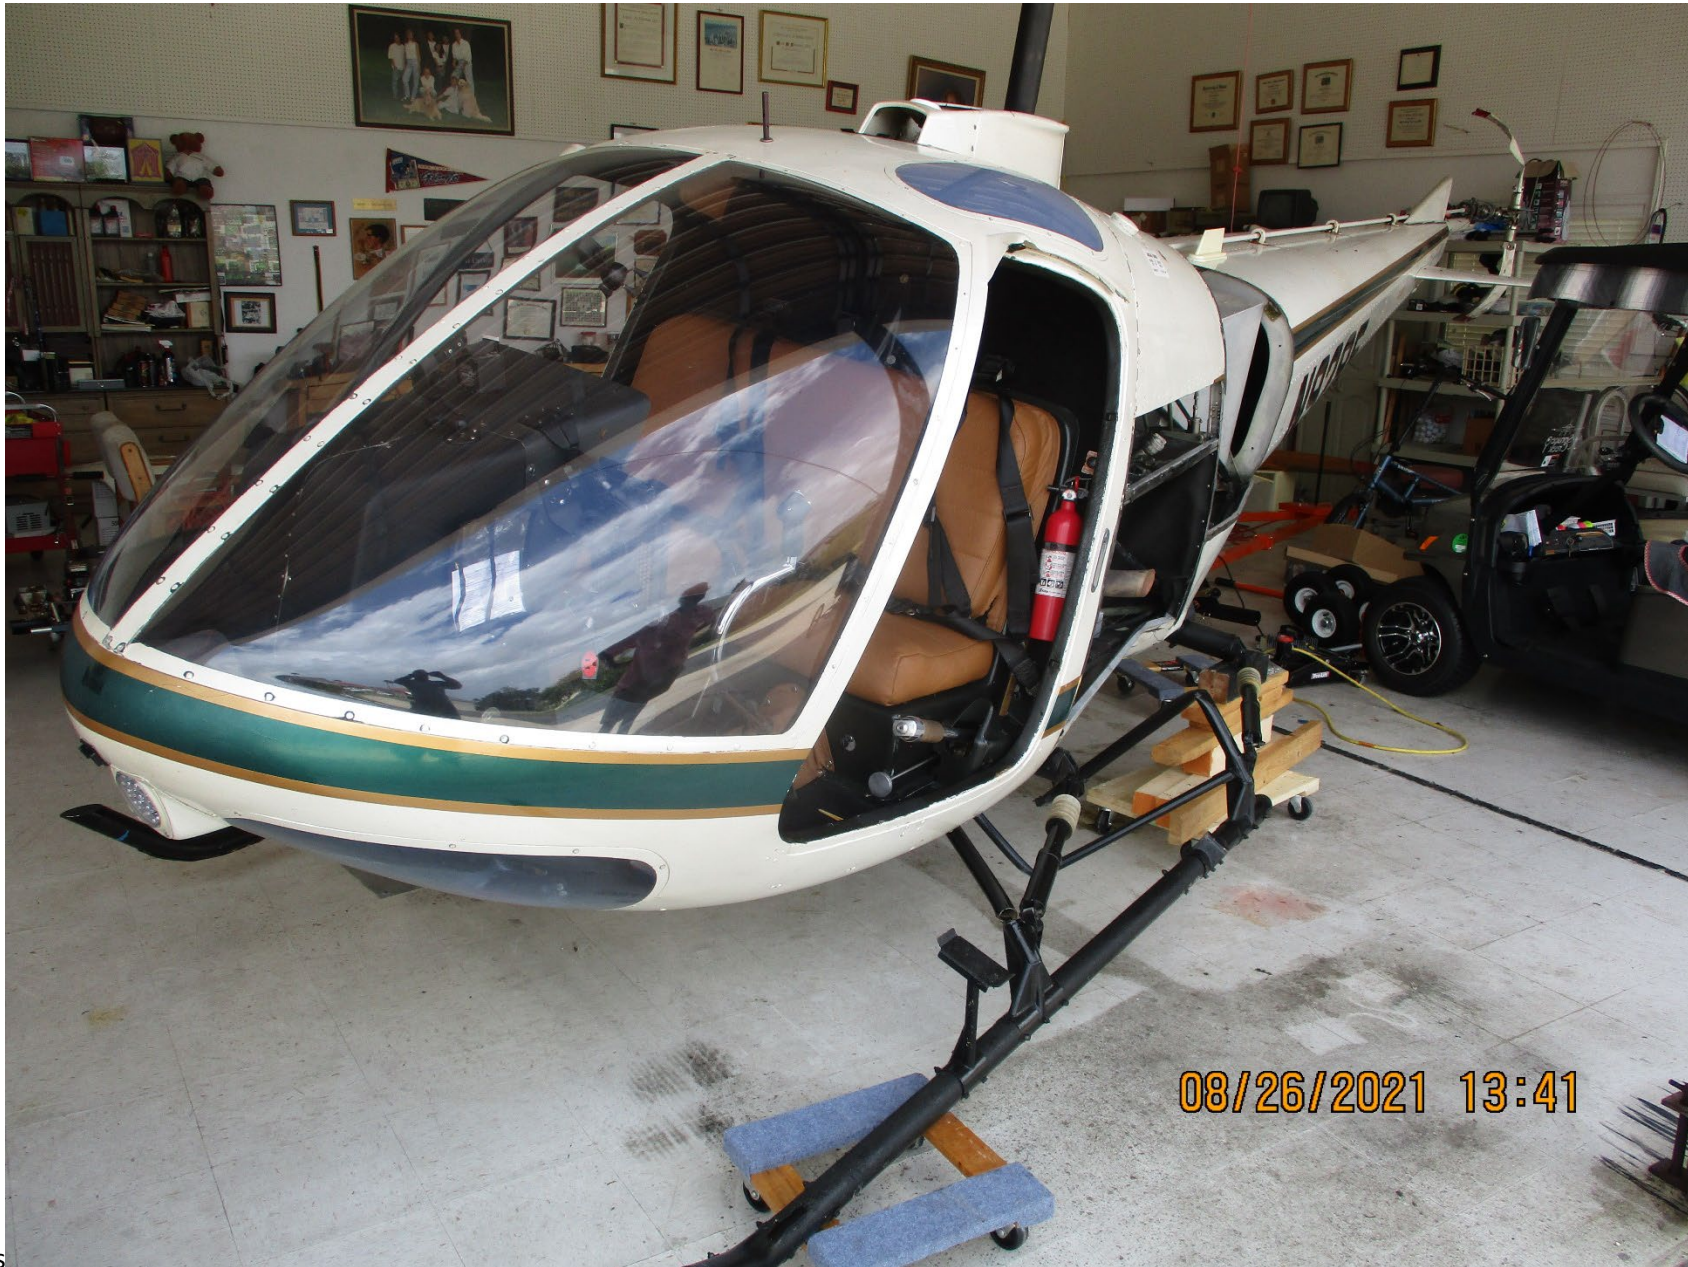
Photo 1 – main wreckage

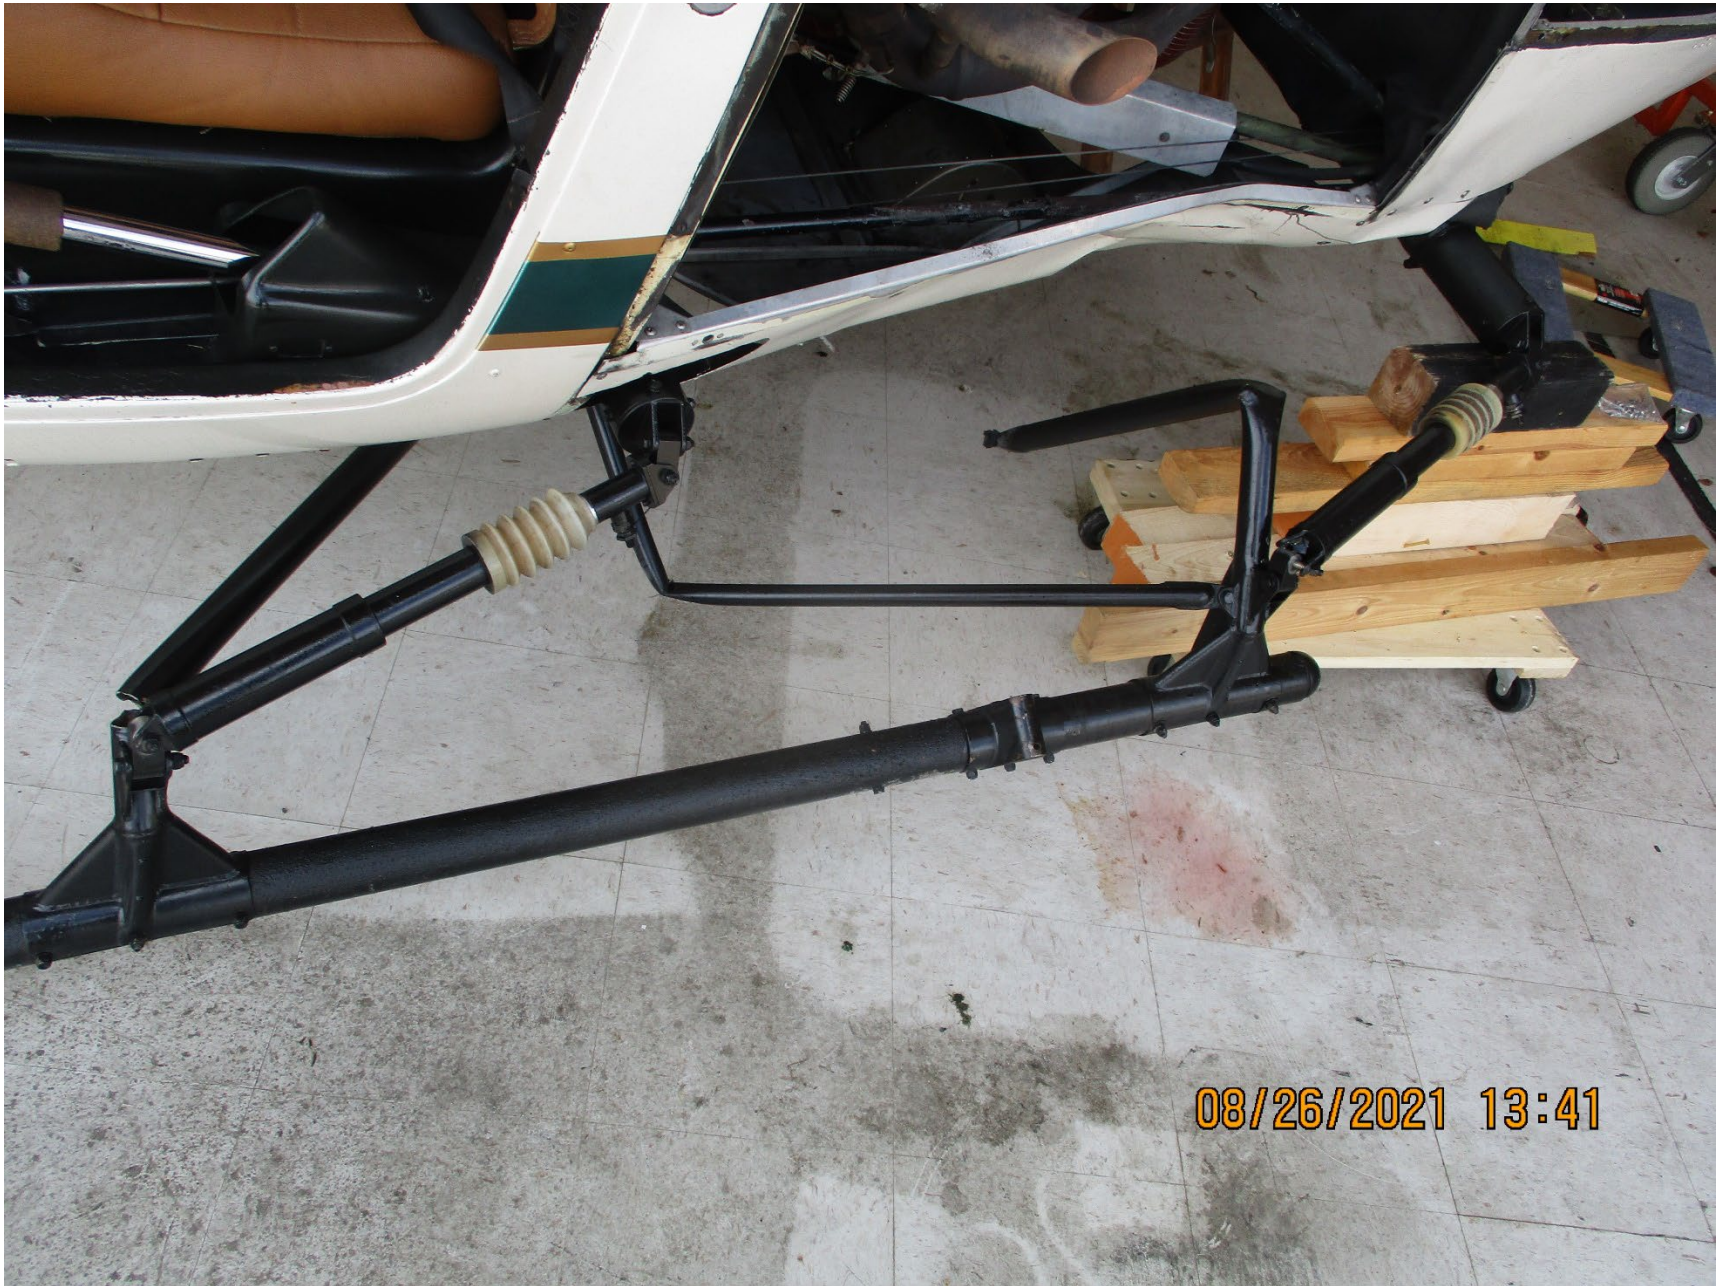
**Photo 2 – skid, fuselage damaged**

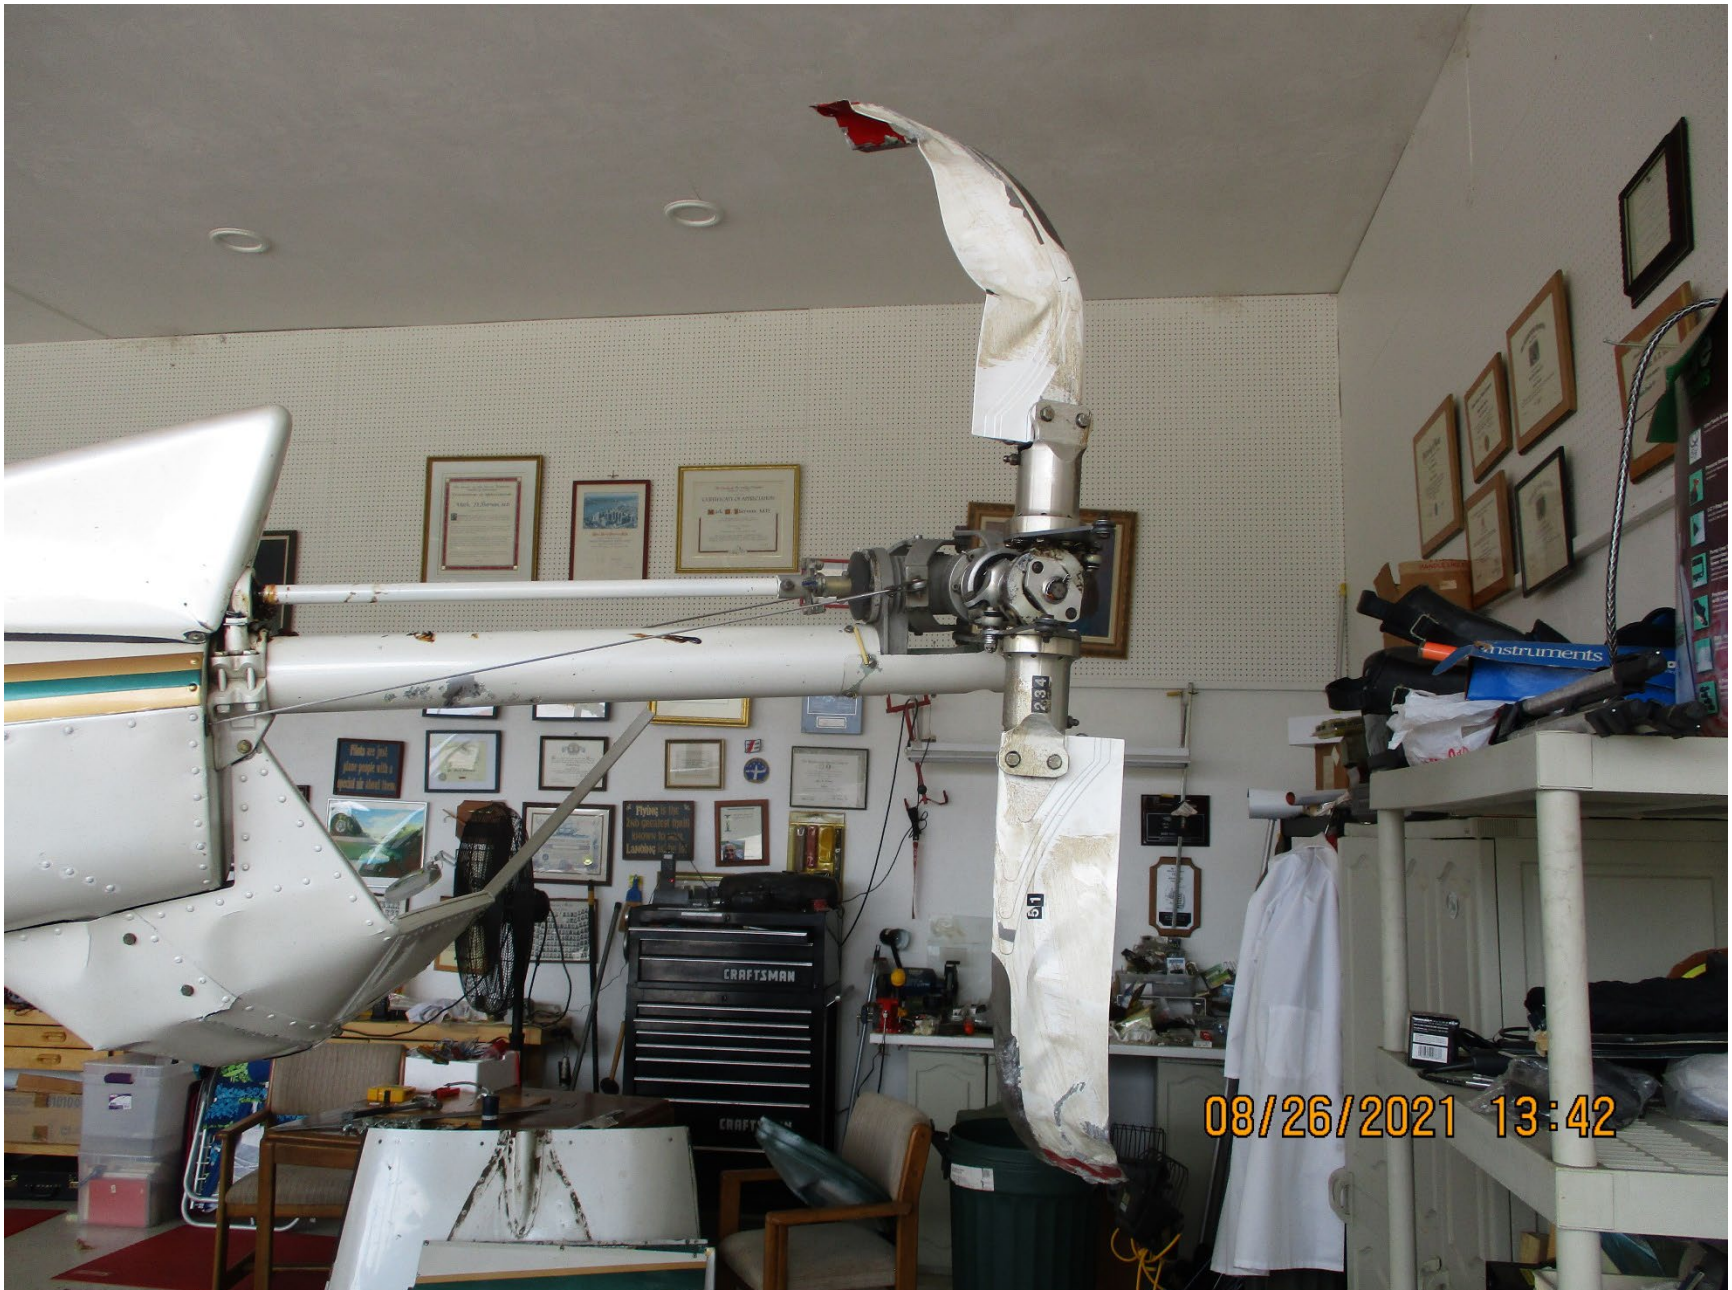
**Photo 3 – tail rotor strike, bent blades**

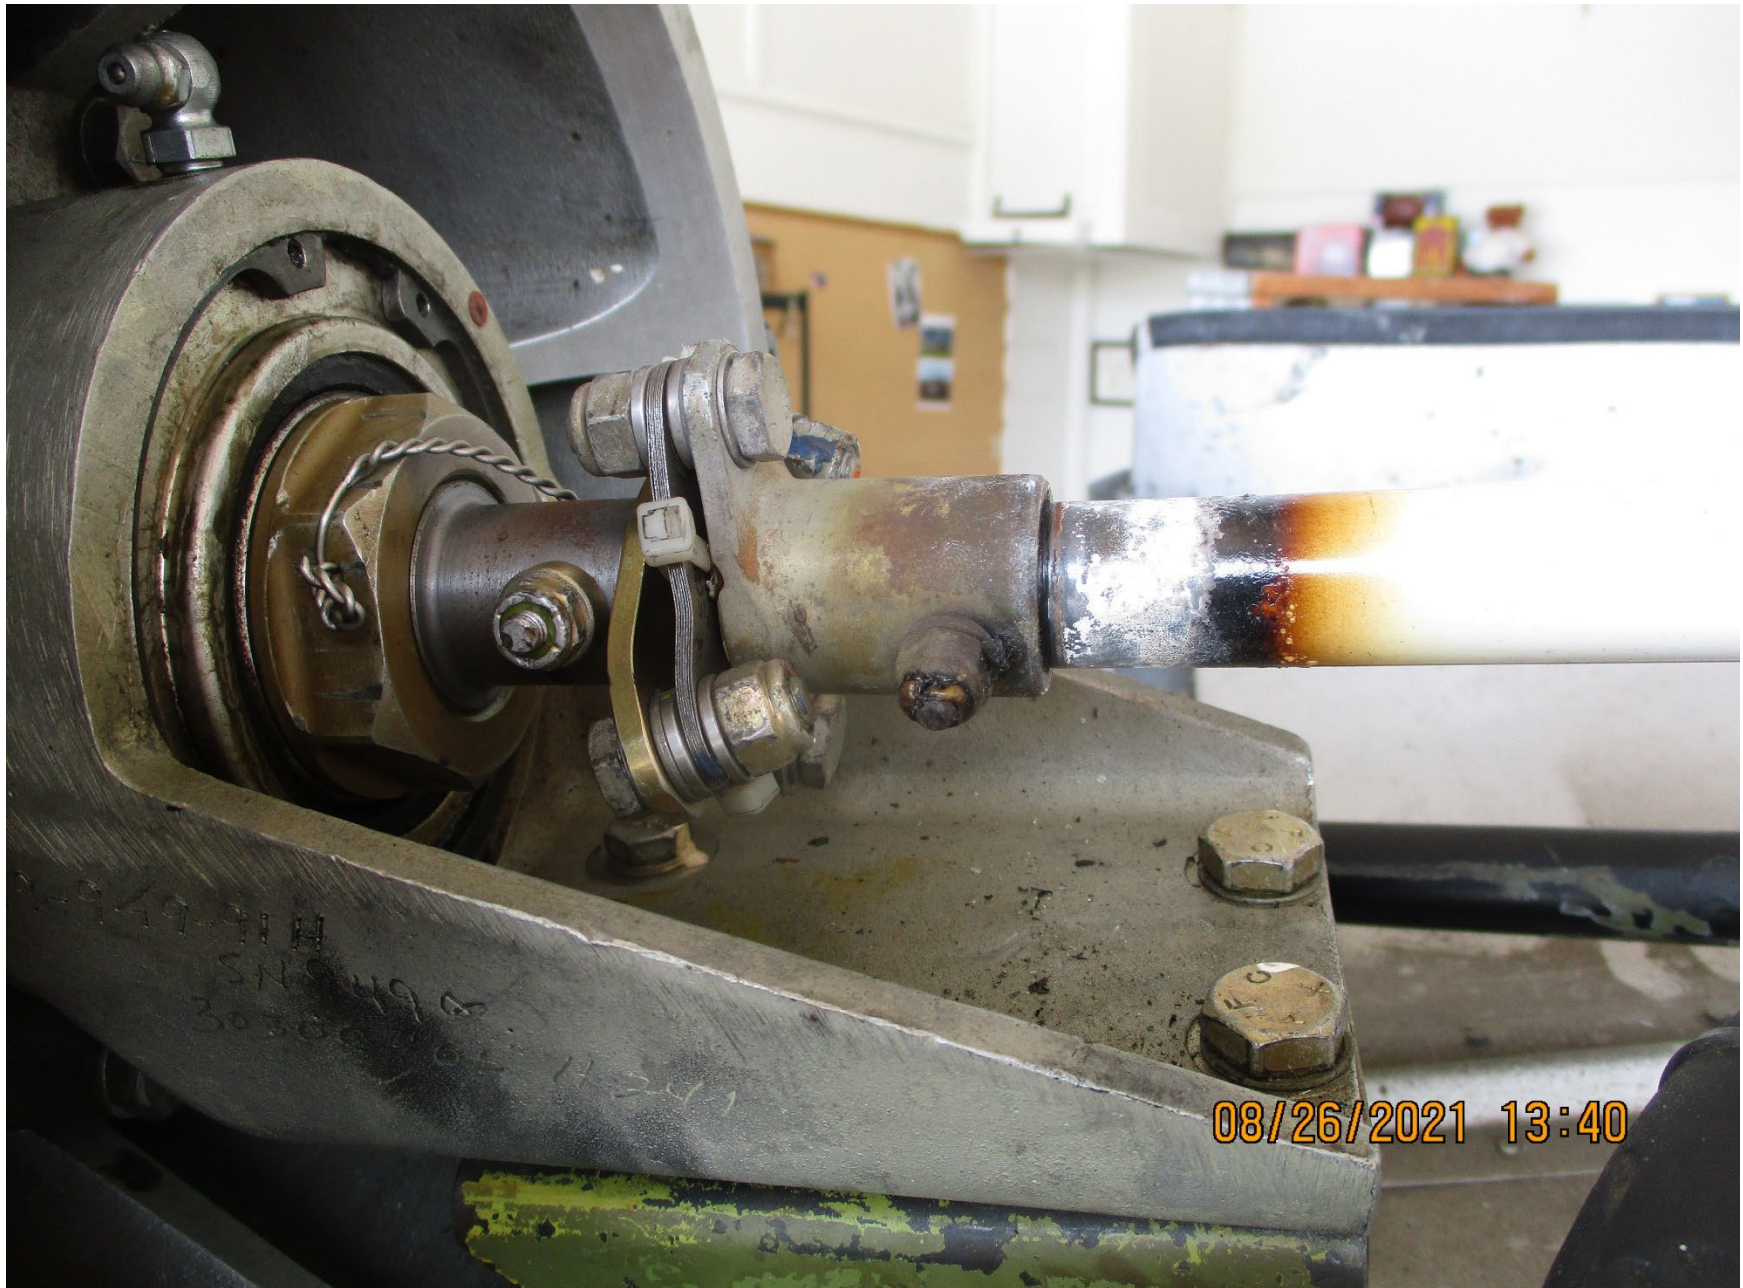
**Photo 4 – driveshaft with burn pattern**

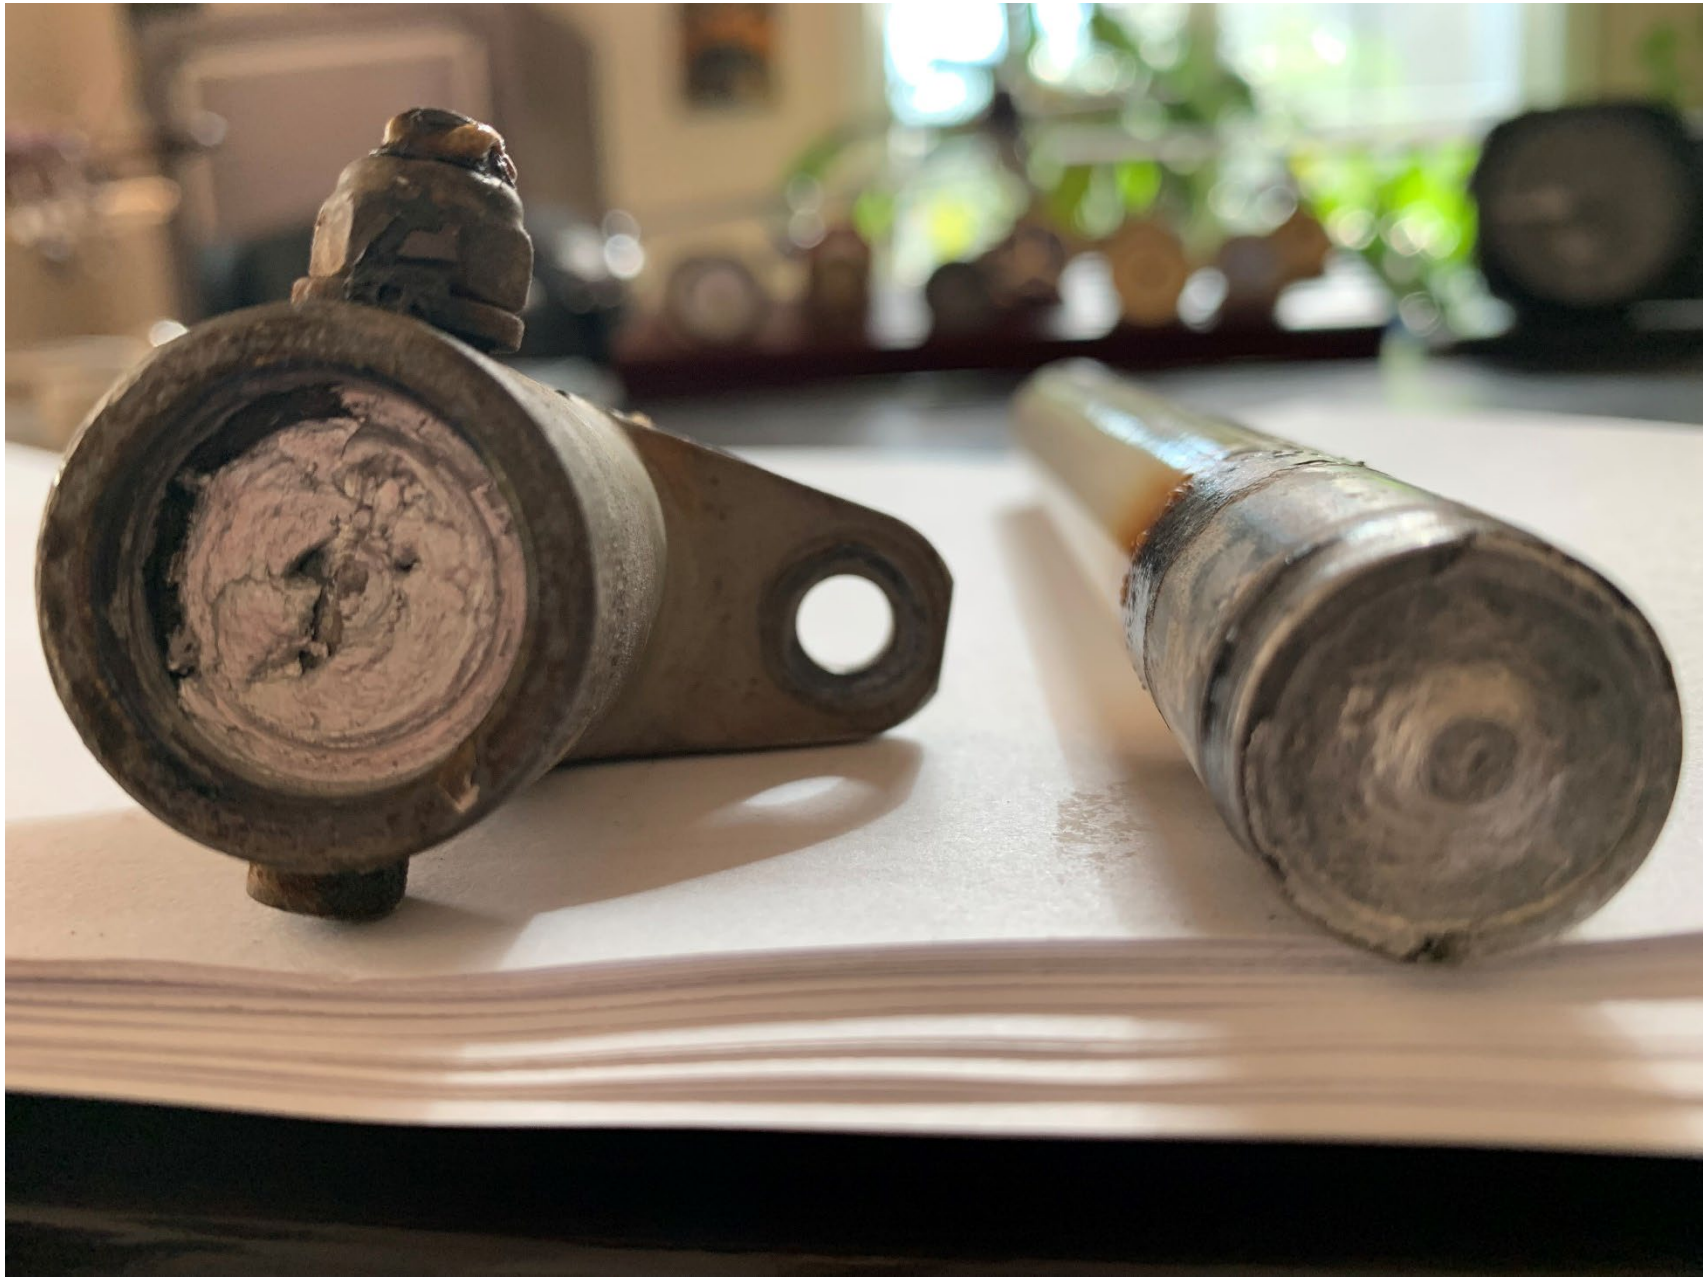
**Photo 5 – driveshaft coupling, plug**
