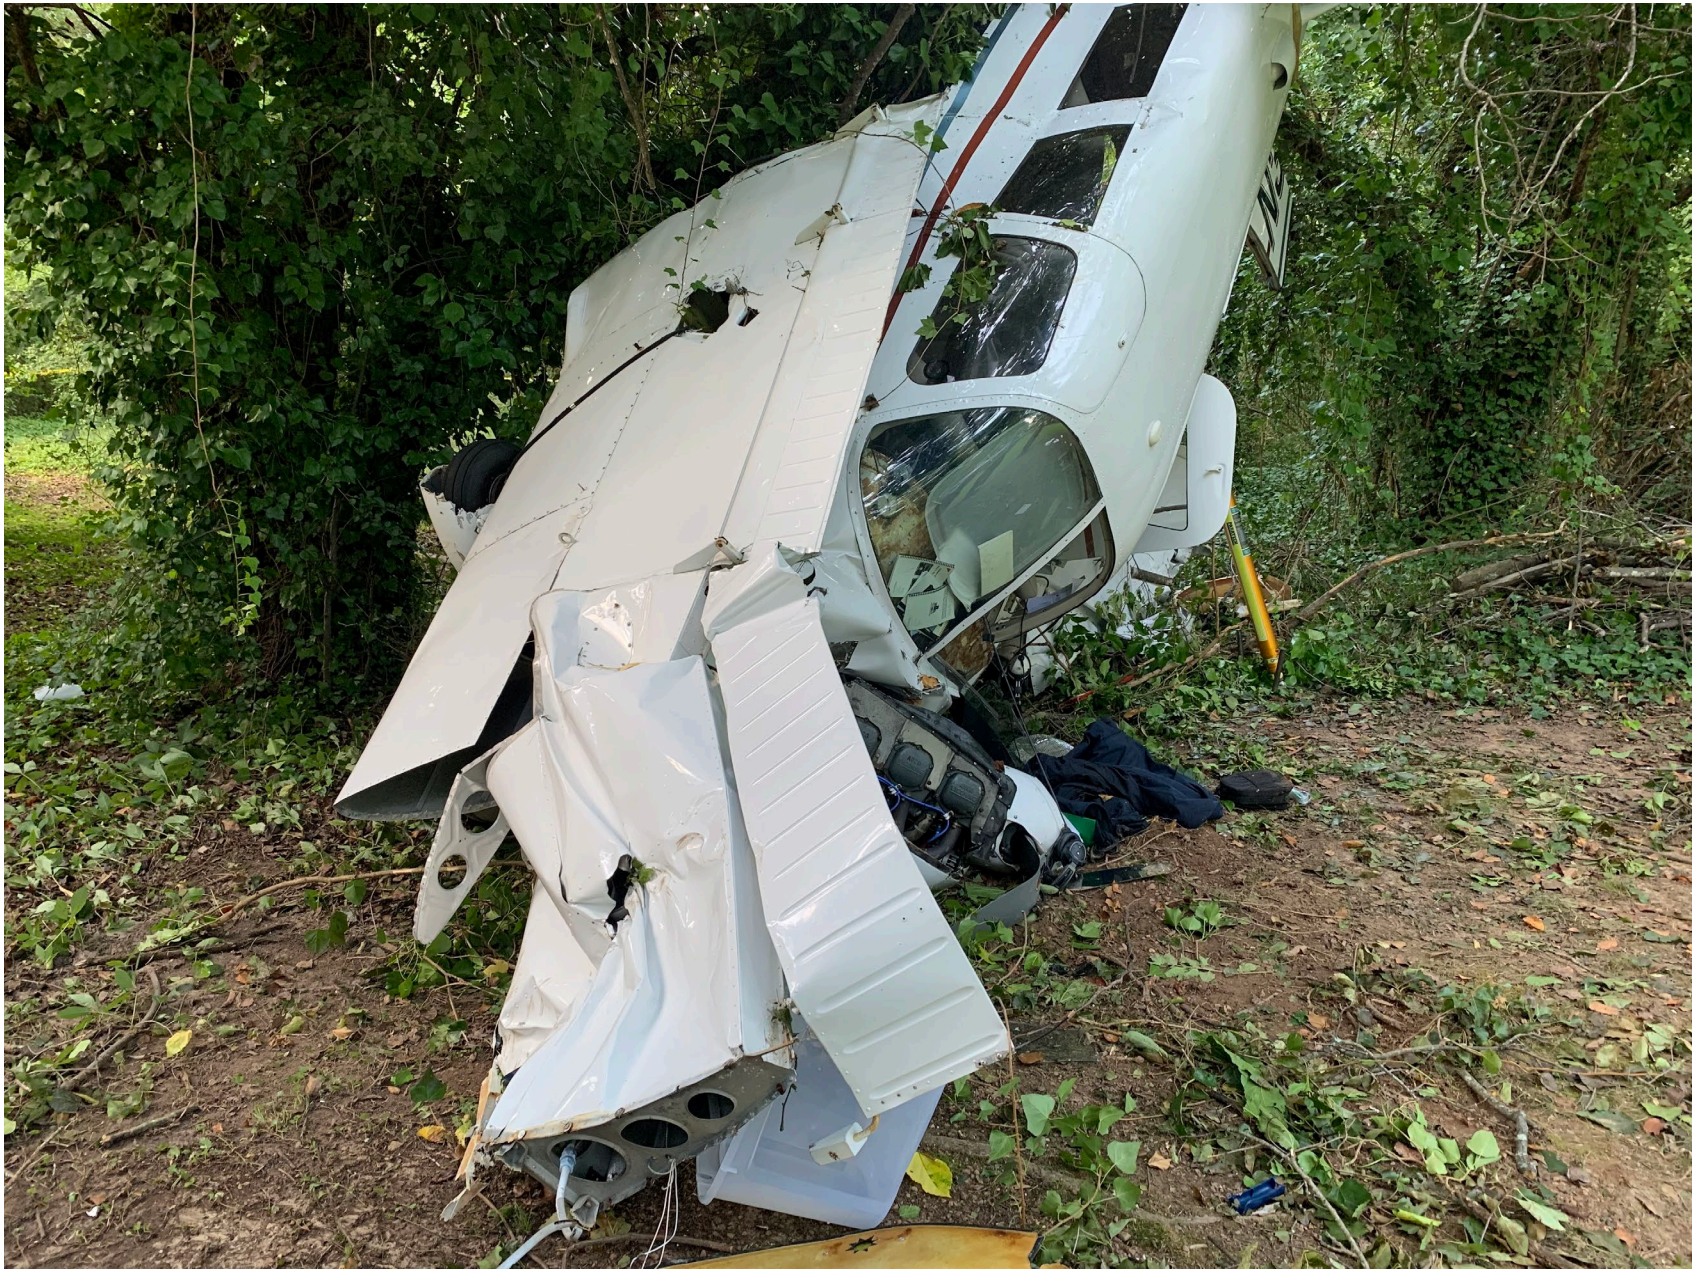
**Photo 1 – View of wreckage as it was discovered up against trees. (Courtesy of FAA)**

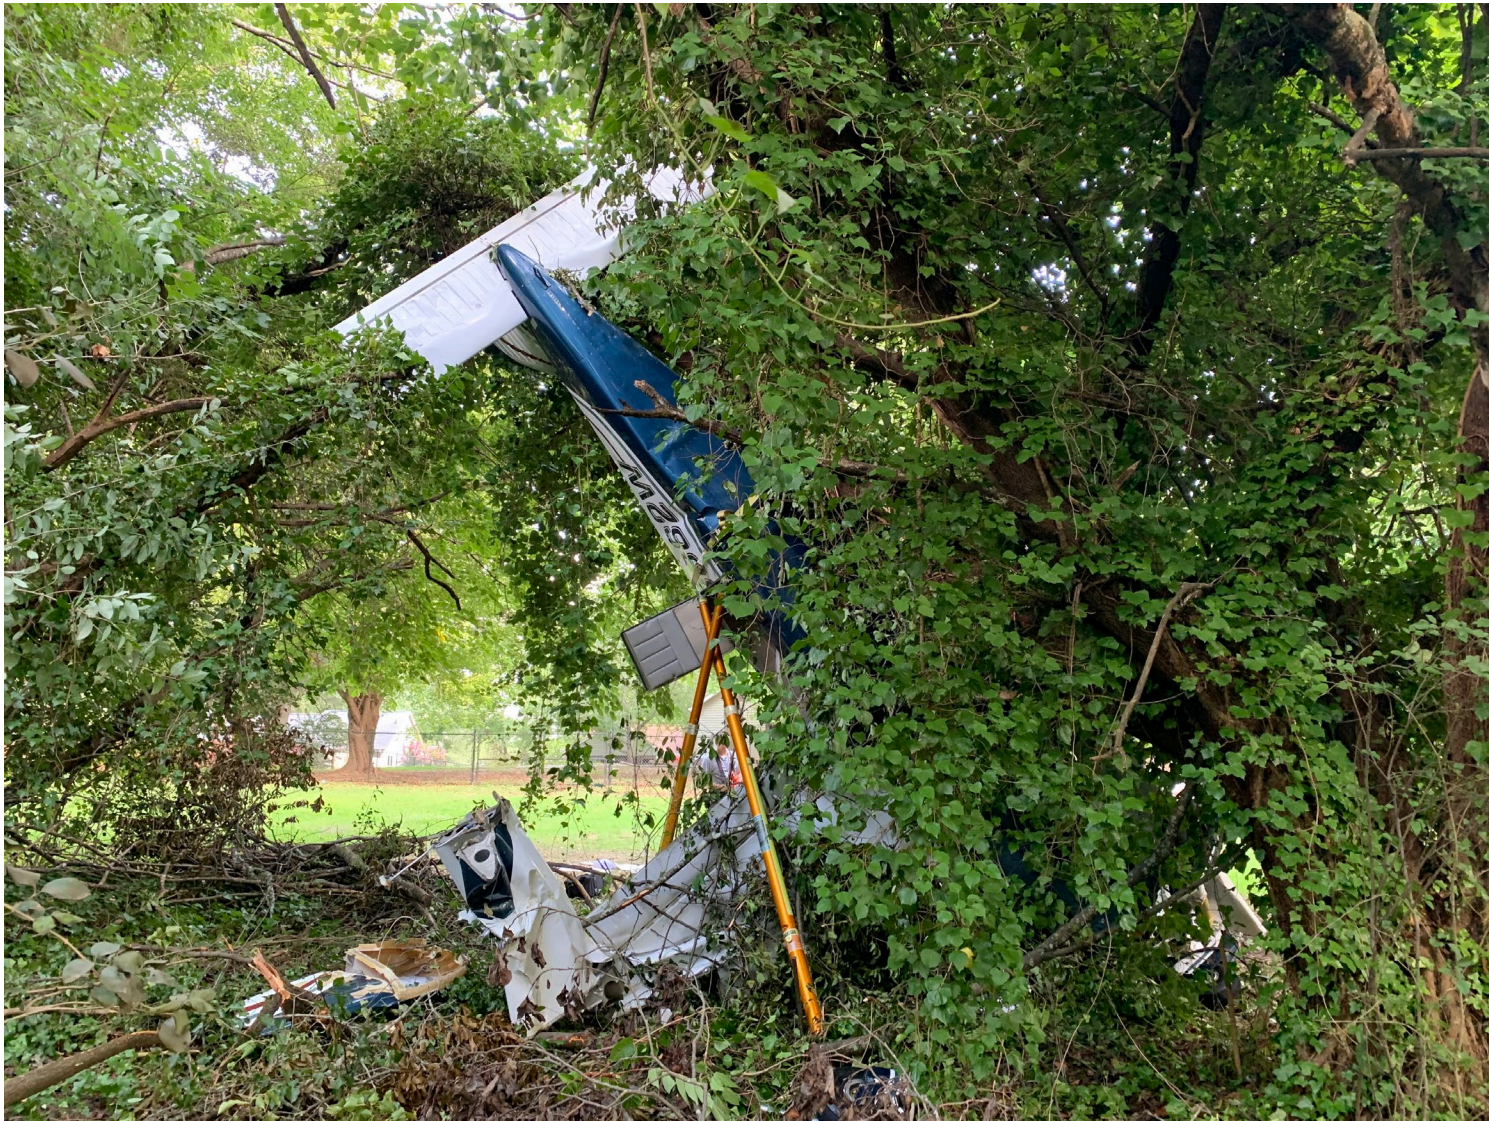
**Photo 2 – View of empennage and left wing resting against trees. (Courtesy of FAA)**

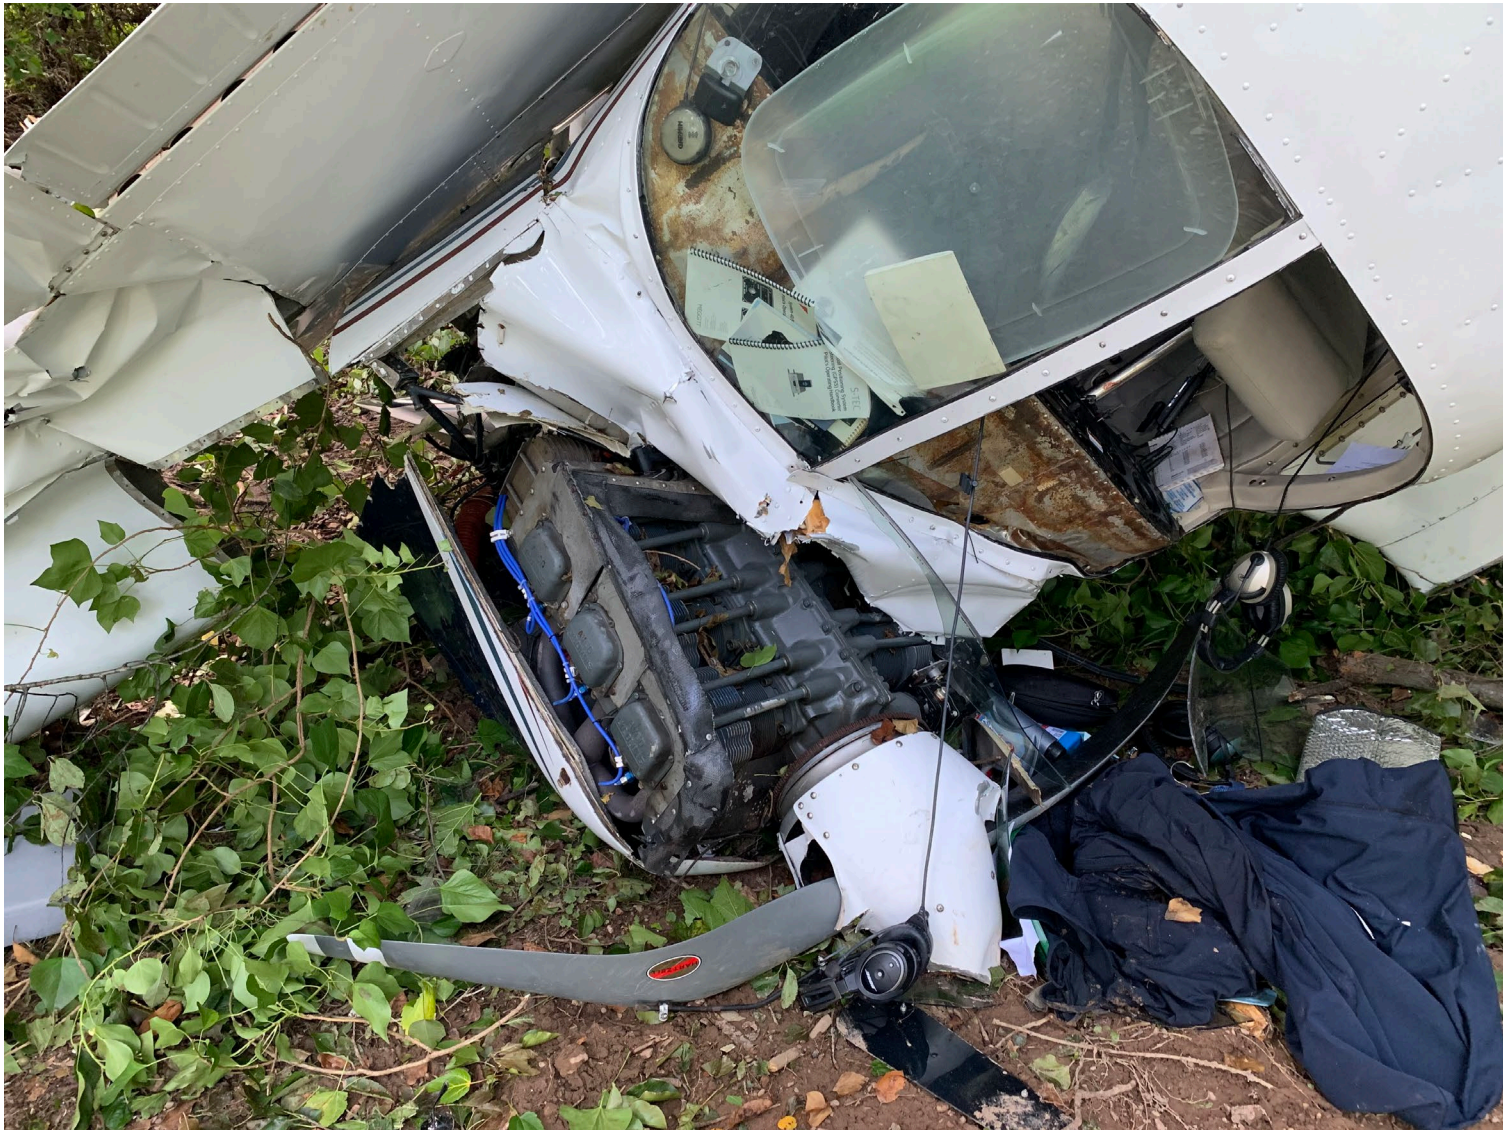
**Photo 3 – Closeup view of engine, propeller, and cockpit damage. (Courtesy of FAA)**

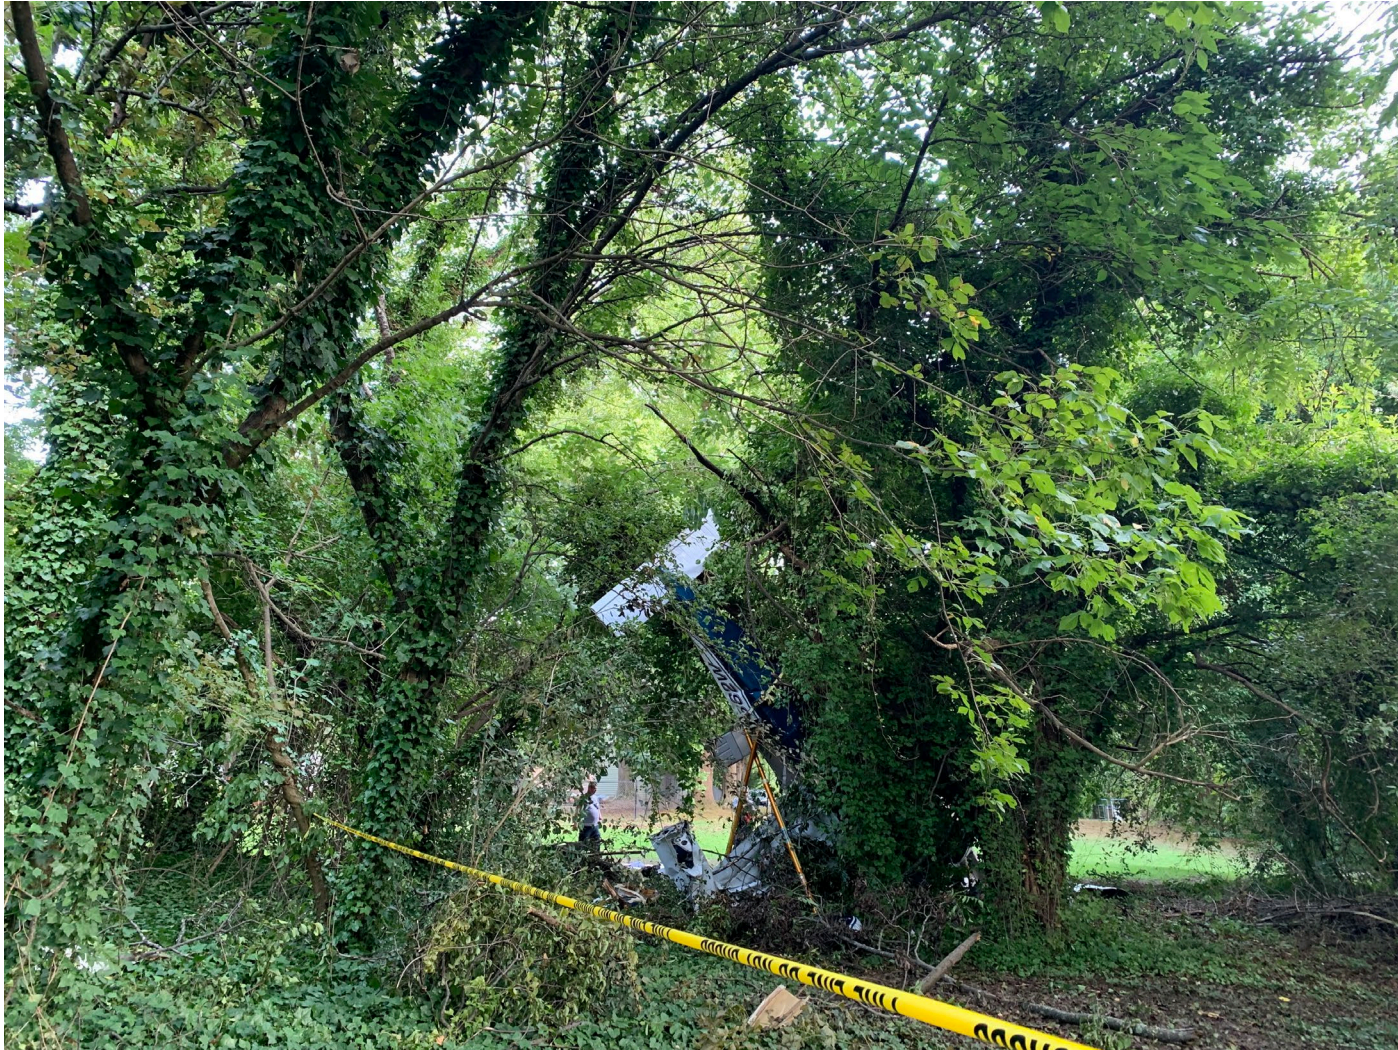
**Photo 4 – Wide view of bottom side of airplane and empennage in the trees. (Courtesy of FAA)**

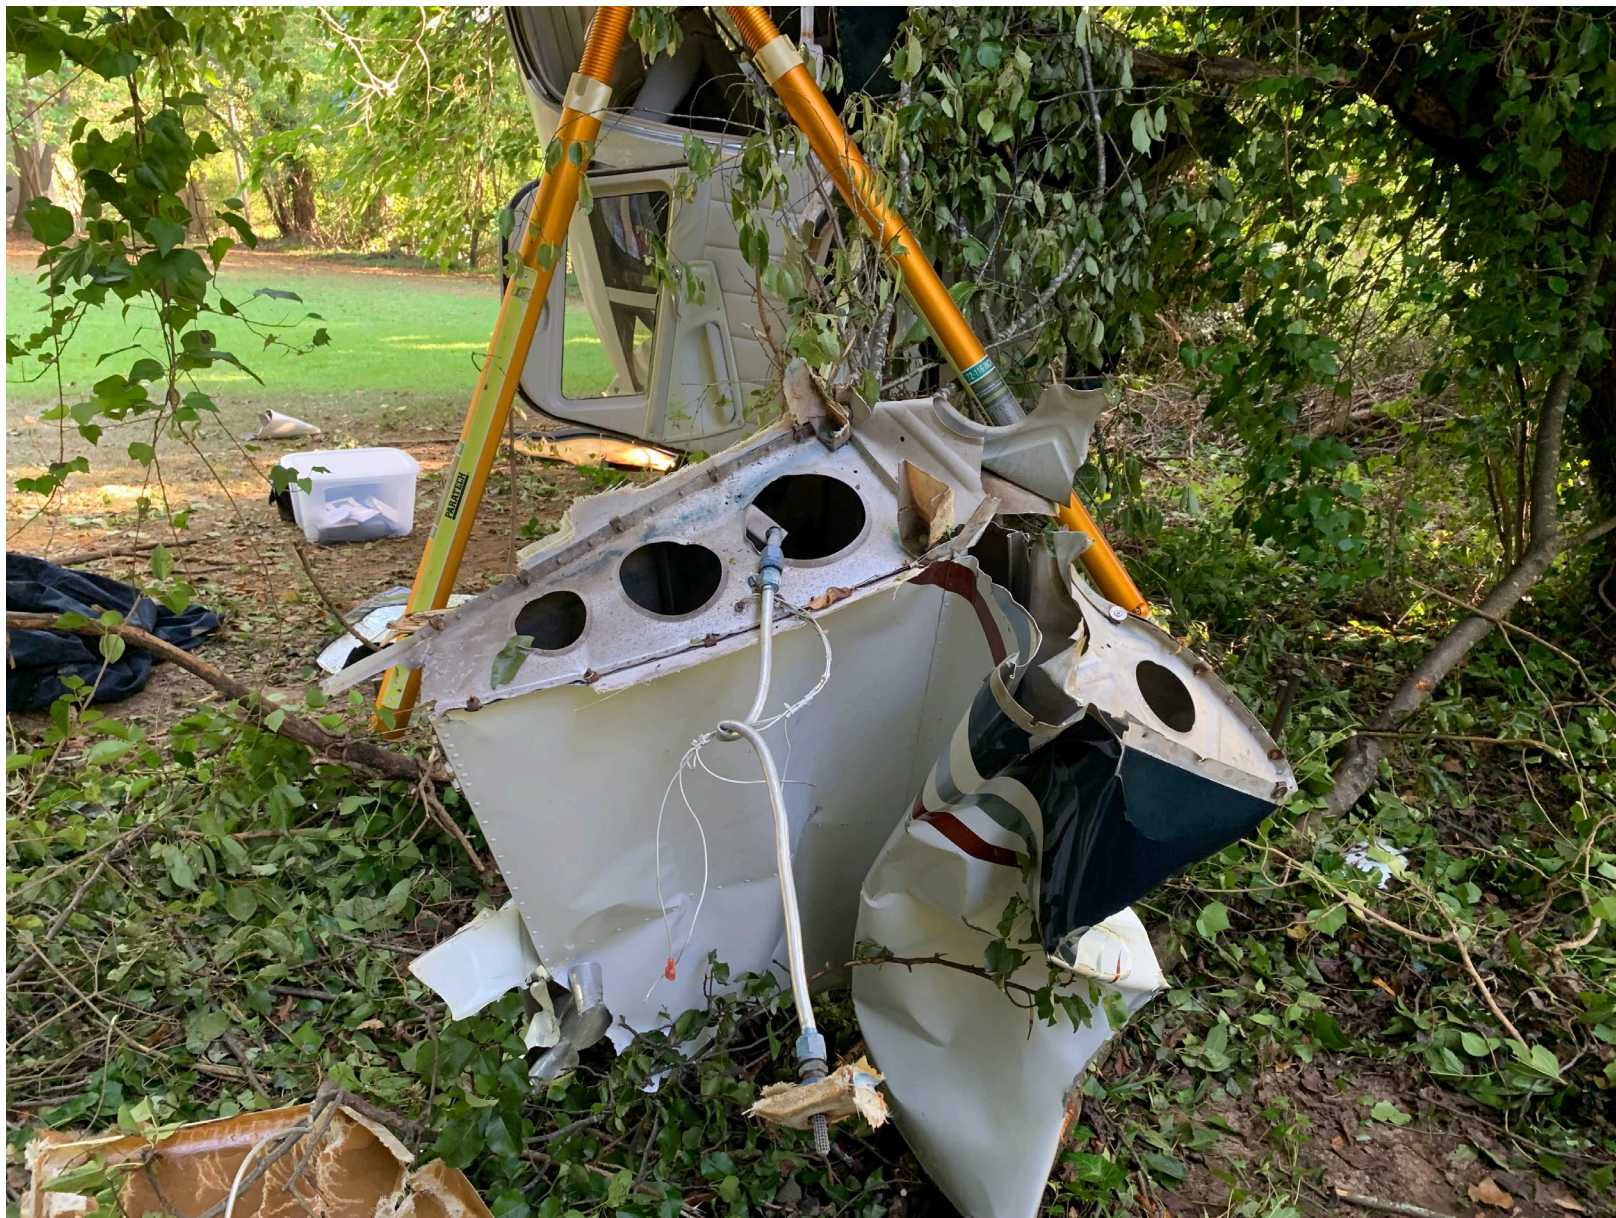
**Photo 5 – Closeup view of left wing damage. (Courtesy of FAA)**

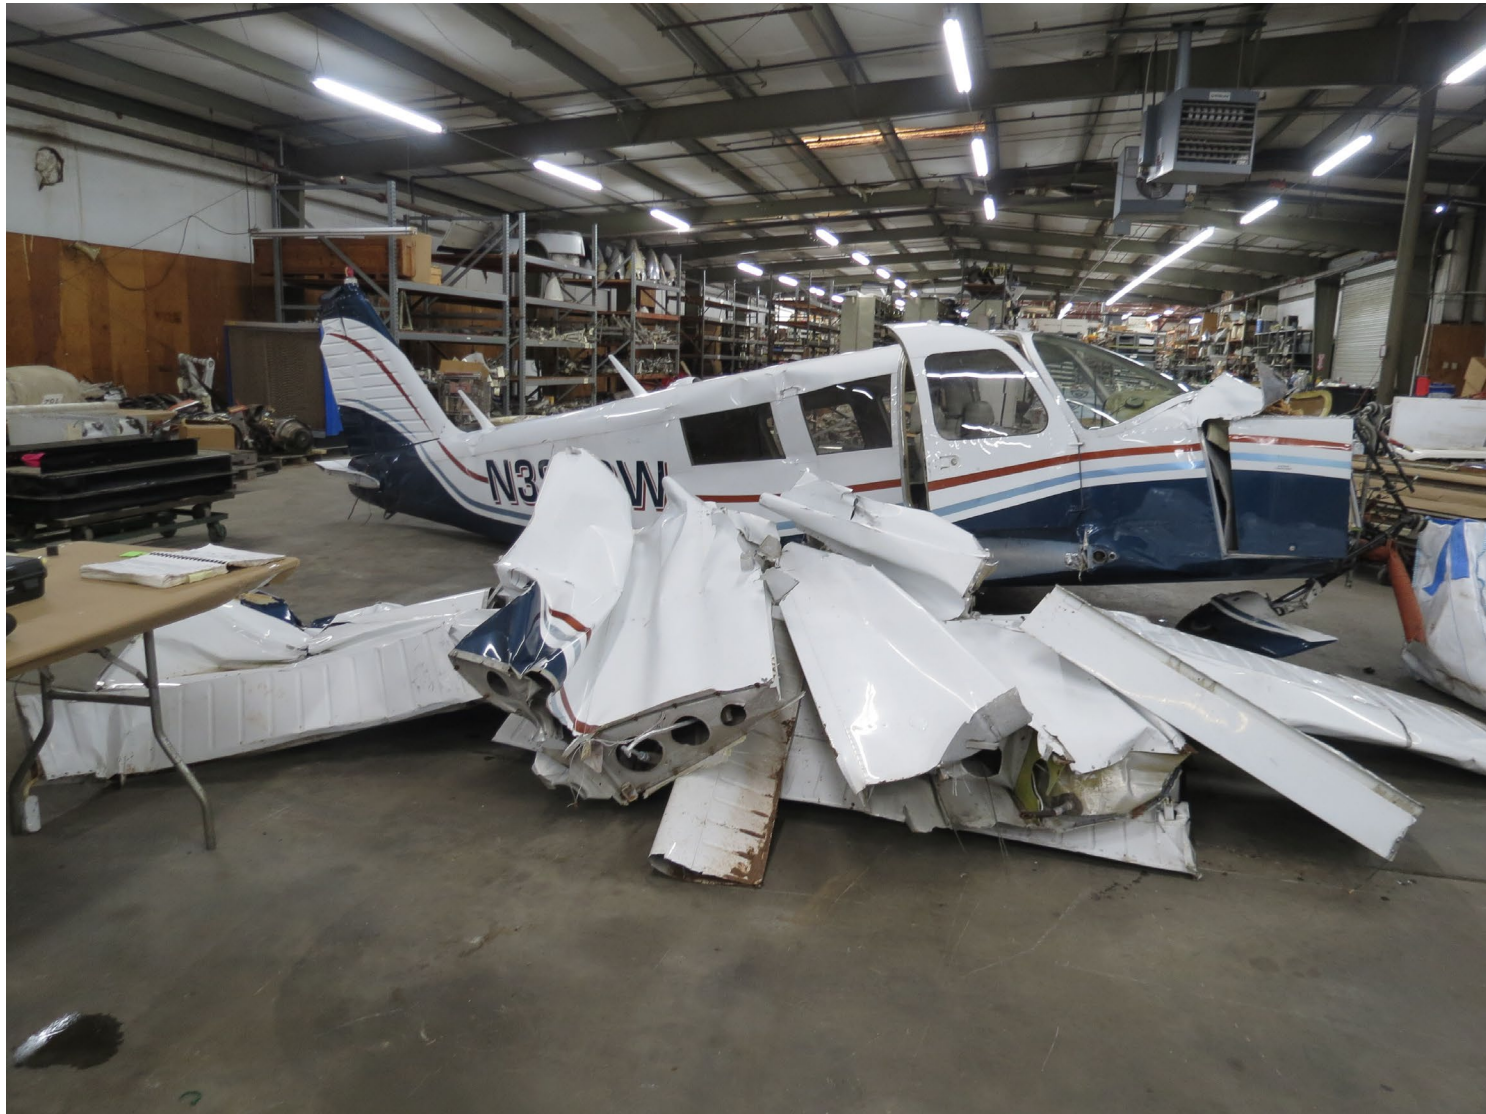
**Photo 6 – Post recovery view of wreckage in examination facility. (Courtesy of Lycoming)**

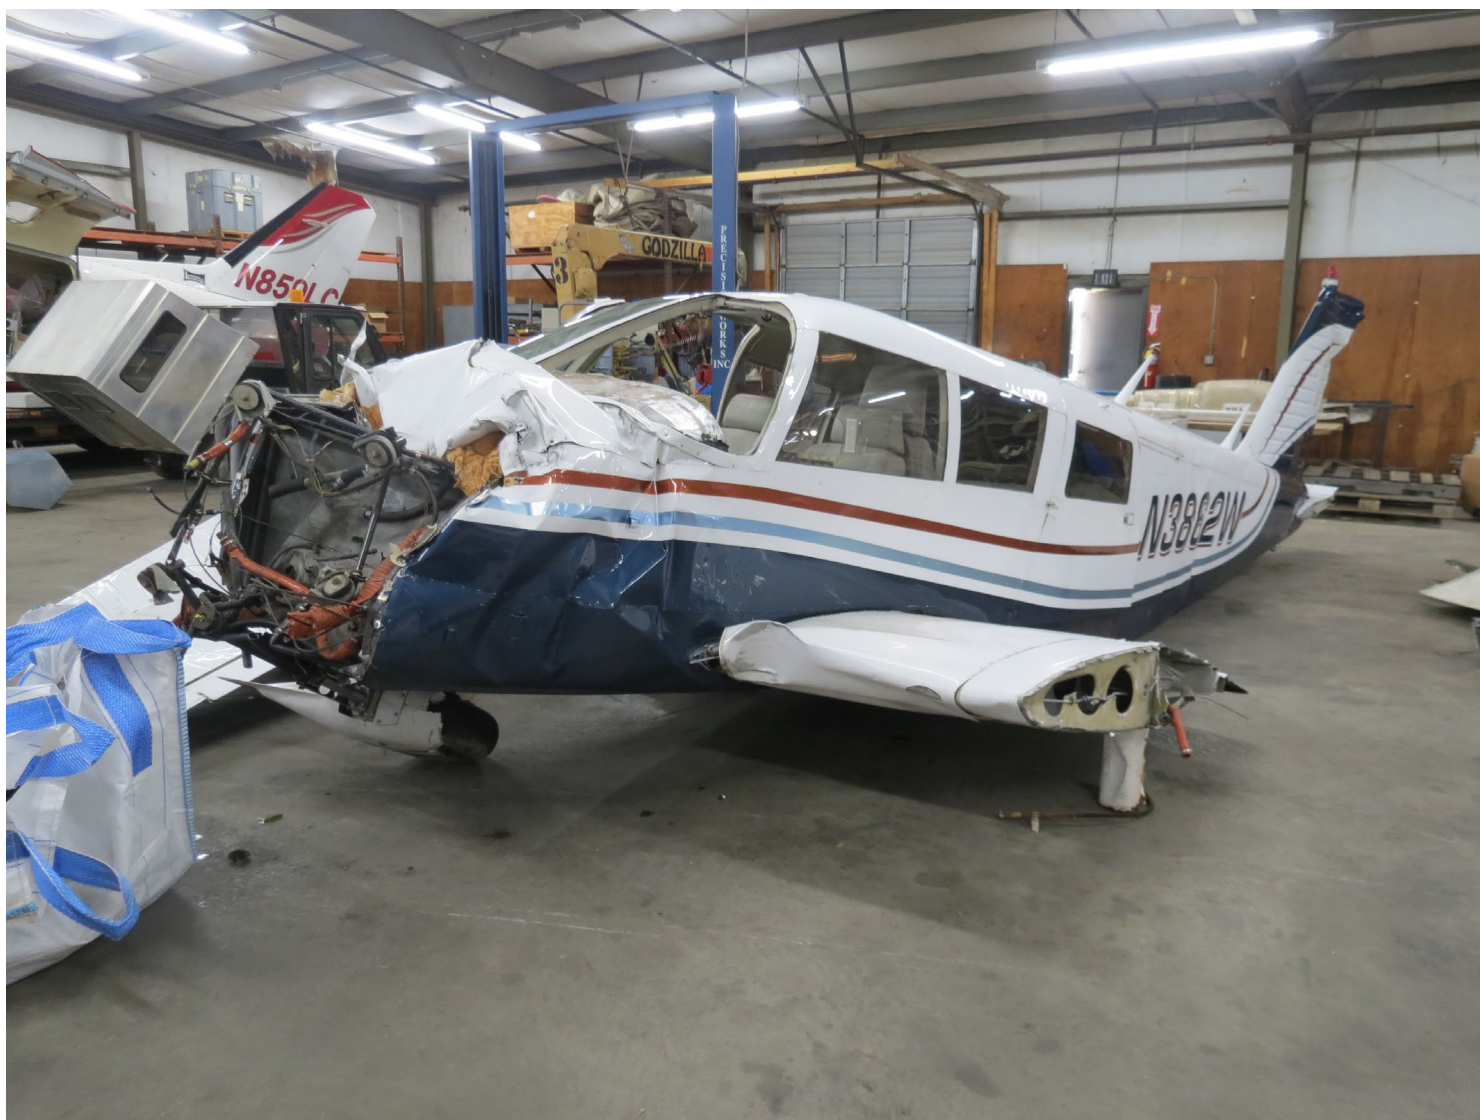
**Photo 7 – Left front quarter view of wreckage post recovery. (Courtesy of Lycoming)**

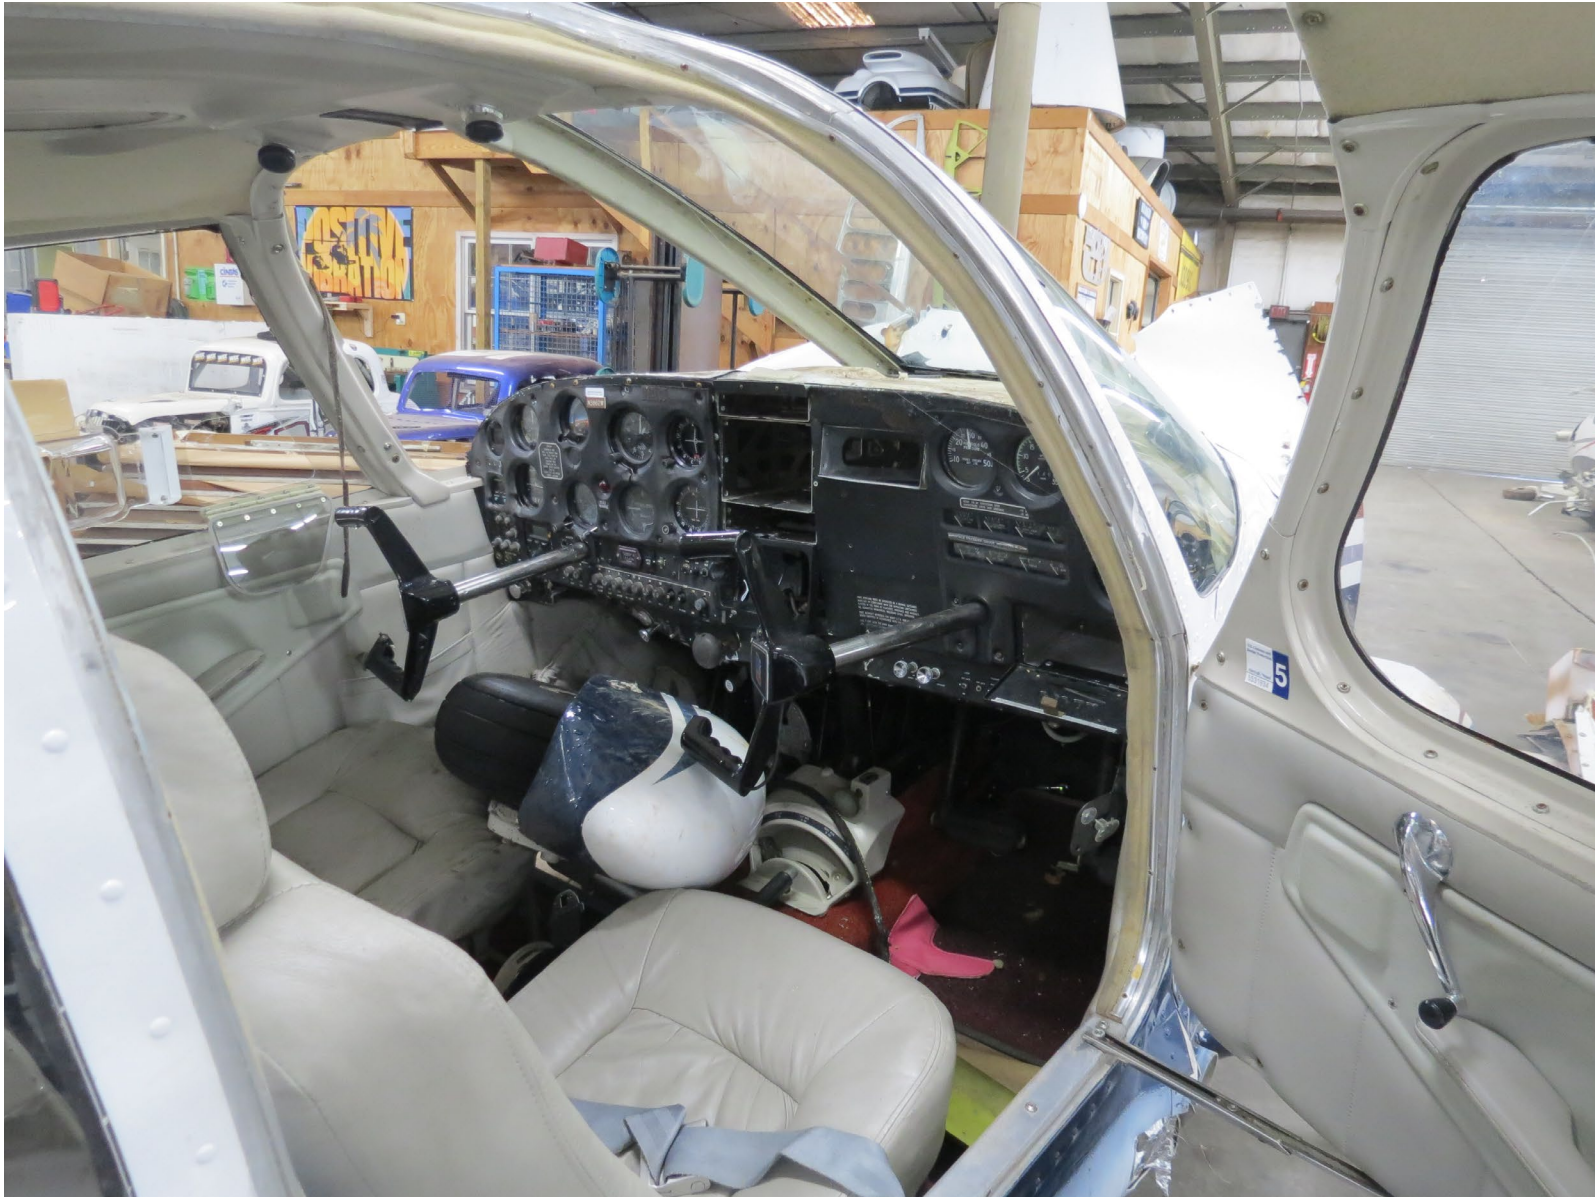
**Photo 8 – Cockpit and instrument panel. (Courtesy of Piper)**

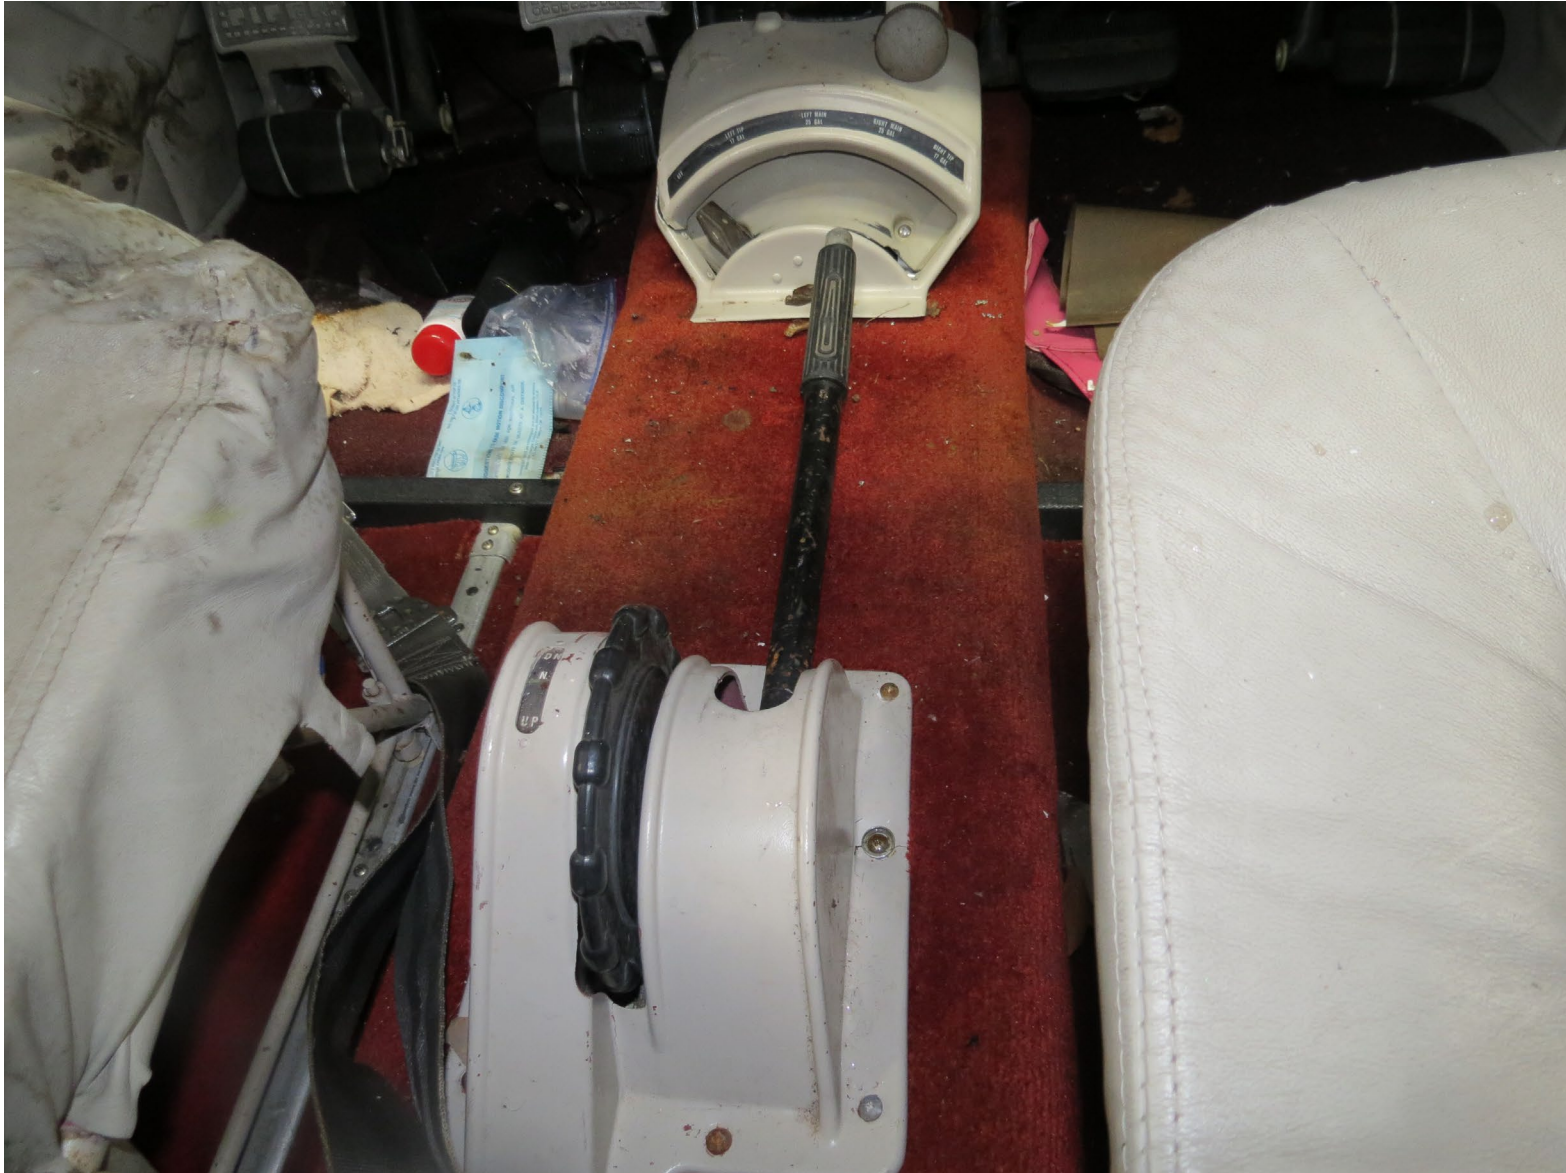
**Photo 9 – View of flap, trim and fuel selectors. Note fuel selector in off position, but after the accident it was found on the Left tank. (Courtesy of Piper)**

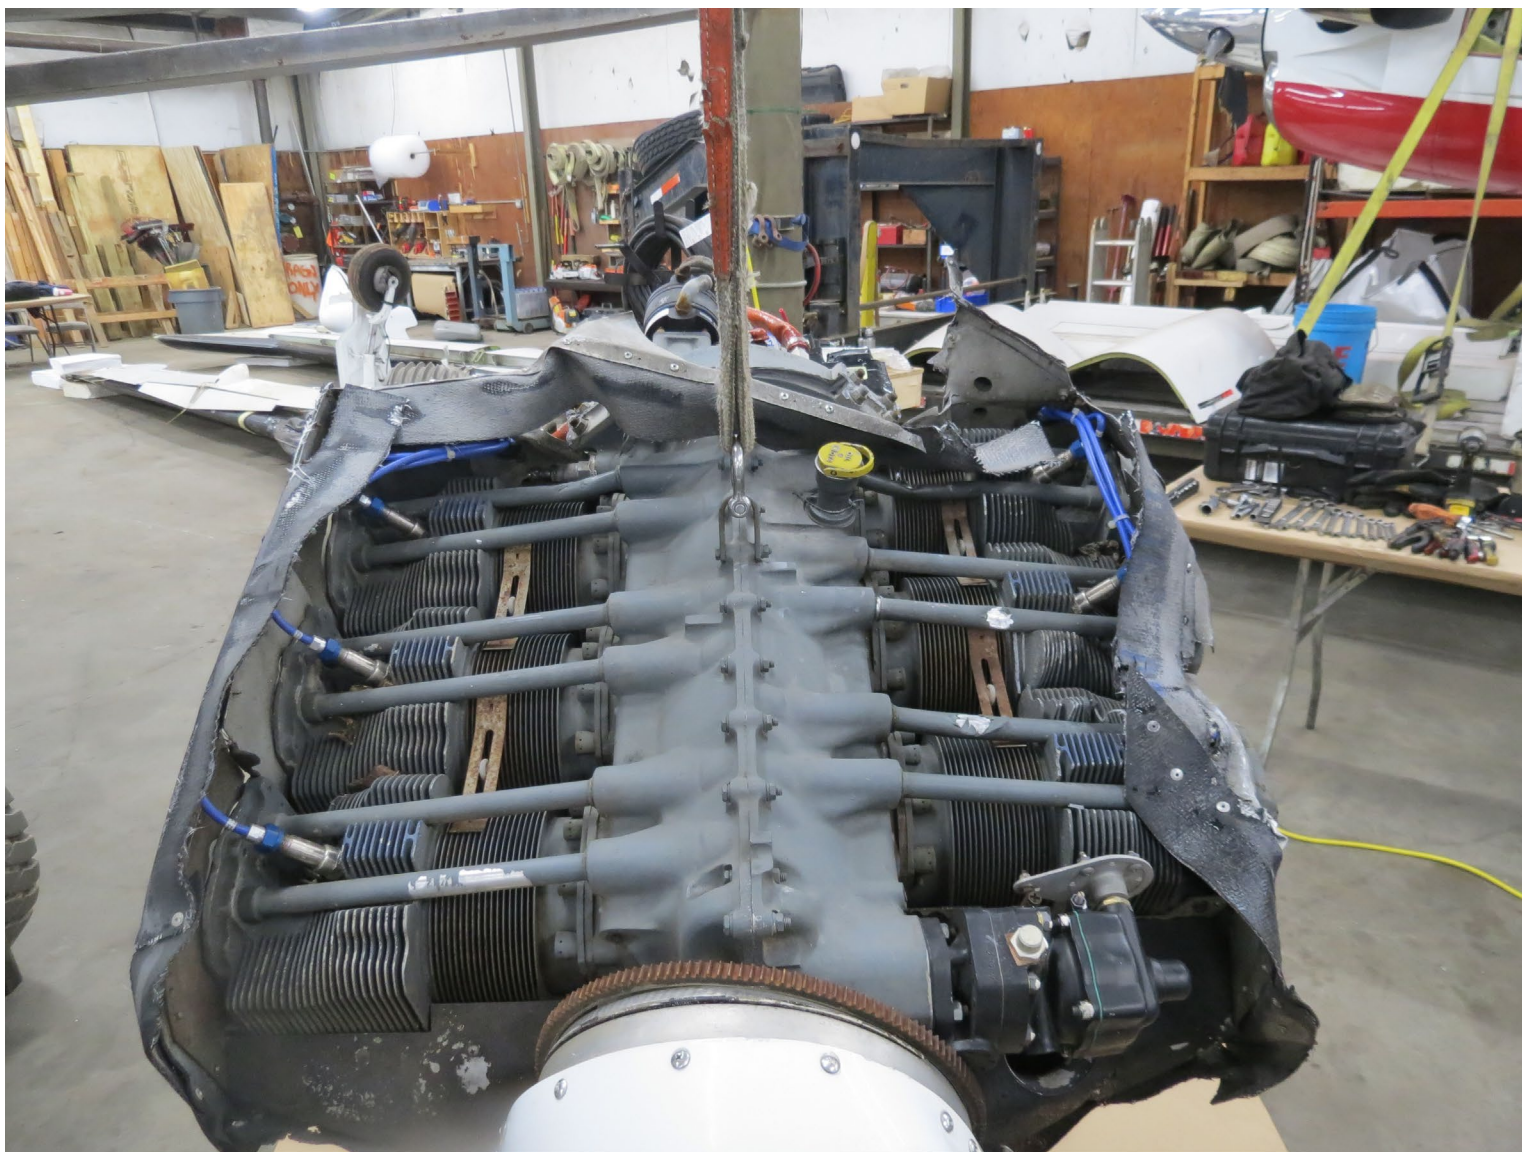
**Photo 10 – View of top side of engine looking aft. (Courtesy of Lycoming)**

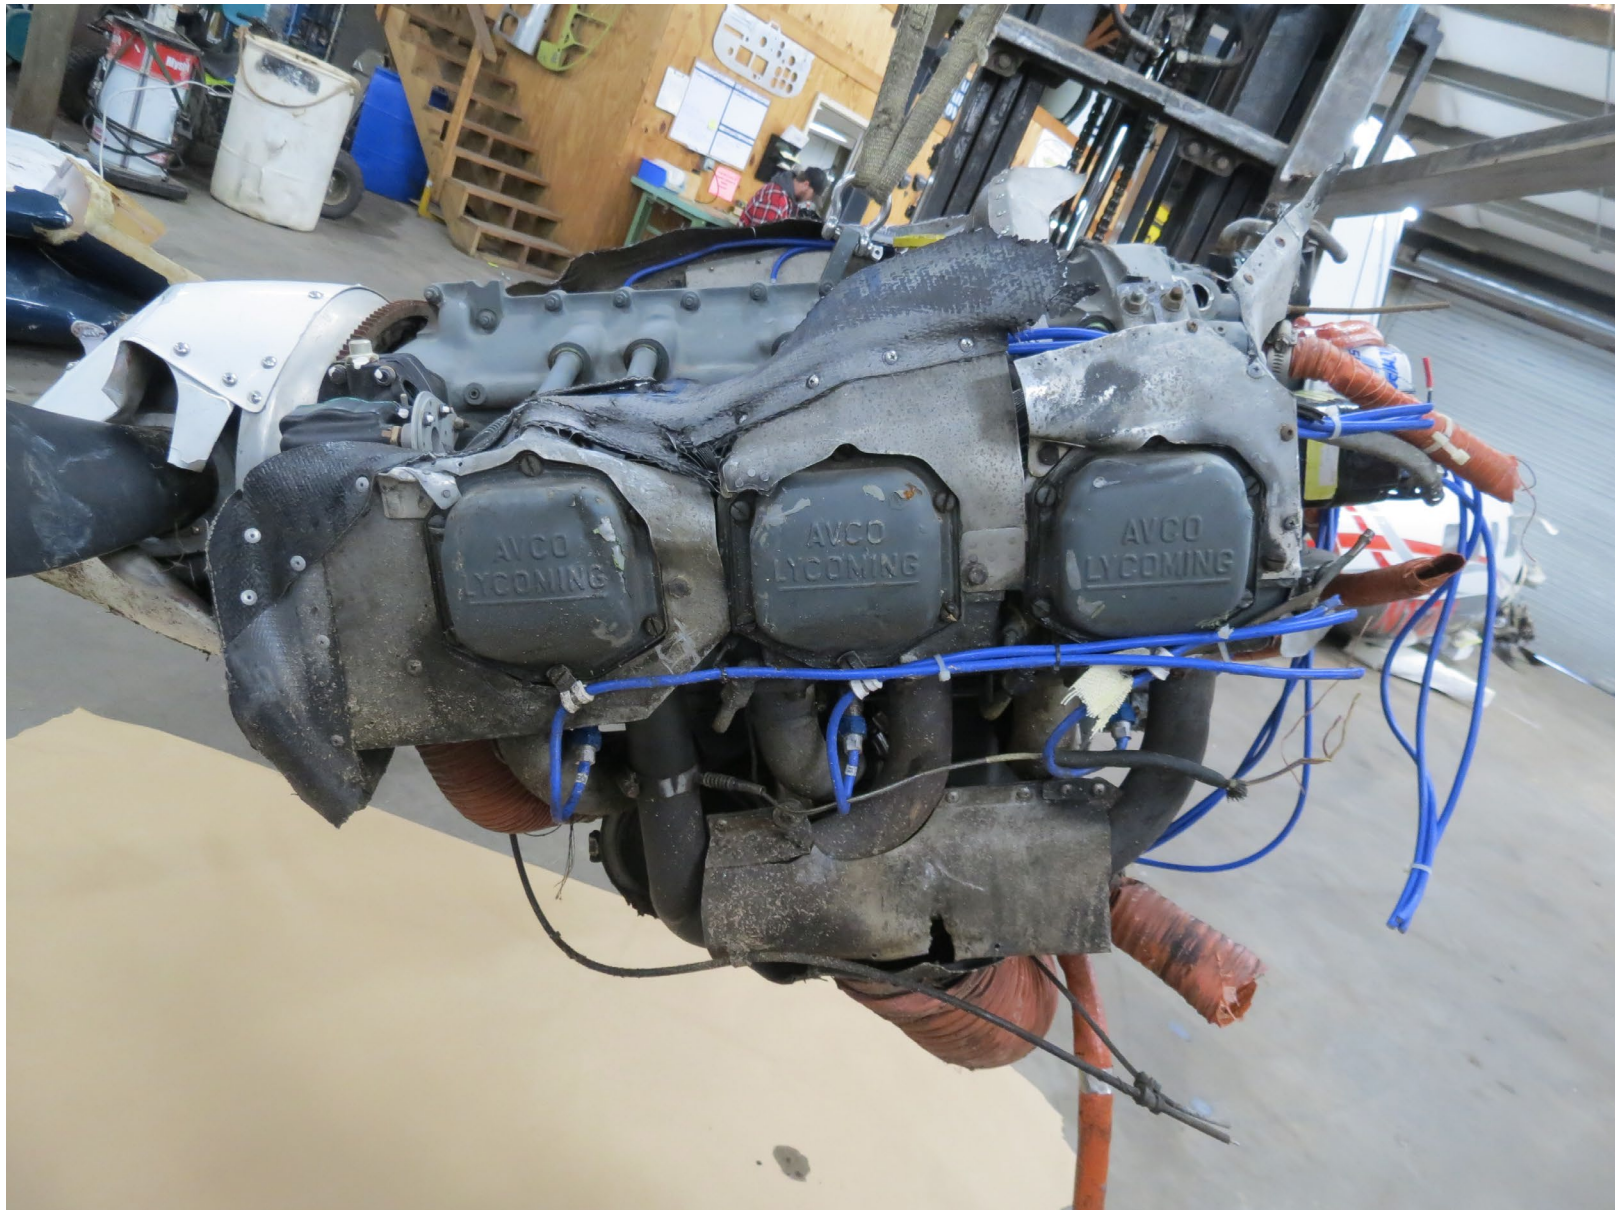
**Photo 11 – View of left side of engine. (Courtesy of Lycoming)**

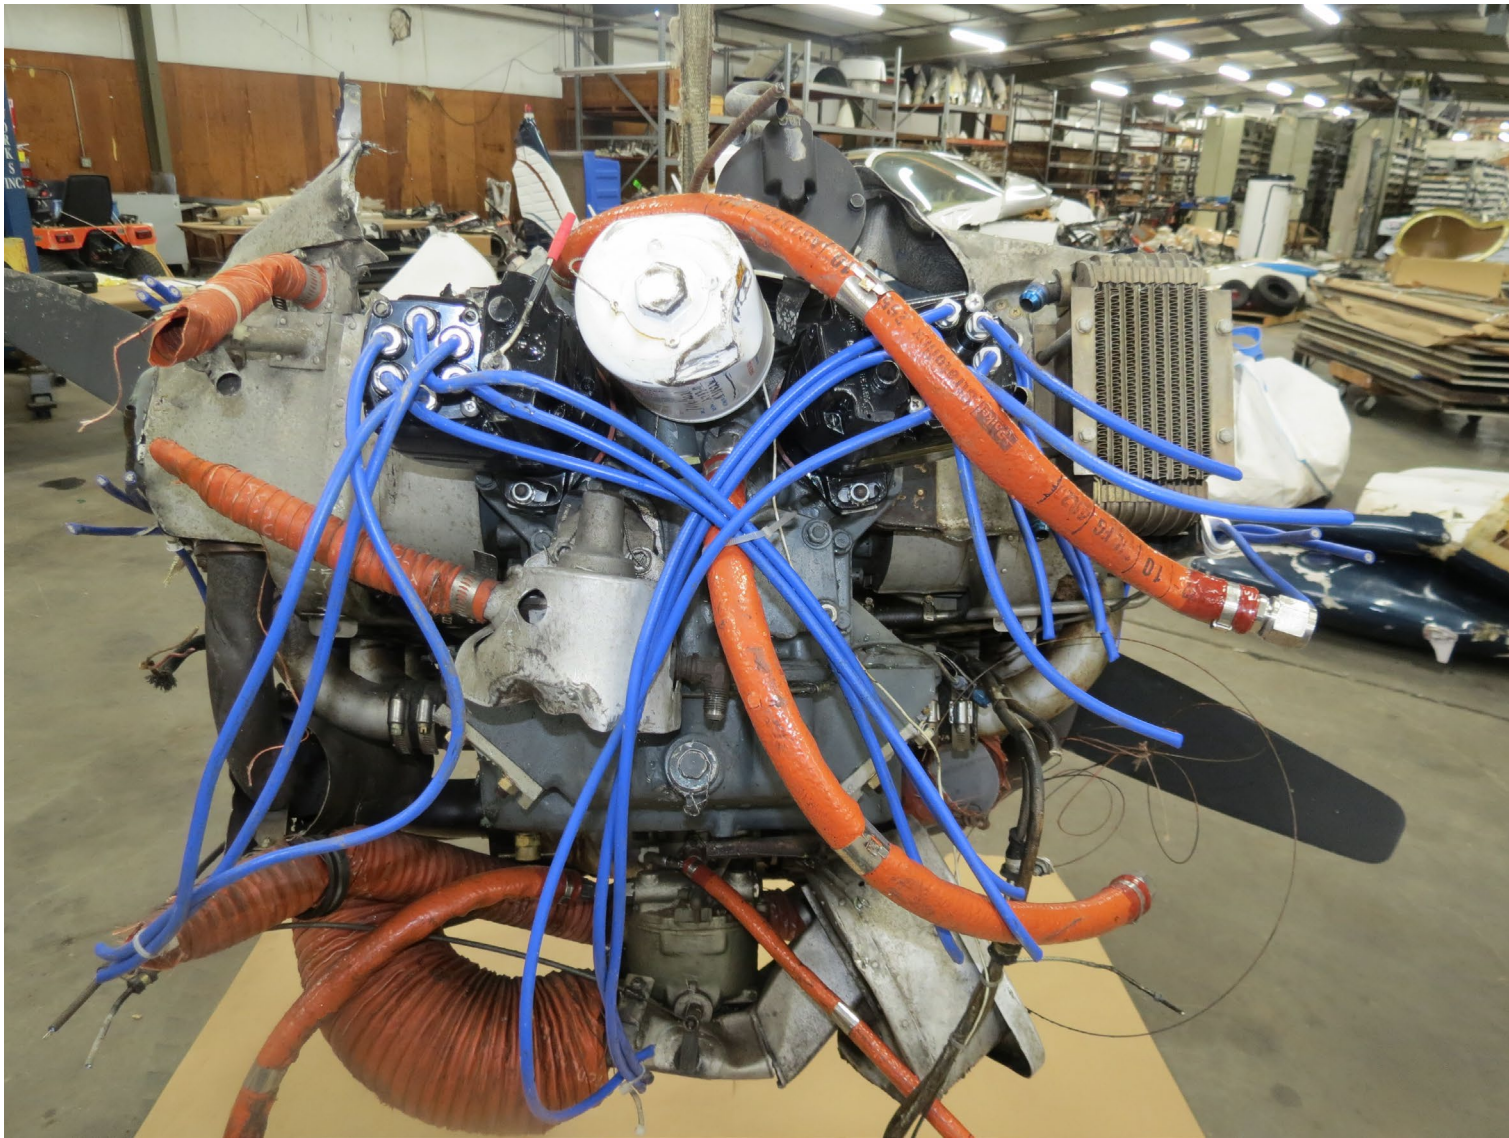
**Photo 12 – View of aft accessory section of engine. (Courtesy of Lycoming)**
