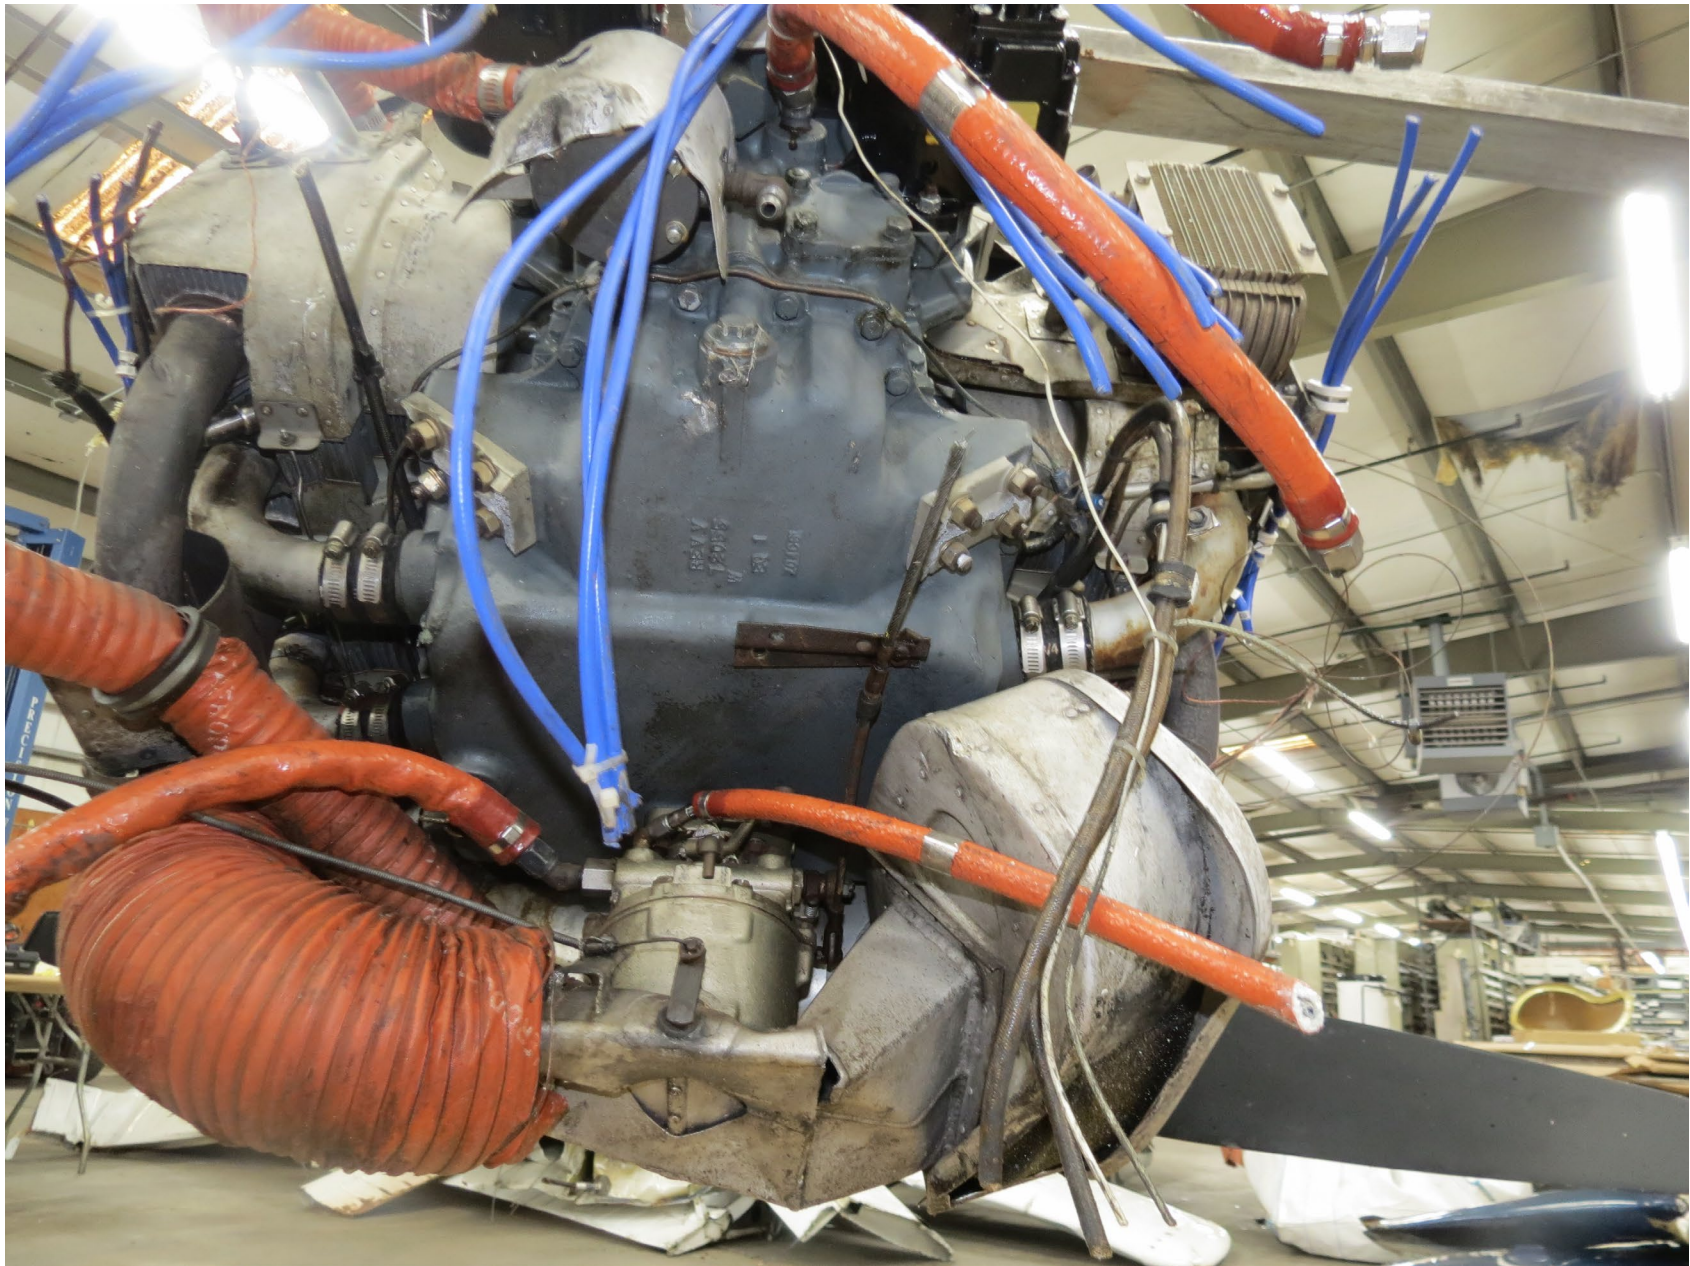
**Photo 13 – View of aft underside of engine showing the carburetor assembly. (Courtesy of Lycoming)**
