**NATIONAL TRANSPORTATION SAFETY BOARD**  
Office of Aviation Safety  
Aerospace Engineering Division  
Washington, DC 20594

**COMPONENT EXAMINATION FACTAL REPORT**

Place : Naples, FL  
Date : September 3, 2021  
Vehicle : Raytheon 390 / N351CW  
NTSB No. : ERA21LA350  
Investigator: D. Boggs

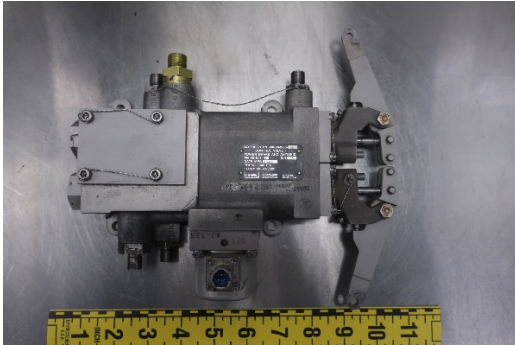
Photo 1 - Power brake and anti-skid control valve assembly.

No physical damage were noted to the control valve assembly. There were no caps on any electrical or hydraulic ports or connections. The right brake “out” port’s safety wire was present but broken. All other fasteners and ports had safety wire installed. The electrical canon plug connection had all 3 pins present, they were straight, and no corrosion was observed. Both arms (metering valve levers) could be physically moved and automatically returned to original position.

| Right Power Brake Full Brake Pressure (Sec 5.4.1) | Right brake maximum pressure output was 30psi below specified minima (1415 psi). |
| Leakage on Brake (Sec 5.11.1) | Exceeded allowable leakage rates |
| Retraction Brake Pressure Leakage (Sec 5.15.1) | Exceeded allowable leakage rate |

Note: Some internal leakage was identified that exceeded the ATP limits, however, this is considered normal for an in-service unit of this age (20 years). The unit would have been capable of providing commanded brake pressure to the brake assemblies.

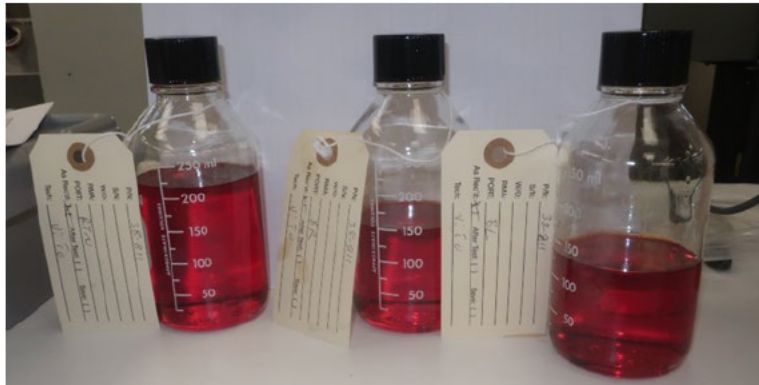
Removed all the safety wire from the assembly. Test procedure TP38-811-1 was followed. The hydraulic ports connectors were removed and replaced with connectors for the test bench. The valve assembly was placed into the test fixture. The technician took fluid samples from the return port, left brake, & right brake ports. The fluid is mixture of test bench fluid and what remained in the valve assembly. Performed ATP in accordance with TP38-811-1 (ATP data sheet included as Attachment 1). Hydraulic samples were tested for cleanliness. [REDACTED] All samples tested as contamination level Class 9.

Photo 3 - Three hydraulic fluid samples obtained from the valve assembly.

| Port | Results |
|---|---|
| Return | AS4059 Class 9F |
| Brake Right | AS4059 Class 9F |
| Brake Left | AS4059 Class 9F |

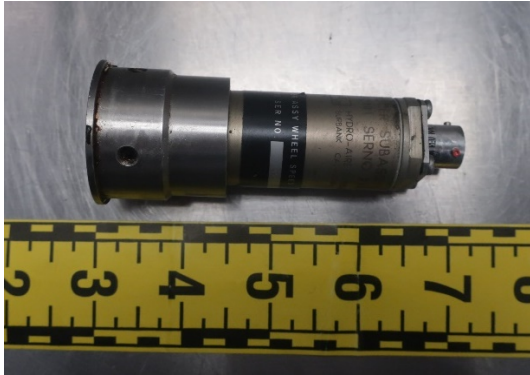
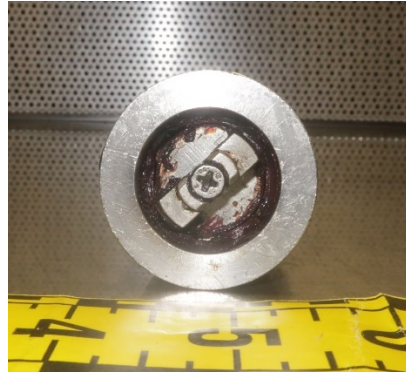
SN: 240

Photo 4- Wheel speed transducer SN: 240, side view.

Photo 5 - Wheel speed transducer SN: 240, view of the rotor.

The canon plug connector was absent. The canon plug receptacle pins (4) were undamaged, straight, with no signs of corrosion. There was no external damage, however, there was some wear and gouging on the axle adaptor. Grease was observed in the rotor chamber. The rotor moved when manually manipulated.

The acceptance test procedure (ATP), test plan TP140-221, was performed with all parameters found to be within test limits. [REDACTED]

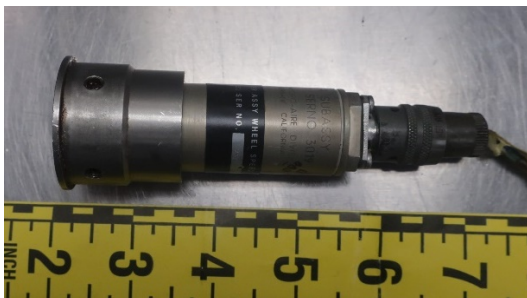
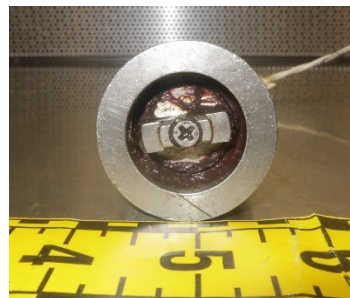
SN: 261

Photo 6 - Wheel speed transducer SN: 261, side view.

Photo 7 - Wheel speed transducer SN: 261, view of the rotor.

The canon plug remained attached to the transducer and was removed for the ATP. The canon plug receptacle pins (4) were undamaged, straight, with no observed corrosion. No external damage observed, however, there was some wear and gouging on the axel adaptor. There was grease in the rotor chamber. The rotor moved when manually manipulated.

The acceptance test procedure (ATP), test plan TP140-221, was performed with all parameters found to be within test limits. [REDACTED]

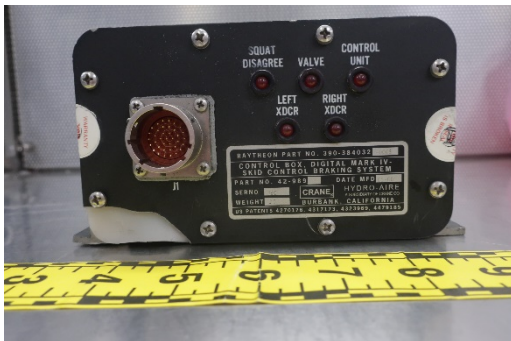
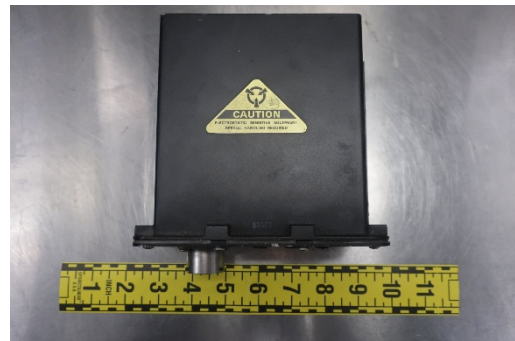
Photo 8 - Front face of the digital skid control box.

Photo 9 - Overhead view of the digital skid control box.

The face plate was damaged on the lower left corner. The mounting flange had damage to the rear left corner. The J1 canon plug pins were straight, no corrosion, with no observable pin damage. The factory seals were in place on left and right face plate edges.

Acceptance test procedure (ATP), TP42-989, Rev F, was performed. None of the LED fault indicator lights illuminated when power was applied to the unit. All test items were within test criteria limits. [REDACTED]
